**MINERALS PROGRAM INSPECTION REPORT**  
**PHONE: (303) 866-3567**

| <b>MINE NAME:</b><br>Henderson Mine | <b>MINE/PROSPECTING ID#:</b><br>M-1977-342 | <b>MINERAL:</b><br>Molybdenum | <b>COUNTY:</b><br>Clear Creek |
| <b>INSPECTION TYPE:</b><br>Monitoring | <b>WEATHER:</b> Clear | <b>INSP. DATE:</b><br>June 24, 2025 | <b>INSP. TIME:</b><br>09:00 |

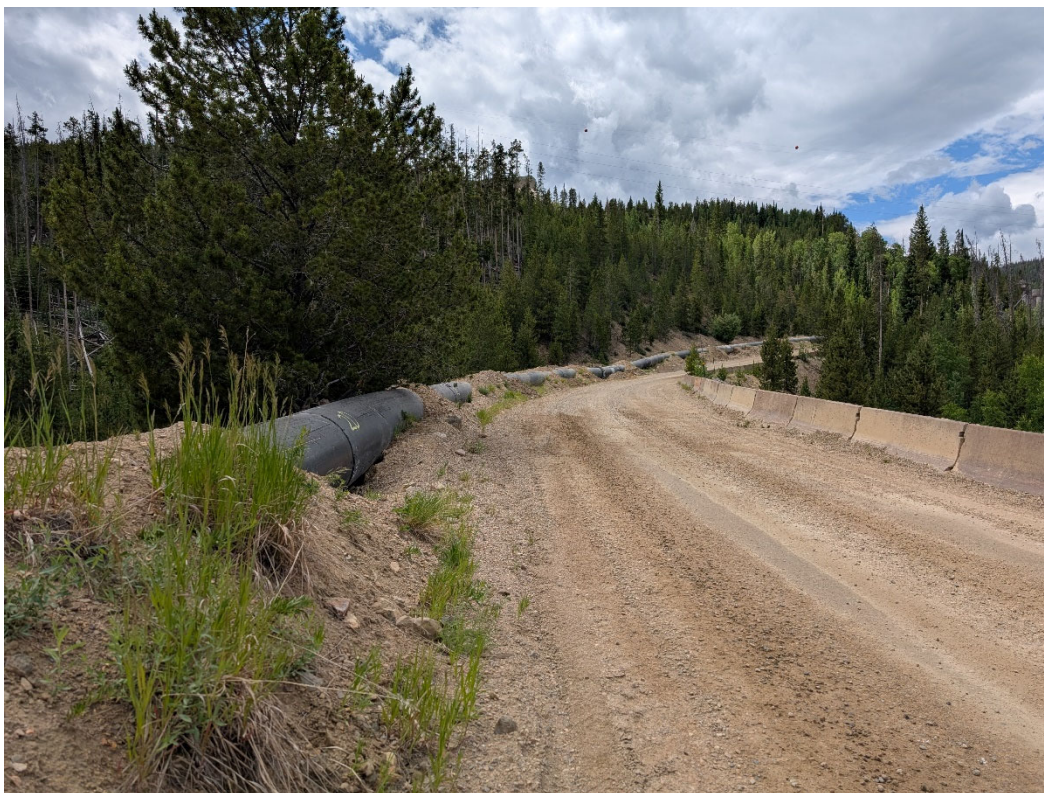
During this inspection, the Division observed the TDL above 3-Dam (Photos 1-3), noting a metal band installed where a hole was discovered during the June investigation (Photo 3).

Photo 2: Looking at the TDL along the road, adjacent to the Bear Paw Pipeline.

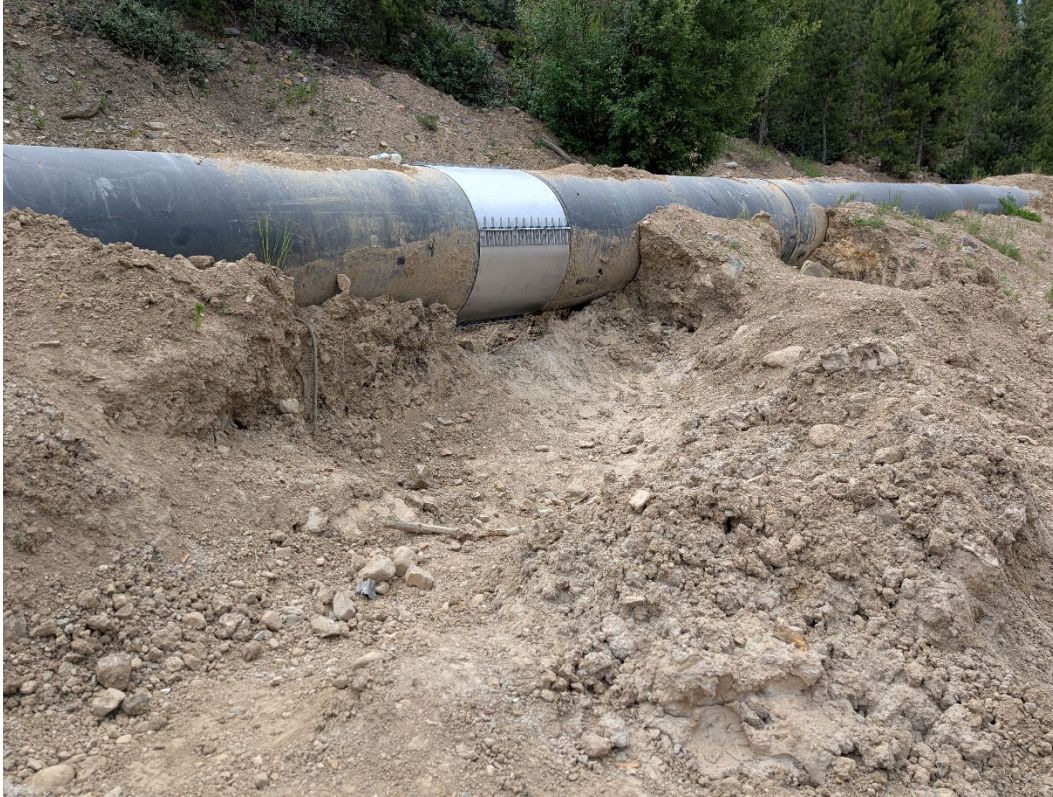
Before the inspection, the Division met with Henderson representatives to discuss the investigation into recent tailings delivery line (TDL) leaks. On June 11-12, 2025, Henderson removed overburden and inspected the pipeline, followed by additional Non-Destructive Testing. The operator surveyed every fuse and found a couple of spots that required new bands. According to Mr. Hickman, the section showing the most accelerated wear was in a steep section above 3-Dam where the turbulence is the highest.

Photo 3: Looking at a temporary metal band installed on the TDL where a leak was observed.

On July 7, 2025, Mr. Hickman submitted a letter to the Division summarizing the investigations and temporary repair work. The letter also provided a schedule for replacements planned for summer 2025. Henderson intends to replace 500 feet of HDPE pipeline and rotate several sections based on wear rates. The operator reported ordering 1500 feet of pipeline for immediate and future repairs.

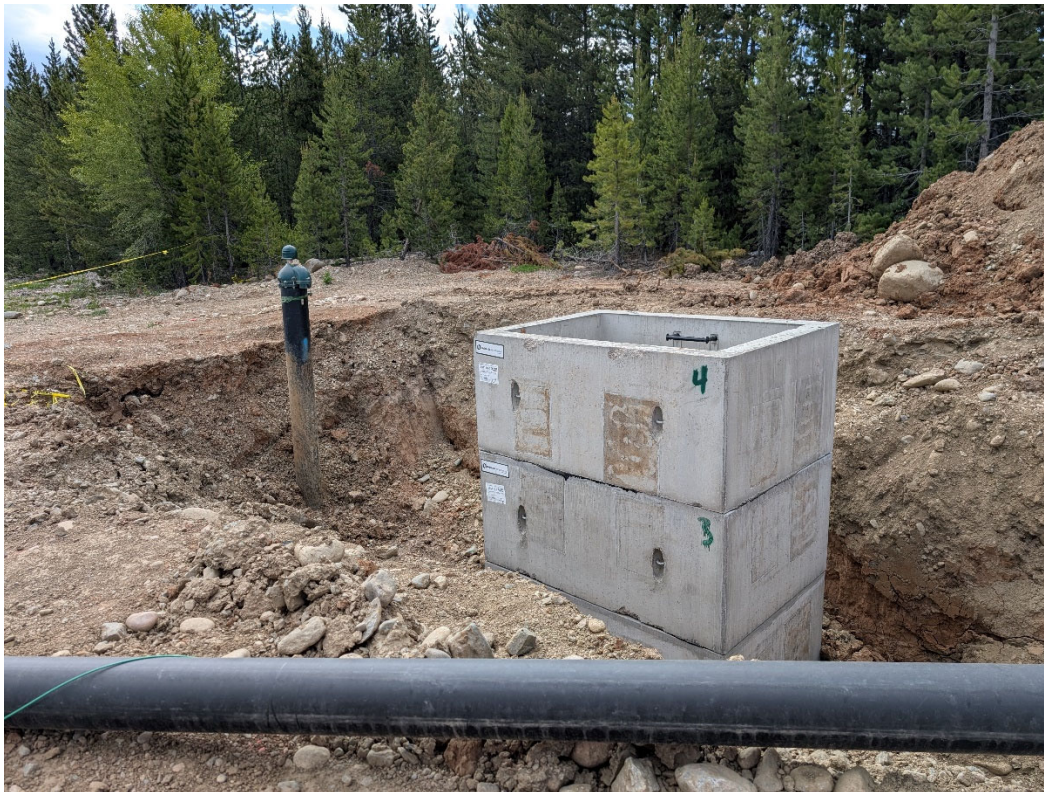
The Division observed a contractor installing the infrastructure for extraction well MLEX-7 within the gravel pit, east of Ute Park (Photos 4-7). Water will be conveyed from the vault via a 6-inch HDPE line and discharged into the seep collection channel adjacent to the Ute Park Pump Station. The contractor was working to install the pipeline beneath County Road 3 (Photo 6). Following pipeline installation, instrumentation will be added to the wellhead, including a down-well transducer and float switches to monitor and maintain water level setpoints, a flow meter located in the vault, a data logger, and a radio transmitter. Photos 8-9 illustrate an example of the instrumentation and vault currently installed at MLEX 1. MLEX 1 is shut down for the installation of a new well (Photo 10). According to Mr. Hickman, within Ute Park, MLEX 4 has the highest average flow, approximately 76 gallons/minute. Flow rates and volumes are continuously measured and recorded electronically. The system is visually checked daily by the pond operator on site. The infrastructure for MLEX-6 on the east side of Ute Park will be installed in July 2025 and the operator will submit the As-Built drawings to the Division once the Phase IV extraction wells are completed.

Photo 4: Looking at extraction well MLEX 7 and vault installed on the south end of the gravel pit.

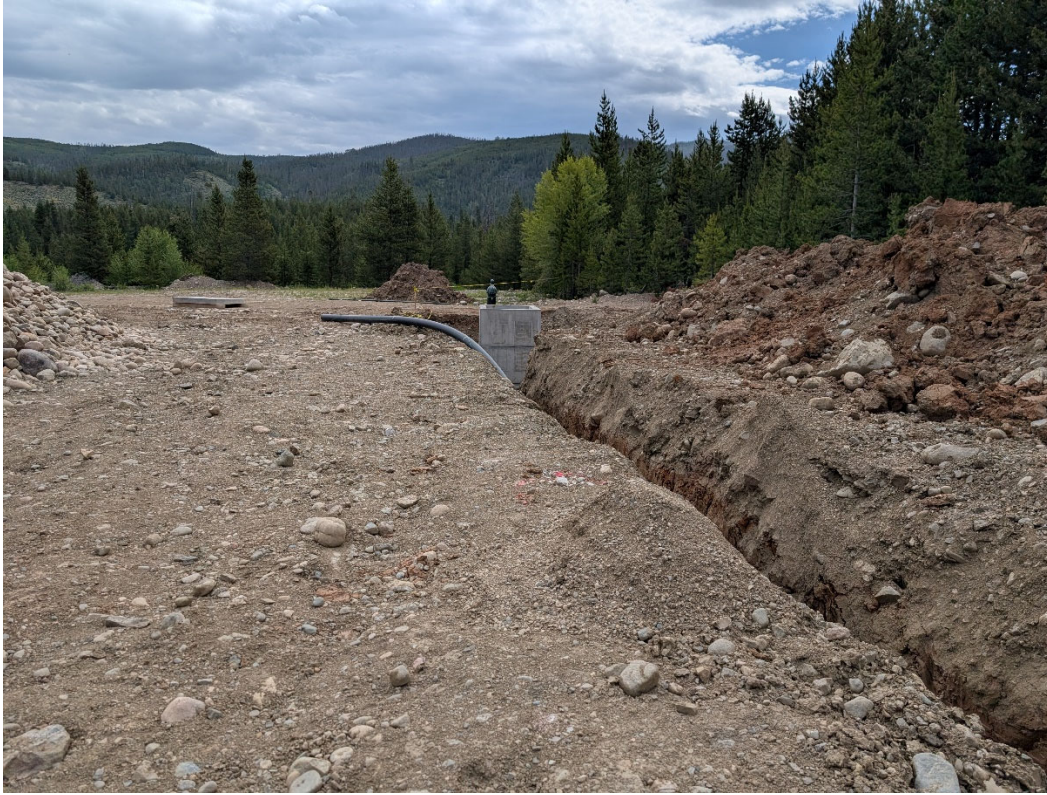
Photo 5: Looking at the excavated trench for the 6-inch pipeline for MLEX-7.

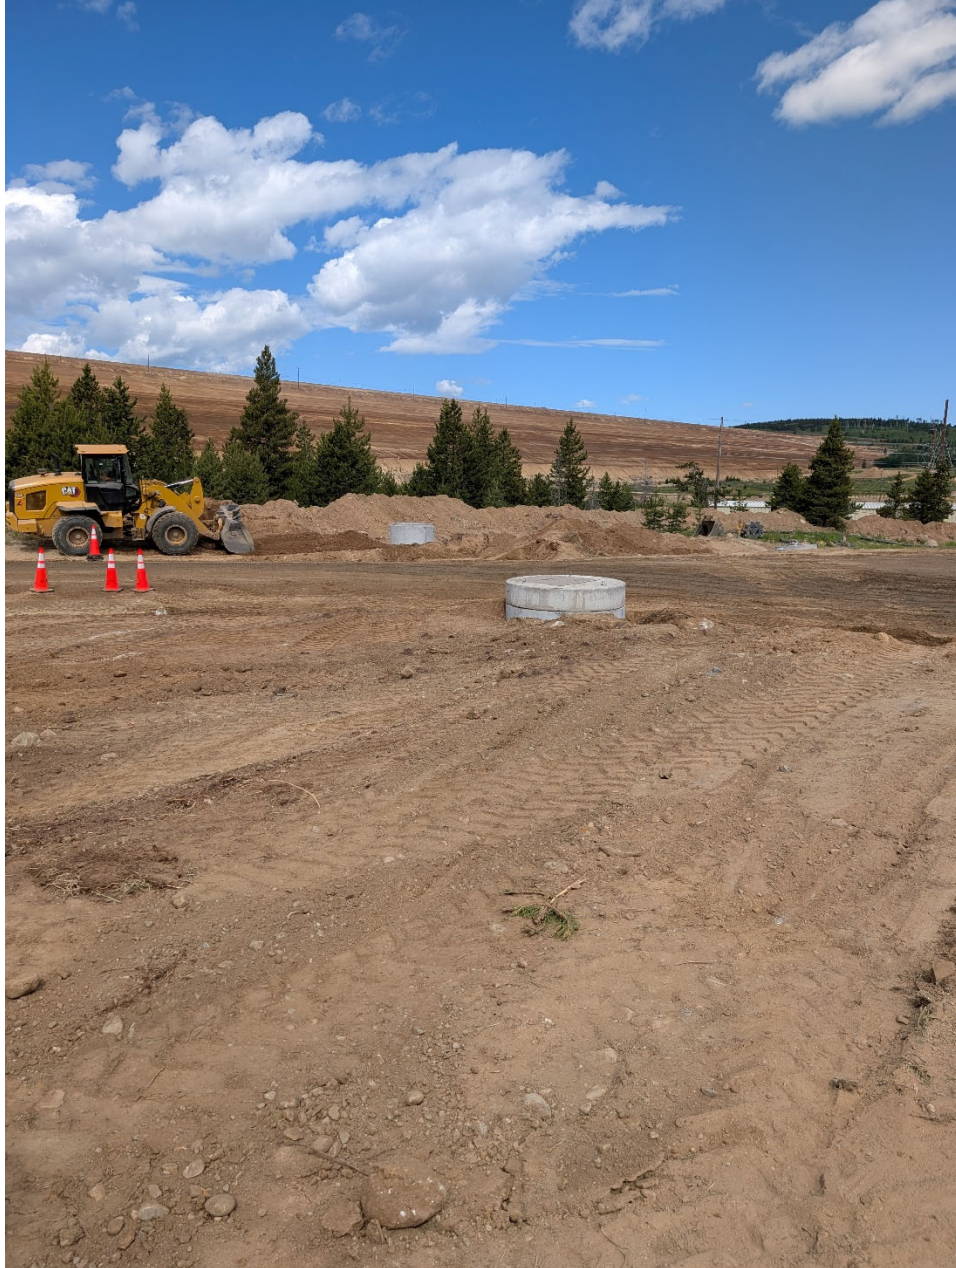
Photo 6: Contractor installing the 6 inch pipeline from MLEX-7 beneath County Road 3 near the Ute Park Pump Station.

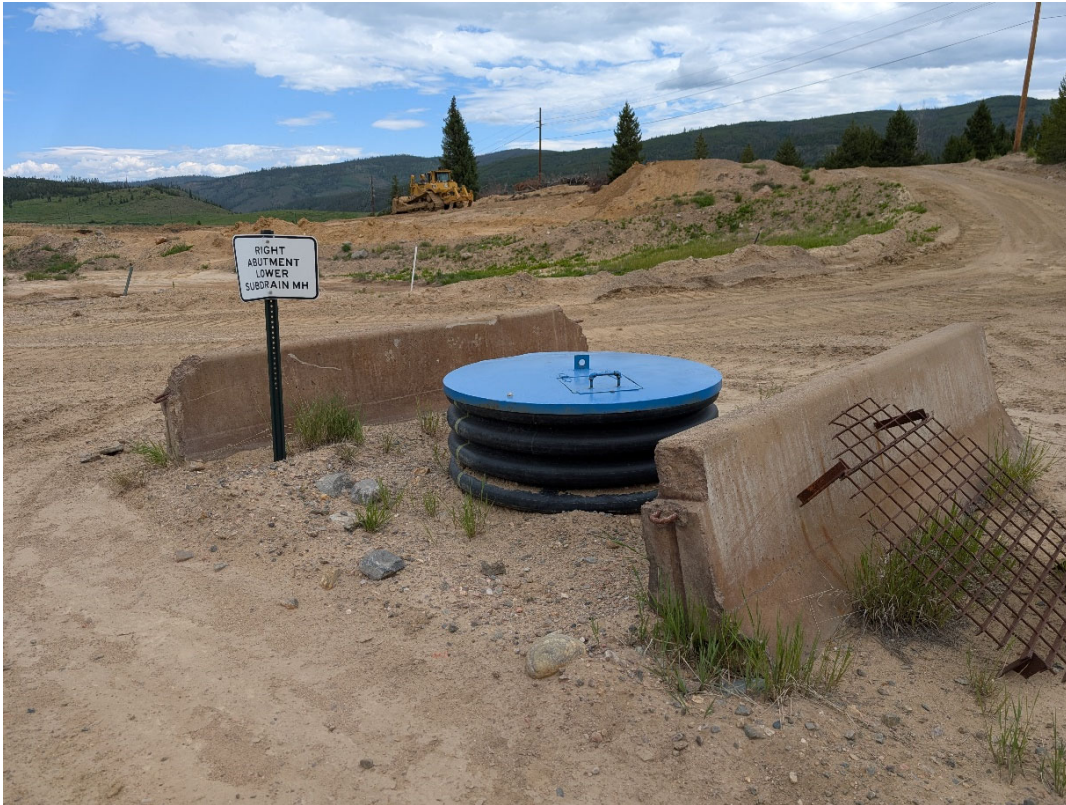
observed the Lower Subdrain manhole in the southwest corner of Ute Park (Photo 13-14). The line never needed replacement; however, plugging is the main concern that requires maintenance. The operator pressure tests the line every year and uses water jets to clean out the iron precipitate that accumulates in the line due.

Photo 13: Looking at the lower subdrain manhole on the south end of Ute Park.

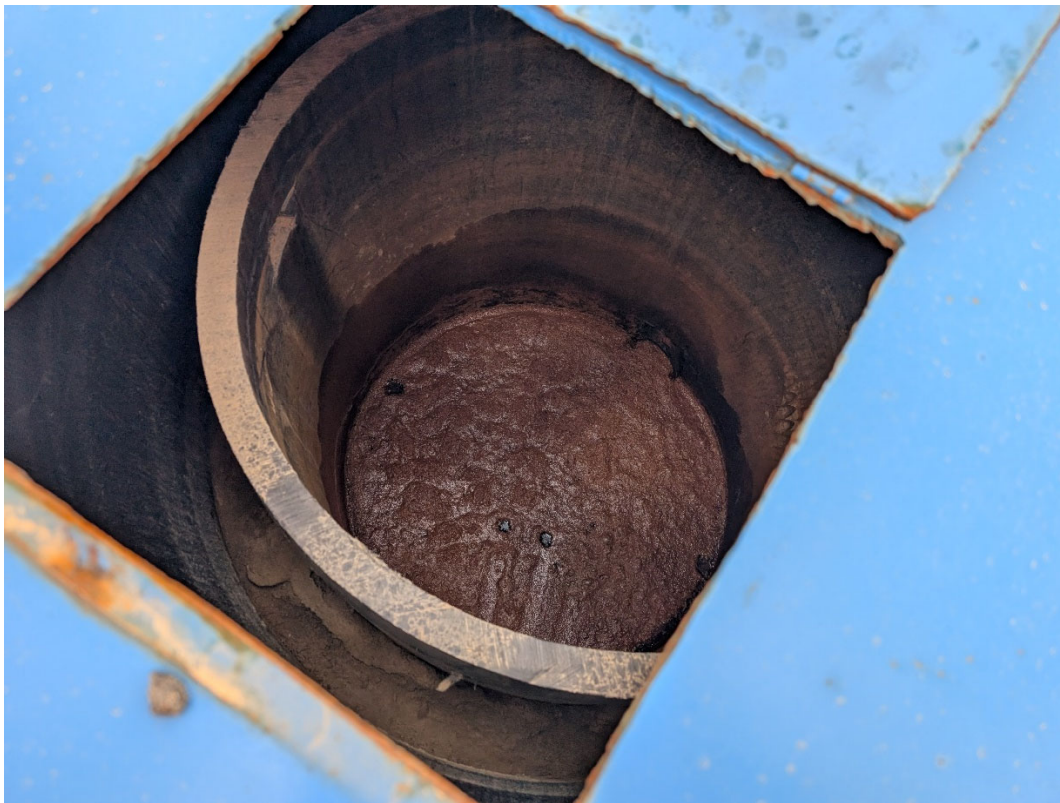
Photo 14: Looking inside the manhole on the lower subdrain.

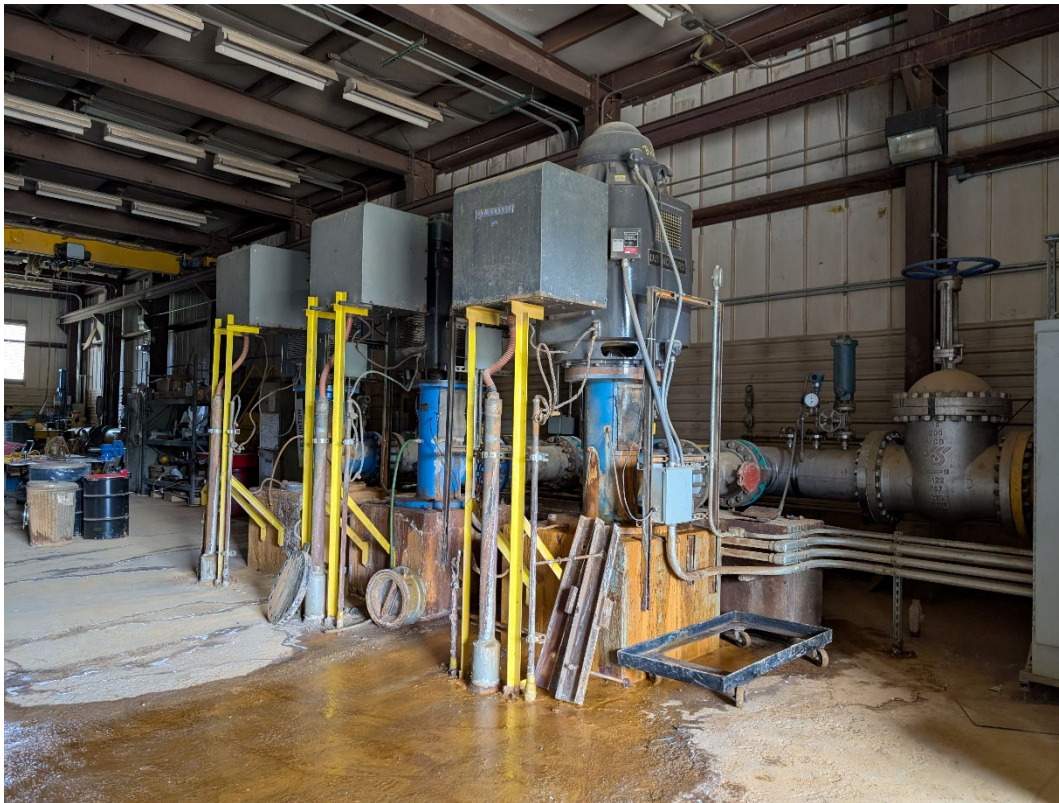
The Division inspected the Ute Park Pump Station (Photo) The pumps were not operating during the inspection. Maintenance is performed on the pumps frequently as needed. Mr. Hickman stated that the pumps push 1100 gal/min when running.

Photo 16: Looking at the pumps inside the Ute Park Pump Station.
