Inspection report

PERMIT INFORMATION

Permit Number: C-1981-028 Mine Name: Keenesburg Strip Mine Operator: Coors Energy Company Operator Address: Mr. Ben Moline P.O. Box 4030 Golden, CO 80402	County: Weld Operation Type: Surface Permit Status: Permanent Cessation Ownership: Private
	Operator Representative Present: None
Operator Representative Signature: (Field Issuance Only)

Inspection Start Date: July 25, 2025 Inspection Start Time: 07:20 Inspection End Date: July 25, 2025 Inspection End Time: 08:20		Inspection Type: Coal Partial Inspection Inspection Reason: Normal I&E Program Weather: Clear	
Joint Inspection Agency: None		Joint Inspection Contacts: 	
Post Inspection Agency: None		Post Inspection Contacts: 	
Inspector(s): Robert Zuber, P.E.	Inspector's Signature:

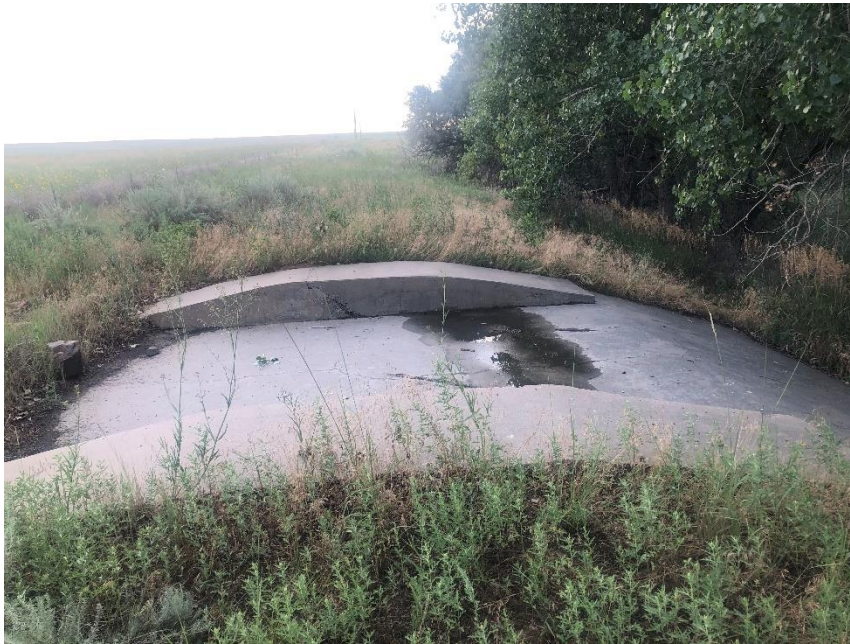
Spillway for Sediment Pond 2

Sediment Pond 2 and the Dugout Pond contained no visible water; both ponds have large amounts of vegetation on their bottoms. Neither was discharging during the inspection, and there were no signs that the ponds had discharged recently. No problems were observed.

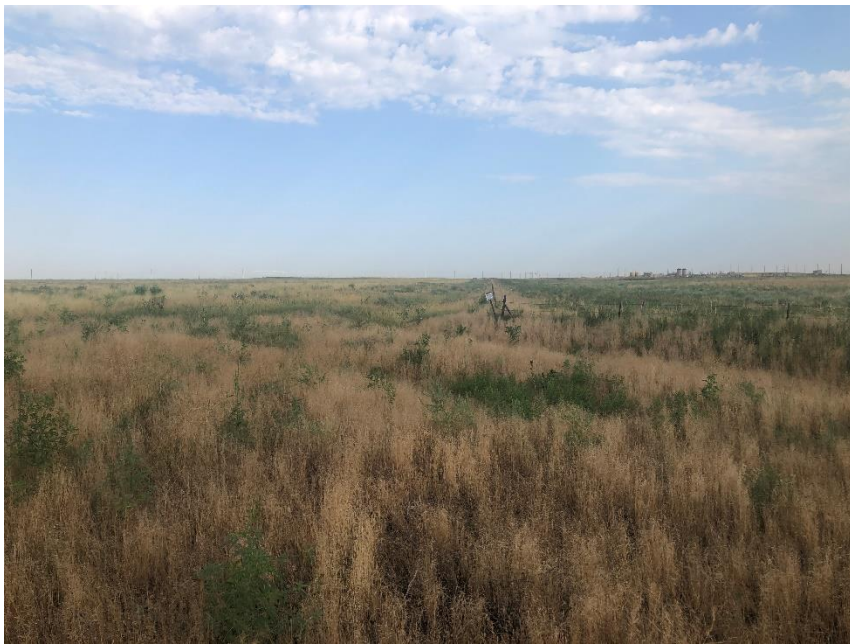
Northern boundary, looking northwest

The ditch along the northern border of the site, which drains to Sediment Pond 2, was functioning.

A large amount of cheatgrass was seen in many areas of the site, including the embankment at Sediment Pond 2 and the northern boundary of the site. Other than cheatgrass, no noxious weeds were identified.

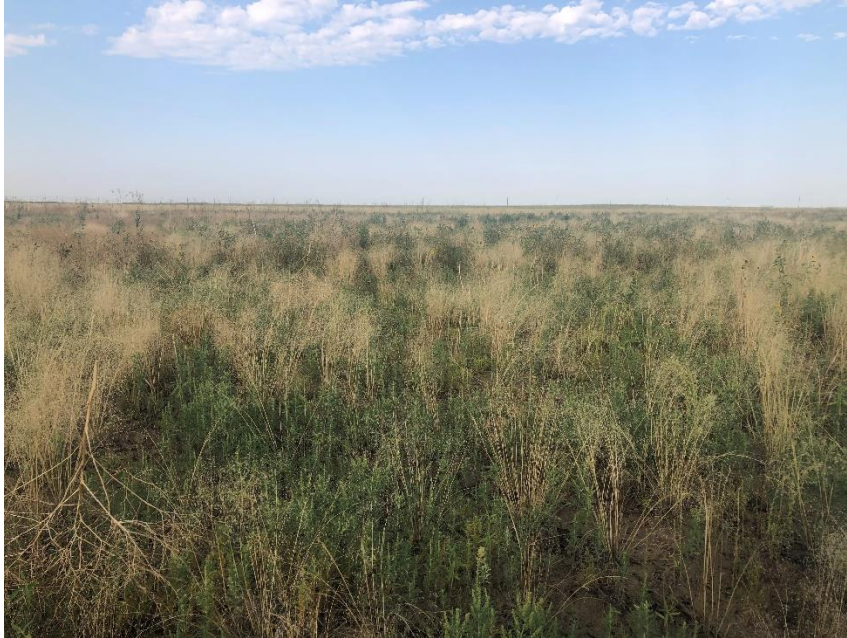
Middle of Area 37, with good vegetation cover

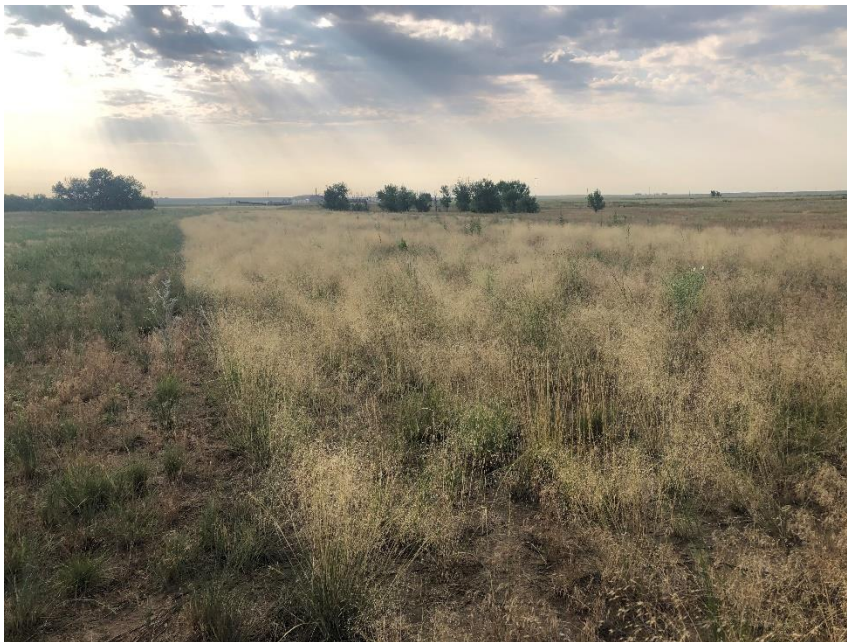
Indian ricegrass was prevalent in some areas, especially the reclaimed road south of Area 25.

Indian ricegrass at reclaimed road south of Area 25
