### MINERALS PROGRAM INSPECTION REPORT

<b>MINE NAME:</b> Baculite Mesa Pit	<b>MINE/PROSPECTING ID#:</b> M-1997-011	<b>MINERAL:</b> Sand and gravel	<b>COUNTY:</b> Pueblo
<b>INSPECTION TYPE:</b> Monitoring	<b>WEATHER:</b> Clear	<b>INSP. DATE:</b> June 11, 2025	<b>INSP. TIME:</b> 12:00
<b>OPERATOR:</b> Baculite Mesa, LLC	<b>OPERATOR REPRESENTATIVE:</b> Perry Hastings	<b>TYPE OF OPERATION:</b> 112c - Construction Regular Operation

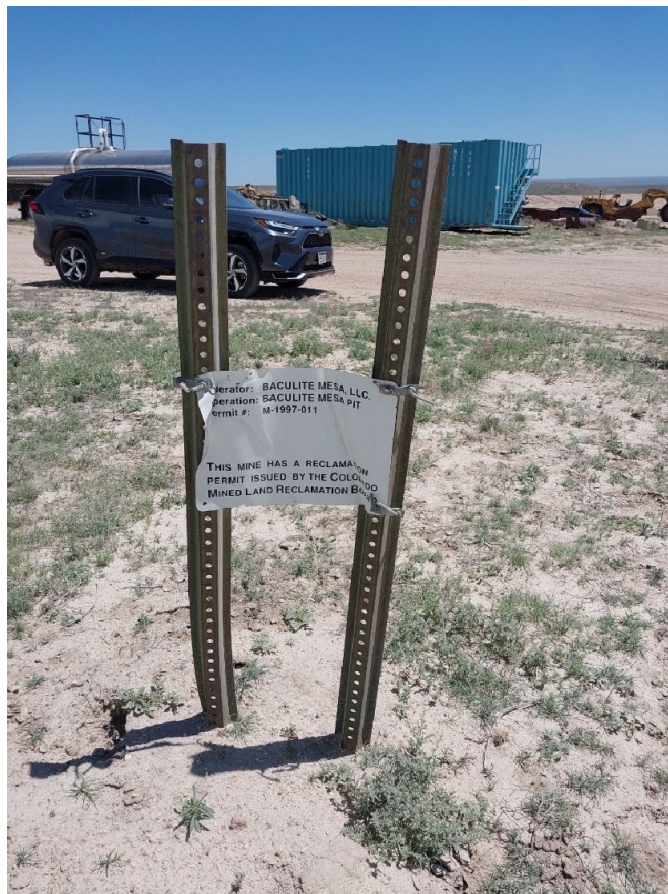
Photo #1: Mine sign posted along the western portion of the disturbed area.

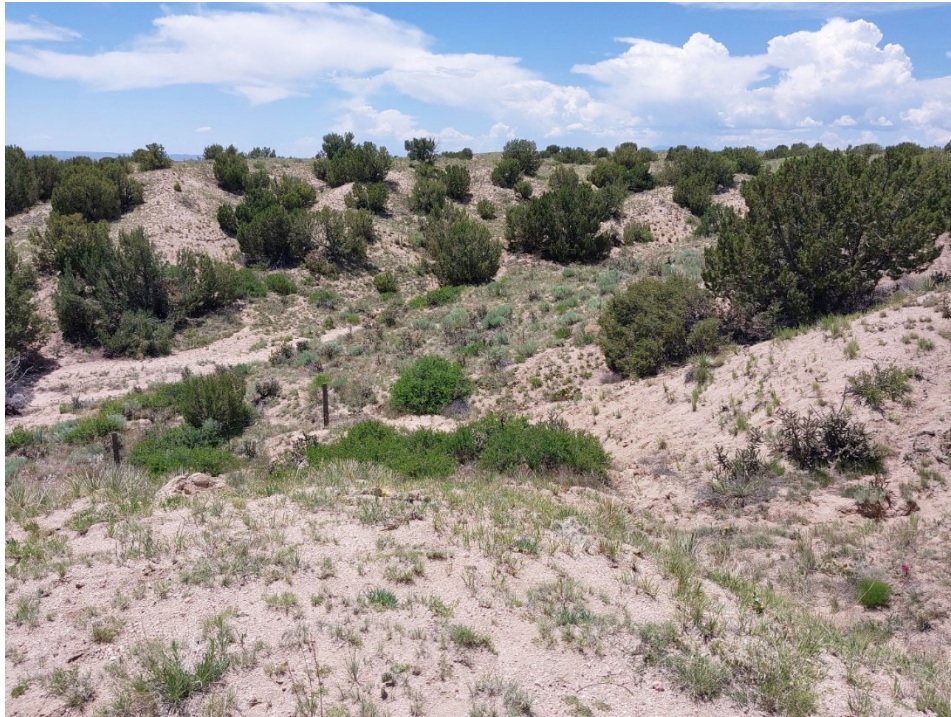
Photo #2: View of the fence that marks the approximate permit boundary.

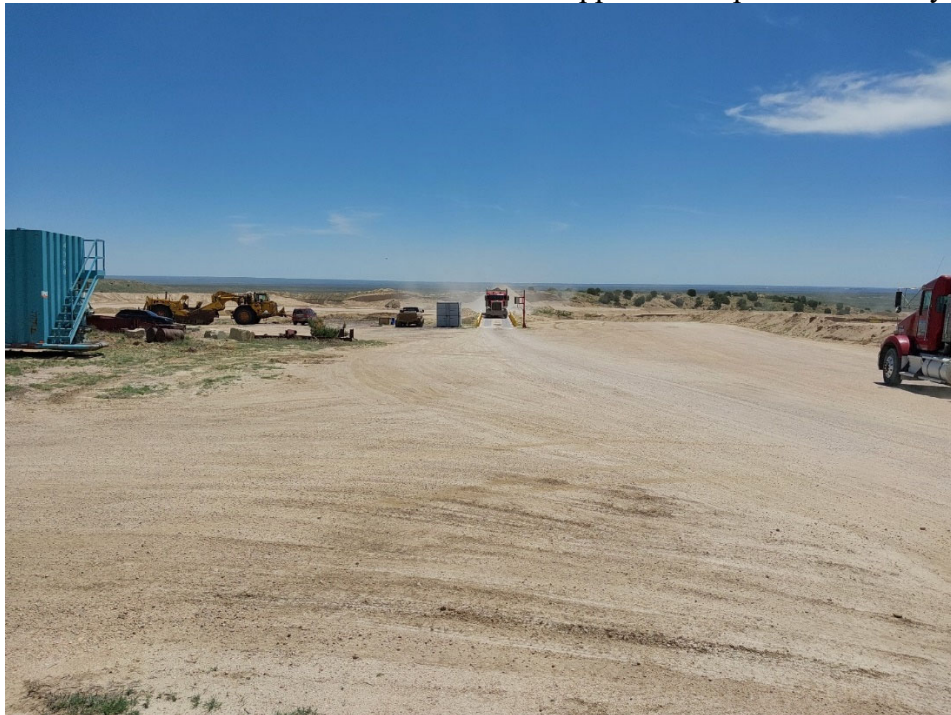
Photo #3: View of the scale located along the western access road to the operation, looking east.

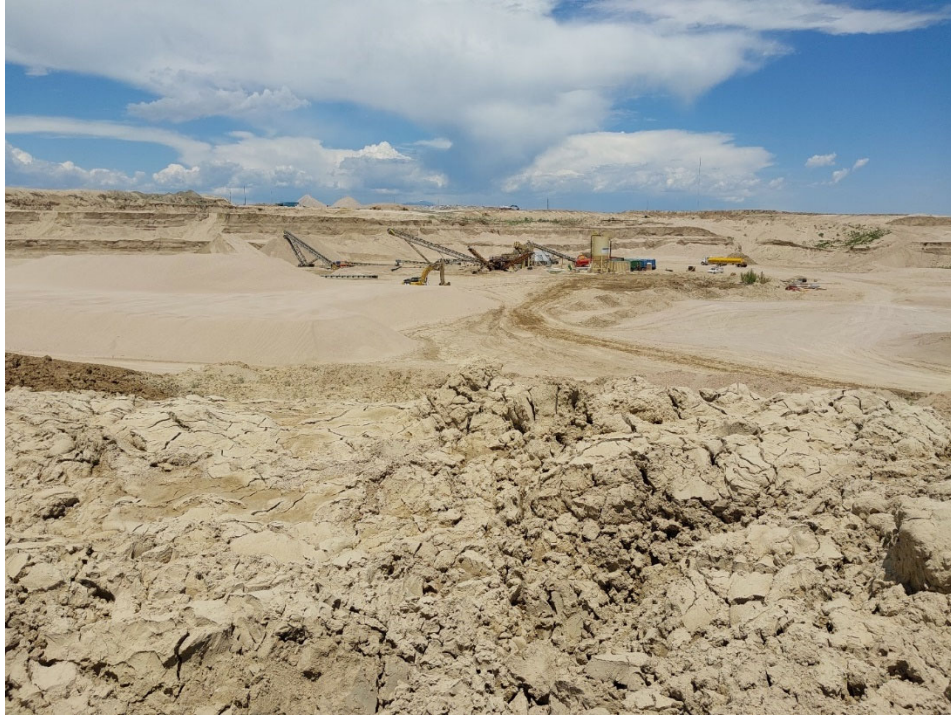
Photo #4: View of the processing equipment and area on the pit floor, looking to the northwest. A portion of the western high wall can be seen in the background on the left side of the photo, and a portion of the central high wall can be seen on the right side of the photo.

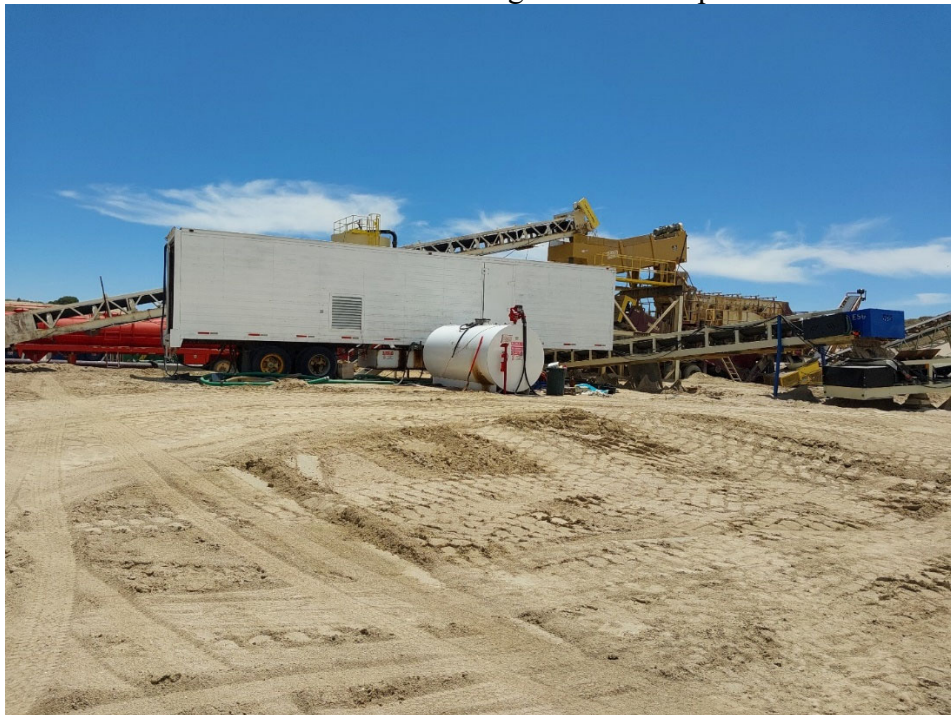
A fuel tank was observed to be on site within the processing area. The fuel vessel appeared to be in good condition with no issues.

Photo #5: View of the fuel tank located adjacent to the processing equipment.

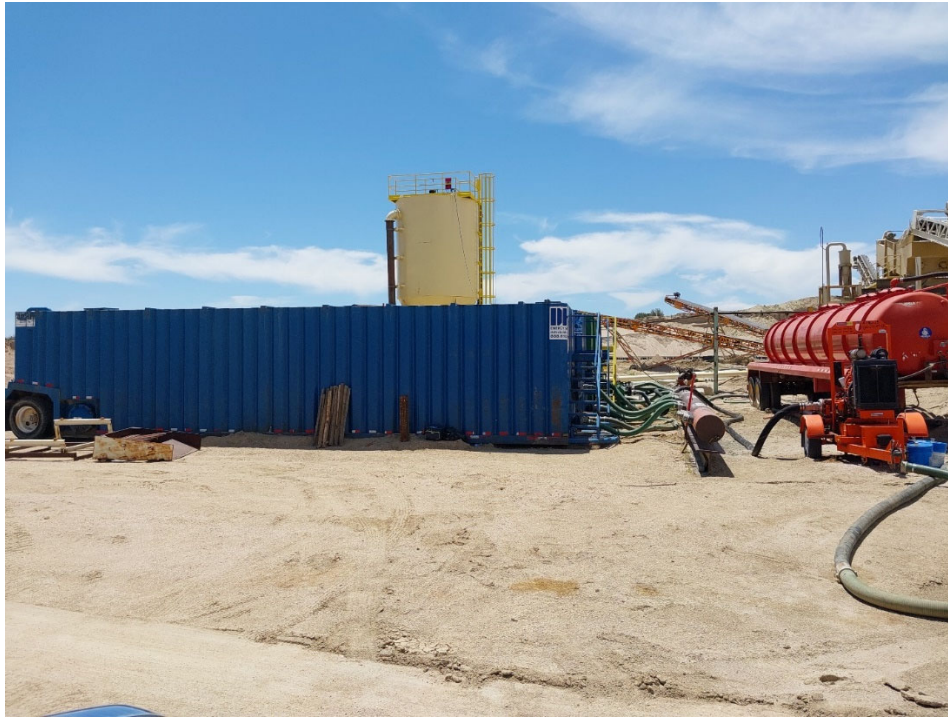
**Problem #4:** Water is being brought to the site for processing material, see **Processing Facilities** below for more information. According to the approved permit file and Exhibit G, the mining operation is to be dry. Exhibit G needs to be updated to provide information about the use of water for the mining operation in accordance with Rule 6.4.7.

A scale and some storage containers are situated along the western access road of the permit area. The processing facilities on site are located on the pit floor and appear to be in good condition. There are multiple water vessels situated next to the processing equipment. The vessels are used for processing materials. Water is brought onto the site by truck and used for processing and washing sand. The used water then goes through a system of other containers used instead of settling ponds and can then be recycled through the wash plant. There is a water overflow ditch which appears to be in good condition. **Problem #4** being cited in this report is regarding the use of water that was observed on site. When addressing the corrective action and providing an updated, please address how the water structures will be reclaimed in the updated reclamation plan.

Photo #6: View of the multiple water vessels used for recycling the water.

**CORRECTIVE ACTIONS:** The operator shall submit a Technical Revision, with the required \$216 revision fee, to update and clarify the current approved mine plan and Exhibit G - Water Information to reflect existing and proposed activities by the corrective action date. The required Technical Revision shall also address the additional problems cited in this report.

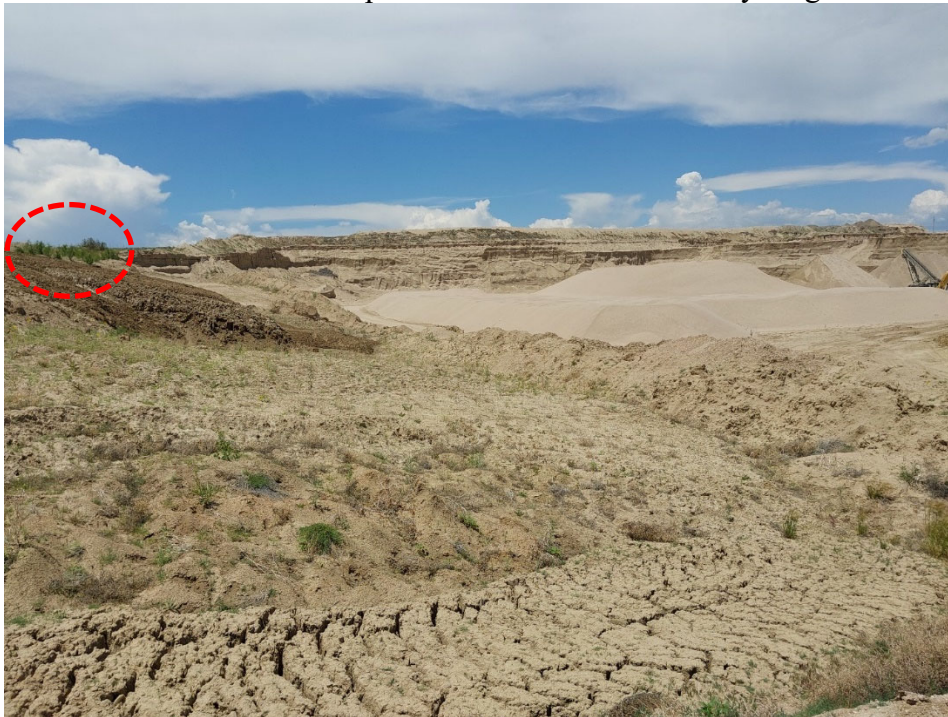
The southern highwall of the pit area has been backfilled and graded. The slope is about 3H:1V grade and appears to be stable, with no erosion issues.

Salt cedar was observed on site at the time of the inspection in two areas, along the banks of the water drainage area of the processing facilities and on the backfilled and graded slope along the southern area of the disturbed area. According to Mr. Hastings, the salt cedar was going to be removed by the end of the work week.

Photo #7: The slope on the left side of the photo is the area that has been backfilled and graded. Salt cedar can be seen on the top of the slope, circled in red. The western highwall can be seen in the background and a large product stockpile is seen on the pit floor.

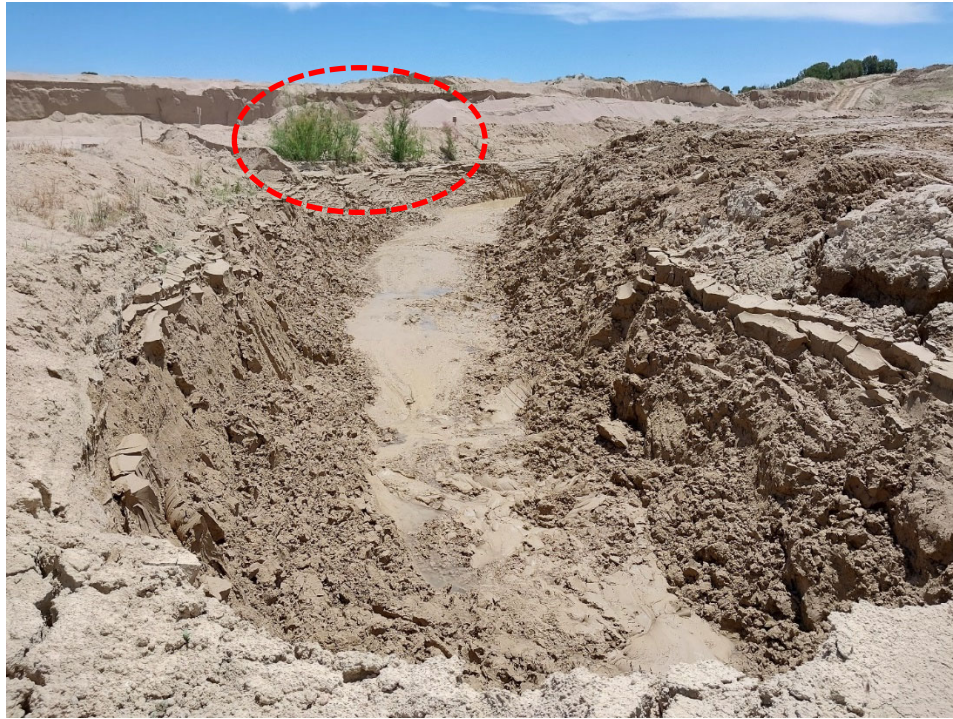
Photo #8: View of the drainage ditch situated next to the water recycling area. Salt cedar can be seen along the banks of the ditch, circled in red. The central highwall can be seen in the background.

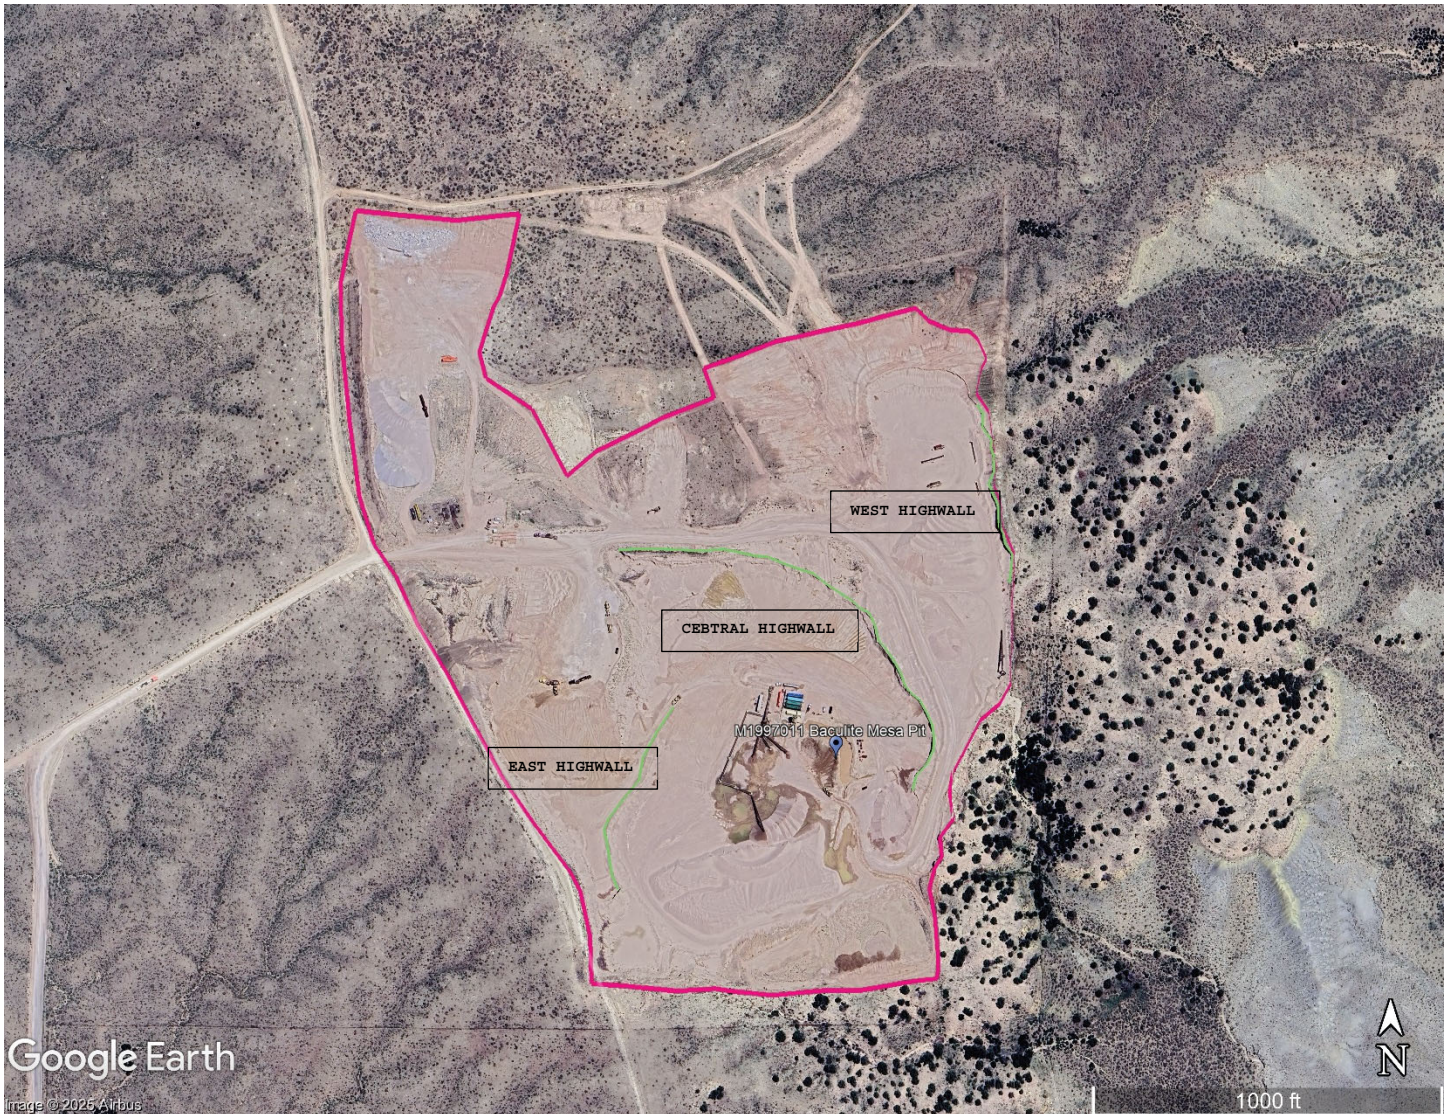
**Problem #1:** The area observed to have been disturbed, and that has been reported to be disturbed in the 2025 annual report, is approximately 57 acres. The approved mining plan allows for no more than 40 acres to be disturbed at any one time.

**Problem #2:** Three high walls were observed at the time of the inspection, an eastern wall (approximately 40 feet in height and 510 feet in length), central wall (approximately 40 feet in height and 1,267 feet in length), and a western wall (approximately 60 feet in height and 525 feet in length). The total length of the high walls is approximately 2,300 feet. The approved mining plan allows for the maximum length of the high wall to be 1,480 feet.

The current bond held by the Division for the permit is \$106,200.00. An updated required financial warranty was calculated by the Division using satellite imagery and observations made during the inspection. Figure 1 below shows the satellite imagery, and the dimensions used to calculate the financial warranty. According to the Division's calculation and the necessary reclamation tasks, the required financial warranty is \$301,586.00; this is \$195,386.00 higher than what is currently held. A problem is being cited for an inadequate financial warranty, **Problem #5**. The corrective action for this problem will be addressed with the required technical revision that will be submitted to address the other problems cited in this report.

Figure 1: Satellite image of the Baculite Pit, the pink polygon represents the approximate 57 acres of disturbance, and the green lines represent the locations of the west, central, and east high walls.

**CORRECTIVE ACTIONS:** The operator shall submit a Technical Revision, with the required \$216 revision fee, to update and clarify the current approved mine plan to reflect existing and proposed activities by the corrective action due date. In addition to an updated mining plan, the operator shall submit an updated mining plan map and reclamation plan map. The revision shall also include information addressing other problems being cited in this report.

**CORRECTIVE ACTIONS:** The operator shall submit a Technical Revision, with the required \$216 revision fee, to update and clarify the current approved mine plan to reflect existing and proposed activities by the

corrective action date. Additionally, the operator shall provide an updated mining plan map and reclamation plan map. The revision shall also include information addressing other problems being cited in this report.

**CORRECTIVE ACTIONS:** The operator shall submit a Technical Revision to include an updated mining plan and map, reclamation plan and map, and an Exhibit G – Water Information addressing the other items cited in this report. The required financial warranty will be recalculated based on the information given in the required Technical Revision and then addressed in a subsequent Surety Increase issued by the Division.
