MINERALS PROGRAM INSPECTION REPORT
PHONE: (303) 866-3567

MINE NAME: Orton Borrow Pit	MINE/PROSPECTING ID#: M-2022-031	MINERAL: Borrow material for	COUNTY: El Paso
INSPECTION TYPE: Monitoring	WEATHER: Clear	INSP. DATE: July 21, 2025	INSP. TIME: 12:00
OPERATOR: Castle Rock Construction Company of Colorado	OPERATOR REPRESENTATIVE: Travis Bell	TYPE OF OPERATION: 111 - Construction by Government Agency	
REASON FOR INSPECTION: Normal I&E Program	BOND CALCULATION TYPE: Complete Bond	BOND AMOUNT: \$45,417.00	
DATE OF COMPLAINT: NA	POST INSP. CONTACTS: None	JOINT INSP. AGENCY: None	
INSPECTOR(S): Hunter Ridley	INSPECTOR'S SIGNATURE:

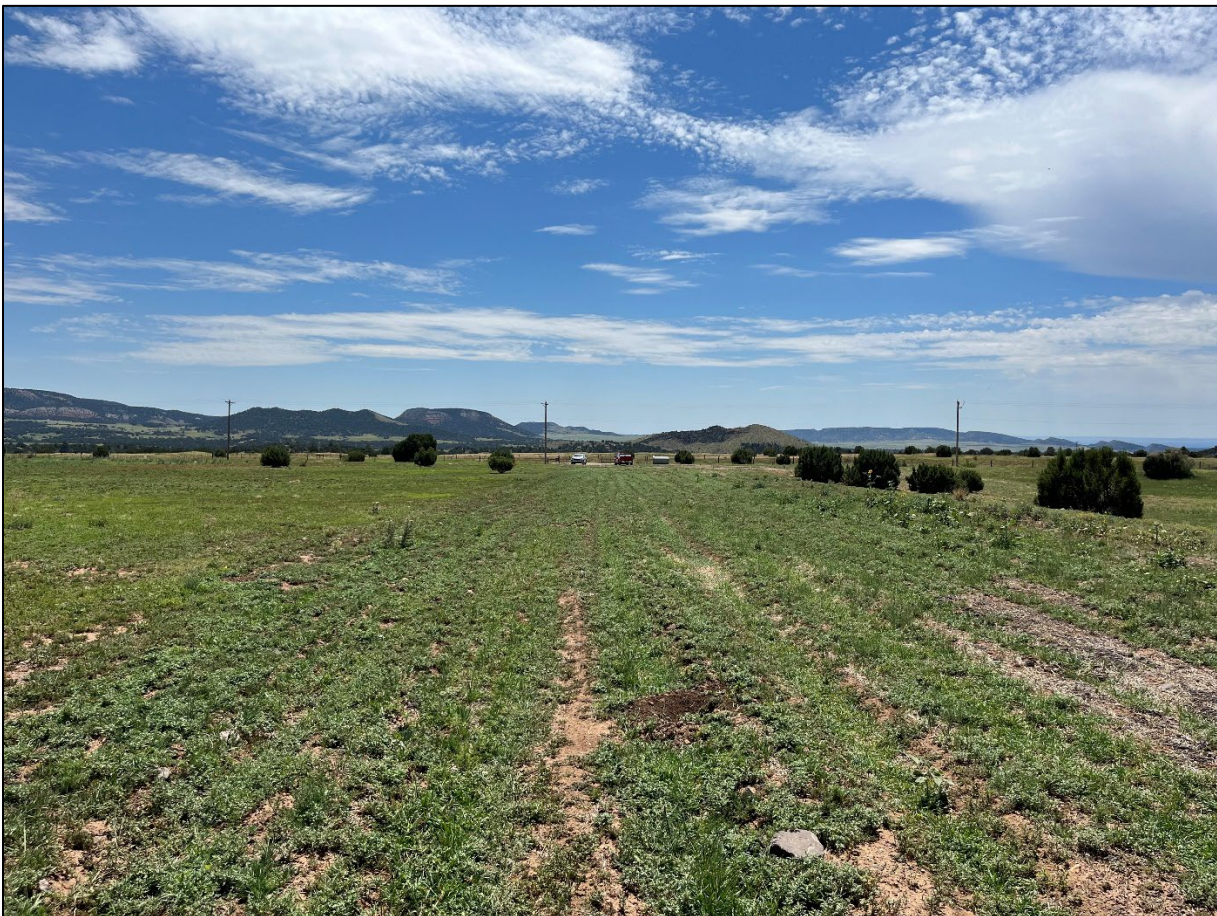
Roads: The non-paved dirt access road and turn-around point had been graded and seeded, with sufficient vegetation present in these areas (Photo 1). Neither appeared to be a source of sediment that could be tracked offsite.

Signs and Markers: A permit sign (Photo 1) and boundary markers (Photo 2) were posted in accordance with Rule 3.1.12. Both the sign and permit boundary markers can be removed after final release.

Photo 1: View east of the reclaimed access road.

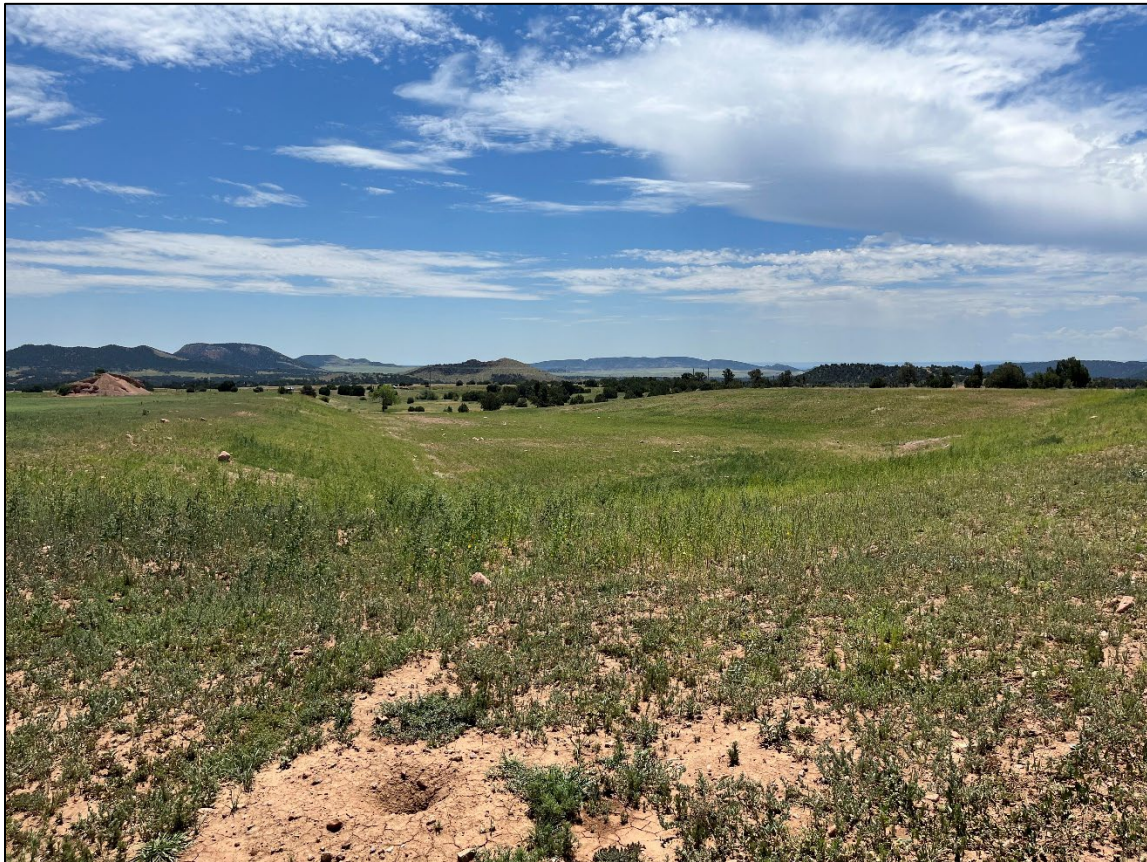
Backfilling and Grading: Site grading is complete and conforms to the Division's backfilling and grading requirements outlined in Rule 3 of the Construction Materials Rules and Regulations and outlined in the permit's approved Reclamation Plan (Photos 2 and 4). Slopes were graded at 3H:1V or gentler throughout the site. No leftover overburden or topsoil piles were observed on site.

Reclamation Success: Revegetation efforts across the site appeared to be very successful. The full 10.24 acres were observed to be supporting established vegetation, made up of predominantly native and desirable species such as wheatgrasses, bromes, sunflowers, alfalfa and clover (Photo 2-4).

Photo 2: View east of the reclaimed pit slopes.

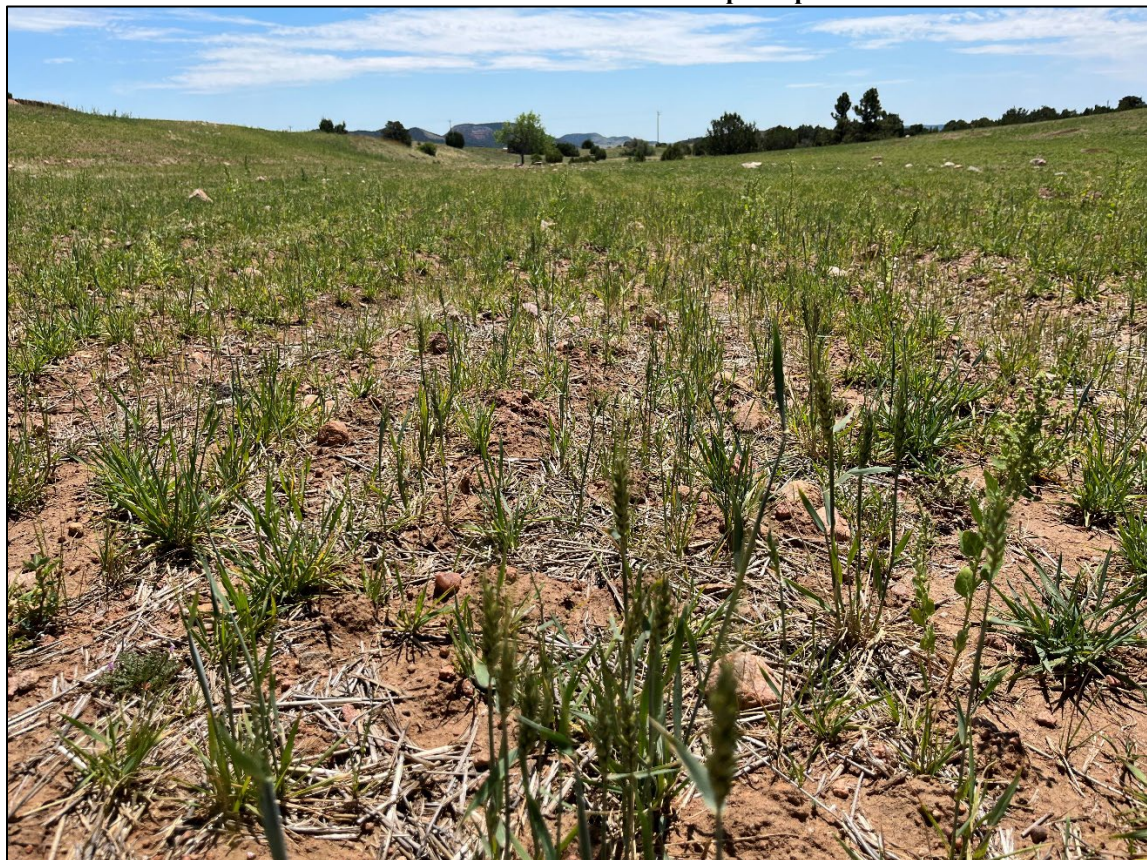
Photo 3: Example of native grass vegetation seen throughout the site.

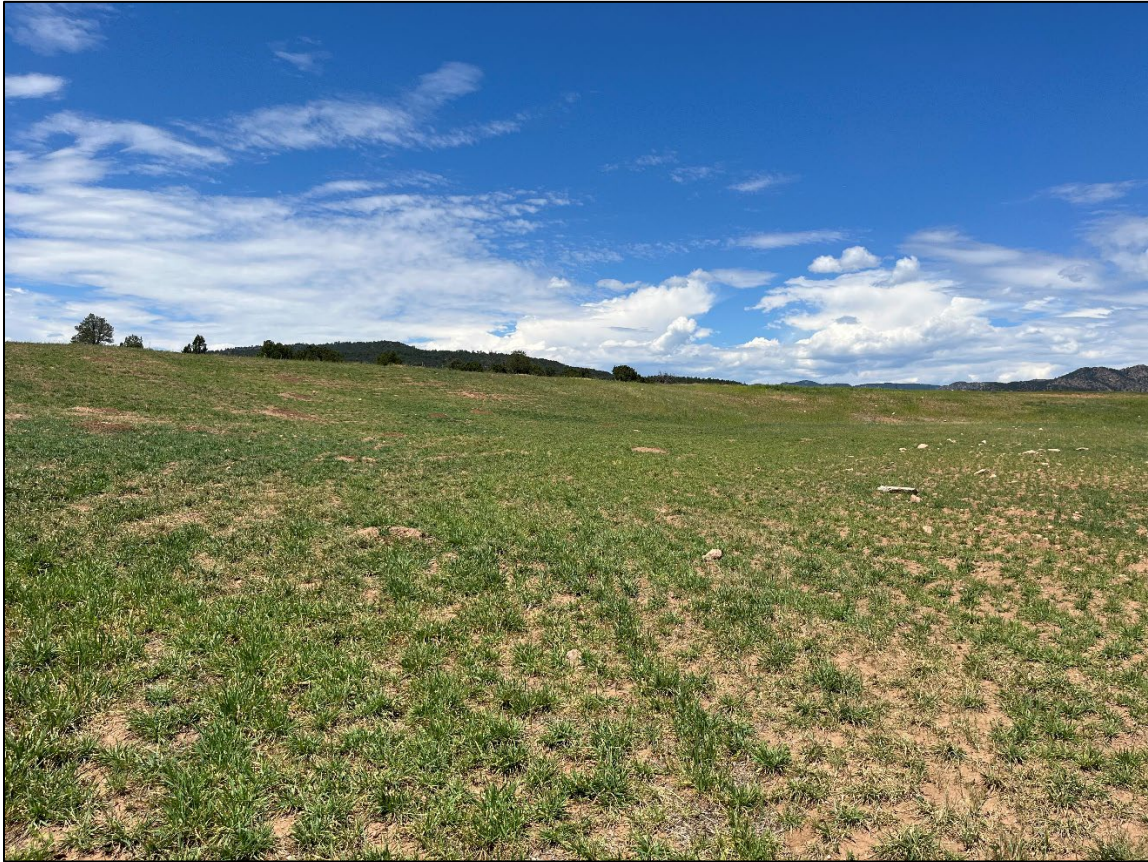
Photo 4: View southwest of the reclaimed pit slopes, standing on the pit floor.

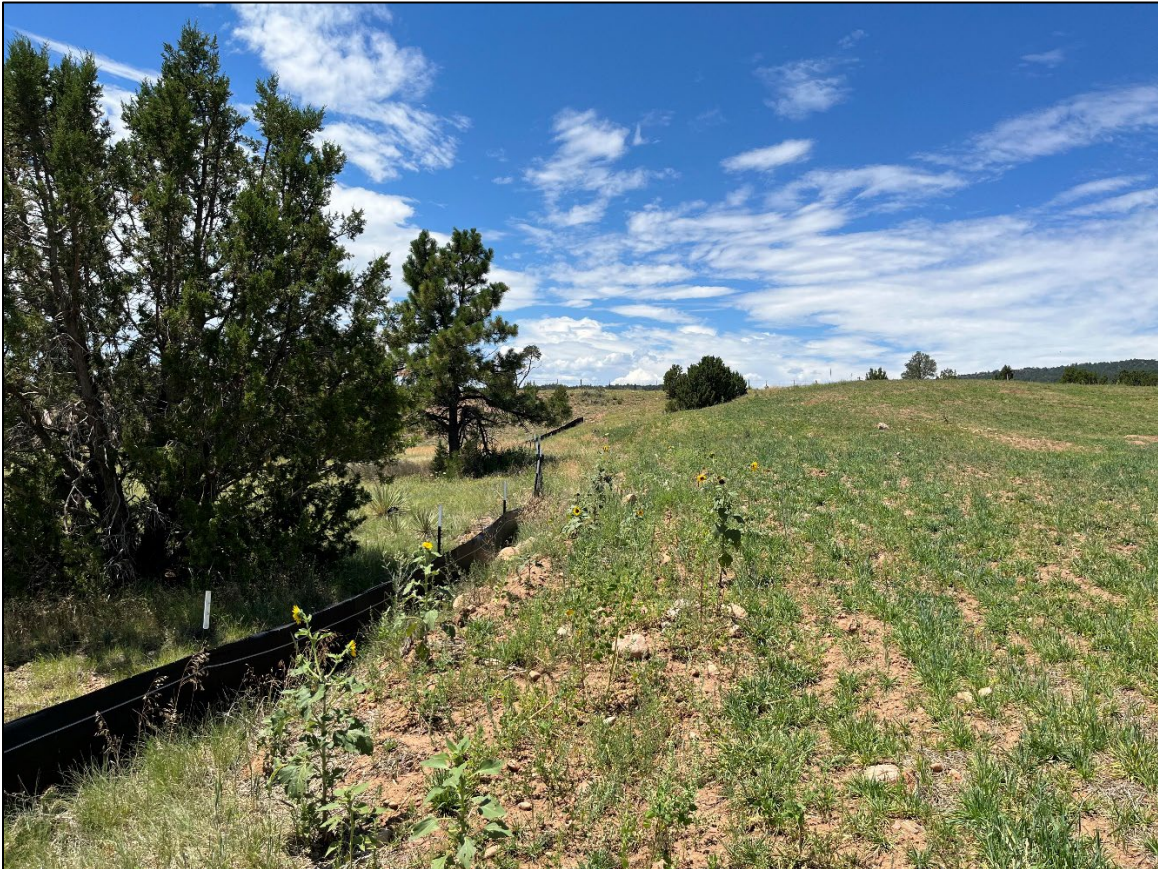
Sediment Control: A silt fence is currently in place at the eastern, downgradient edge of the site to help with any erosion (Photo 5). No erosional issues were noted anywhere at the site. Mr. Bell stated that the silt fence would be removed after approval of final release.

Photo 5: View south of the silt fence installed at the eastern end of the pit floor, towards the site's natural drainage.
