MINERALS PROGRAM INSPECTION REPORT
PHONE: (303) 866-3567

MINE NAME: Urie Gravel Pit	MINE/PROSPECTING ID#: M-2009-038	MINERAL: Gravel	COUNTY: Rio Blanco
INSPECTION TYPE: Surety-Related Inspection	WEATHER: Clear	INSP. DATE: July 9, 2025	INSP. TIME: 11:00
OPERATOR: Shallenberger Energy LLC	OPERATOR REPRESENTATIVE: Mike Sanford	TYPE OF OPERATION: 112c - Construction Regular Operation	
REASON FOR INSPECTION: Priority	BOND CALCULATION TYPE: Complete Bond	BOND AMOUNT: \$91,600.00	
DATE OF COMPLAINT: NA	POST INSP. CONTACTS: DRMS	JOINT INSP. AGENCY: None	
INSPECTOR(S): Amy Yeldell	INSPECTOR'S SIGNATURE:

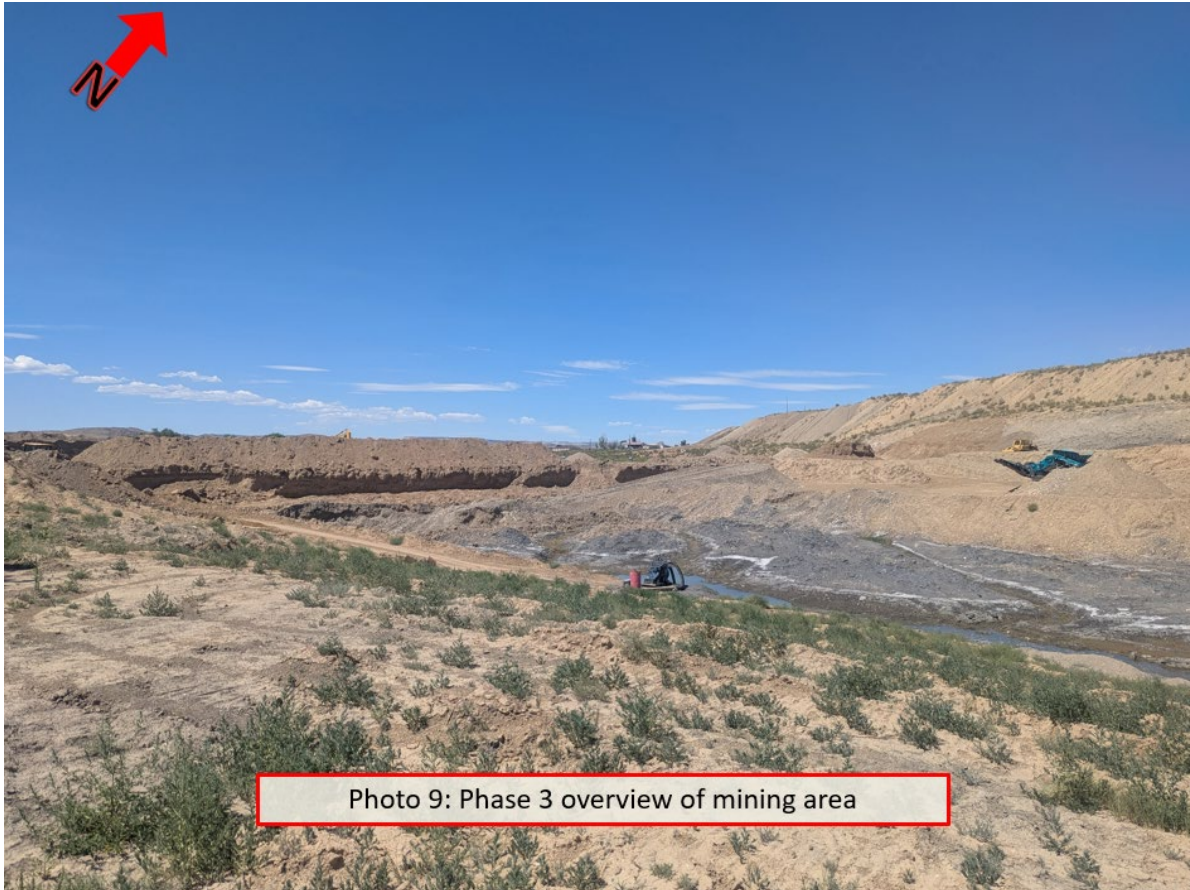
The site was active at the time of the inspection. The site is approved for a maximum disturbance of 15 acres. Slopes while mining are to be at a 2H: 1V to a depth of approximately 18 feet. Only one mining phase is to be mined at a time. To date Phase 1 and 2 mining is complete. The southwest corner of Phase 3 is actively being excavated with mining progressing to the southwest. Phase 3 is also being utilized for processing and stockpile storage. All stockpiles appear to be stable. Processing material on site includes crushing and screening but no washing of material. The crusher is located within Phase 3.

Photo 9: Phase 3 overview of mining area

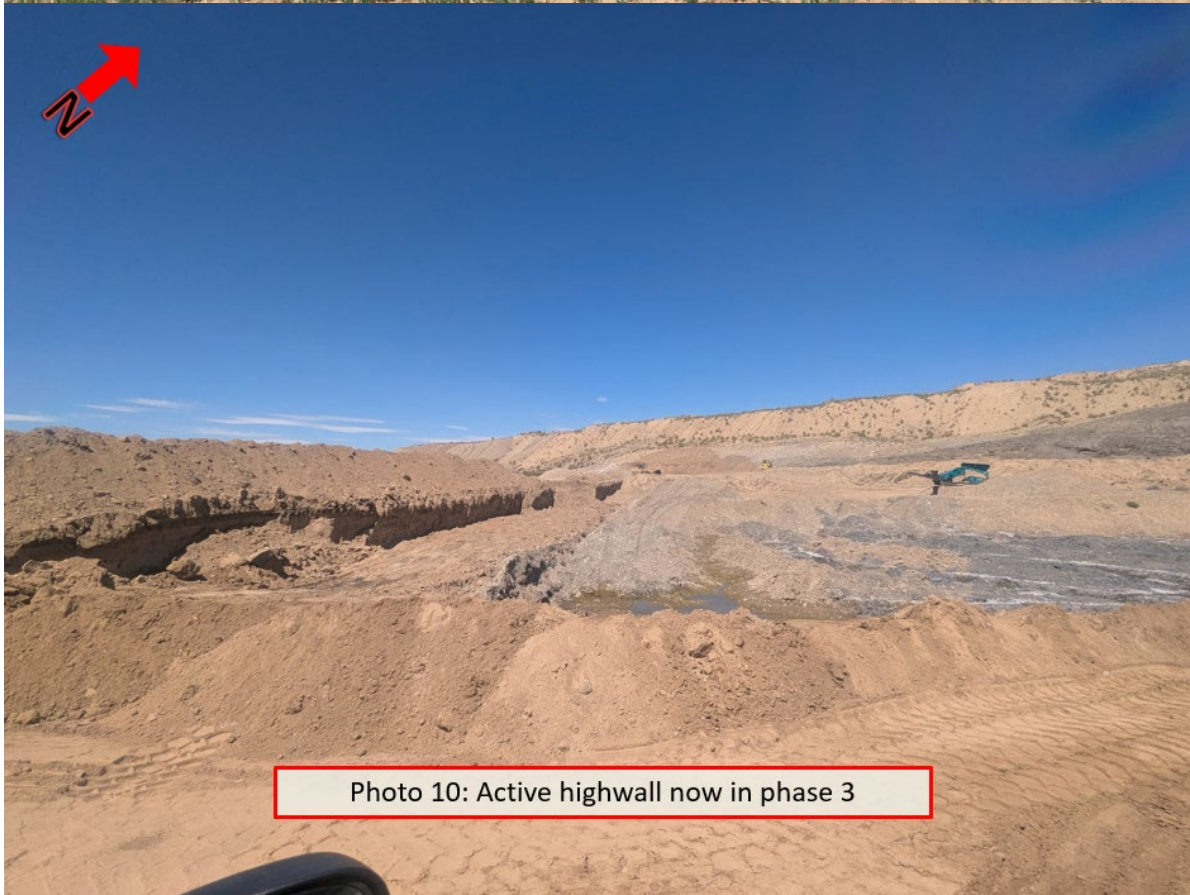
Most slopes within Phase 3 graded to a 3H: 1V or less up till it meets the active highwall. The active highwall is moving to the west then turning southwest. The active highwall is approximately 20 feet high and near vertical with some portions having a working bench mid way. There is some misc. grading to be required around Phase 2 and 3 to blend out some of the berms and stockpiles. As well as decompaction of the road surrounding the lake.

Photo 10: Active highwall now in phase 3
