MINERALS PROGRAM INSPECTION REPORT
PHONE: (303) 866-3567

MINE NAME: Climax Mine	MINE/PROSPECTING ID#: M-1977-493	MINERAL: Molybdenum	COUNTY: Lake
INSPECTION TYPE: Monitoring	WEATHER: Clear	INSP. DATE: July 22, 2025	INSP. TIME: 10:00
OPERATOR: Climax Molybdenum Company, Climax Mine	OPERATOR REPRESENTATIVE: Alex Ungers	TYPE OF OPERATION: 112d-3 - Designated Mining Operation	
REASON FOR INSPECTION: Normal I&E Program	BOND CALCULATION TYPE: None	BOND AMOUNT: \$284,783,656.00	
DATE OF COMPLAINT: NA	POST INSP. CONTACTS: None	JOINT INSP. AGENCY: None	
INSPECTOR(S): Todd Jesse	INSPECTOR'S SIGNATURE:

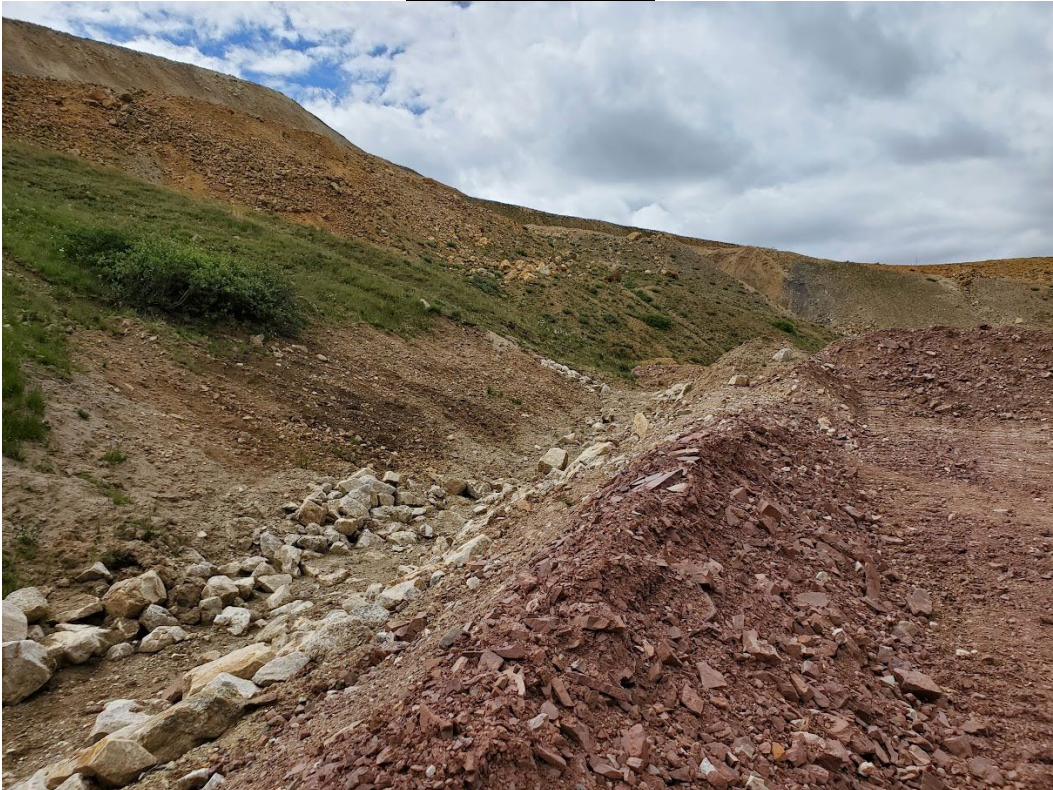
Interceptors function to intercept clean water before it enters the mine site and route it around the mine. Water that enters the mine site is considered impacted water and must be treated prior to discharge. Interceptors may be a pipeline, culverts or open channel. The East Interceptor begins at the McNulty OSF. The East Interceptor flows from the south to the north. It recently has been extended to wrap around the back side (northeast) of the OSF (Photo 1). The interceptor in this area begins as an open channel before entering a pipeline. The grate at the entrance to the pipeline is clean and free of obstruction (Photo 2). The interceptor is in good condition with no obstructions or excessive erosion.

Photo 1: View to the south of the start of the East Interceptor above McNulty.

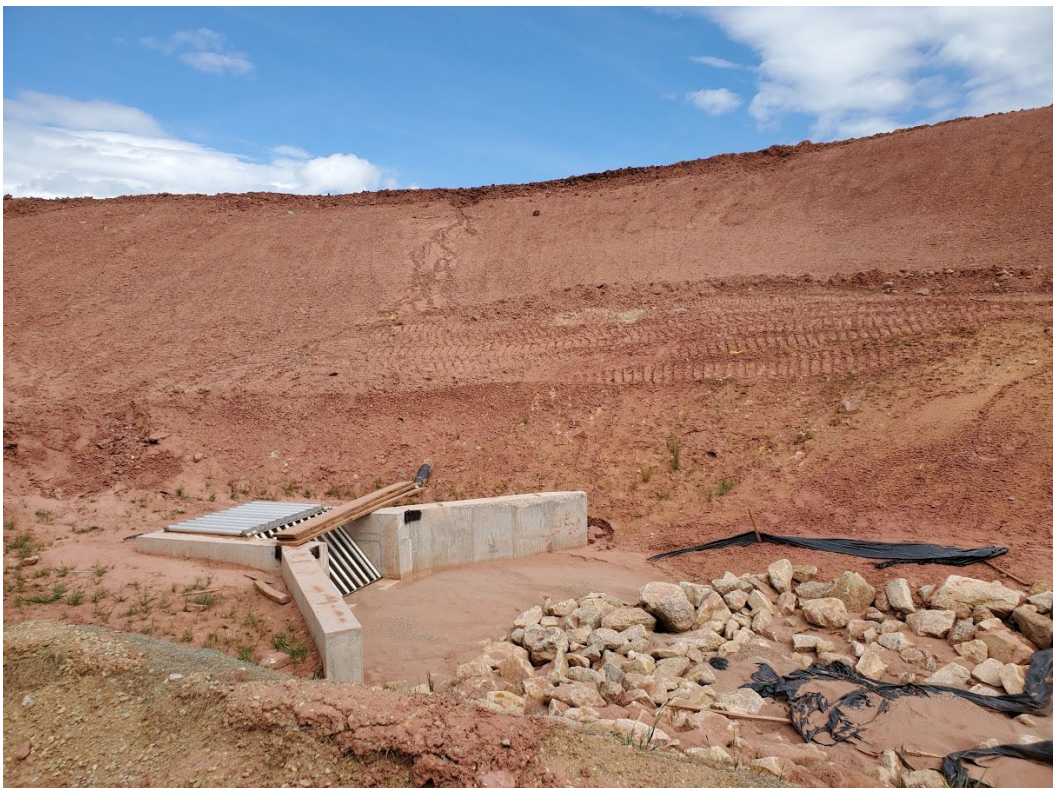
Photo 2: View to the north of the East Interceptor

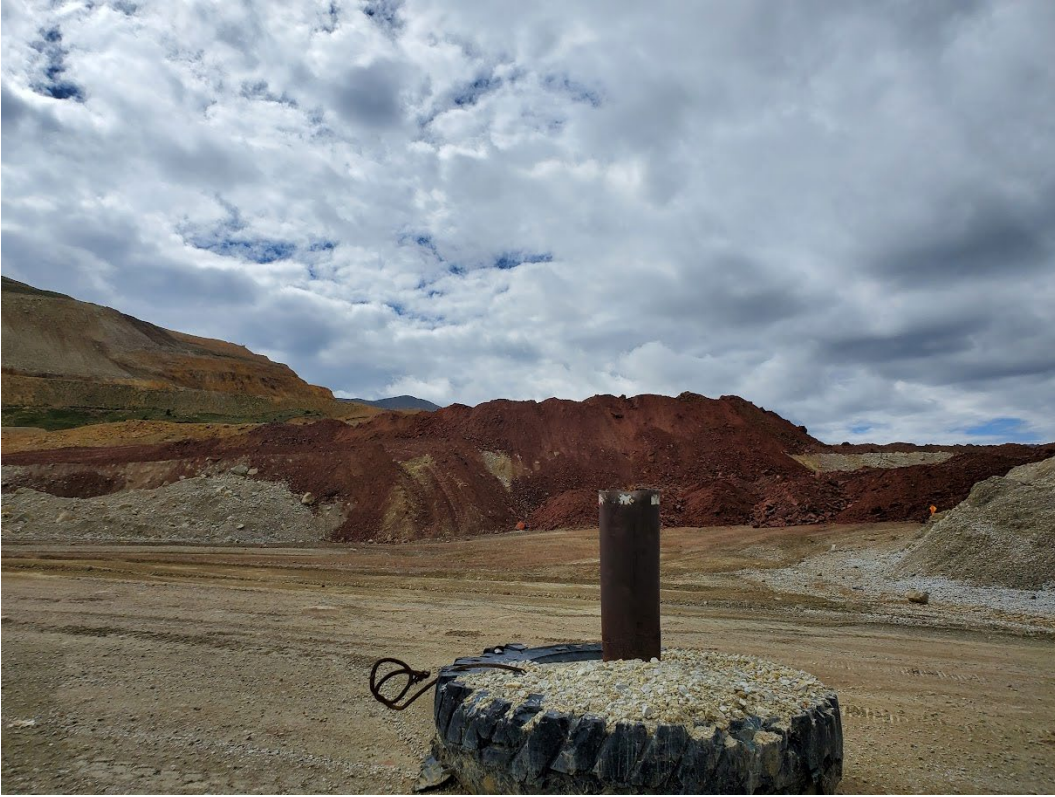
Reclamation cover stockpiles in the McNulty area were also observed to be in good condition. Crews have begun to construct the SE Reclamation Cover Stockpile and have so far stockpiled 80,000 of the anticipated 1,700,000 cubic yards of reclamation cover that is anticipated to be in this stockpile (Photo 3). Stockpiled material comes from removing the topsoil as the McNulty OSF continues to expand to the north. Material that was stockpiled and seeded last year is stable with vegetative cover beginning to grow (Photo 4).

Photo 3: View to the south of the start of the SE Reclamation Cover Stockpile.

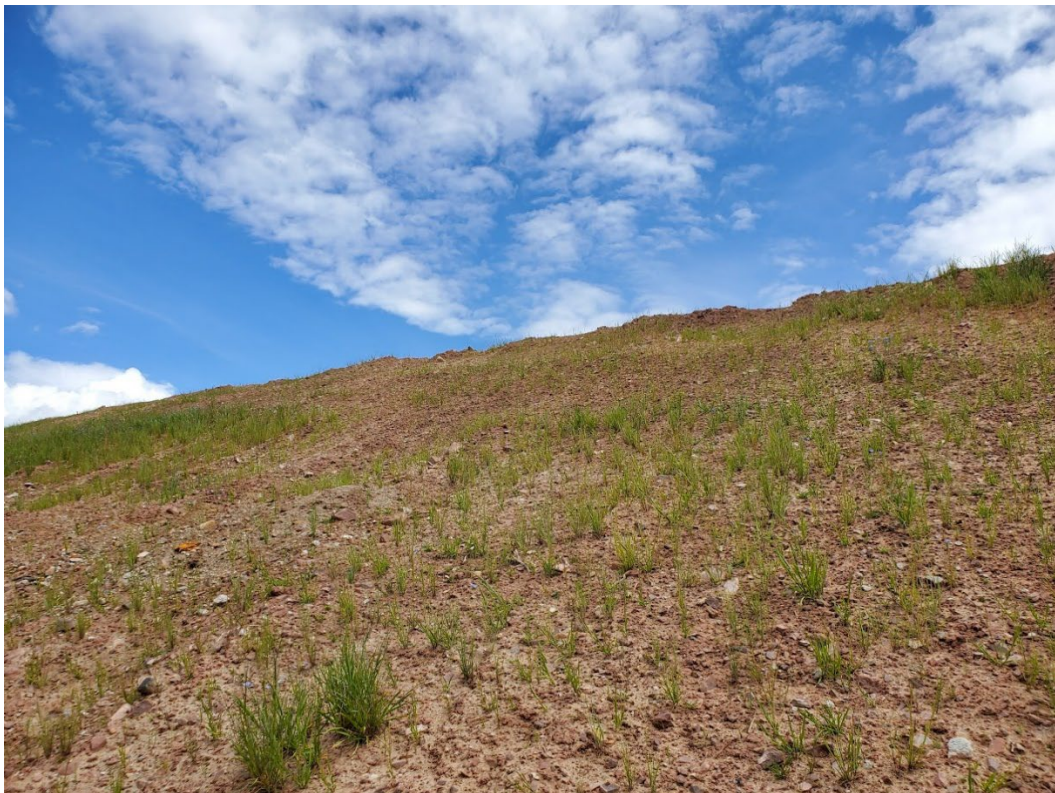
Photo 4: View to the north of vegetation growing on reclamation cover stockpile.

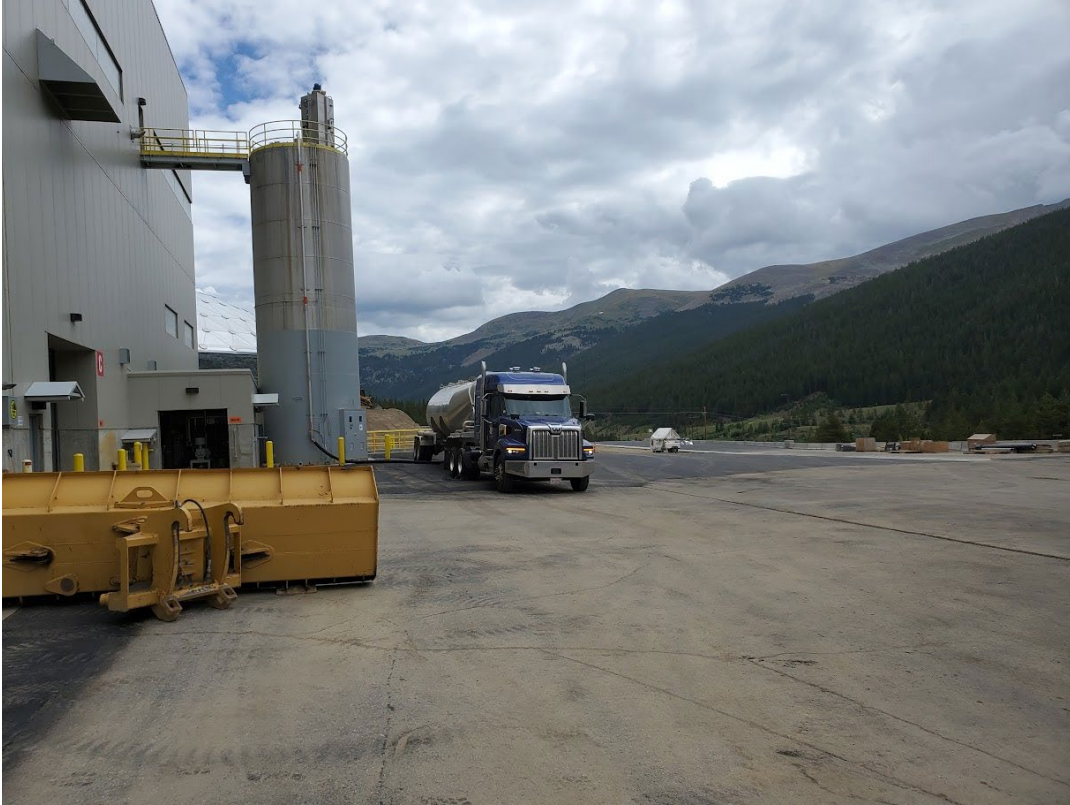
The operator continues to commission the new MRWTP. The plant is running intermittently during the commissioning process. This is a supplementary process to Climax's PDWTP. Affected raw water first enters the MRWTP then reports to the PDWTP. The pH of the affected water is changed and then dosed with ferric sulfide to remove Molybdenum. A delivery of ferric sulfide occurred during the inspection (Photo 5). Reactor, sludge, and clarifier tanks were observed to be in good condition at the time of the inspection. Floor sumps and troughs that provide secondary containment were free of obstructions and appear to be in proper condition (Photo 6). No problems were noted.

Photo 5: View to the north chemical delivery at MRWTP.

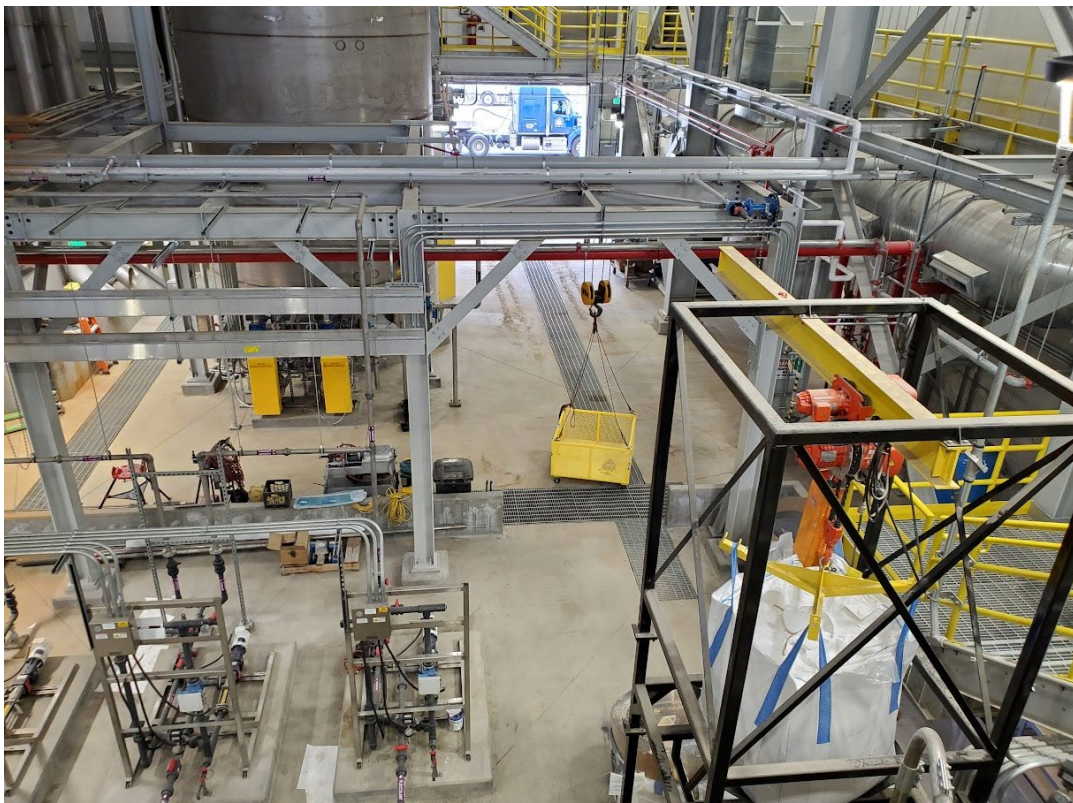
Photo 6: View to the east of containment in the MRWTP.

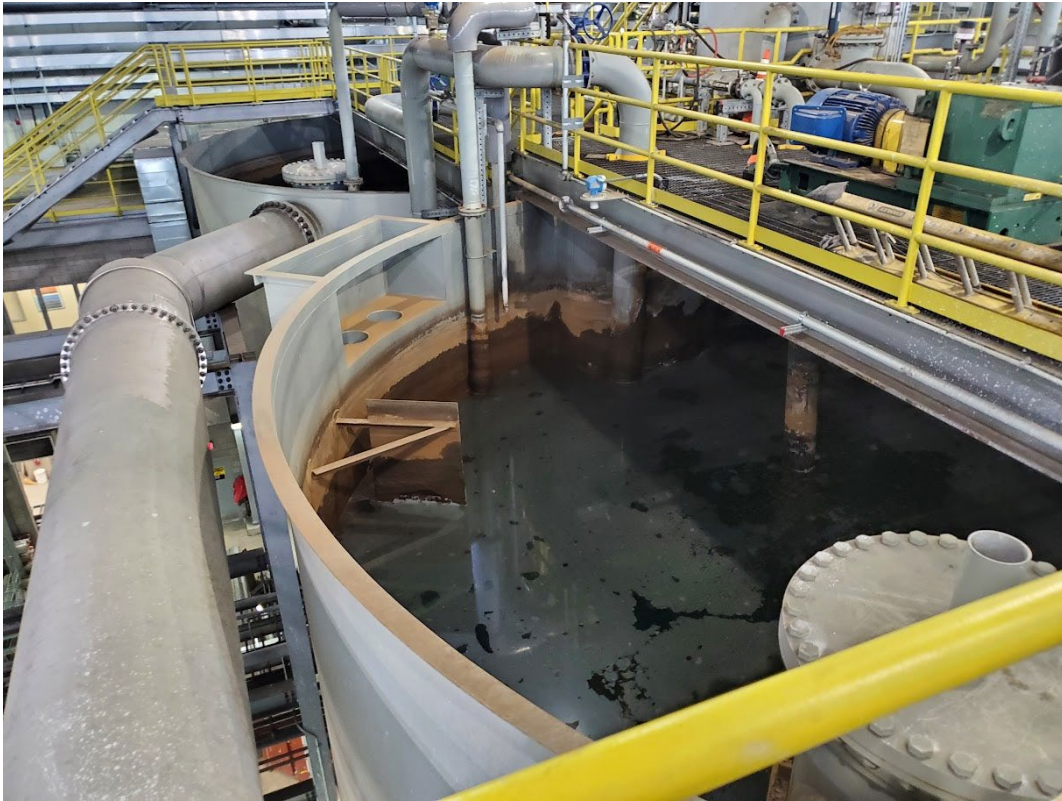
affected water in reactor tanks to raise the pH. The Slurry and Reactor Tanks are in good condition (Photo 7). Solids from the PDWTP are transported via a cement truck to the sludge cells. The filter press in the facility is not being utilized. Once the water leaves the reactor tanks it enters clarifiers and is dosed with flocculant. The clarifiers were in good working conditions and operating at the time of the inspection. Adjacent to the clarifiers is the Filter Building which houses a series of sand filters. Filter tanks appear in good condition. Sulfuric acid is also used in this facility to lower the pH before water is discharged. The sulfuric acid storage is isolated from the rest of the plant and located in an epoxy coated containment area (Photo 8). No spills or other problems were noted within the PDWTP during the inspection.

Photo 7: View to the east of the reactor tank in PDWTP.

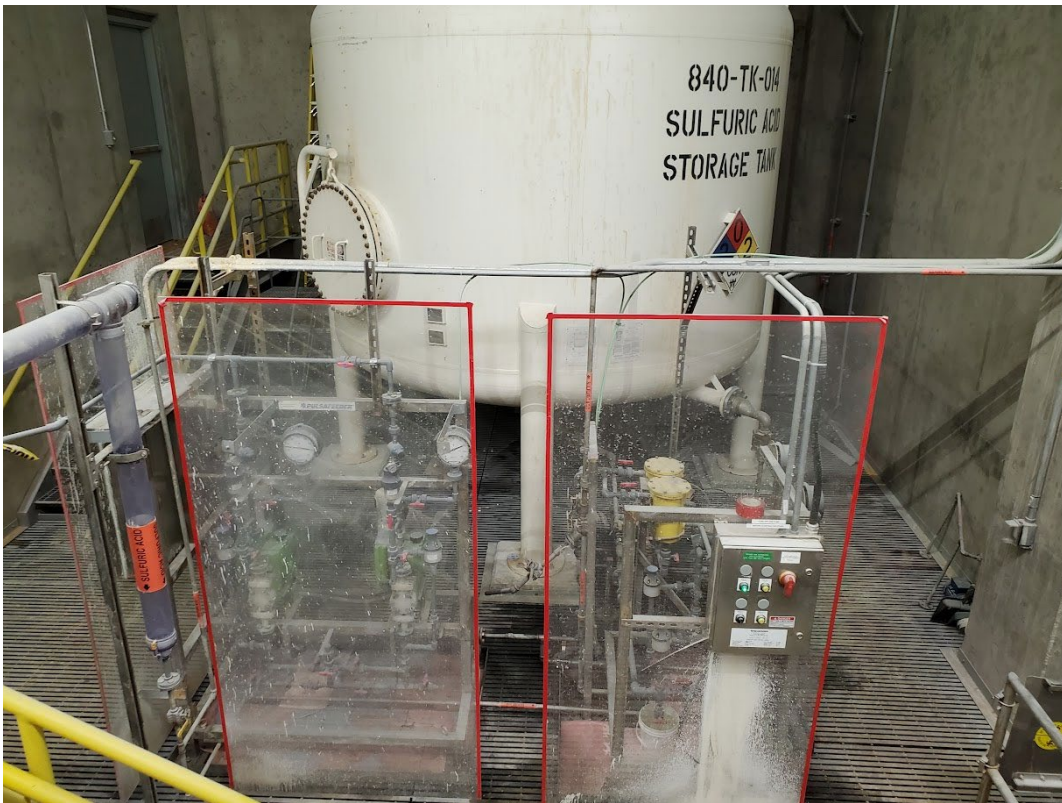
Photo 8: View to the west of sulfuric acid storage in the PDWTP.

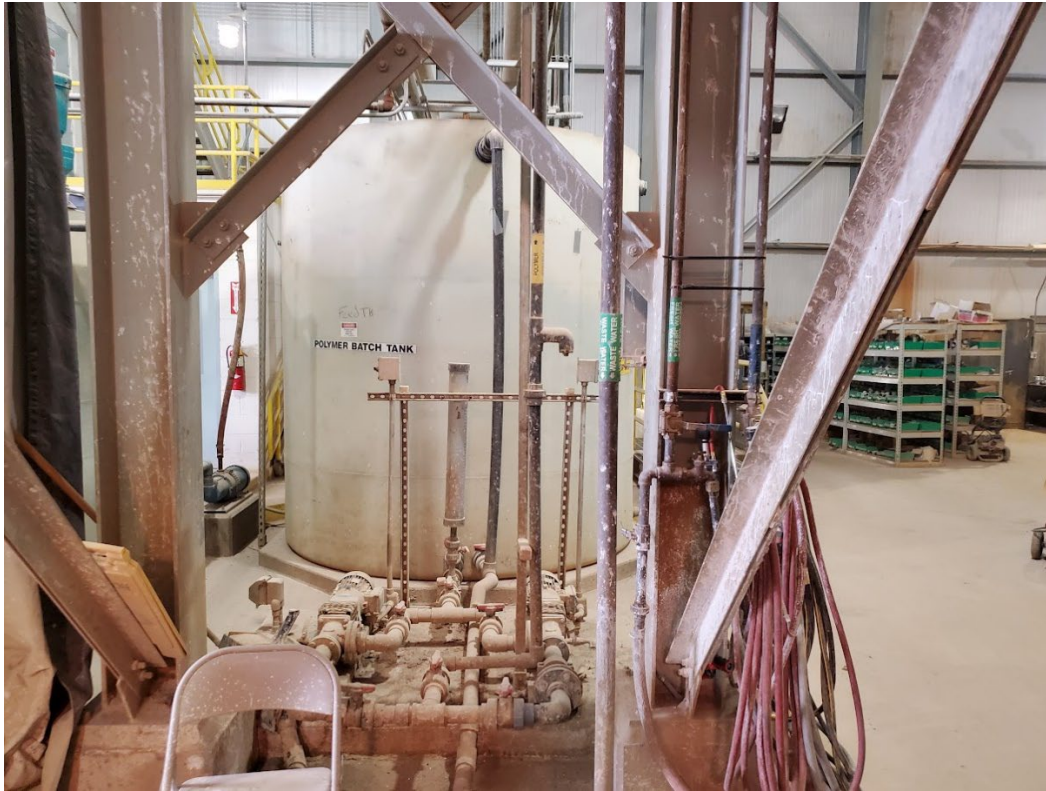
The SDP provides first stage metals treatment for a significant portion of the mine's affected water. The plant creates a sludge that is deposited in a sludge cell on the Tenmile tailing storage facilities. The sludge cell was stable and there was no observed discharge into the cell during the inspection. While operating the plant utilizes lime and flocculant as reagents in the water treatment process. The interior of the facility was in good condition and well kept. Observed reagent materials were properly stored (Photo 9). Tanks appear to be in good condition. Floor sumps and troughs that provide secondary containment appear to be in proper condition and free of obstructions (Photo 10). No problems were noted.

Photo 9: View to the north of reagent storage in SDP.

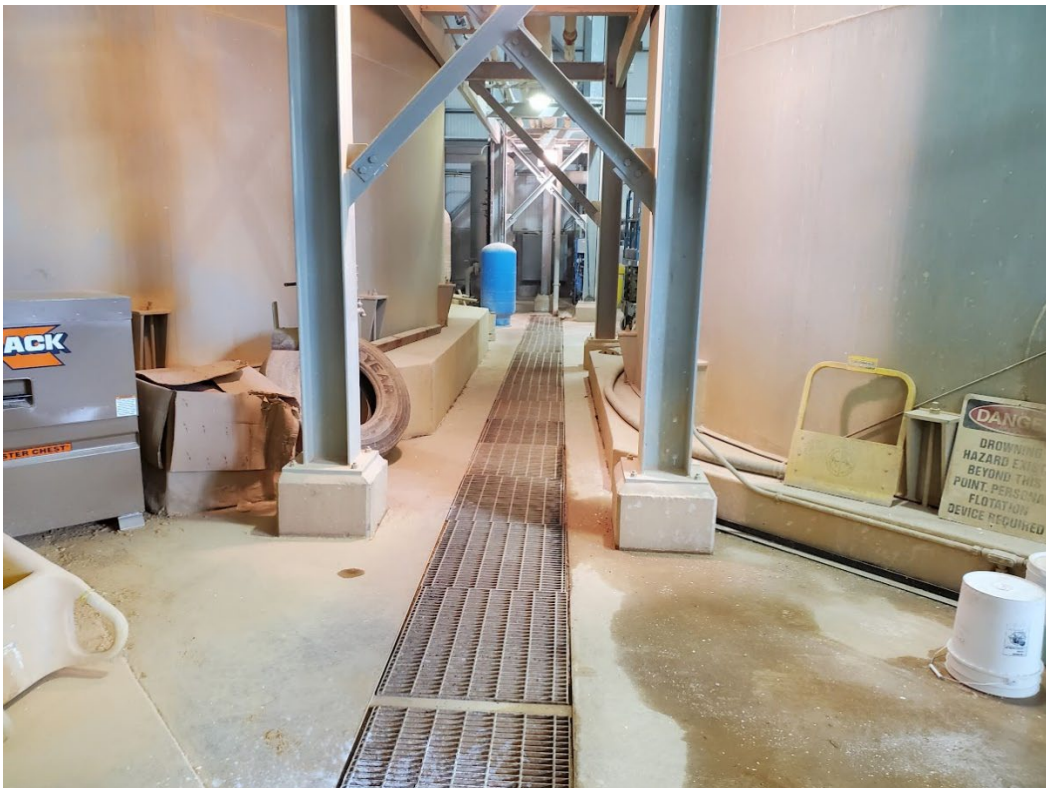
Photo 10: View to the south of containment in SDP.
