**MINERALS PROGRAM INSPECTION REPORT**  
**PHONE: (303) 866-3567**

<b>MINE NAME:</b> Orchard Grove Industrial Pit	<b>MINE/PROSPECTING ID#:</b> M-1990-094	<b>MINERAL:</b> Gravel	<b>COUNTY:</b> Mesa
<b>INSPECTION TYPE:</b> Monitoring	<b>WEATHER:</b> Clear	<b>INSP. DATE:</b> July 16, 2025	<b>INSP. TIME:</b> 09:00
<b>OPERATOR:</b> Kilgore Companies LLC dba Elam Construction	<b>OPERATOR REPRESENTATIVE:</b> Jon Muller	<b>TYPE OF OPERATION:</b> 112c - Construction Regular Operation	
<b>REASON FOR INSPECTION:</b> Normal I&E Program	<b>BOND CALCULATION TYPE:</b> Complete Bond	<b>BOND AMOUNT:</b> \$362,519.00	
<b>DATE OF COMPLAINT:</b> NA	<b>POST INSP. CONTACTS:</b> DRMS	<b>JOINT INSP. AGENCY:</b> None	
<b>INSPECTOR(S):</b> Amy Yeldell	<b>INSPECTOR'S SIGNATURE:</b>

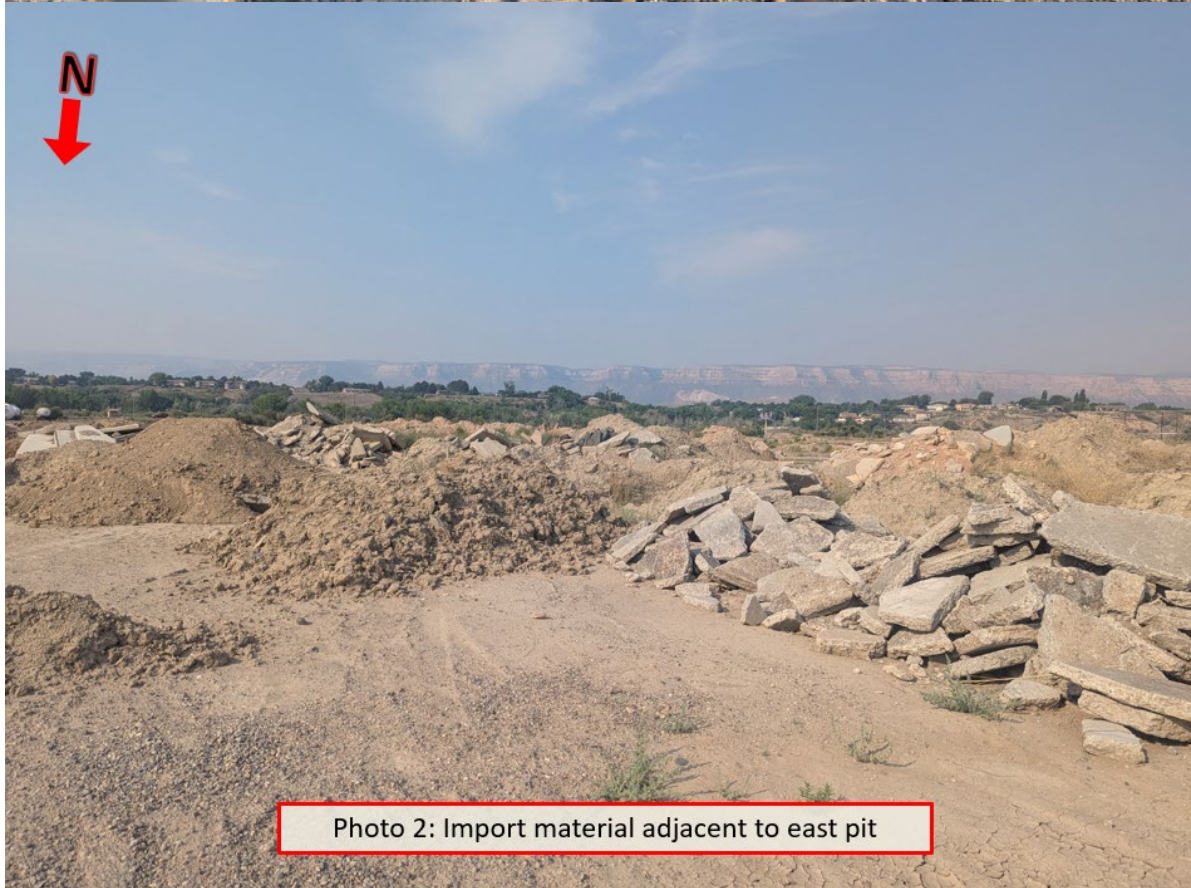
The Operator is continually accepting clean (inert) backfill for of the pits. No ponds will remain upon completion of final reclamation. The Division estimates that 5,000 CY of imported material is on side on the east side of the East Pond ready to be placed. Pond slopes of the East pit are approximately 2200 LF at a 1H: 1V slope and 10 feet above water with an estimated 5-10 feet below water. The West pit also has some backfill material present, though the majority of the stockpiles on the west side of the pit are processed material. The 1400 LF of highwall ranges from 1H: 1V to near vertical.

Photo 2: Import material adjacent to east pit

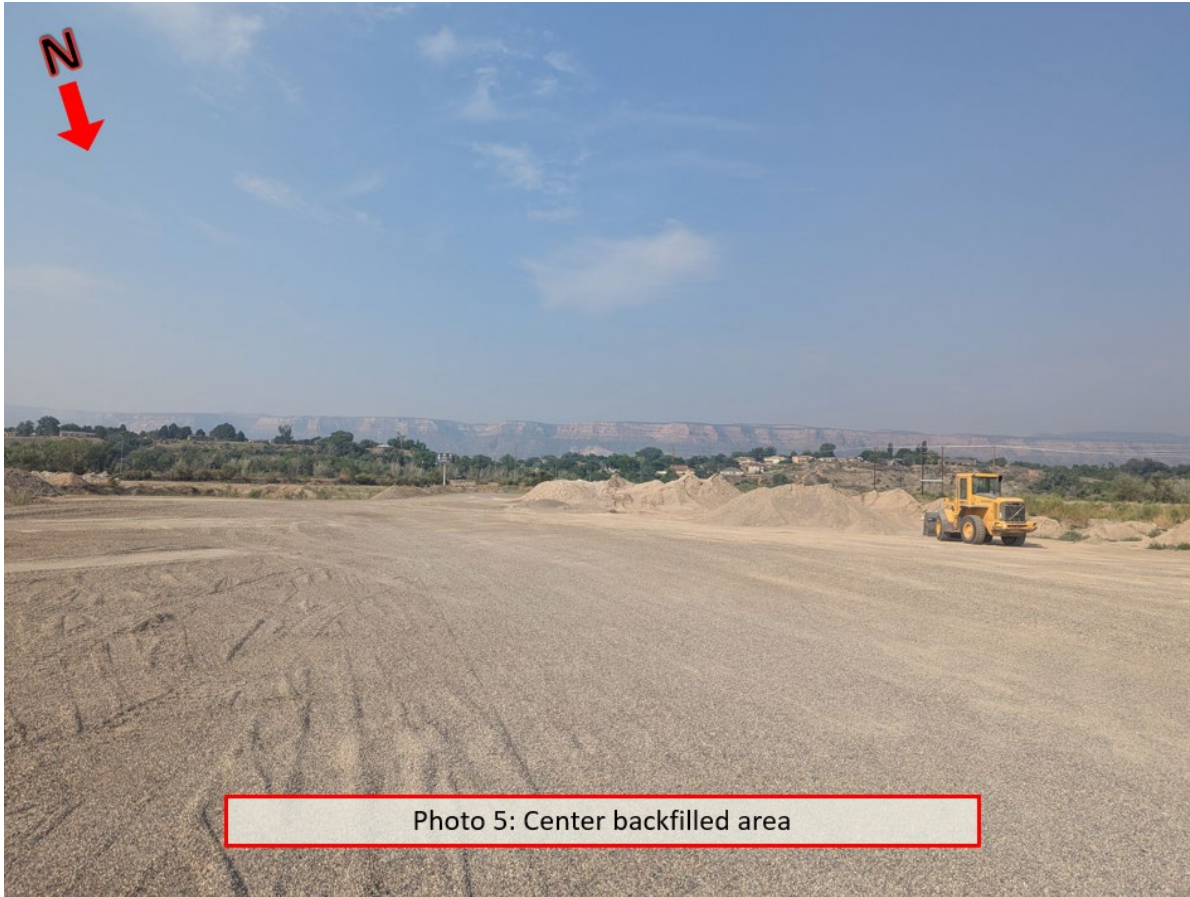
Photo 5: Center backfilled area

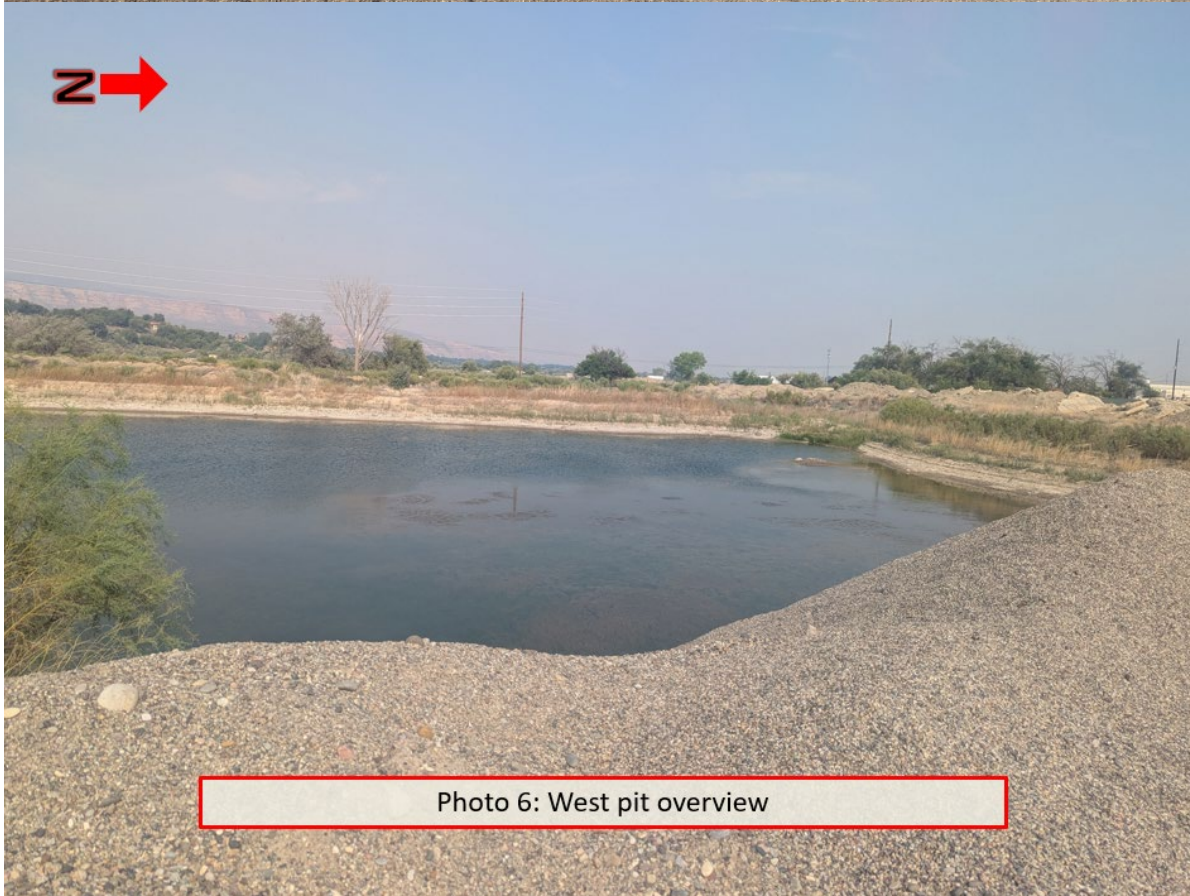
Photo 6: West pit overview
