### MINERALS PROGRAM INSPECTION REPORT

<b>MINE NAME:</b> Grisenti Farms Gravel Pit	<b>MINE/PROSPECTING ID#:</b> M-2001-005	<b>MINERAL:</b> Sand and gravel	<b>COUNTY:</b> Fremont
<b>INSPECTION TYPE:</b> Monitoring	<b>WEATHER:</b> Clear	<b>INSP. DATE:</b> June 24, 2025	<b>INSP. TIME:</b> 10:00
<b>OPERATOR:</b> Continental Materials Corporation	<b>OPERATOR REPRESENTATIVE:</b> Mr. Jerry Schnabel	<b>TYPE OF OPERATION:</b> 112c - Construction Regular Operation	
<b>REASON FOR INSPECTION:</b> Normal I&E Program	<b>BOND CALCULATION TYPE:</b> Complete Bond	<b>BOND AMOUNT:</b> \$115,600.00	
<b>DATE OF COMPLAINT:</b> NA	<b>POST INSP. CONTACTS:</b> None	<b>JOINT INSP. AGENCY:</b> None	
<b>INSPECTOR(S):</b> Jocelyn Carter	<b>INSPECTOR'S SIGNATURE:</b>

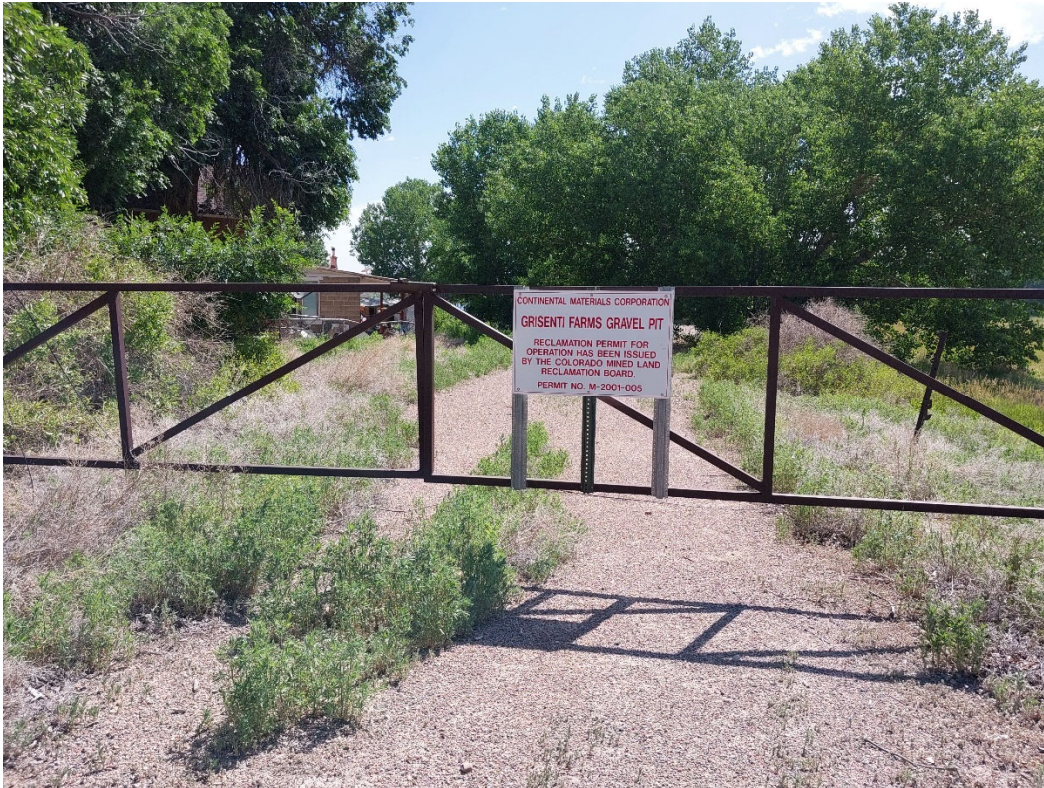
The mine sign is posted on the gate at the southwest entrance to the site, see Photo #1.

Photo #1: Mine sign posted on gate along the southern access road, off CO Hwy 115.

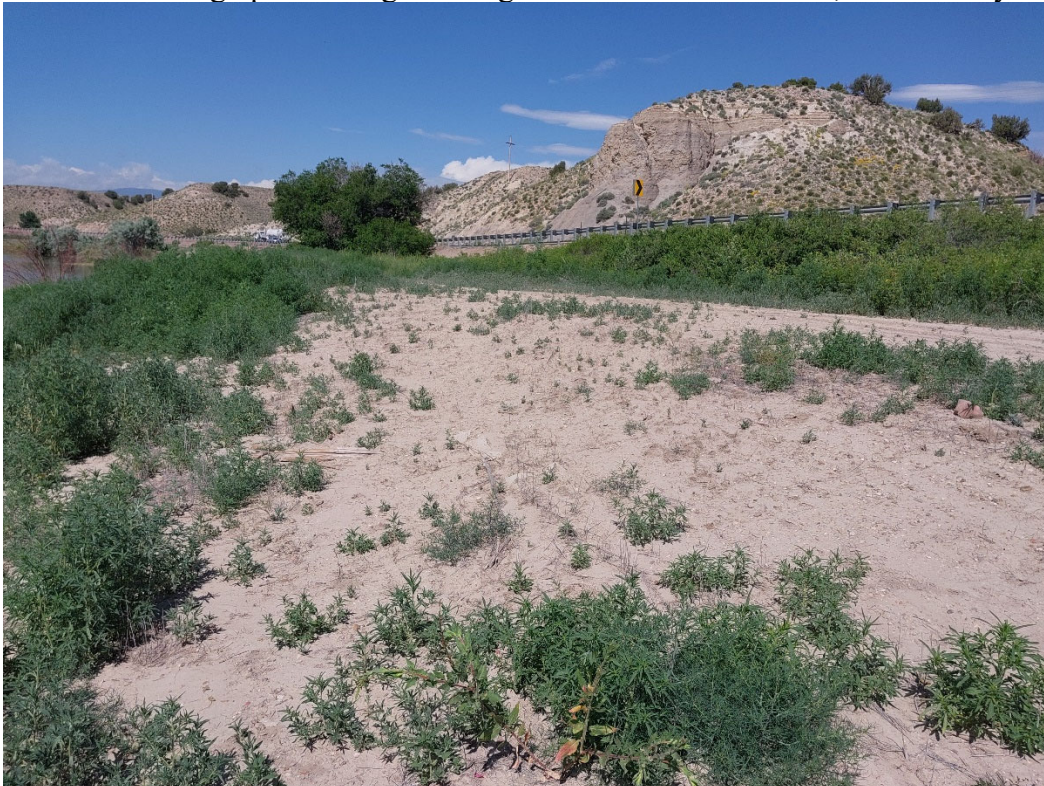
The overall vegetation of the area appeared to be well established, with one small exception where vegetation was relatively sparse compared to surrounding areas. There is a small area to the north of the western pond where there is a notable bare spot, measuring less than 0.1 acres, see Photo #2. The most recent updated seed mix (TR6, May 2025) included the use of alfalfa which appeared to have a great success on the areas where the seed was applied. There was a wide variety of vegetation observed across the permitted area including multiple grasses, milkweed, kochia, tick sunflowers, and cattails, see Photos #5, and #12.

Photo #2: Area of sparse vegetation located north of wester pond, looking to the west southwest.

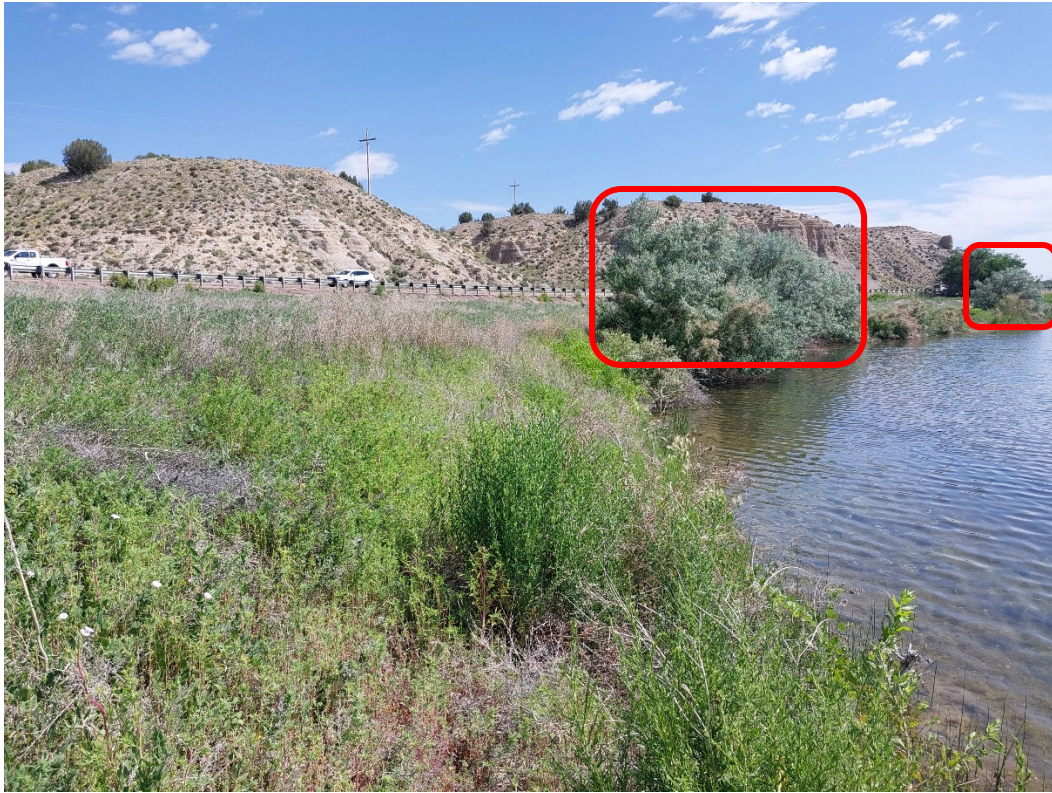
**PROBLEM #2:** Russian olive and tamarisk trees are present within or have volunteered into the permit area and are becoming established. This is a problem for failure to employ weed control methods for a state listed noxious weed species within the permitted area, and to reduce the spread of weeds to nearby areas as required by Section 3.1.10 (6) of the rule.

There are two List B species that were observed on the site at the time of the inspection: Russian Olive and Salt cedar, see Photos #3, #4, and #8. CMC is advised to implement their approved weed management plan (TR1, June 2005). Russian olive and Salt cedar were observed along the shoreline of the west pond and along the southern permit boundary between the two ponds.

Photo #3: From the western edge of the west pond, looking north, CO Hwy 115 can be seen in the background. Russian olive and tamarisk can be seen along the pond shore, outlined in red.

**CORRECTIVE ACTIONS:** The operator shall implement the existing weed control plan in accordance with Section 3.1.10 (6) of the Rule. Submit documentation demonstrating completed control methods for Russian olive and Tamarisk trees by the corrective action due date.

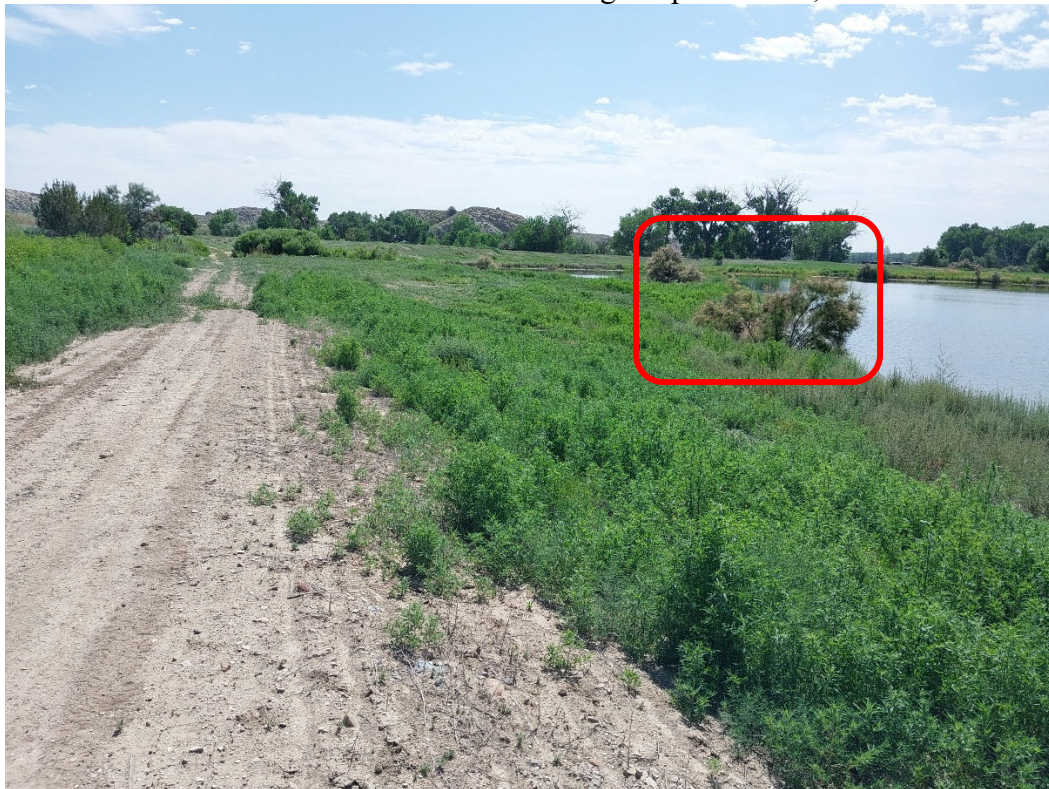
The access roads are to remain in place for use by the landowner, according to the approved reclamation plan. The roads appear to be in good condition, easily traversable, with no erosion issues, see Photo #4.

Photo #4: From the north side of the west pond, looking to the east. View of the road to be left for use by the landowner. Tamarisk can be seen along the pond shore, outlined in red.

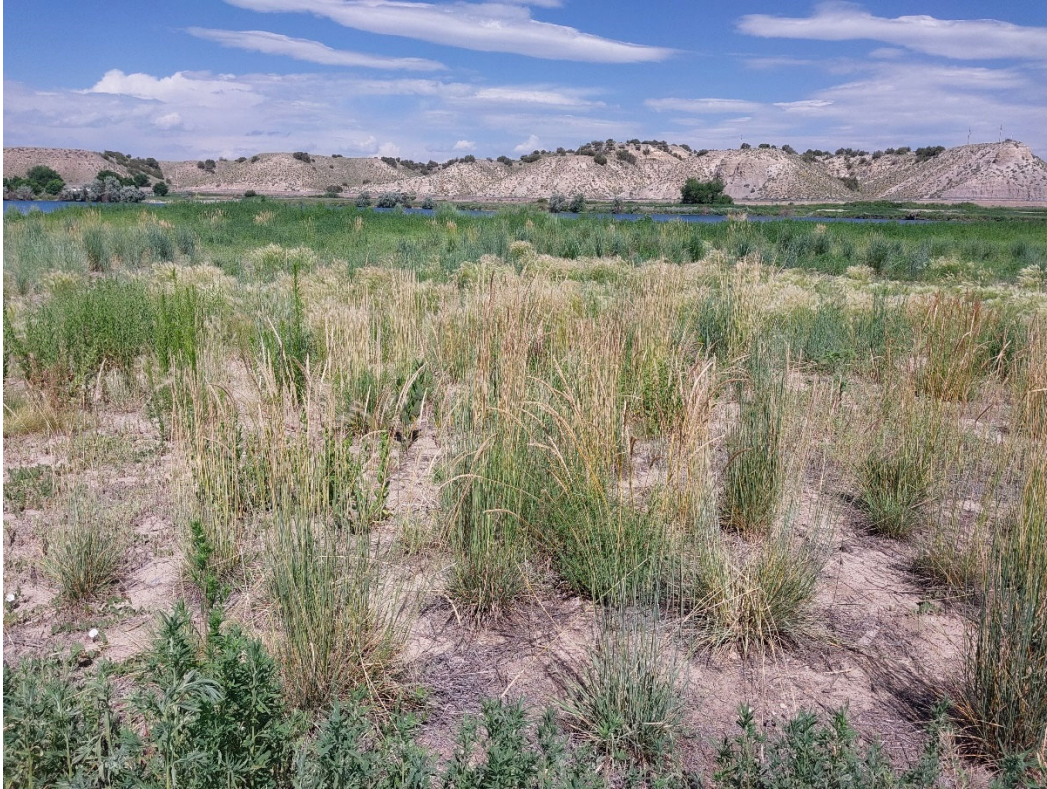
Photo #5: From the southcentral area of the permitted area, looking to the west towards the west pond. A view of the various vegetation along the southeast shore of the west pond.

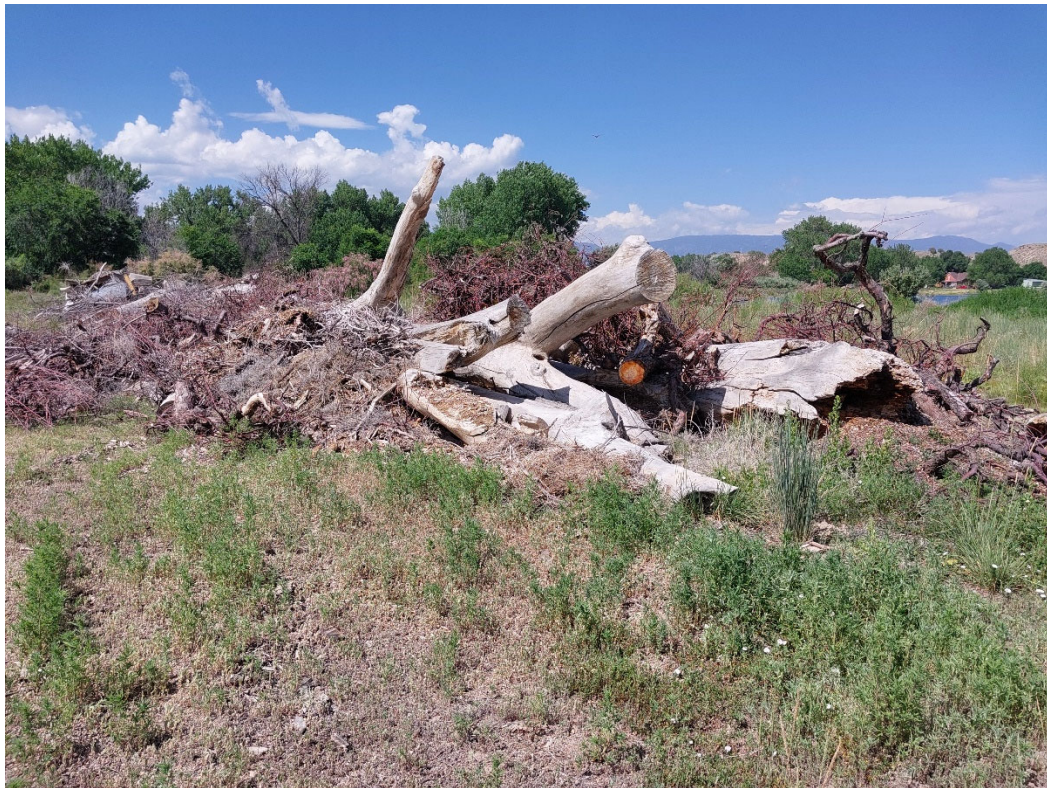
A stockpile of tree slashings and mulch were on site, situated to the southeast of the western pond. According to Mr. Schnabel, the trees were collected from the property by the landowner and are being mulched for use by the landowner, see Photos #6 and #7. There were also some irrigation pipes observed, located south of the access road between the ponds, see Photo #8. The irrigation pipes were placed there and are used by the landowner. Additionally, an old dump truck was also observed to be on site, see Photo #9. According to past inspections reports, this dump truck is to be removed. It is recommended that CMC remove the dump truck prior to seeking final release of the permit.

Photo #6: Stockpile of tree slash material located southeast of the west pond.

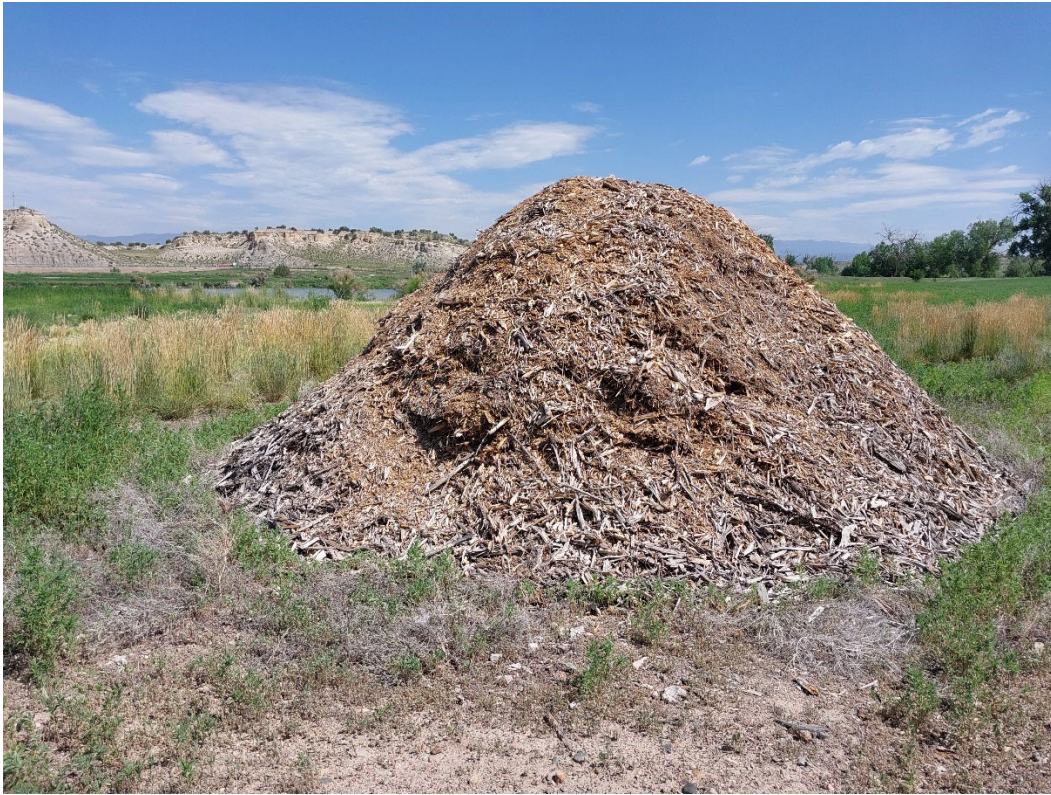
Photo #7: Stockpile of mulch, adjacent to the stockpile of tree slash material.

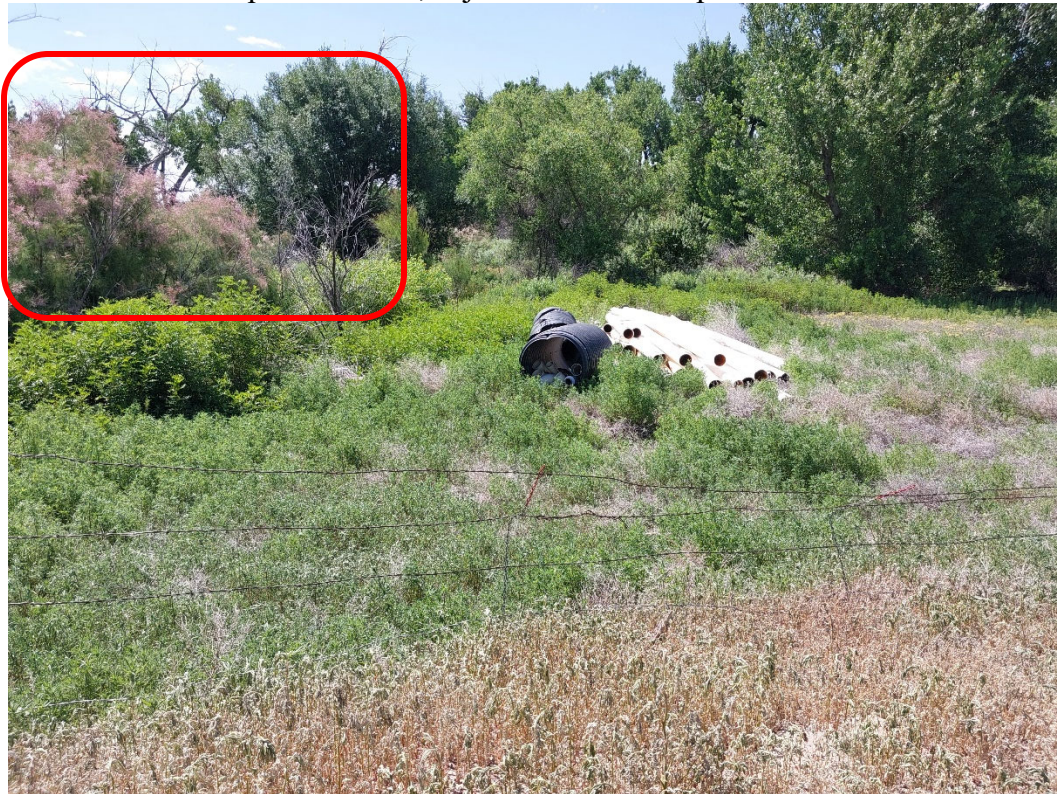
Photo #8: Irrigation pipes located south of the access road between the west and east ponds. Russian olive and Tamarisk can be seen in the background on the left side of the photo, outlined in red.

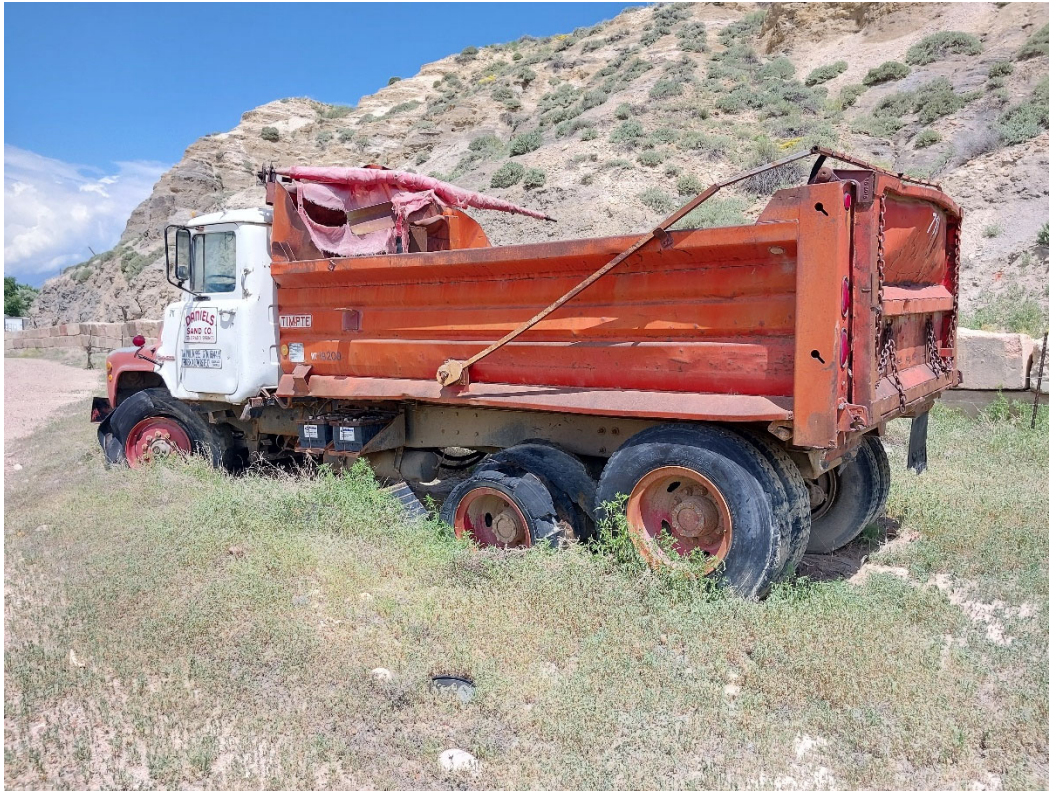
Photo #9: Old dump truck that needs to be removed from the permitted area prior to release of the permit.

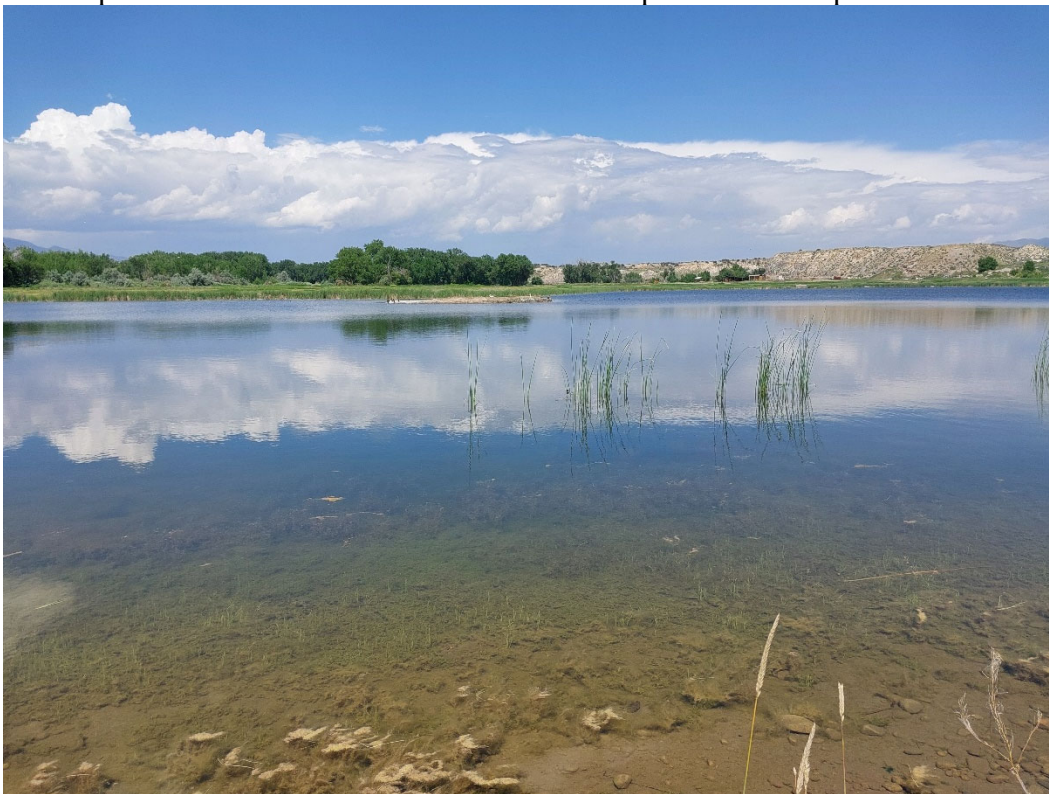
The aquatic life and wildlife in the area appeared to be thriving. Turtles were observed to be living in both ponds. Waterfowl were observed on the island on the eastern pond, mostly ducks and a small number of egrets; the island structure was approved with TR4 (September 2019), see Photo #10. Small songbirds populated the shores of the ponds, such as red-winged black birds and western and mountain bluebirds. A deer was also seen during the inspection, between the south shore of the eastern pond and the north bank of the Arkansas River.

Photo #10: From the east shore of the east pond, looking west. View of the east pond and the island with waterfowl.

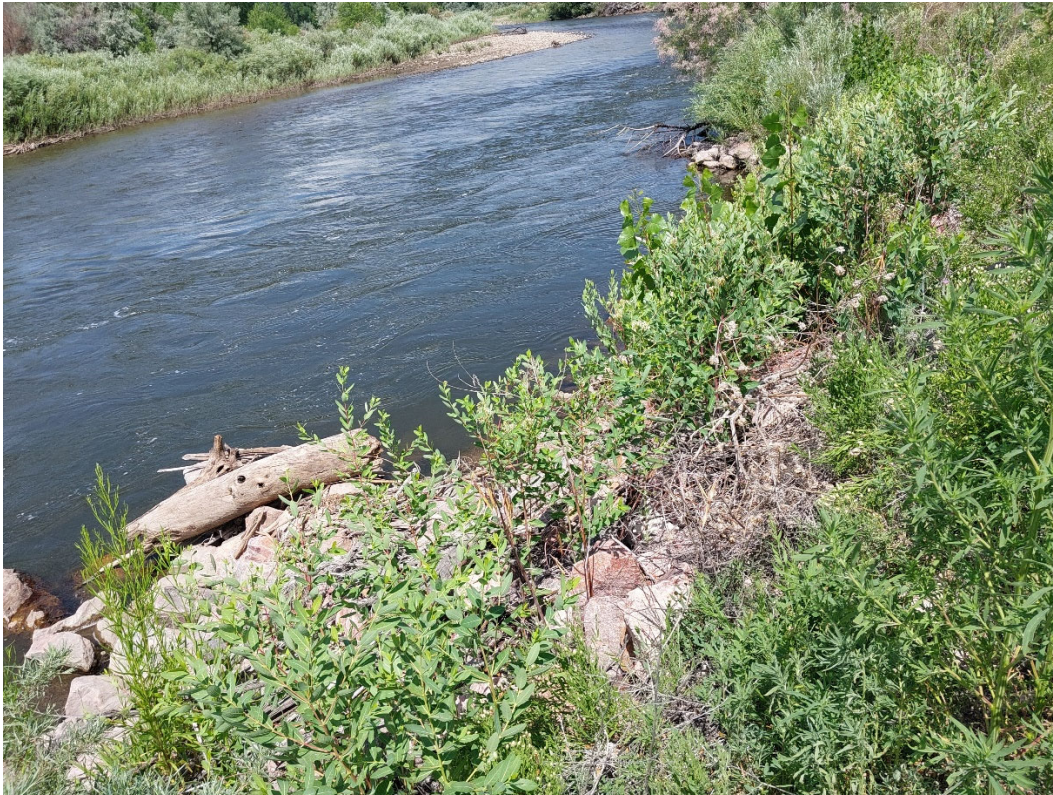
There did not appear to be an issue with the hydrologic balance in the area. The approval of TR3 (August 2018) allowed for armoring to be installed along 415 feet of the northern bank of the Arkansas River to control erosion. The armor appeared to be in place with vegetation having established and furthered control of erosion, see Photo #11.

Photo #11: The armored north bank of the Arkansas River with voluntary vegetation established.

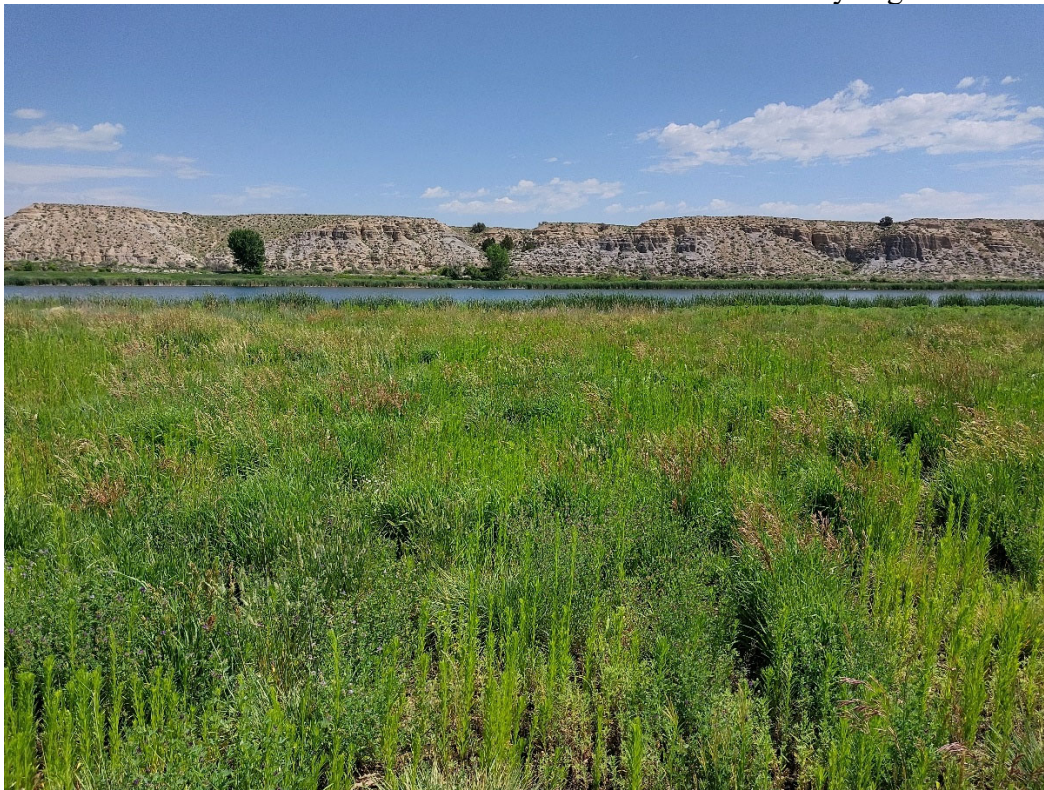
Photo #12: From the southcentral portion of the permit area, looking north toward the east pond. View of the various types of vegetation.
