MINERALS PROGRAM INSPECTION REPORT
PHONE: (303) 866-3567

MINE NAME: Bradford Mesa Quarry	MINE/PROSPECTING ID#: M-2019-046	MINERAL: Crushed stone material and gravel	COUNTY: Huerfano
INSPECTION TYPE: Surety-Related Inspection	WEATHER: Cloudy	INSP. DATE: July 25, 2025	INSP. TIME: 09:04
OPERATOR: Southway Construction Company, Inc.	OPERATOR REPRESENTATIVE: Jodi Schreiber	TYPE OF OPERATION: 112c - Construction Regular Operation	
REASON FOR INSPECTION: Surety Related	BOND CALCULATION TYPE: Complete Bond	BOND AMOUNT: \$534,185.00	
DATE OF COMPLAINT: NA	POST INSP. CONTACTS: None	JOINT INSP. AGENCY: None	
INSPECTOR(S): Amber M. Gibson	INSPECTOR'S SIGNATURE:

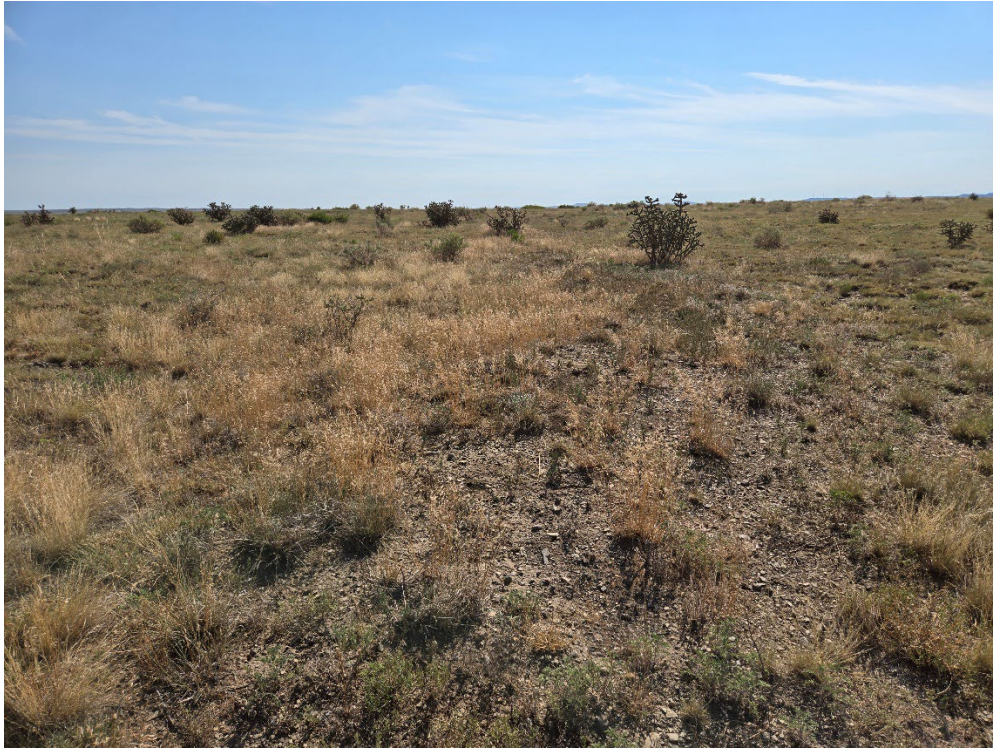
Photo 1: Existing undisturbed conditions onsite.

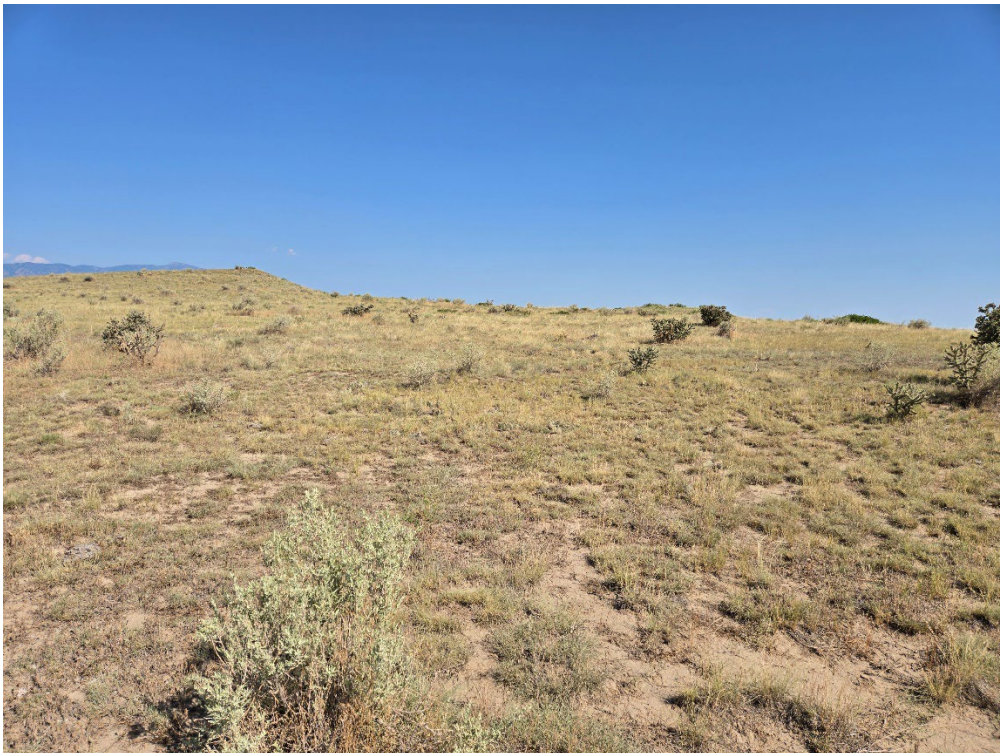
Photo 2: Existing undisturbed conditions onsite.
