MINERALS PROGRAM INSPECTION REPORT
PHONE: (303) 866-3567

MINE NAME: 23 1/4 West Pit	MINE/PROSPECTING ID#: M-2020-035	MINERAL: Sand and gravel	COUNTY: Mesa
INSPECTION TYPE: Monitoring	WEATHER: Clear	INSP. DATE: July 16, 2025	INSP. TIME: 09:40
OPERATOR: Elam Construction, Inc.	OPERATOR REPRESENTATIVE: Jon Muller	TYPE OF OPERATION: 112c - Construction Regular Operation	
REASON FOR INSPECTION: Normal I&E Program	BOND CALCULATION TYPE: Complete Bond	BOND AMOUNT: \$288,111.00	
DATE OF COMPLAINT: NA	POST INSP. CONTACTS: DRMS	JOINT INSP. AGENCY: None	
INSPECTOR(S): Amy Yeldell	INSPECTOR'S SIGNATURE:

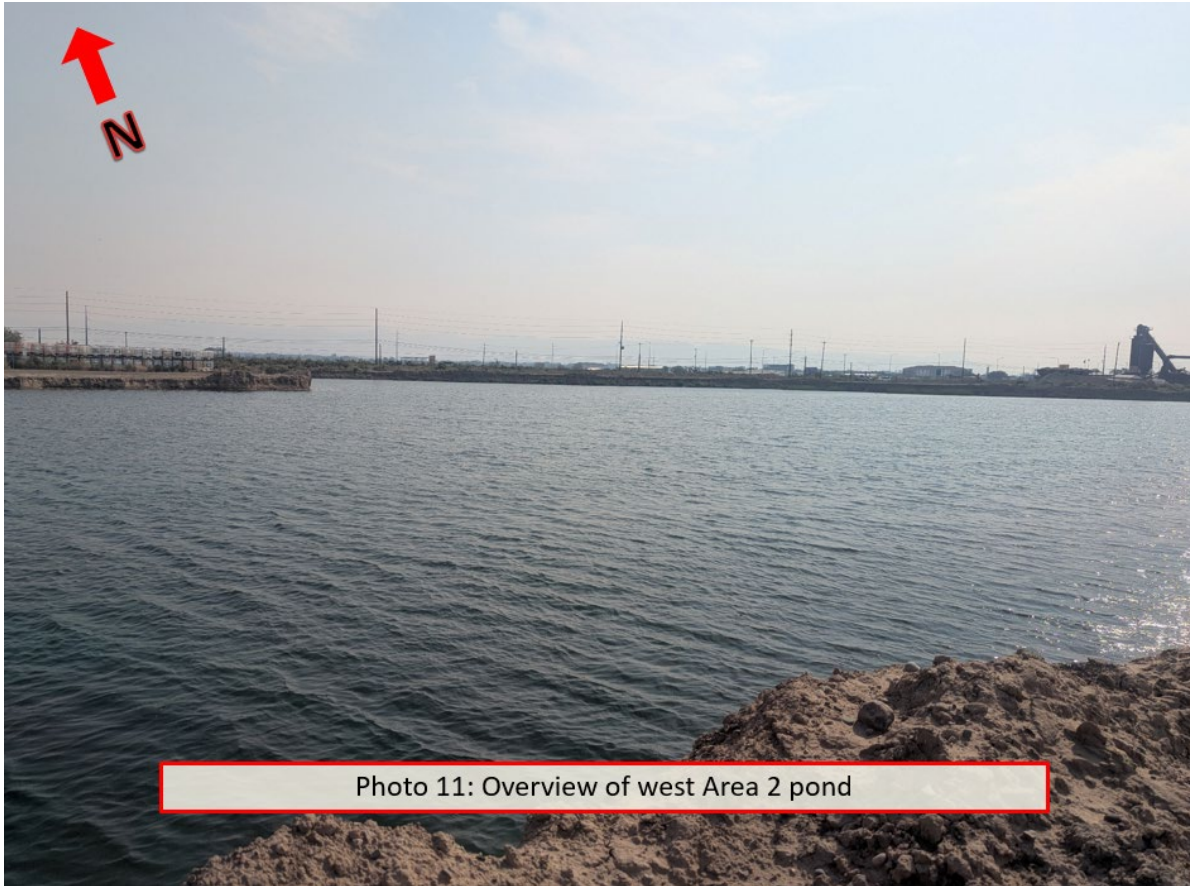
Two ponds have been created within Area 2 by exposing ground water. The Eastern pond is estimated to be 10 acres and the west is estimated to be 1.23 based on the Mesa County Accessors website. Dewatering will be required prior to backfill. Groundwater depth varies from 2 ft in some areas to approximately 10 feet in other areas.

Photo 11: Overview of west Area 2 pond

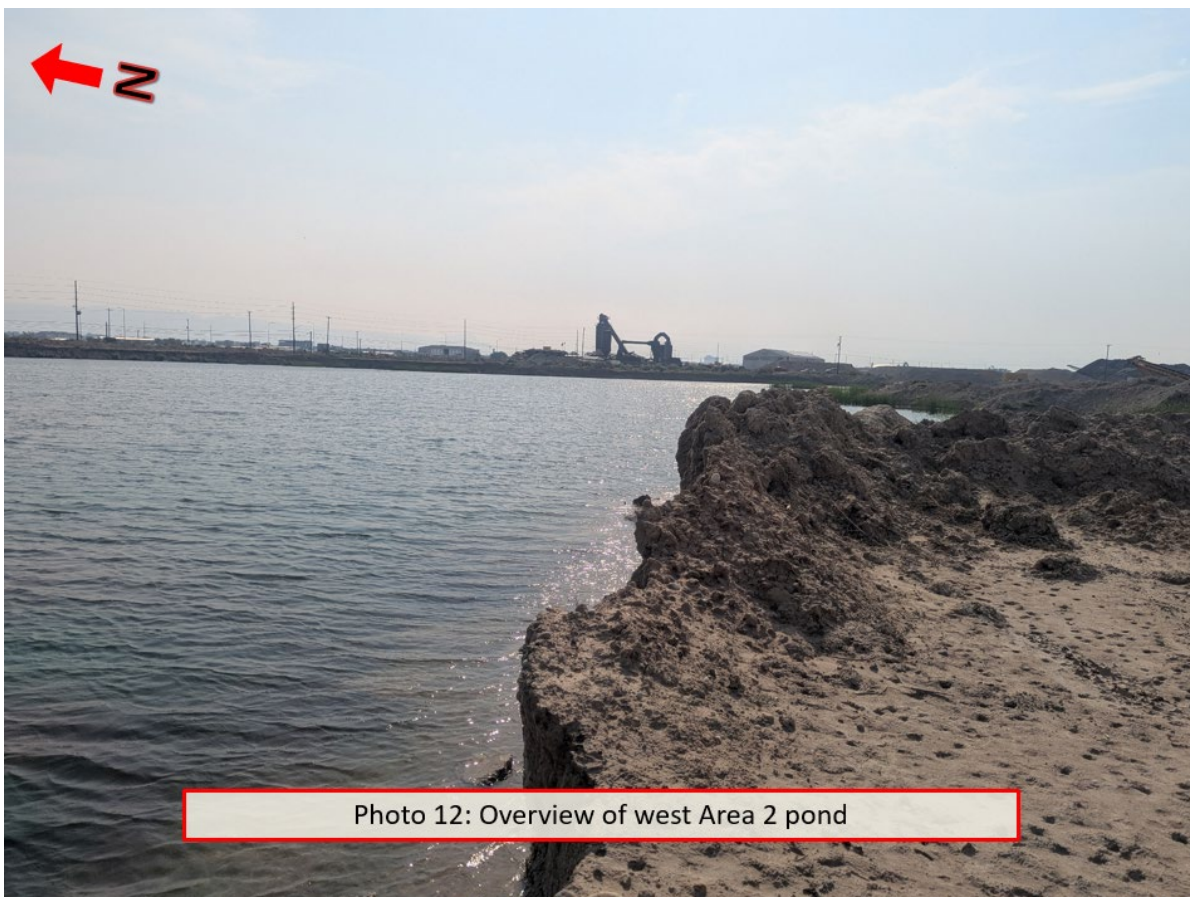
Photo 12: Overview of west Area 2 pond
