MINERALS PROGRAM INSPECTION REPORT PHONE: (303) 866-3567

North Fork Pit	M-2004-025	Sand and gravel	Delta
INSPECTION TYPE:	WEATHER: Clear	INSP. DATE:	INSP. TIME:
Surety-Related Inspection		July 23, 2025	14:45
OPERATOR:	OPERATOR REPRESENTATIVE:	TYPE OF OPERATION:	
Farnsworth Construction and Gravel Compan	Patricia and Cecil Farnsworth	110c - Construction Limited Impact	
REASON FOR INSPECTION:	BOND CALCULATION TYPE:	BOND AMOUNT:	
Surety Related	None	\$22,212.00	
DATE OF COMPLANT	DOGE INGD CONTACTED	TOTALE TAKEN A CITY	ATOX7

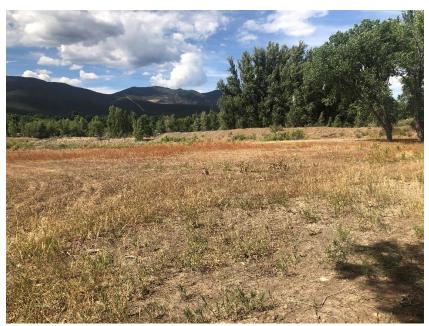
The small portion of the site that is the subject of AR-01 has not been disturbed for mining activities, based on observations during the inspection and based on a review of past aerial photographs in Google Earth. The site includes some grasses and forbs as well as four large trees.

AR-01 area, looking north, with large trees (mentioned in text) on the right

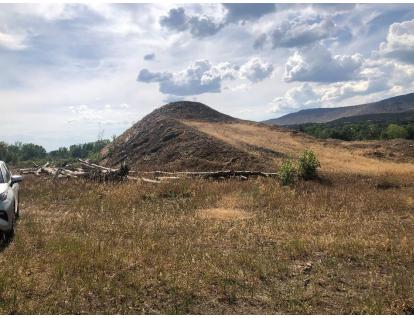
Two large topsoil piles were observed. The one on the east side of the site is approximately 350 feet long, 30 to 40 feet wide, and 8 feet high. The one west of the AR-01 area is approximately a cone that is 100 feet in diameter and 30 feet high. It appears that there is more than enough soil to complete reclamation at the site.

Topsoil stockpile west of AR-01 area

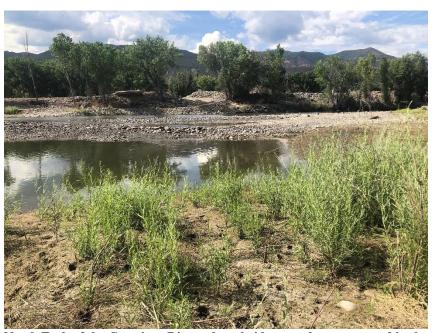
The bridge across the river has not been installed. The metal superstructure and the concrete supports are stored off the permit boundary.

North Fork of the Gunnison River where bridge may be constructed in the future

- The status of discussions with the USACE regarding the bridge should be included in the List of Other Permits and Licenses Required, Exhibit F.

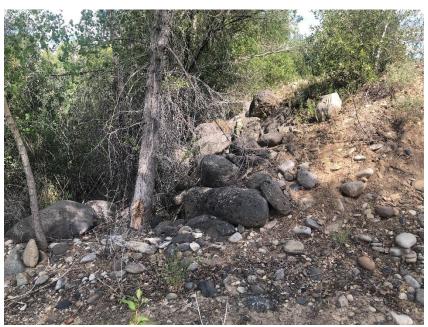
Along the riverside of the permit area (north side), the large boulders for bank protection appear to be stable. This riprap runs along most of the north side of the site.

Riprap on riverbank

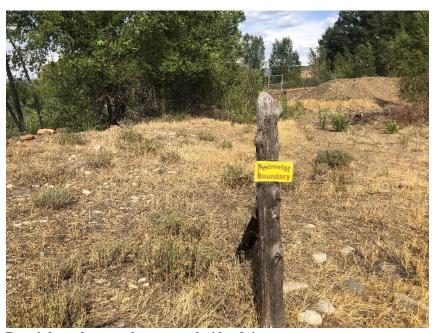
The entrance sign was clearly visible on the gated entrance, and it was large enough and contained the necessary information, per Rule 3.1.12. The permit boundary was generally marked well with posts, a fence, and a berm. The acreage reduction portion of the site was not marked, but the use of technology (the map from the application on a cell phone, using the application Field Maps) sufficed to delineate this portion from surrounding areas.

Permit boundary marker on north side of site

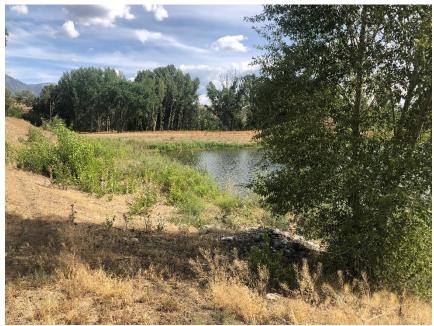
East side of large pond, with large topsoil stockpile on the left

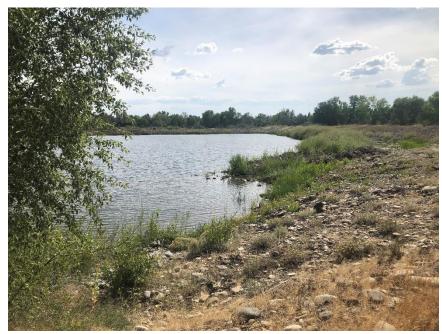
North side of large pond

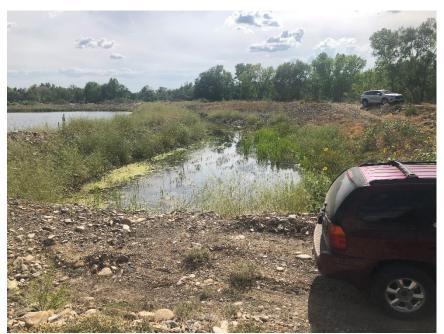
Small pond on north side

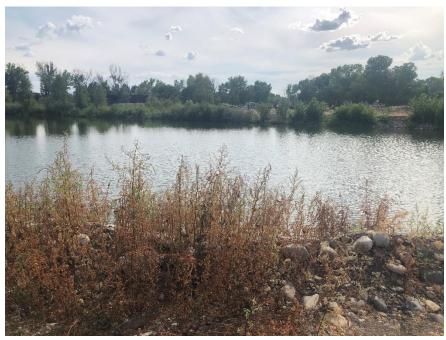
Pond on west side of site

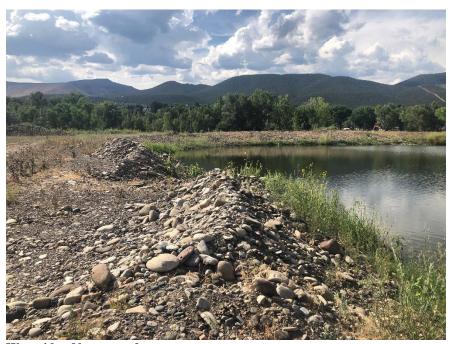
There are three ponds on site, as shown on Map 2 attached to this report. All of the banks of these ponds are well graded. The west side of the large pond has been worked recently, according to Mr. Farnsworth. A rock and soil berm remains along this side of the large pond. Mr. Farnsworth indicated that future mining will likely take place in this area.

West side of large pond

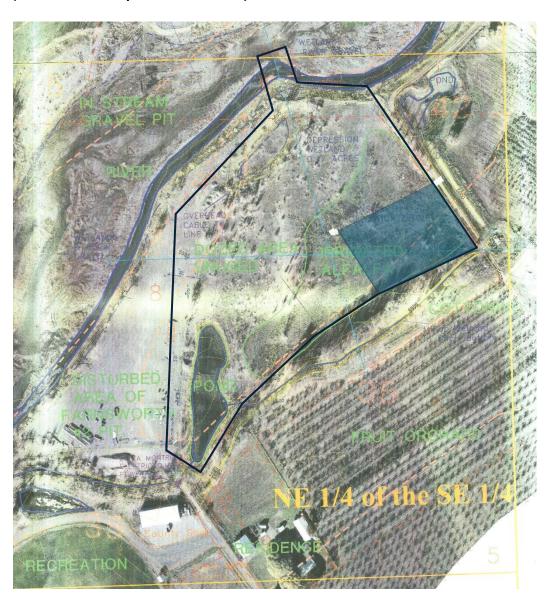
Map 1 – Permit Boundary (black line) and AR-01 Boundary (blue shaded area) (Note that aerial photo is outdated)

This inspection was performed for two reasons. An Acreage Reduction application, AR-01, was received June 2, 2025, and found complete on July 3, 2025. The application requests the release of 1.52 acres of unmined land from the permit area. Please see Map 1 attached to this report, which shows the permit boundary and the area that is the subject of AR-01. To satisfy the requirements of the acreage reduction process (Rule 4.17.2), Rob Zuber with the Division of Reclamation, Mining and Safety (Division) inspected the site within 60 days of the application submittal. The Division intends to make a proposed decision to approve the AR-01 application (observations discussed below). No objections or comments were received. After the approval date, the Division must wait 30 days for the appeal period to end before the approval will be finalized.

A Technical Revision (TR) is required to update the permit exhibit maps in Exhibit E showing the permit boundary, since AR-01 will reduce this area. Additional updates to permit exhibits are also required:
