C1980007, West Elk Mine, July Inspection Report

PERMIT INFORMATION

Permit Number: C-1980-007 Mine Name: West Elk Mine Operator: Mountain Coal Company, LLC Operator Address: Robert Munz 5174 Highway 133 Somerset, CO 81434	County: Delta, Gunnison Operation Type: Underground Permit Status: Active Ownership: Private
	Operator Representative Present: Bob Munz
Operator Representative Signature: (Field Issuance Only)

Inspection Start Date: July 24, 2025 Inspection Start Time: 09:00 Inspection End Date: Inspection End Time:	Inspection Type: Coal Partial Inspection Inspection Reason: Normal I&E Program Weather: Clear
Joint Inspection Agency: None	Joint Inspection Contacts:
Post Inspection Agency: None	Post Inspection Contacts:
Inspector(s): Leigh Simmons	Inspector's Signature:

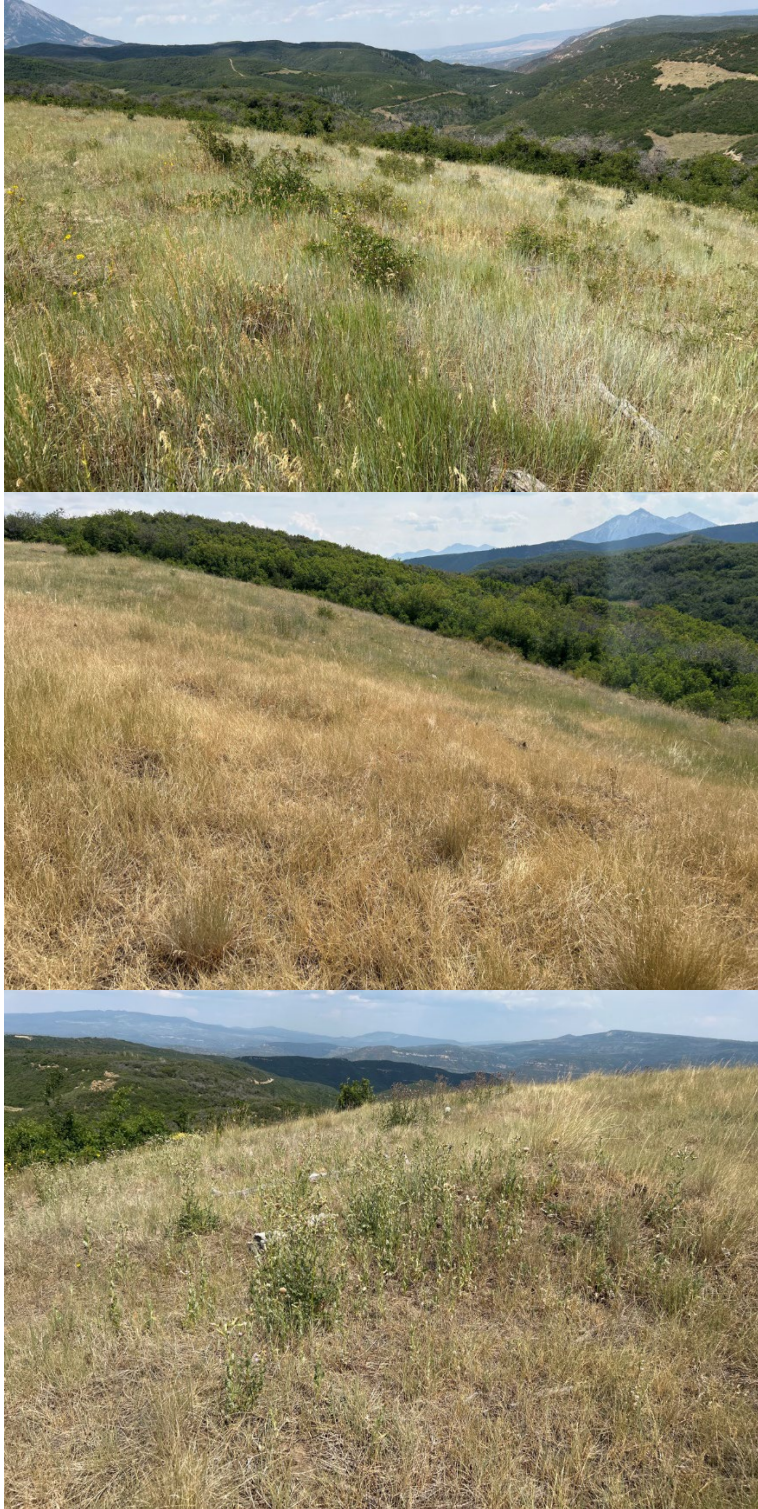
Label	Comments
E1-26.5	Stable, well vegetated. Grass dominant, with varied forbs, and shrubs on N side. Recommend treating several patches of thistle (Canada?) next season – maybe too late this year
E1-30	Looks like some musk thistle and hounds tongue has been sprayed earlier in year
E1-34	Pad has lots of good vegetation, but also houndstongue, musk, Canada - recommend regular treatment before bond release
E1-38	Fenced. Scotch thistle and Canada thistle
E1-41.5	Scotch thistle on N side, musk and Canada on S side, otherwise great diversity
E2-38	Looks good. Just a little Canada thistle - low priority
E2-42	Looks like houndstongue has been sprayed
E1-45	Just a little Canada thistle on NE side
E2-44.5 & -47.5	Some big thistles on S side of pad. Has been sprayed but will need continued follow up
E2-51, 52, 54	Fine
E3-51	Fine
09WE4X53	Fine
Road damage	Road has not been repaired, but creek would be passable upstream in high clearance vehicle

Figure 4: E1-26.5

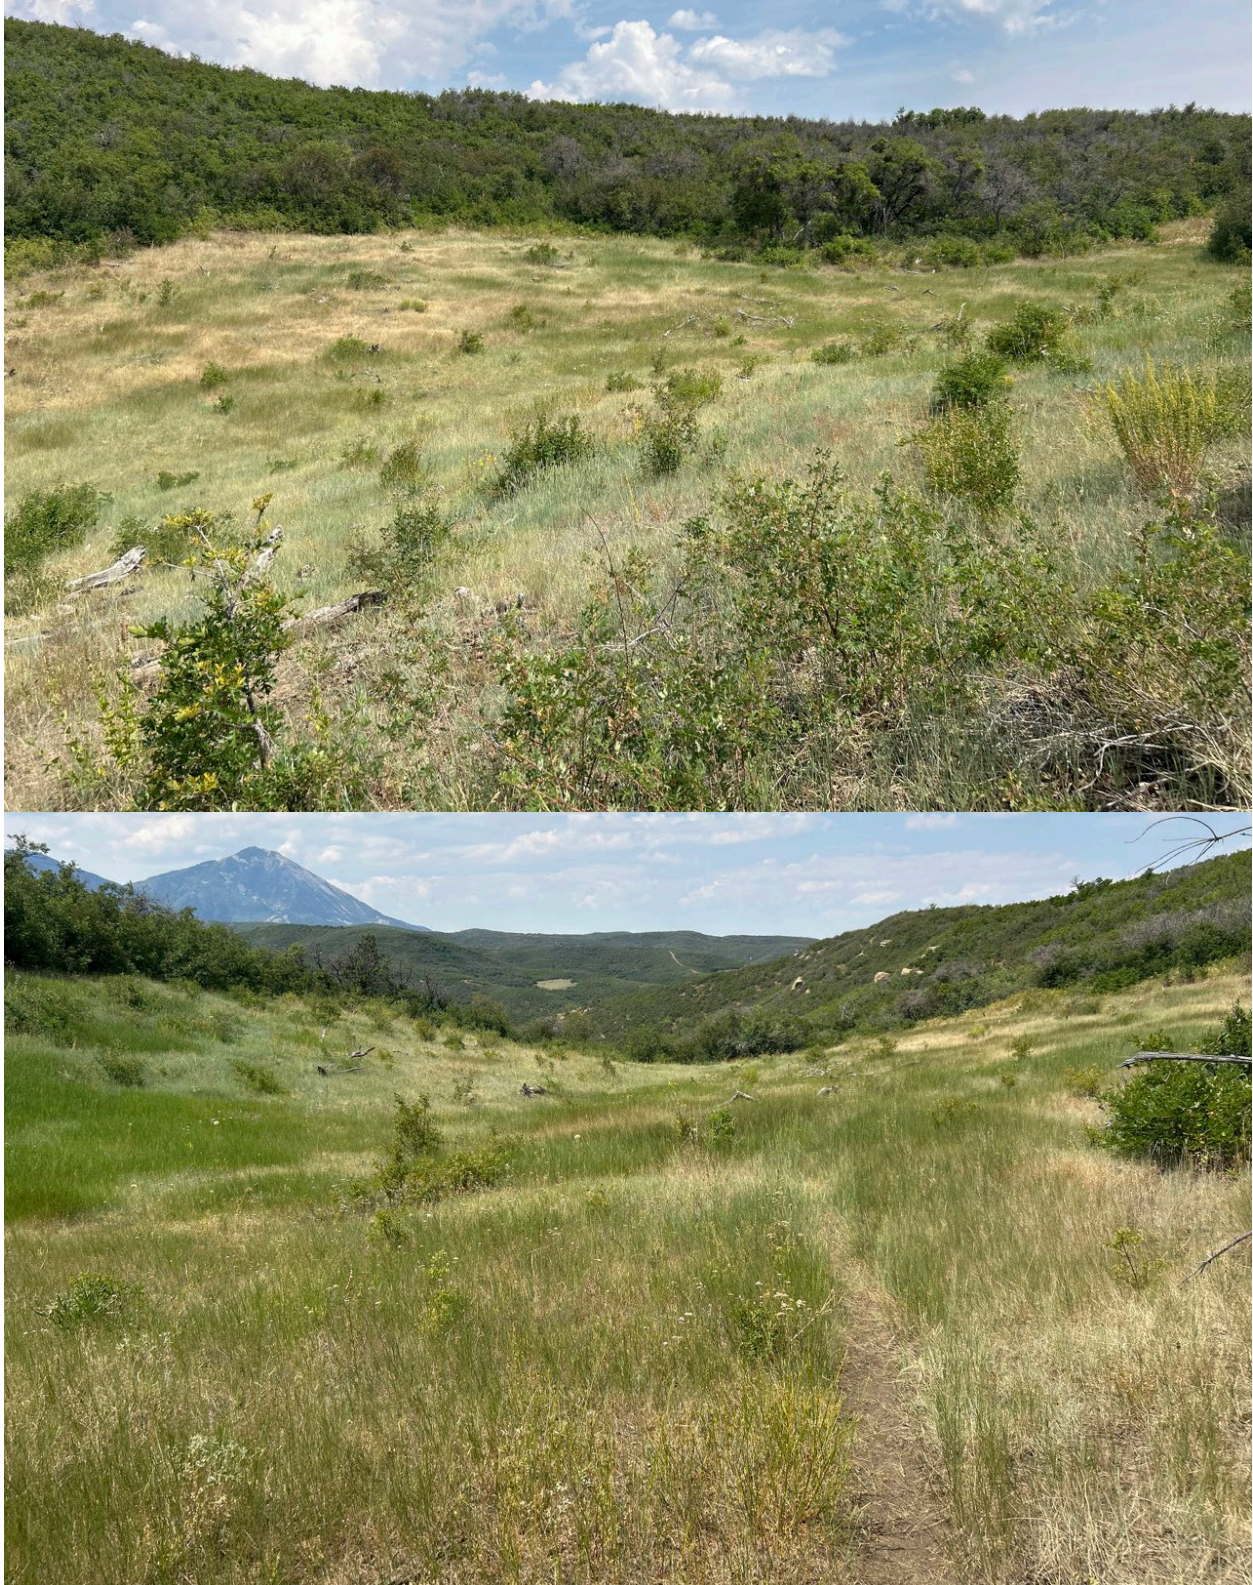
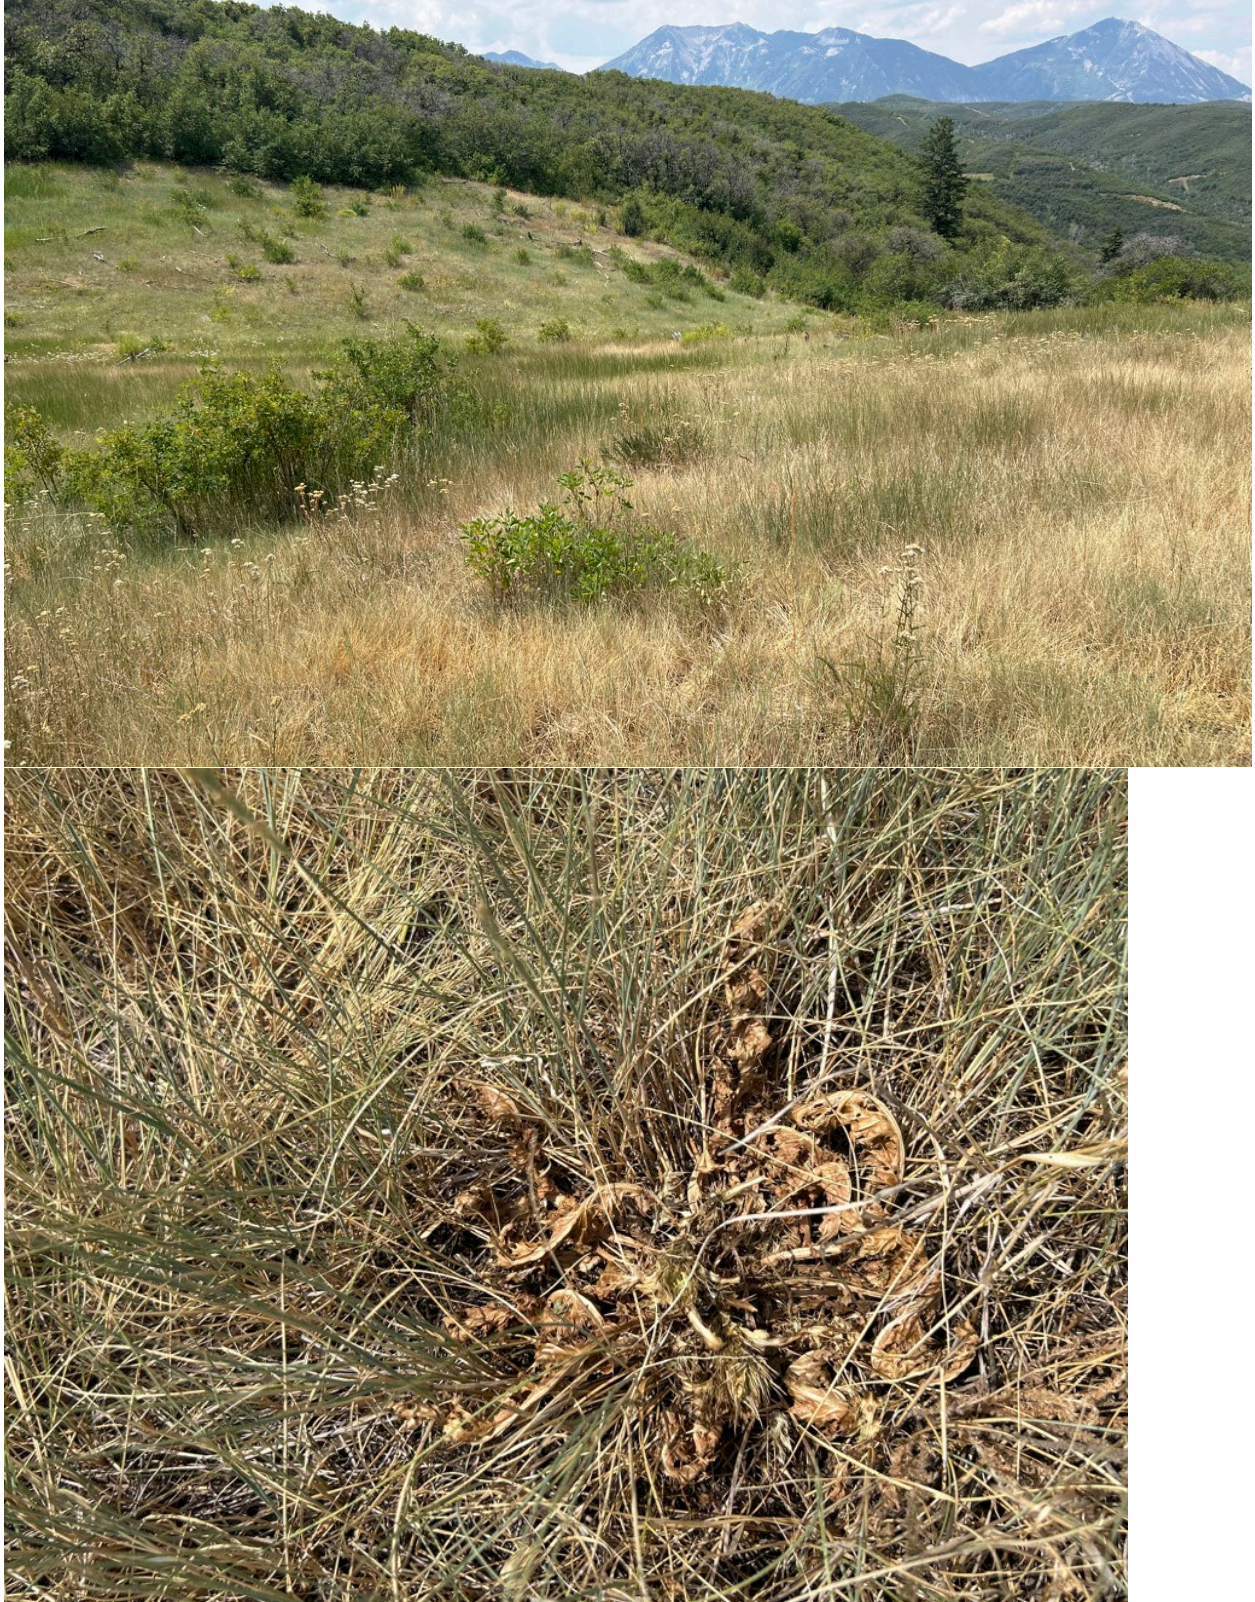
Figure 5: E1-30

Figure 6: More photos of E1-30

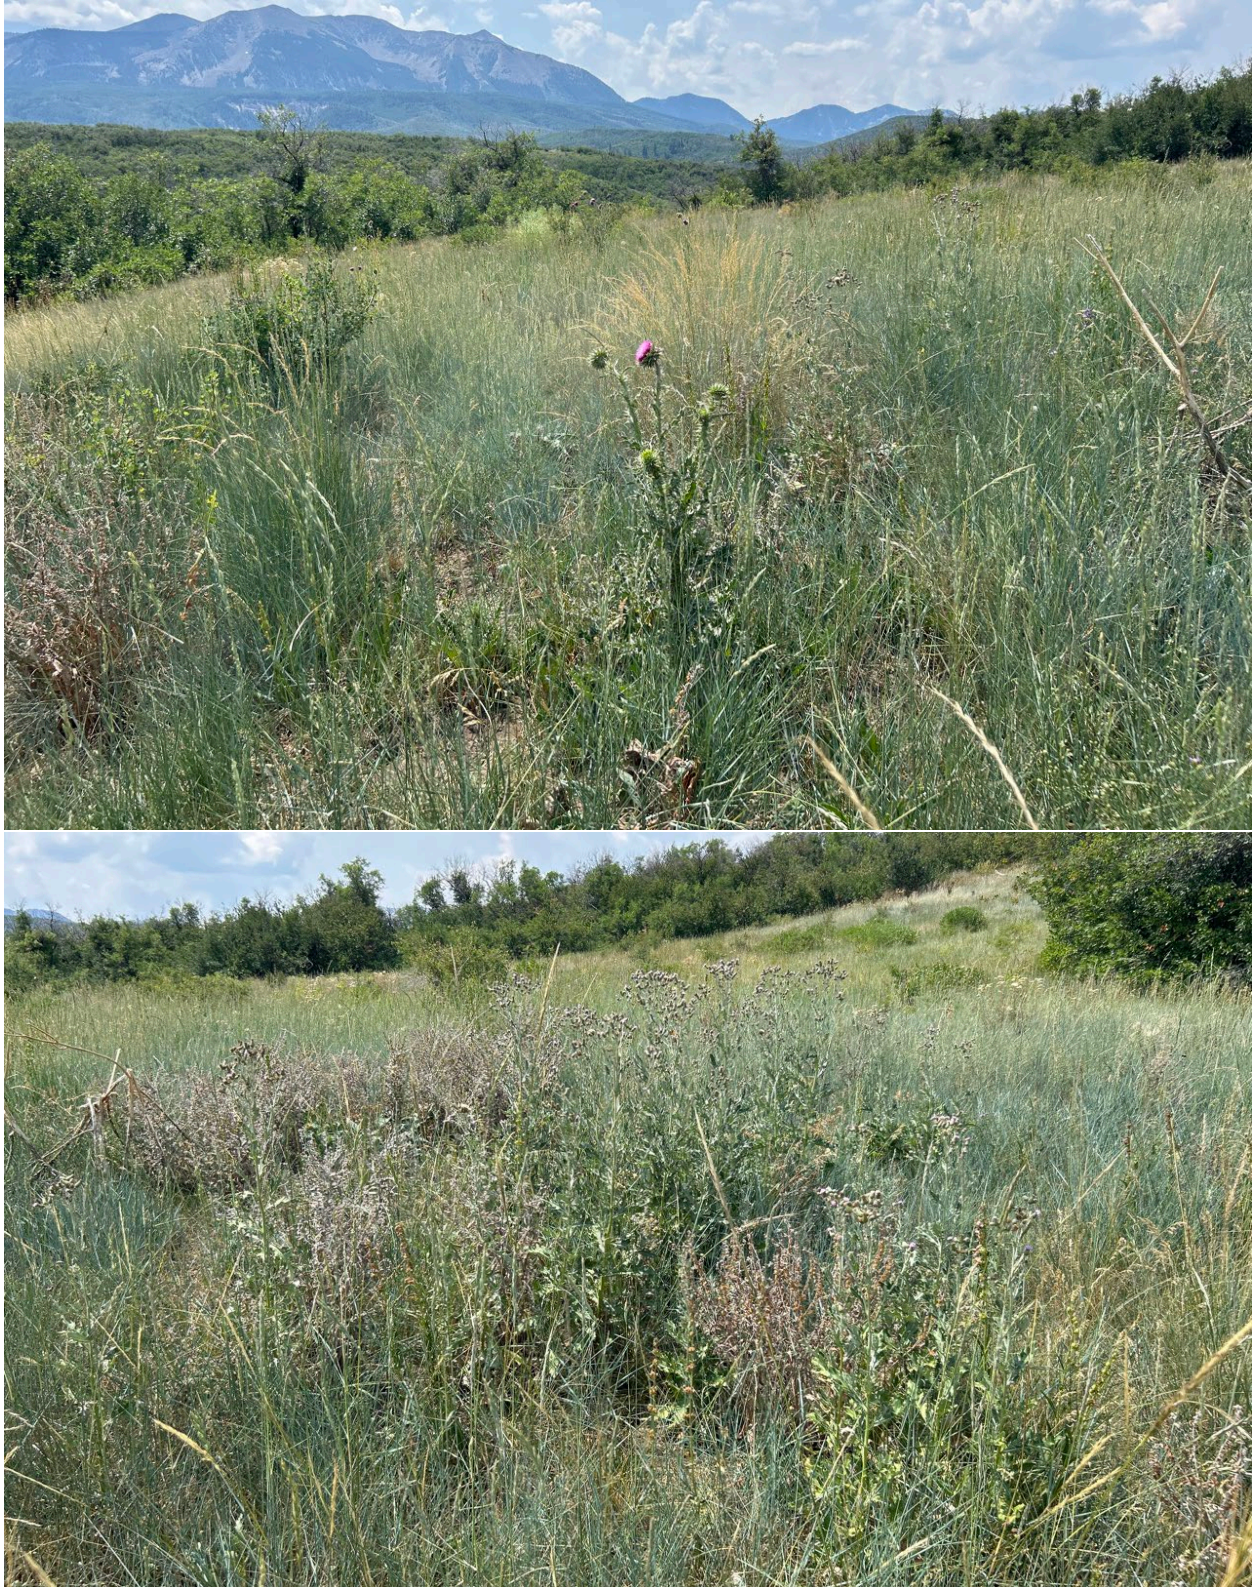
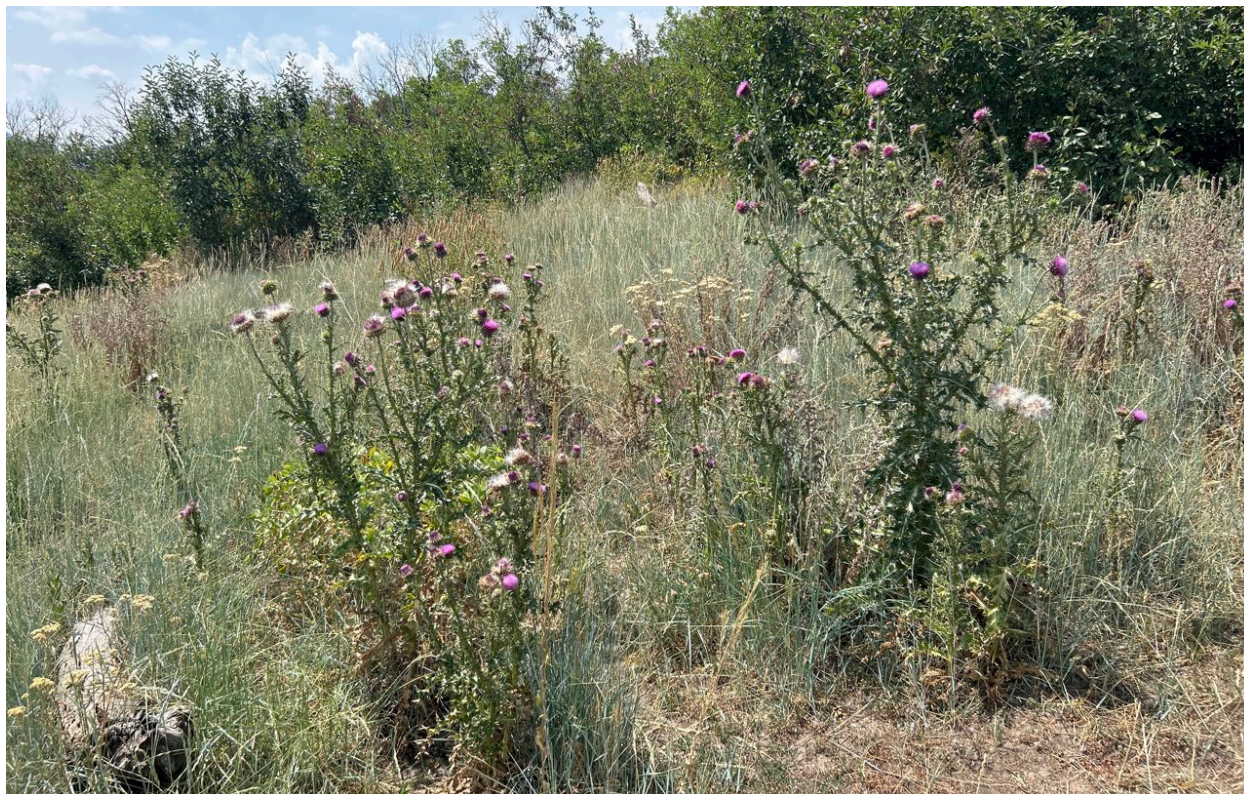
Figure 7: E1-34

Figure 8: Musk thistle on E1-34

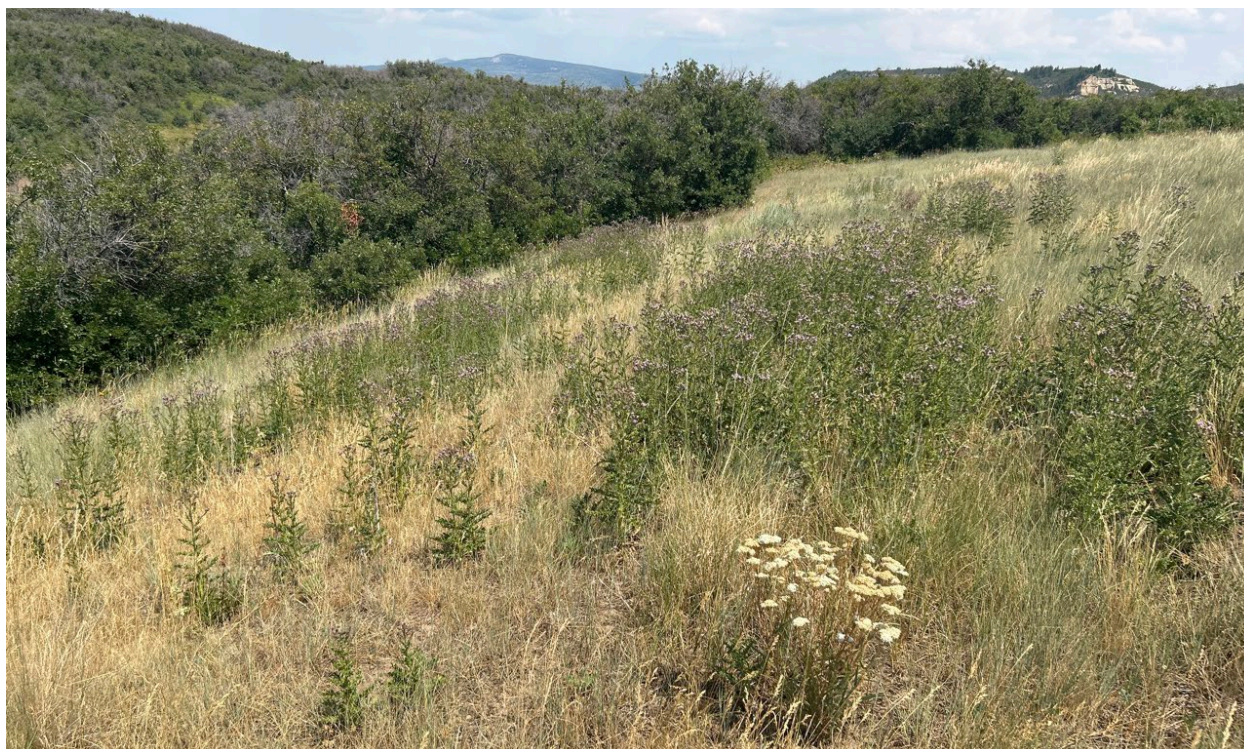
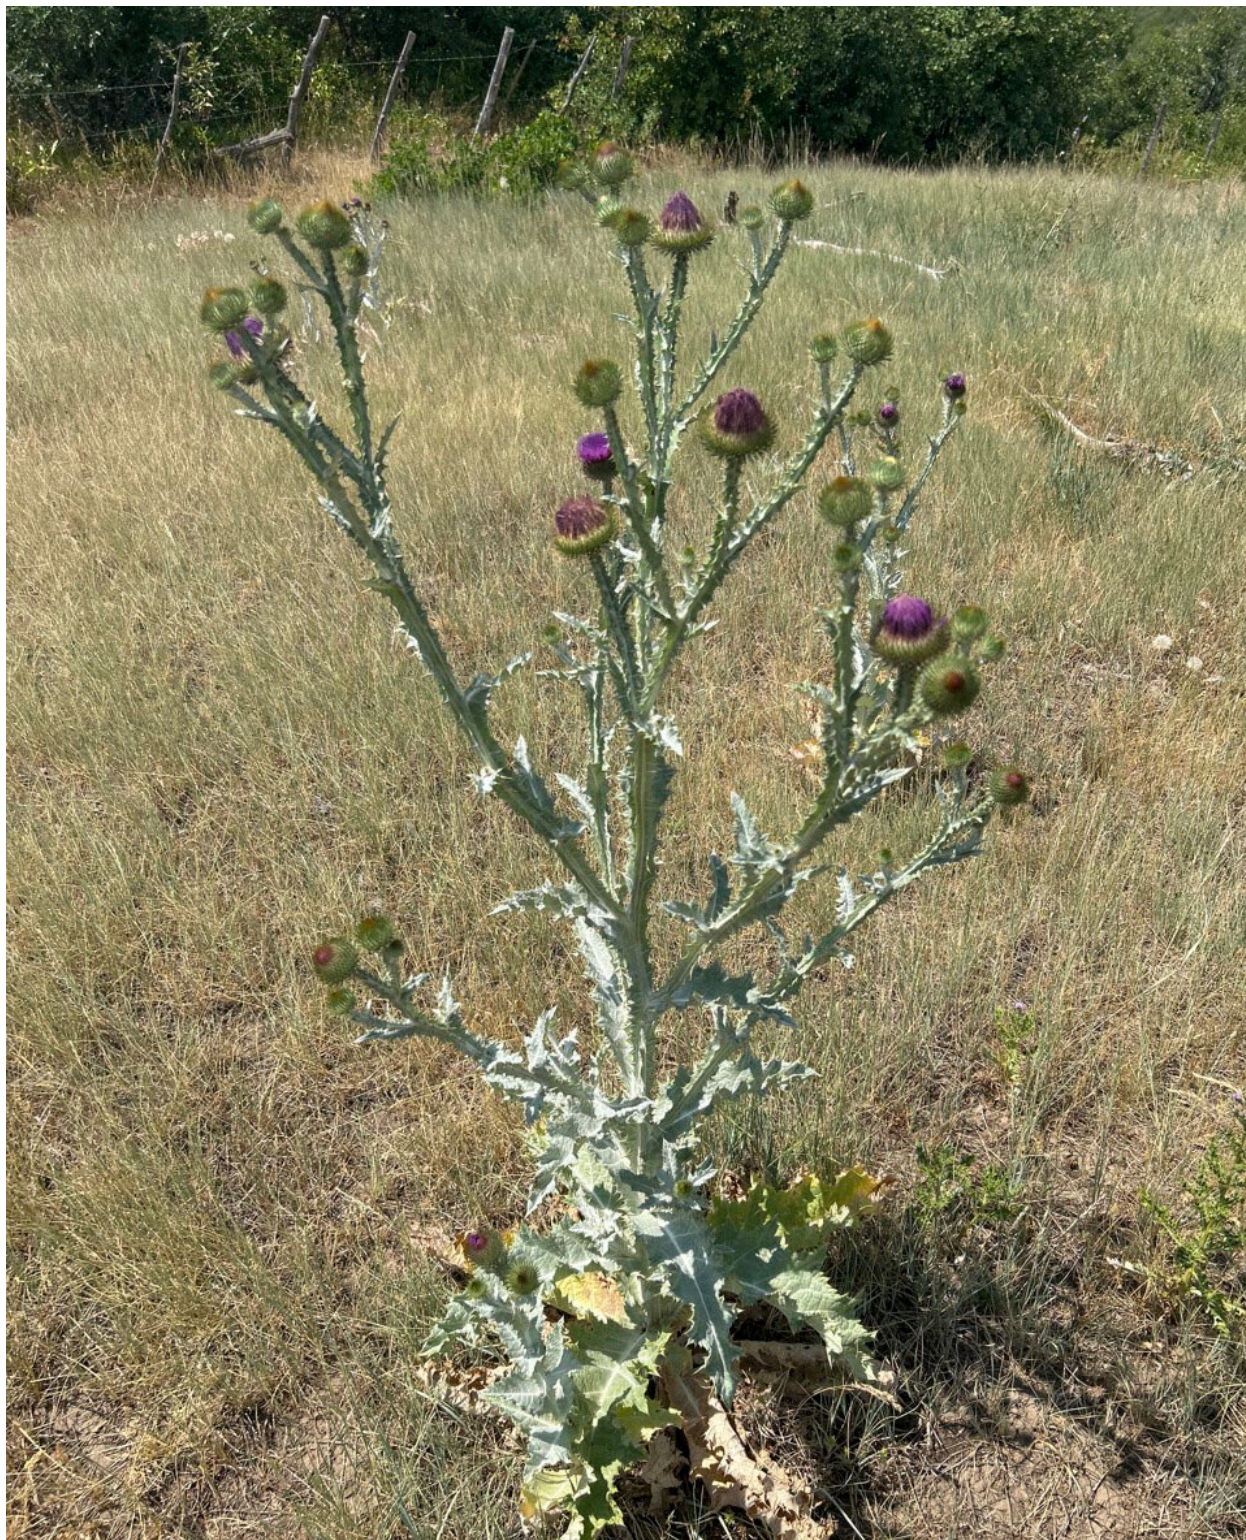
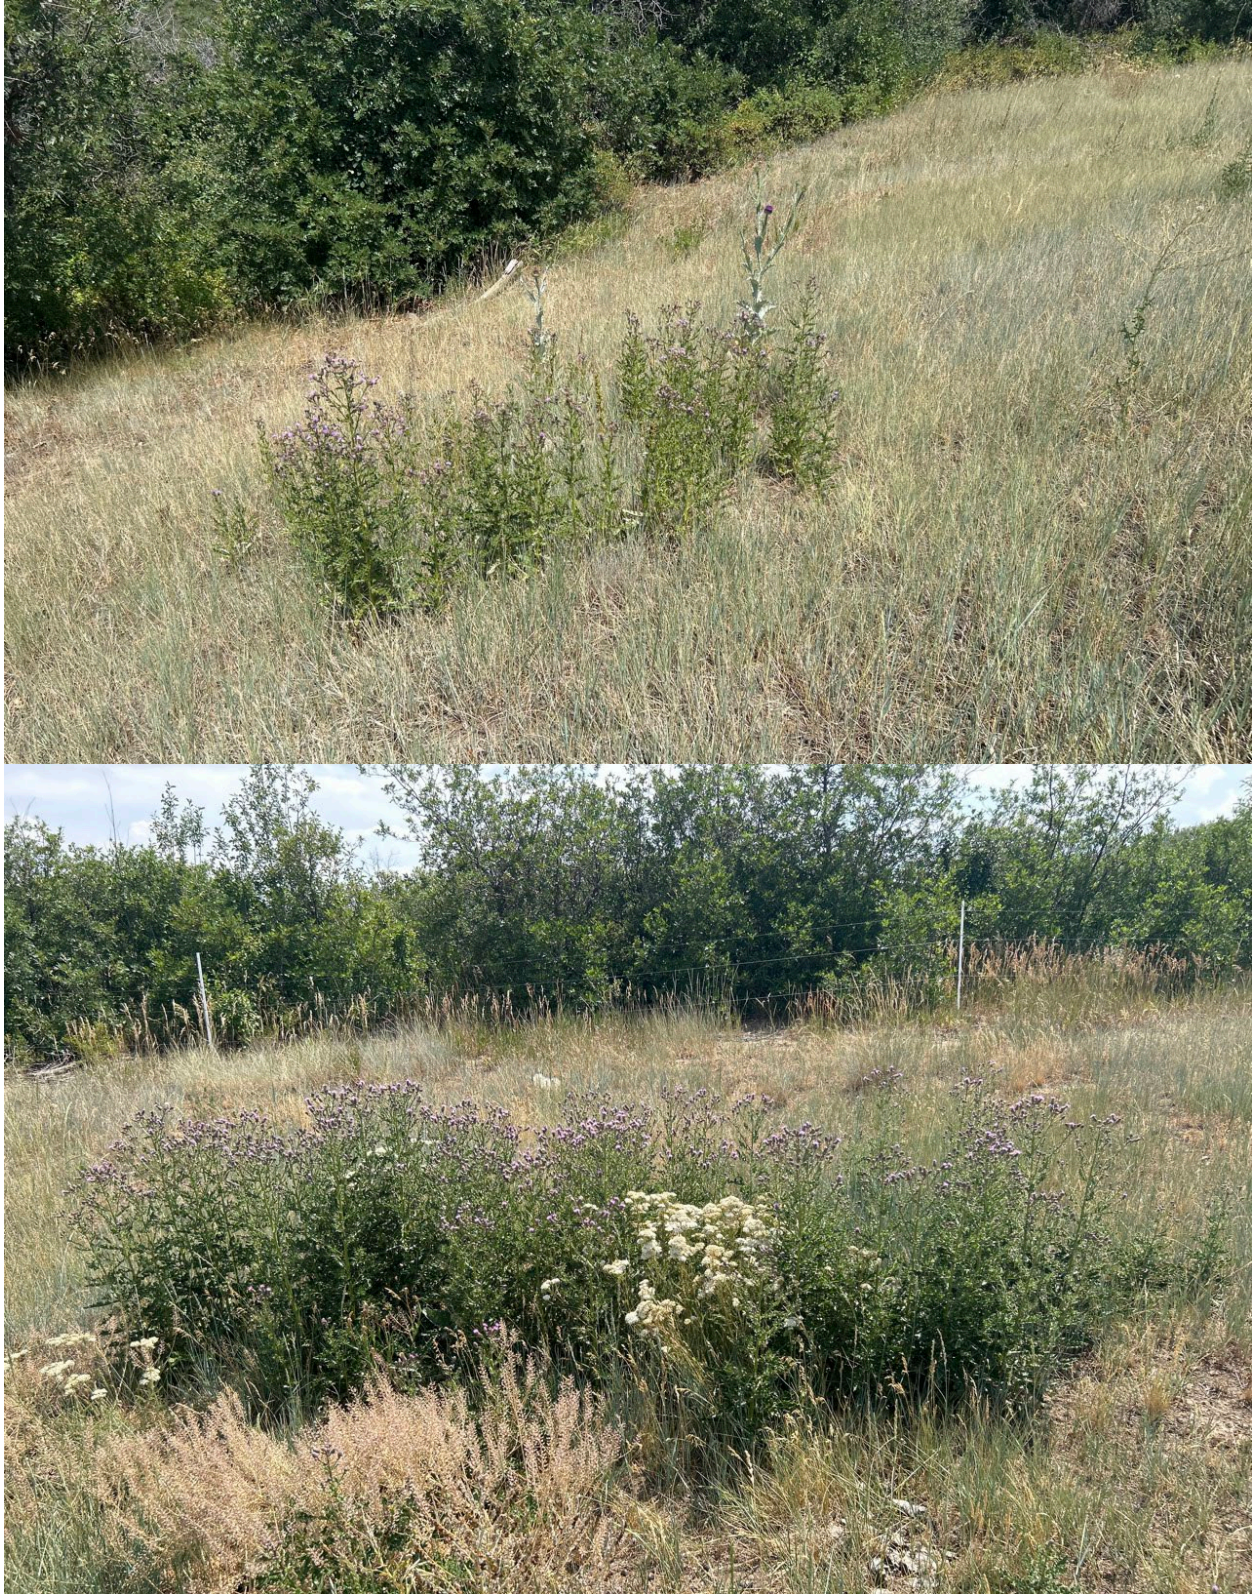
Figure 9: Canada thistle on E1-38

Figure 10: Scotch thistle on E1-38

Figure 11: More Canada thistle on E1-38

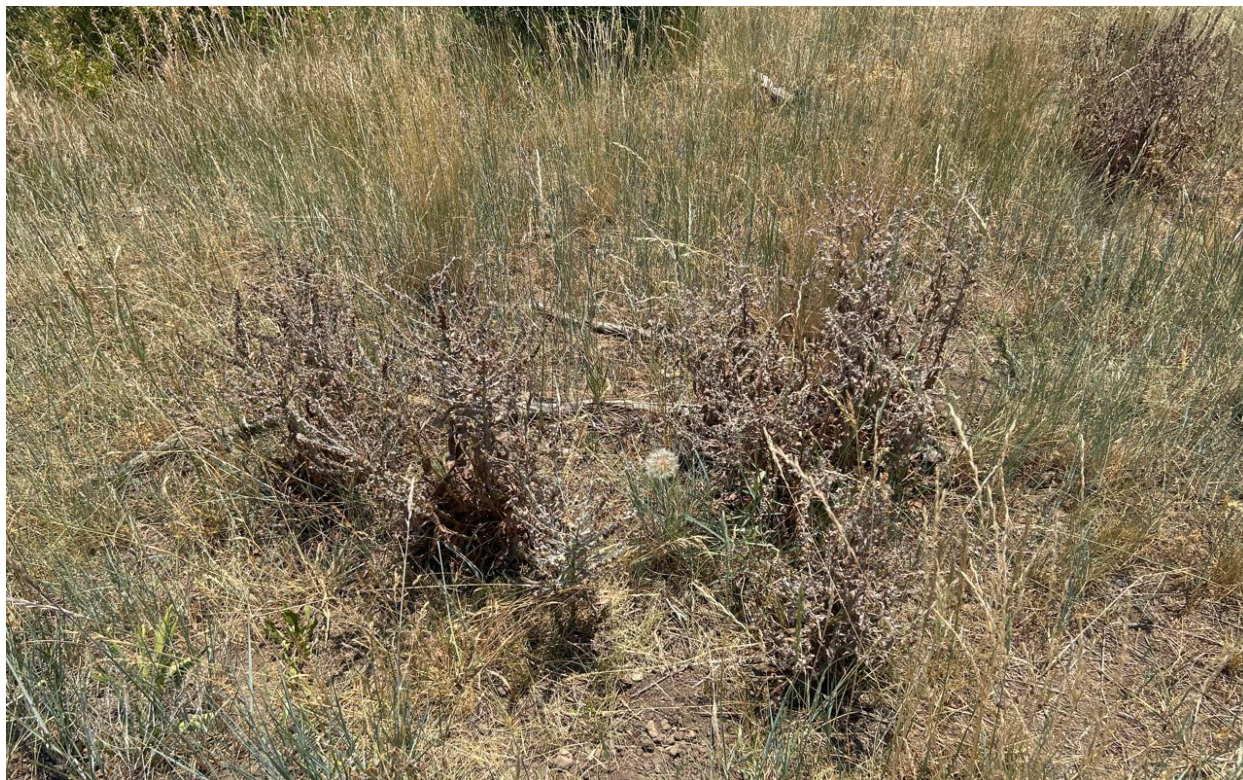
Figure 14: Sprayed weeds on E2-42

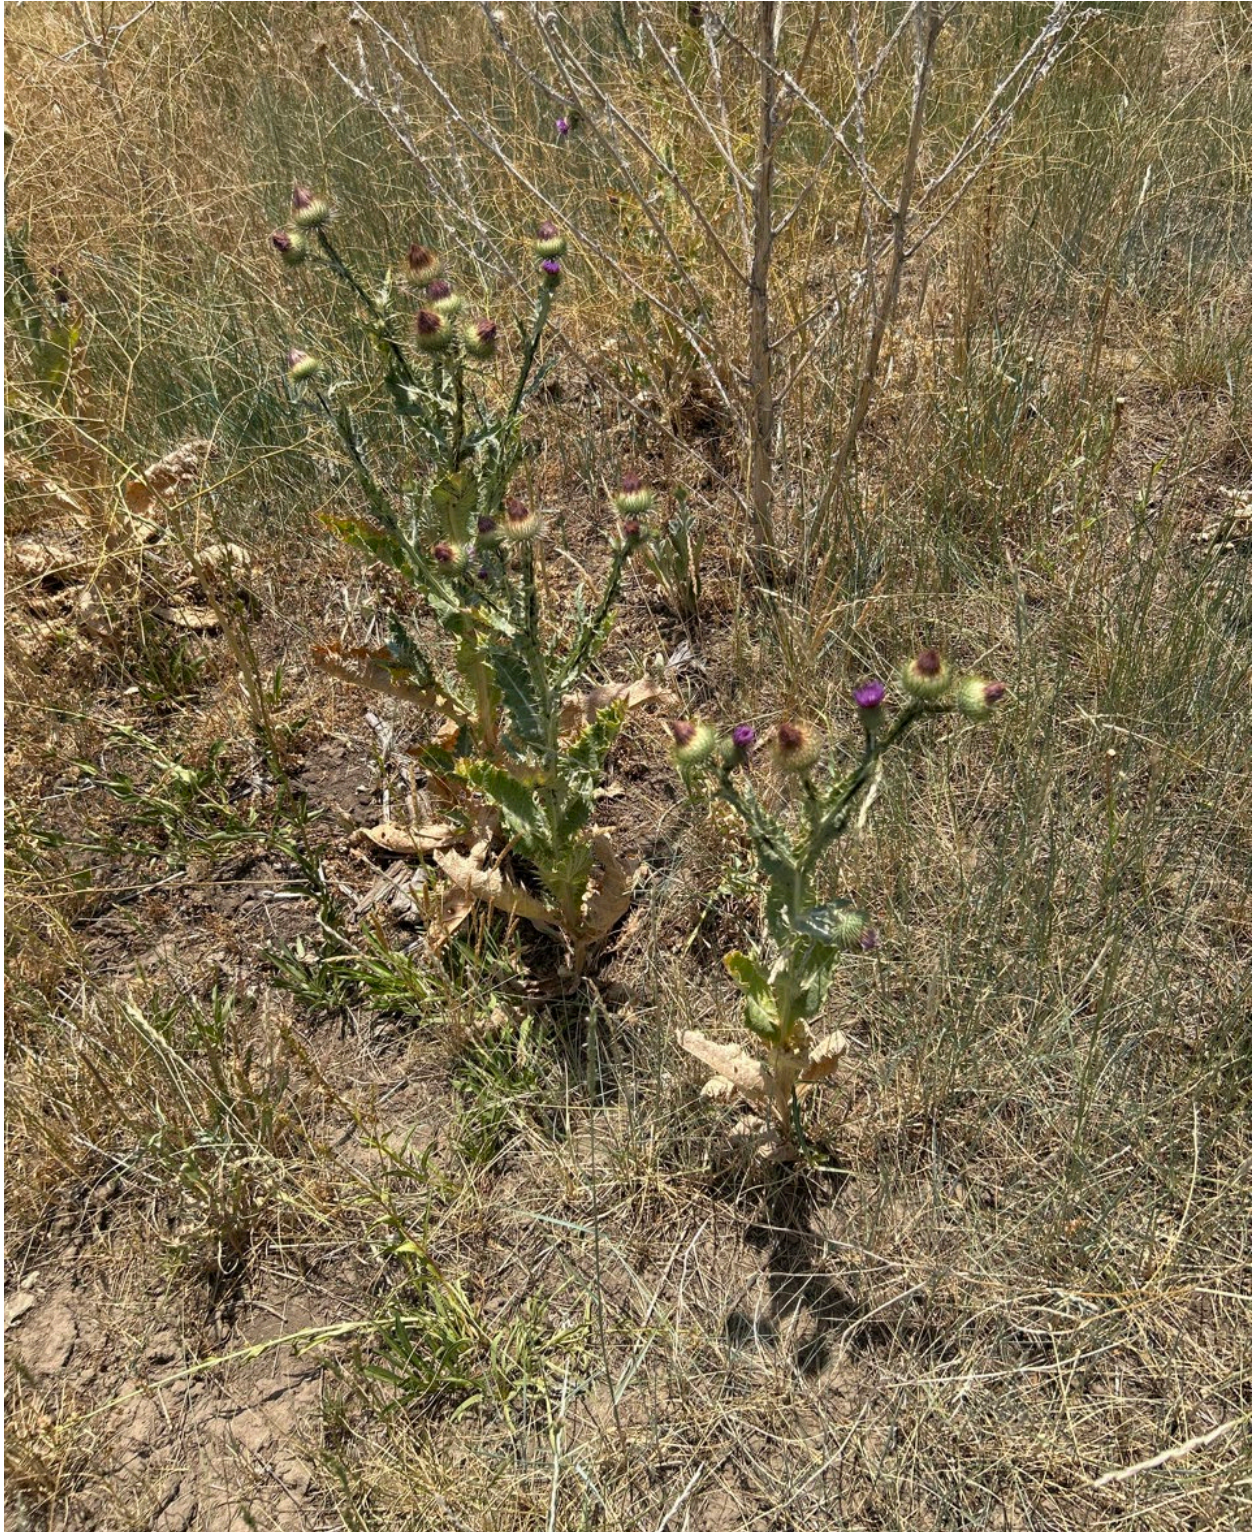
Figure 18: Previously treated thistle on E2-44.5 & -47.5

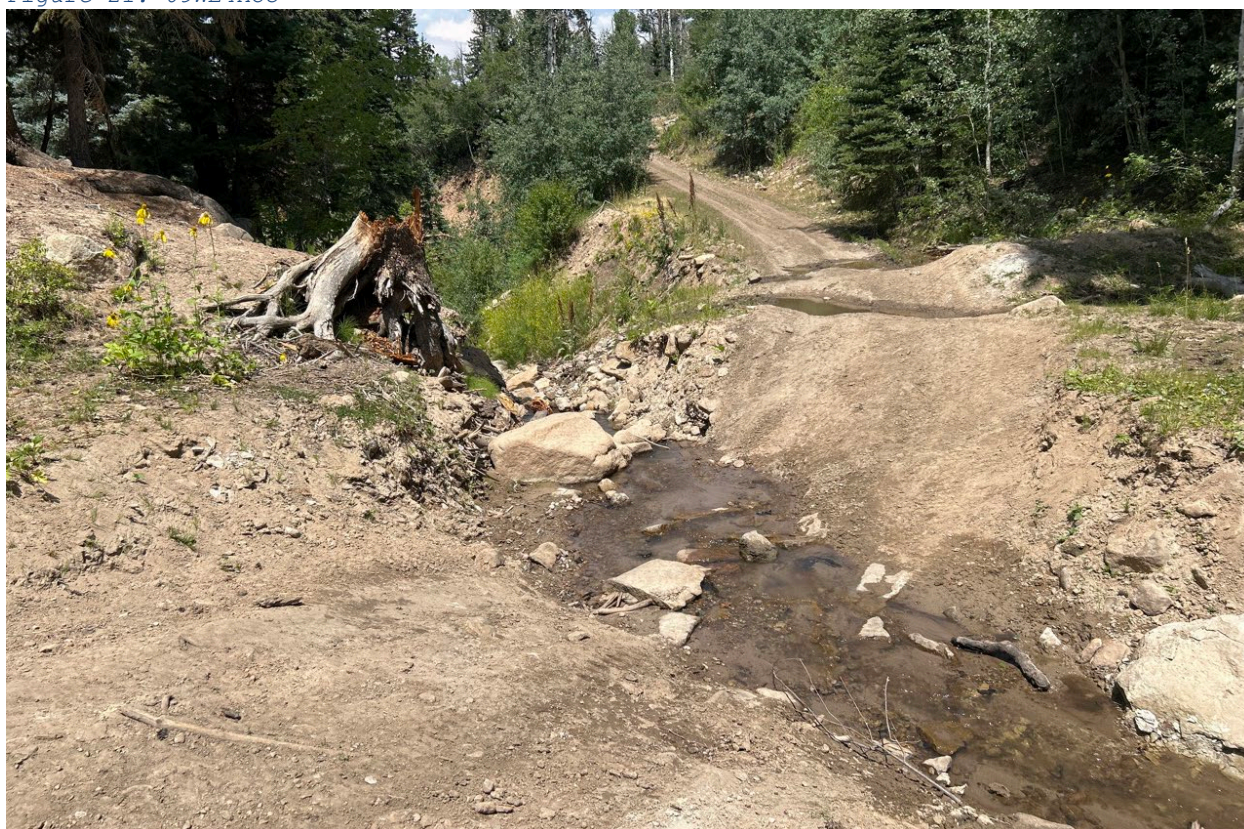
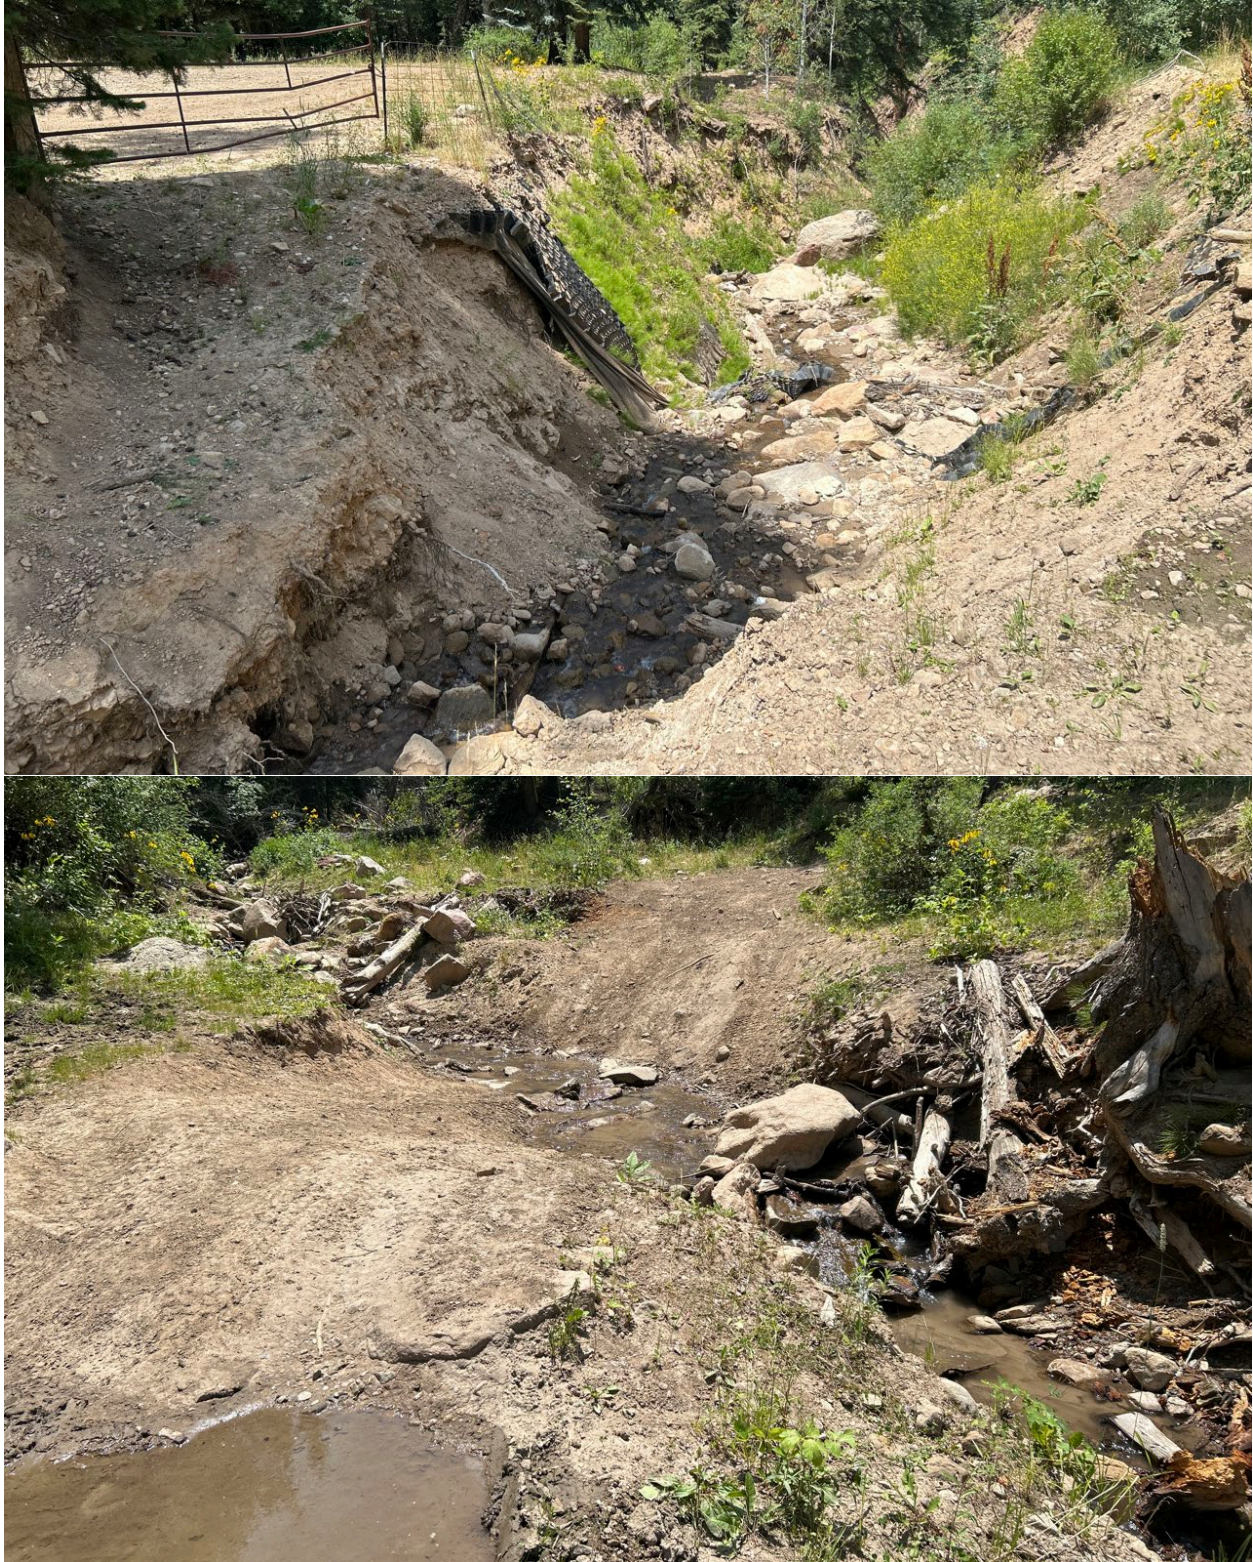
Figure 22: Deep Creek crossing

Figure 23: More photos of Deep Creek crossing

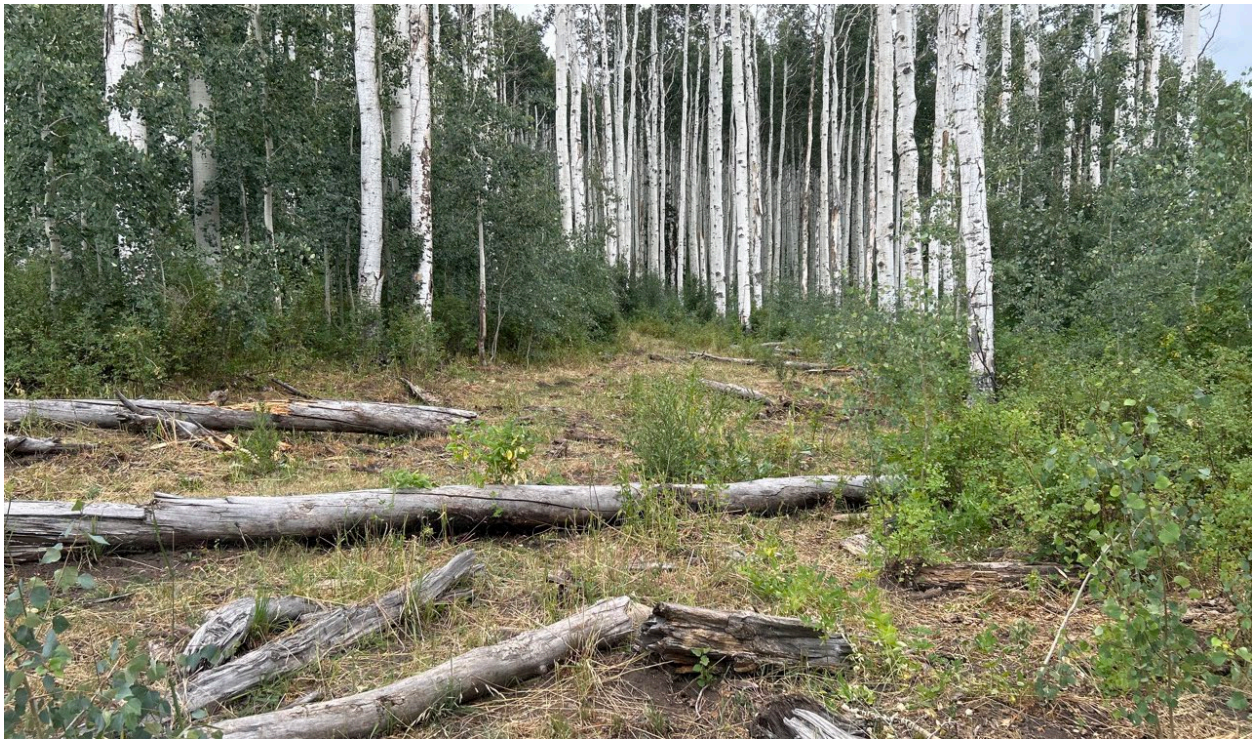
E6-4(61)	Fine
SS1-2	
SS1-1	
Old exploration road	Thistle and houndstongue at junction
Road to sunset trails	Mostly ok, but beginning of road is very sparsely vegetated, with many thistle rosettes and houndstongue. Recommend treatment and supplemental seeding asap

Figure 25: Old Exploration Road
