C1980007, West Elk Mine, July Inspection Report

PERMIT INFORMATION

Permit Number: C-1980-007 Mine Name: West Elk Mine Operator: Mountain Coal Company, LLC Operator Address: Robert Munz 5174 Highway 133 Somerset, CO 81434	County: Delta, Gunnison Operation Type: Underground Permit Status: Active Ownership: Private
	Operator Representative Present: Bob Munz
Operator Representative Signature: (Field Issuance Only)

Inspection Start Date: July 24, 2025 Inspection Start Time: 09:00 Inspection End Date: Inspection End Time:	Inspection Type: Coal Partial Inspection Inspection Reason: Normal I&E Program Weather: Clear
Joint Inspection Agency: None	Joint Inspection Contacts:
Post Inspection Agency: None	Post Inspection Contacts:
Inspector(s): Leigh Simmons	Inspector's Signature:

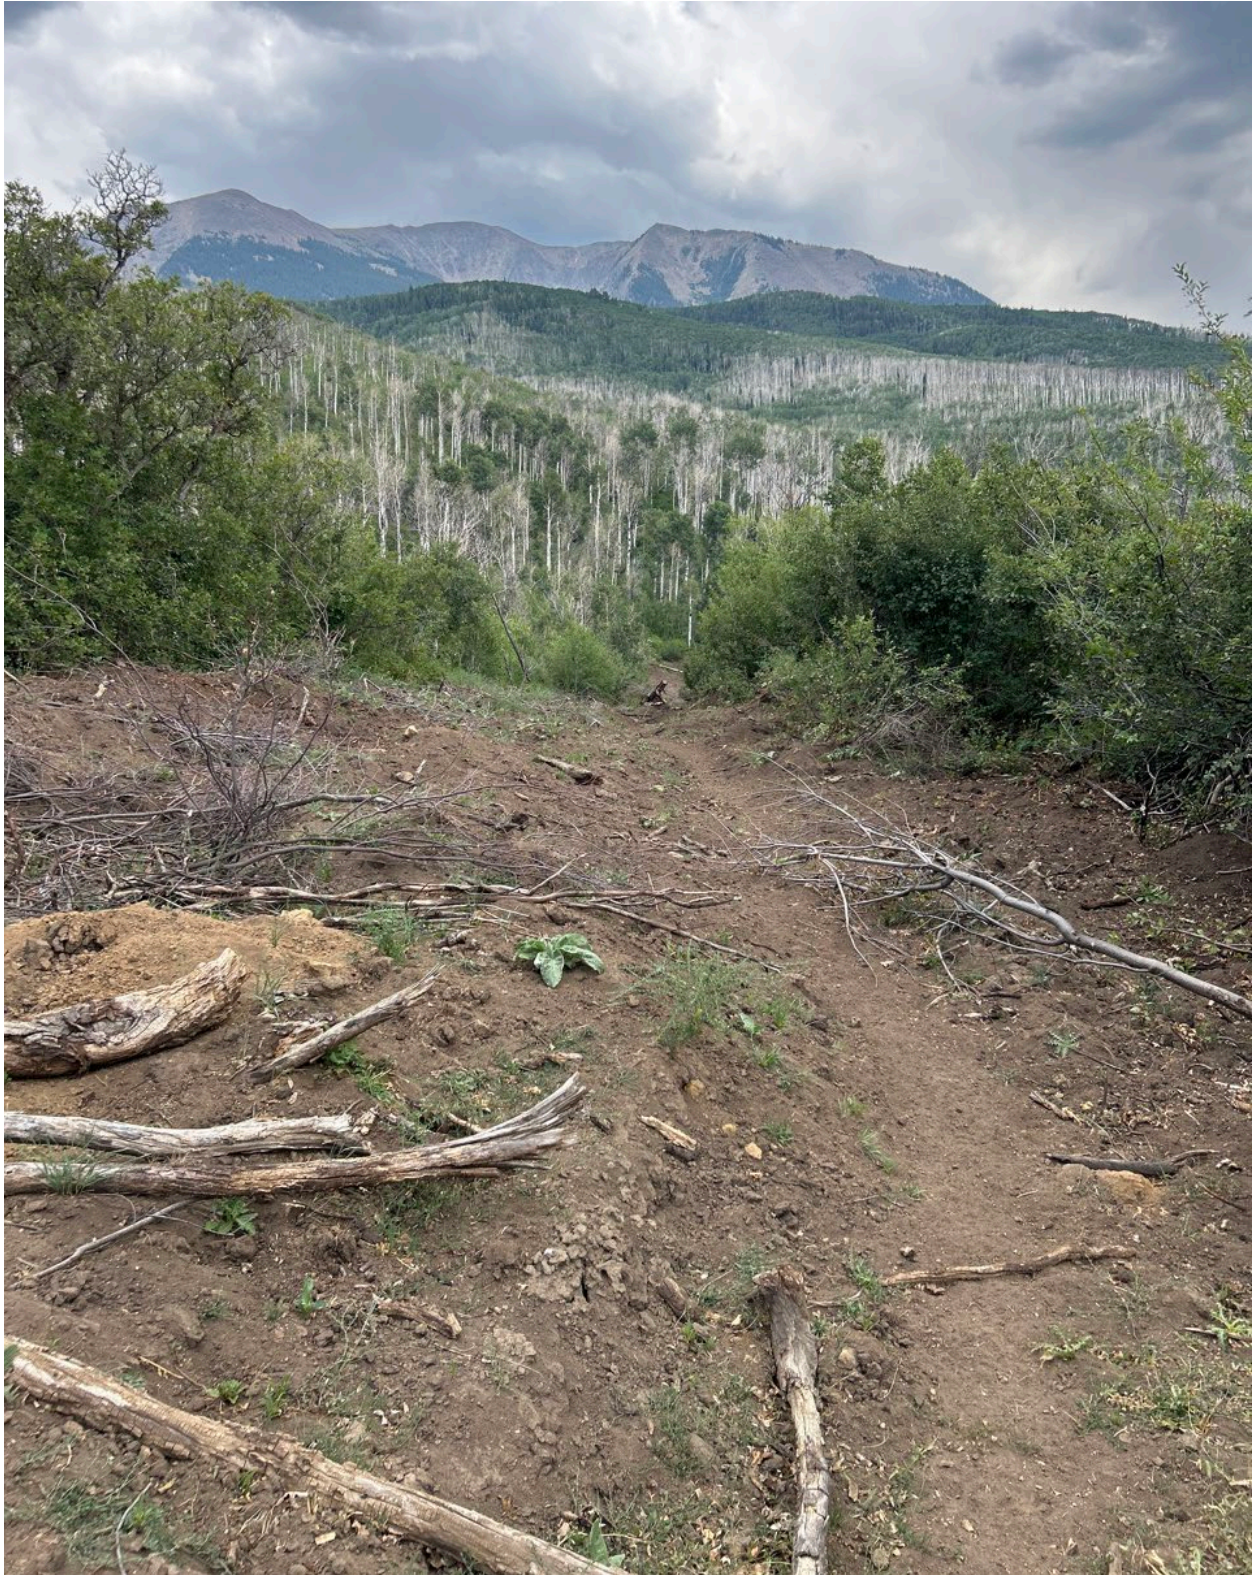
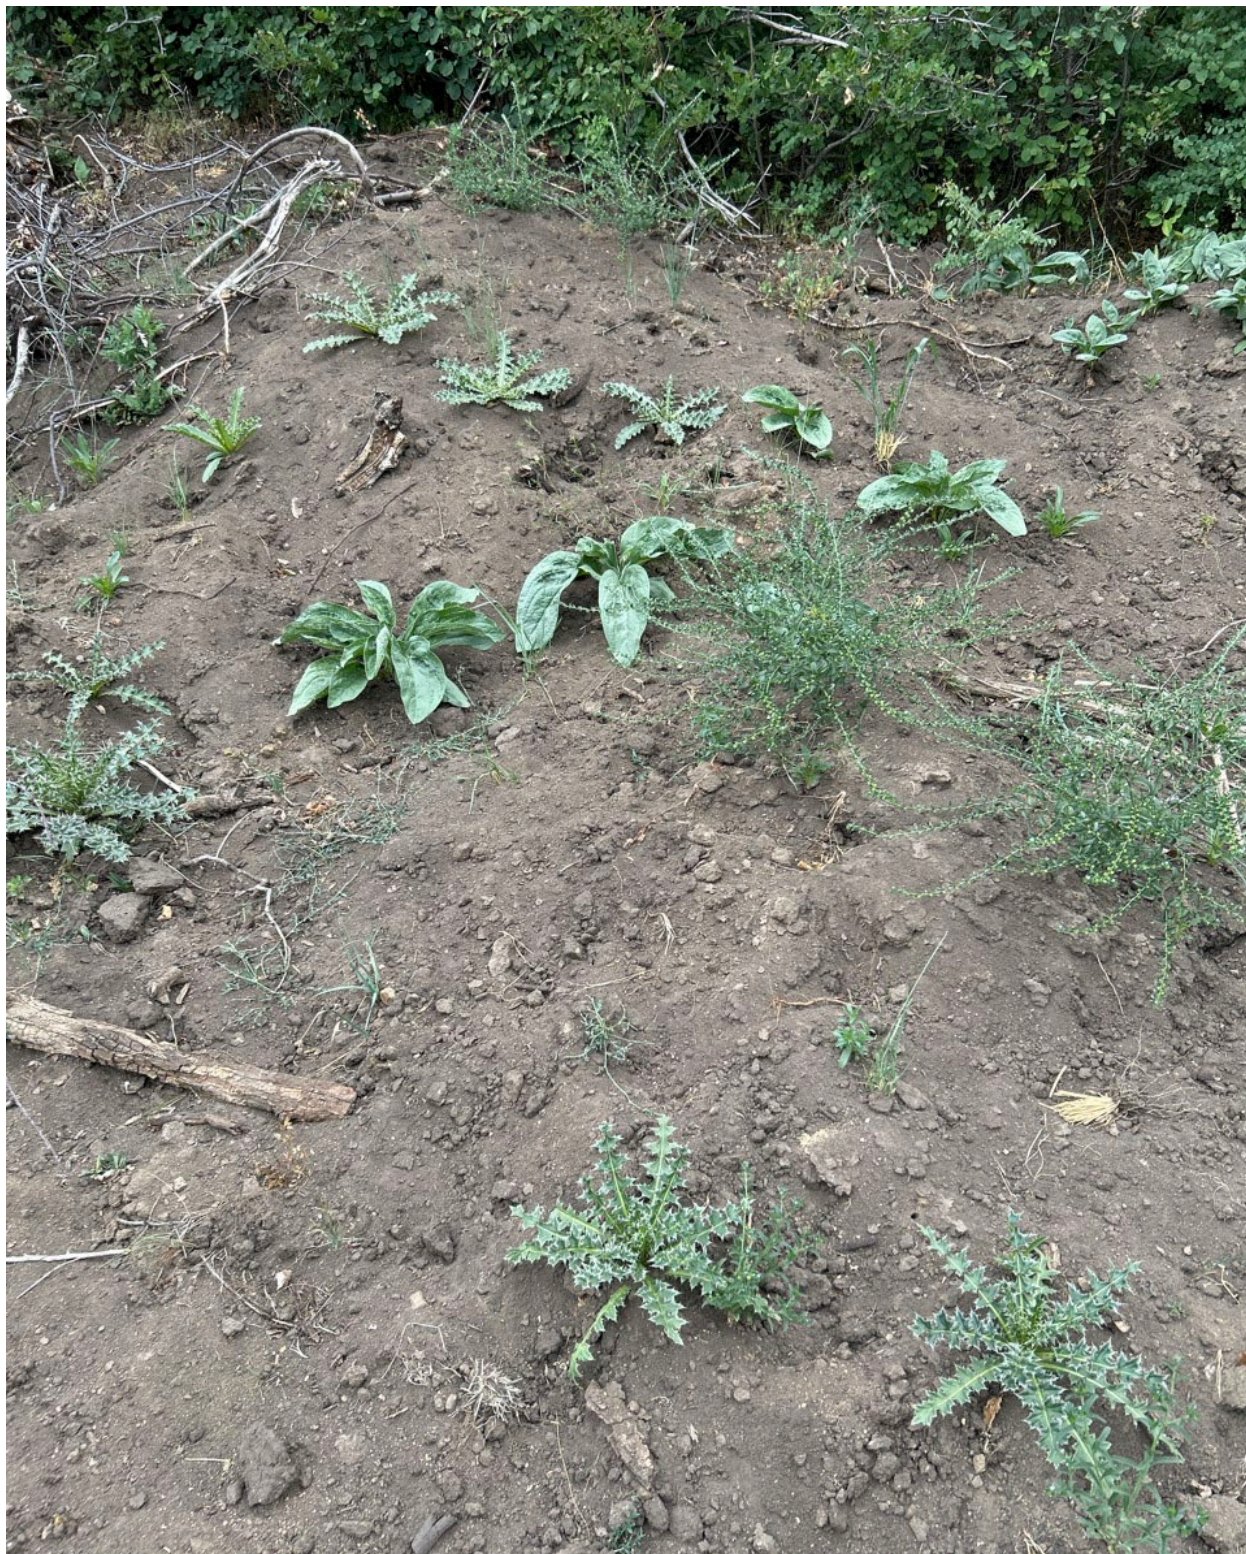
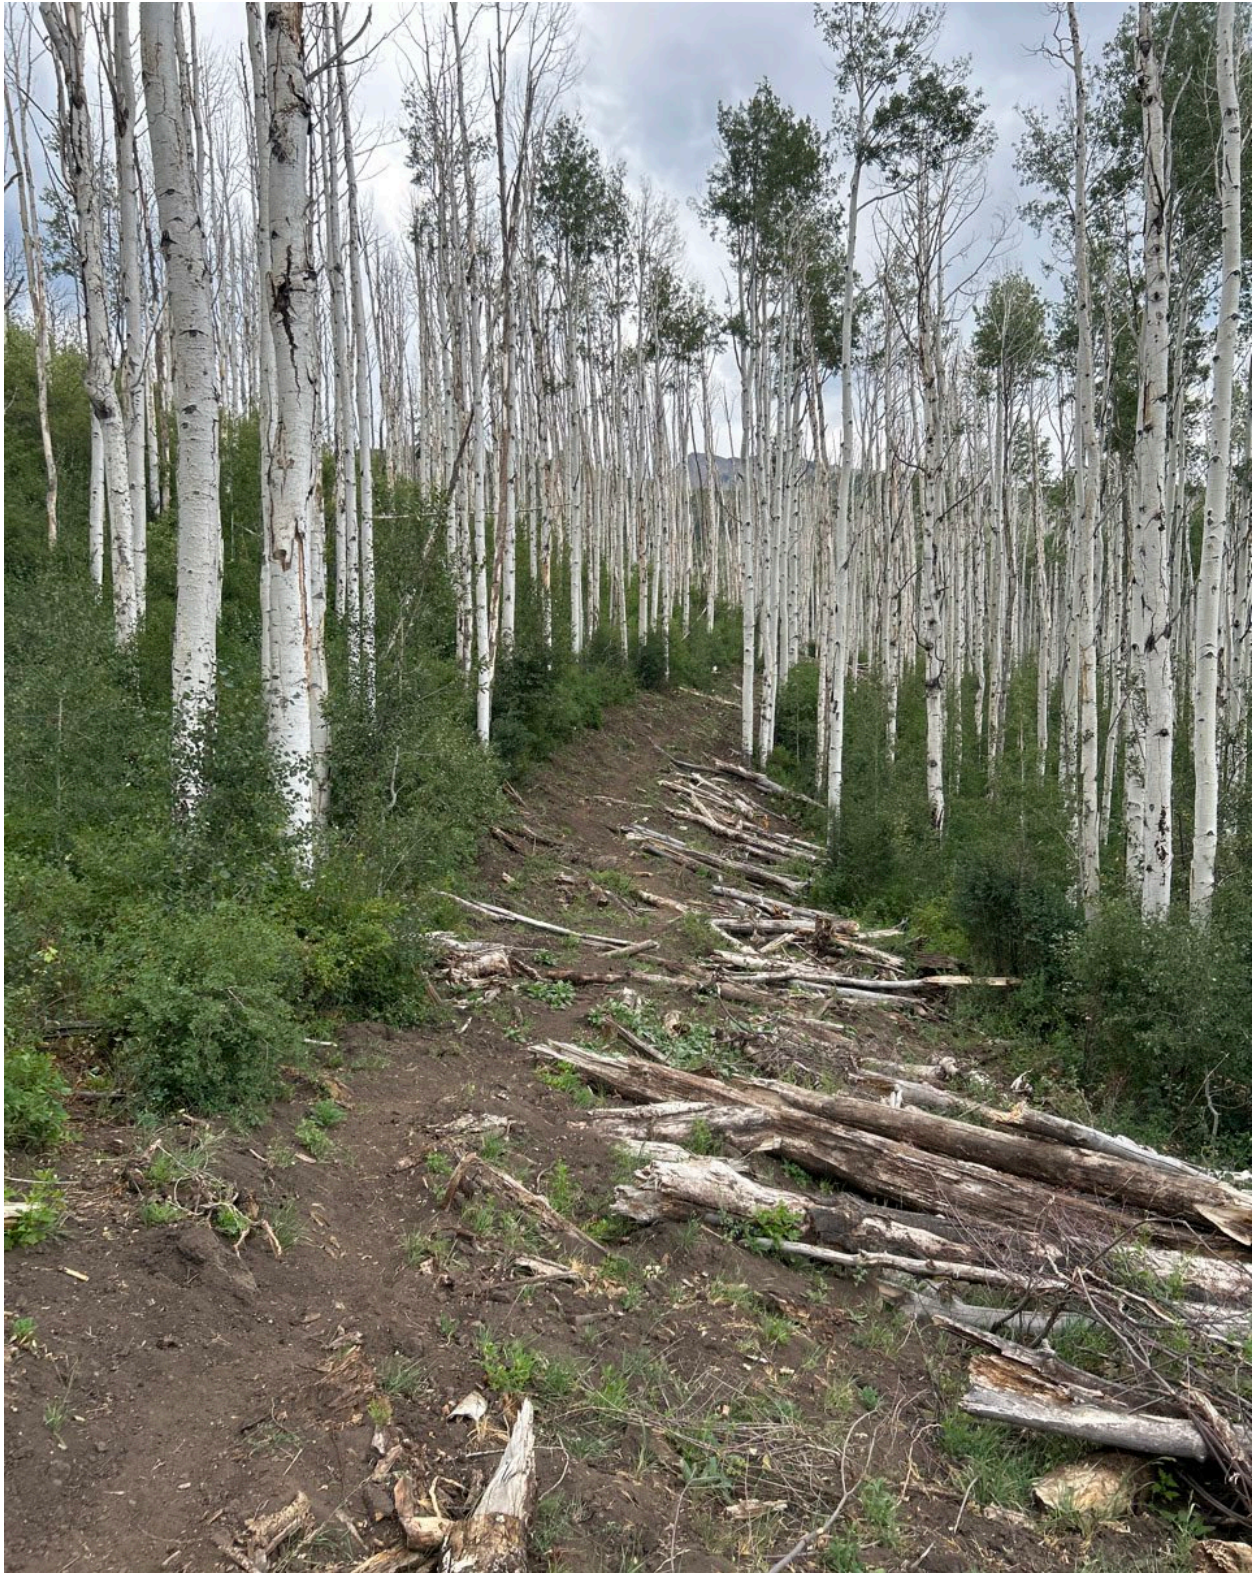
evident throughout, however no severe infestations were observed, and ongoing weed treatment appears to be effective; site-specific recommendations are given below. Of particular note is the road to the sunset trails area (which has been reclaimed, but has not yet been through any bond release) where the north end of the reclaimed segment is very sparsely vegetated, which is giving an opportunity to thistle and houndstongue to become established. The Division strongly recommends prioritizing treatment of the weeds as soon as possible, and supplemental seeding this fall.

E6-4(61)	Fine
SS1-2	
SS1-1	
Old exploration road	Thistle and houndstongue at junction
Road to sunset trails	Mostly ok, but beginning of road is very sparsely vegetated, with many thistle rosettes and houndstongue. Recommend treatment and supplemental seeding asap

Figure 26: N end of Road to Sunset Trails, very sparse vegetation

Figure 27: Weeds at N end of Road to Sunset Trails

Figure 28: Road to Sunset Trails

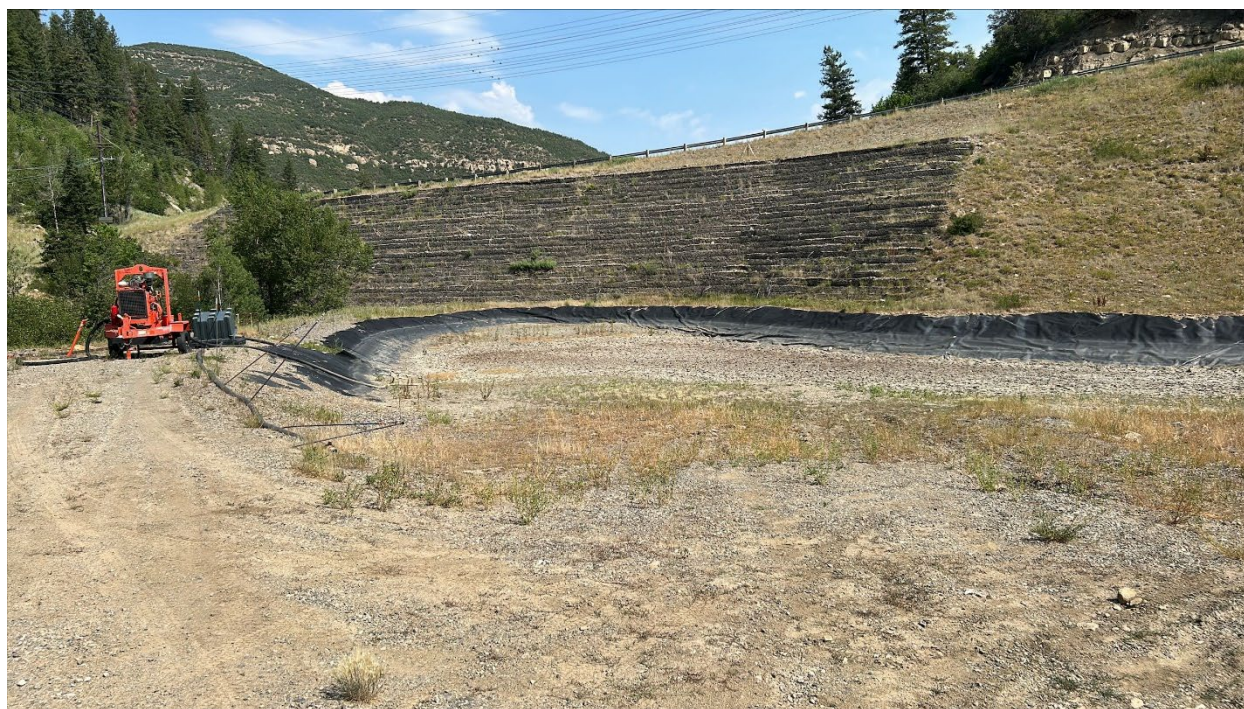
Mr. Munz reported that MCC had noticed damage to the liner of the SG-1 pond during a routine inspection and had plans to repair it. The Division anticipates a letter giving details of the plans. At the time of the inspection the pond was not holding any water, but there was some dried mud at the bottom of the pond.

Figure 34: SG1 pond

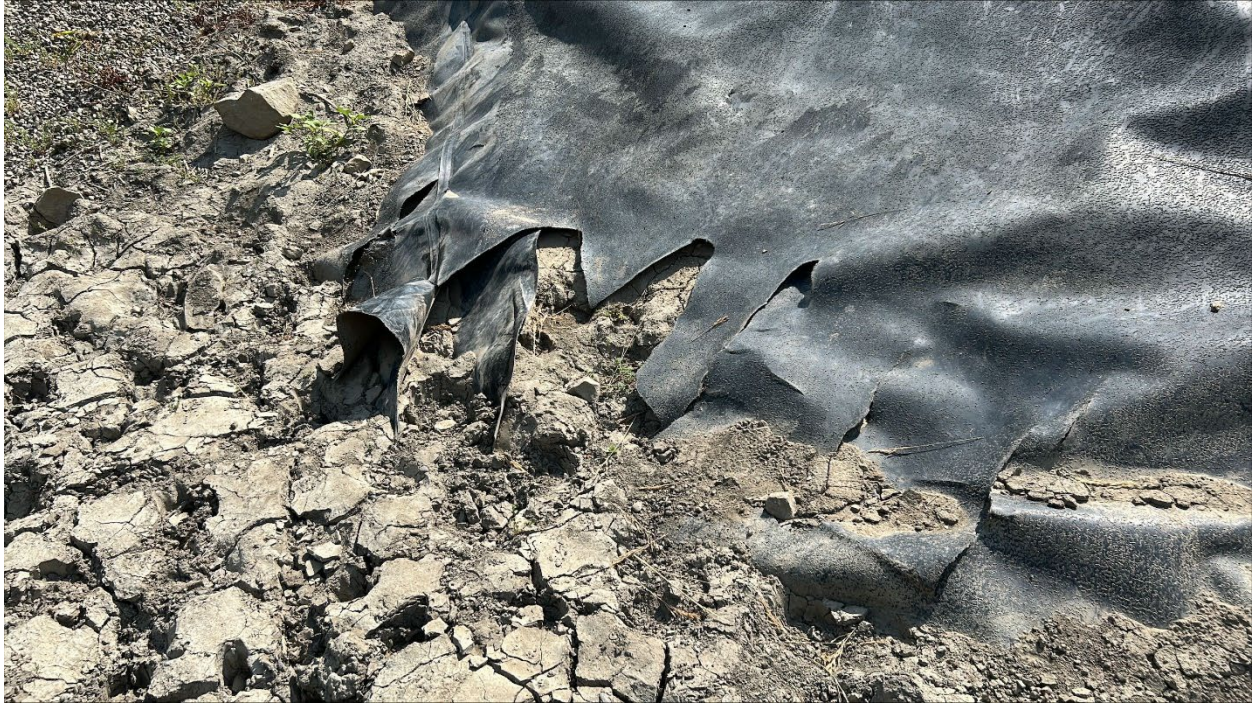
Figure 35: Damage to SG-1 liner
