## C1983059, Terror Creek Loadout, July Inspection Report

<b>Permit Number:</b> C-1983-059 <b>Mine Name:</b> Terror Creek Loadout <b>Operator:</b> Oxbow Mining, LLC <b>Operator Address:</b> Mr Doug Smith PO Box 535 Paonia, CO 81434	<b>County:</b> Delta <b>Operation Type:</b> Loadout <b>Permit Status:</b> Active <b>Ownership:</b> Private
	<b>Operator Representative Present:</b>  N/A
<b>Operator Representative Signature: (Field Issuance Only)</b>

<b>Inspection Start Date:</b> July 25, 2025 <b>Inspection Start Time:</b> 12:45 <b>Inspection End Date:</b> <b>Inspection End Time:</b>	<b>Inspection Type:</b> Coal Partial Inspection <b>Inspection Reason:</b> Normal I&E Program <b>Weather:</b> Clear
<b>Joint Inspection Agency:</b>  None	<b>Joint Inspection Contacts:</b>
<b>Post Inspection Agency:</b>  None	<b>Post Inspection Contacts:</b>
<b>Inspector(s):</b>  Leigh Simmons	<b>Inspector's Signature:</b>

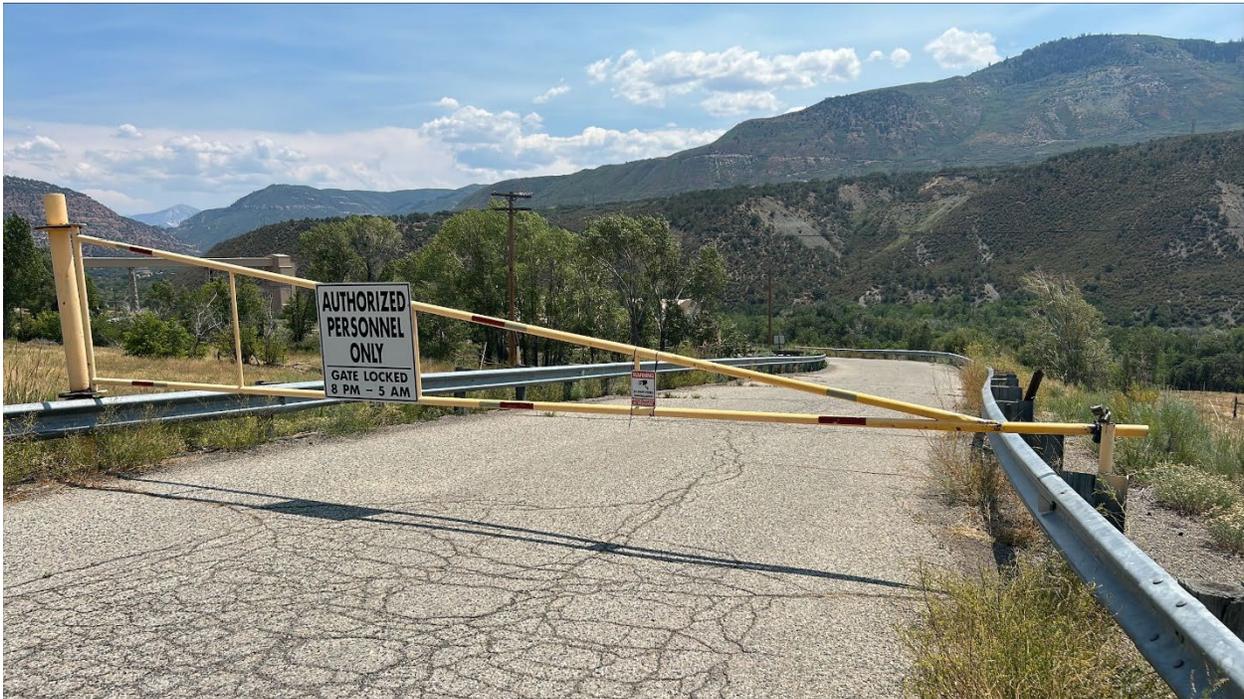
This was a partial inspection by Leigh Simmons of the Division of Reclamation, Mining and Safety (Division). The weather was clear and dry. The gate to the site was secure. There was no mining-related activity at the site, but part of the site was being used for the storage of equipment and materials for other industrial and commercial activities.

*Figure 1: Site access secure*

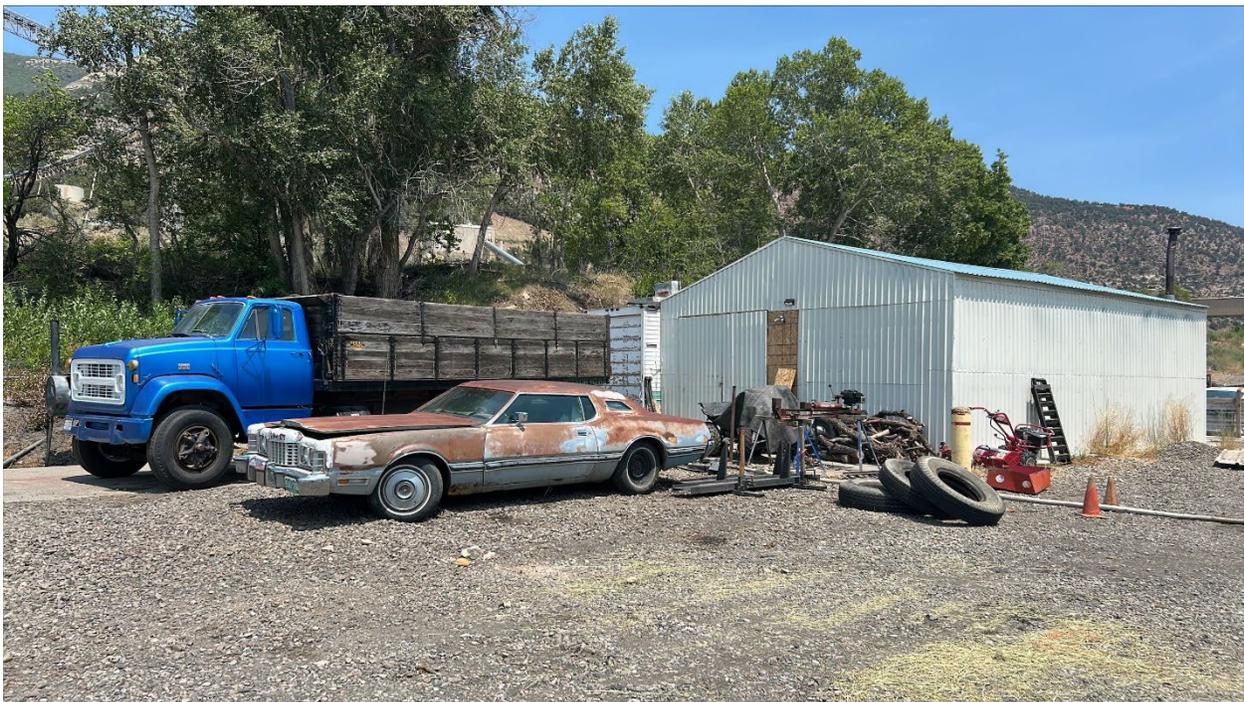
There was no activity on the lower pad. The temporary building was empty of materials. It had recently been swept out and had been left open. On the upper pad, the tenants continued to use the site to store equipment (mainly vehicles) and conduct maintenance. They had continued to irrigate the slope below the upper pad and had recently mown it for hay.

*Figure 2: Equipment on upper pad*

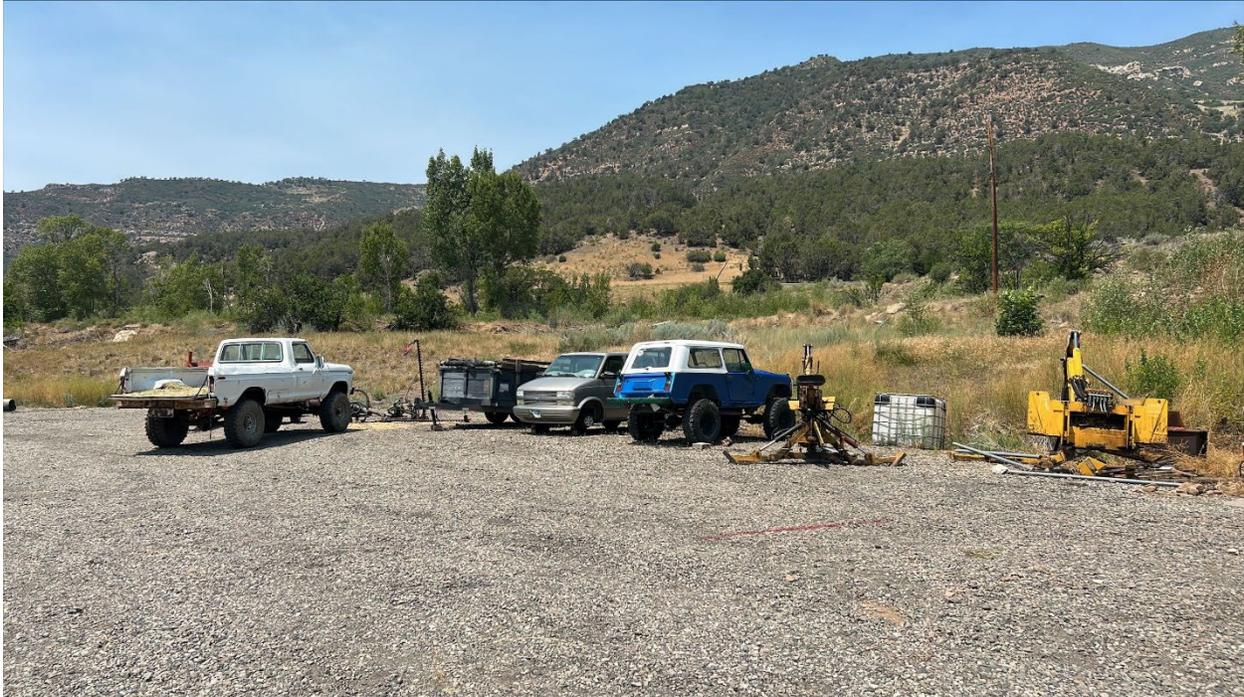
Figure 3: More equipment on upper pad

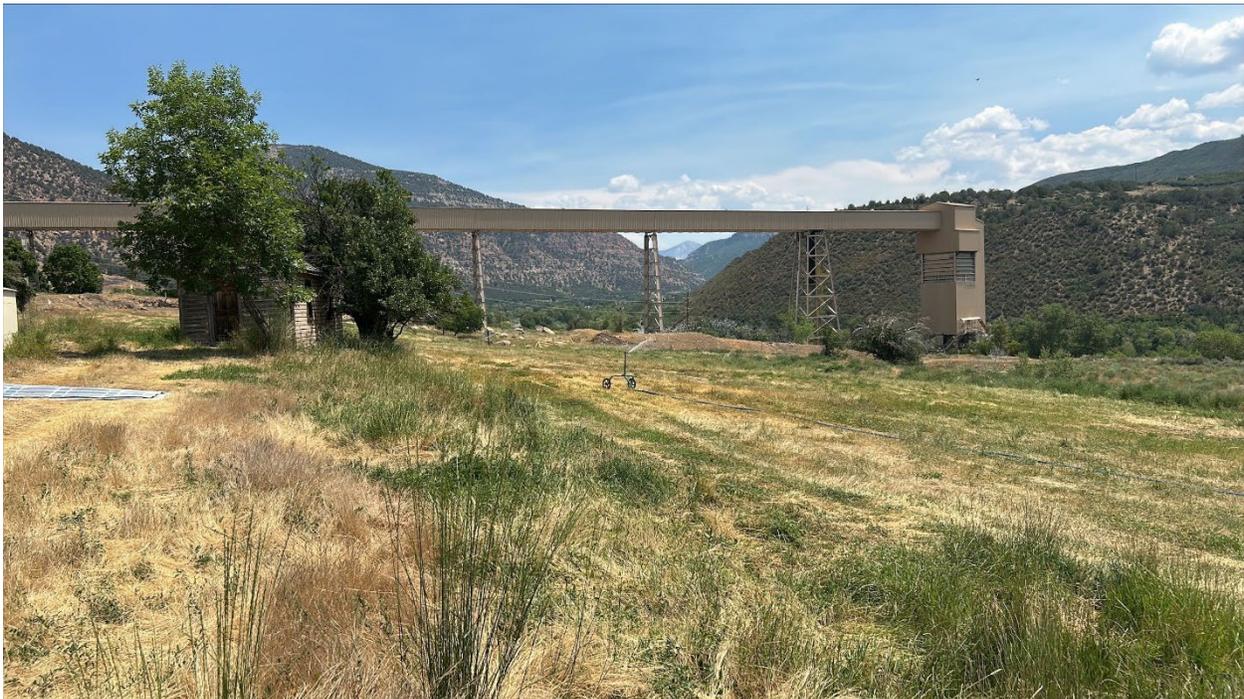
Figure 4: Irrigation on slope below upper pad

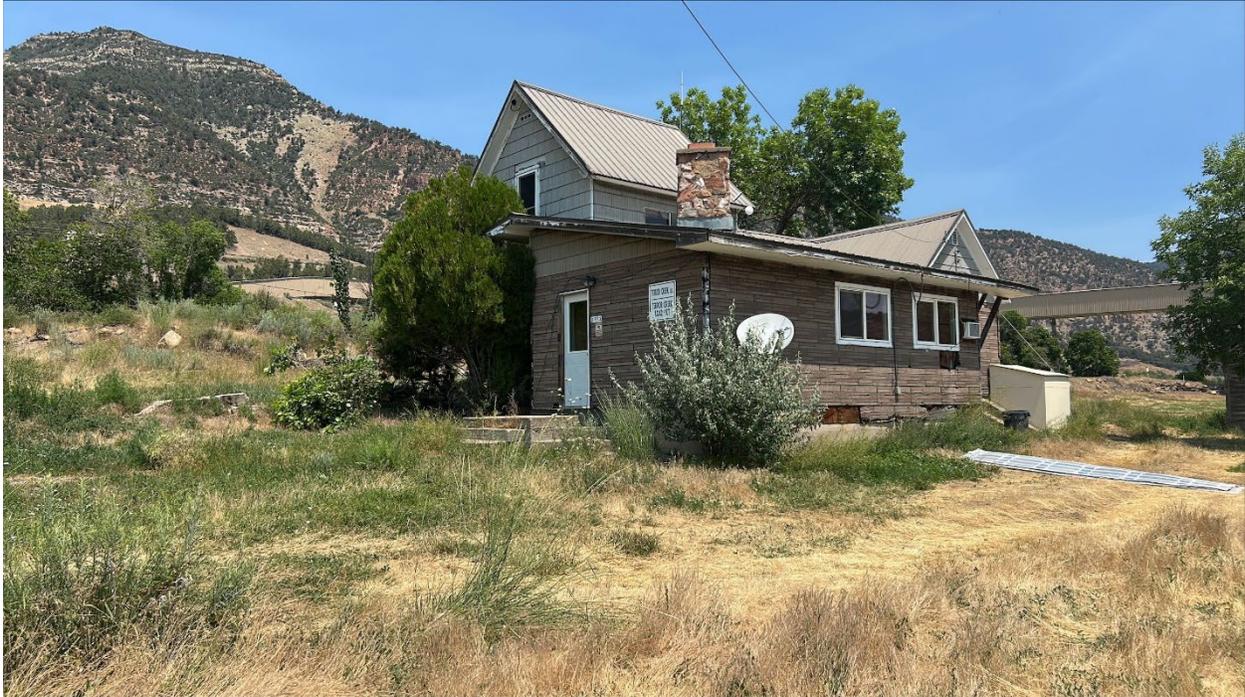
Figure 5: Office building, with cut hay in foreground

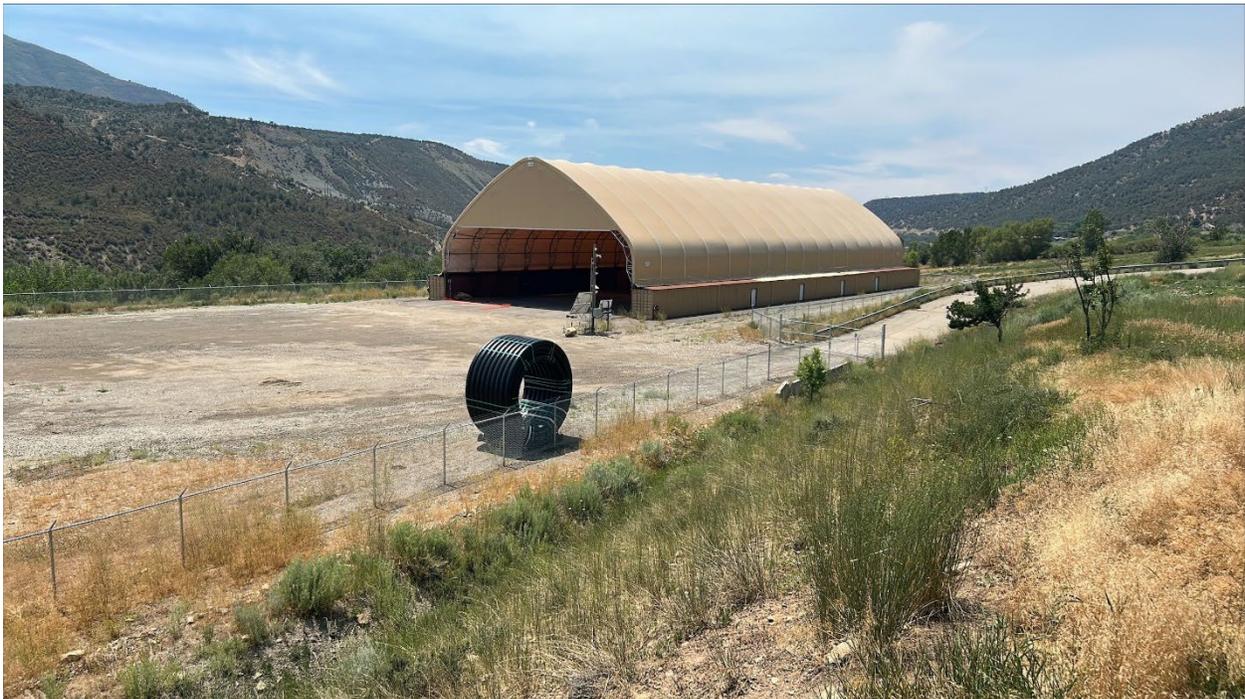
Figure 6: Temporary building on lower pad

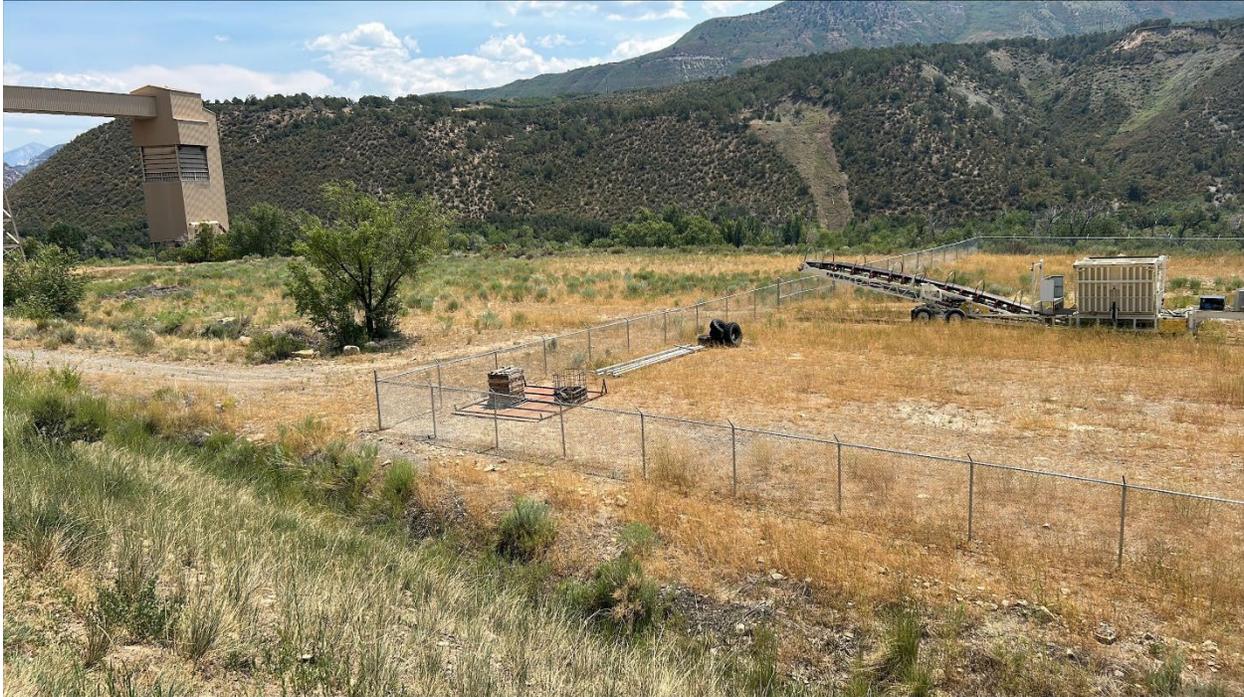
*Figure 7: Eastern end of lower pad*
