C1981022, Elk Creek Mine, July Inspection Report

PERMIT INFORMATION

Permit Number: C-1981-022 Mine Name: Elk Creek Mine Operator: Oxbow Mining, LLC Operator Address: Mr Doug Smith 3737 Hwy 133 P. O. Box 535 Somerset, CO 81434	County: Delta, Gunnison Operation Type: Underground Permit Status: Active Ownership: Private
	Operator Representative Present: Doug Smith
Operator Representative Signature: (Field Issuance Only)

Inspection Start Date: July 25, 2025 Inspection Start Time: 09:00 Inspection End Date: Inspection End Time:	Inspection Type: Coal Partial Inspection Inspection Reason: Normal I&E Program Weather: Clear
Joint Inspection Agency: None	Joint Inspection Contacts:
Post Inspection Agency: None	Post Inspection Contacts:
Inspector(s): Leigh Simmons	Inspector's Signature:

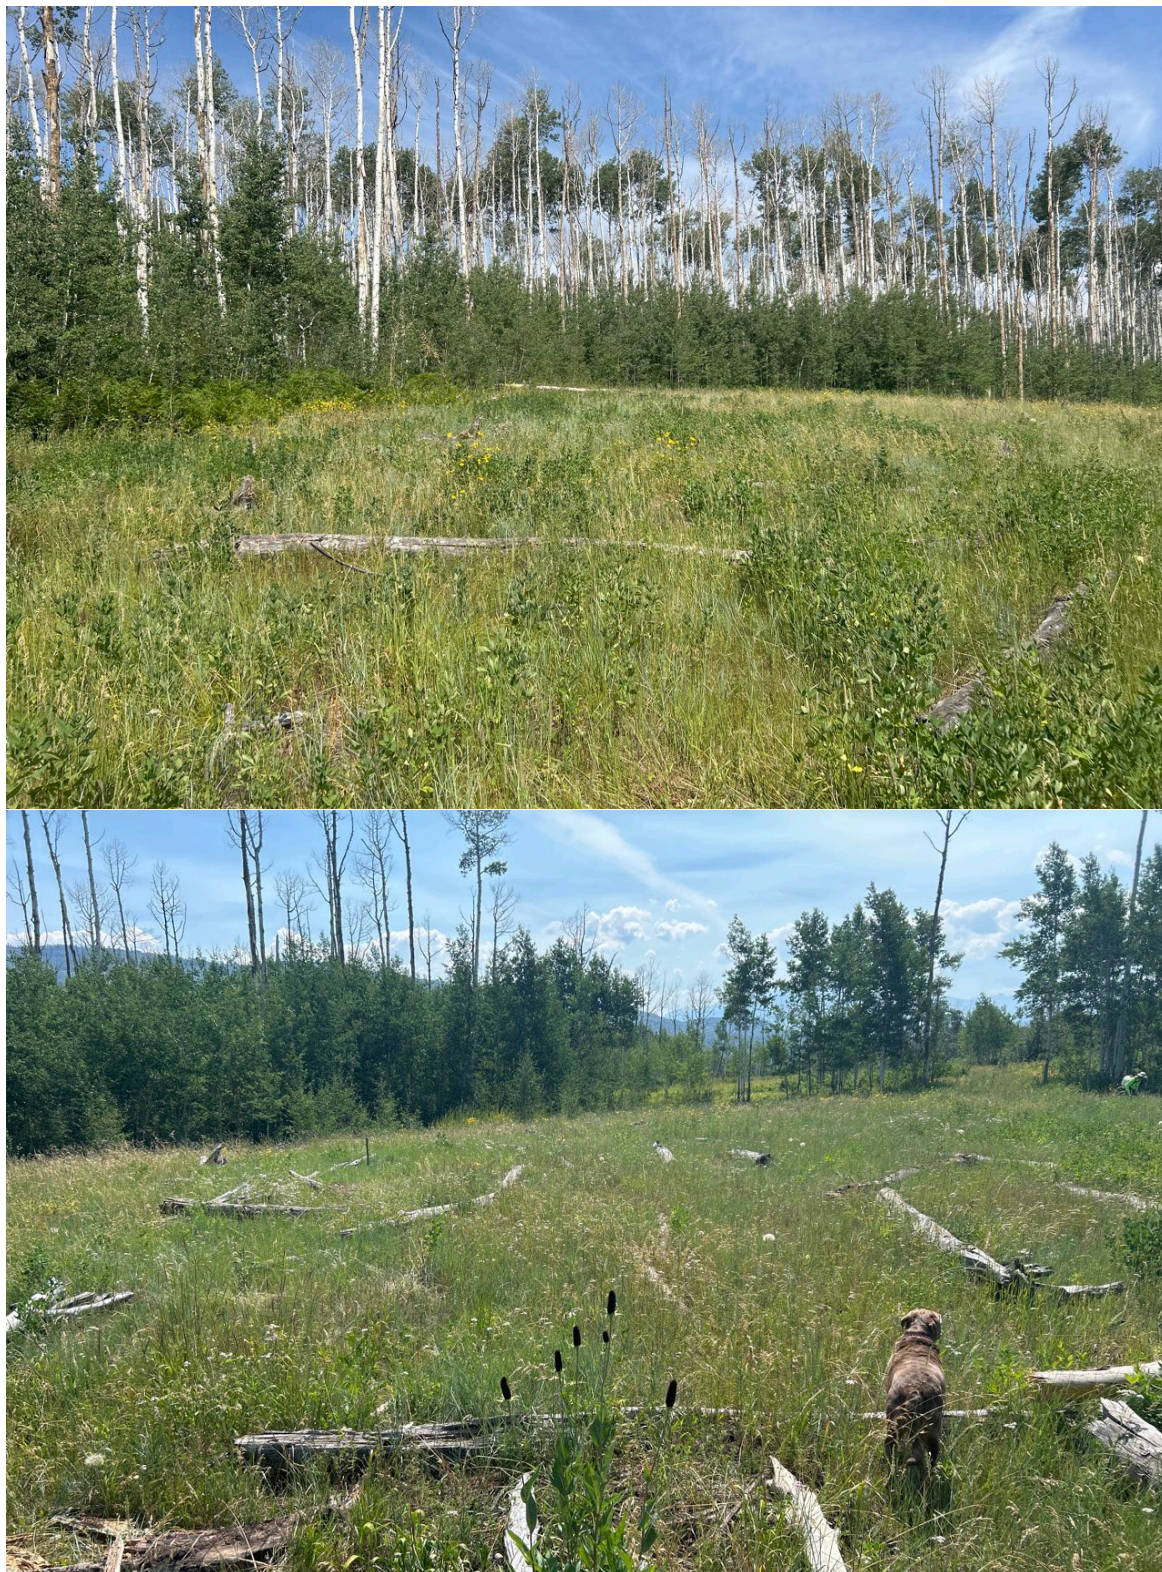
Figure 3: GVB-LW-19-06

Label	Comments
GVB-LW-19-06	Spectacular diversity on pad. Some Canada thistle, mostly on N side
GVB-LW-19-07	Chuck and Sam already sprayed. Canada thistle
HGA	Bad Canada thistle. Not yet sprayed
GVB-LW-18-08	Already sprayed, not bad. Sheep have grazed it
TGA	Ok, heavily grazed

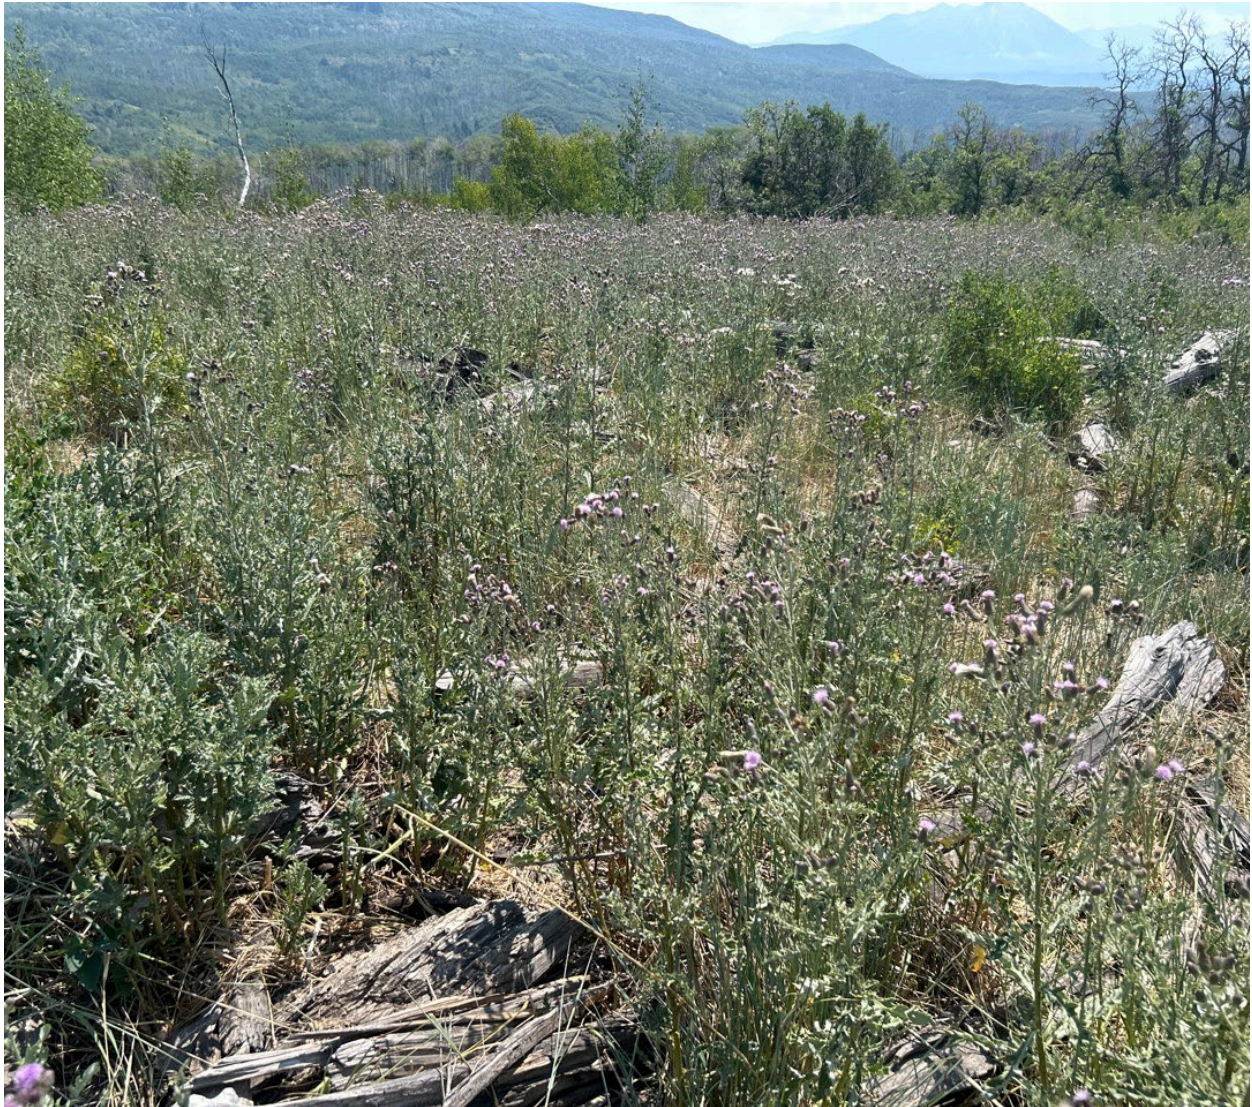
Figure 5: Extensive Canada thistle on HGA

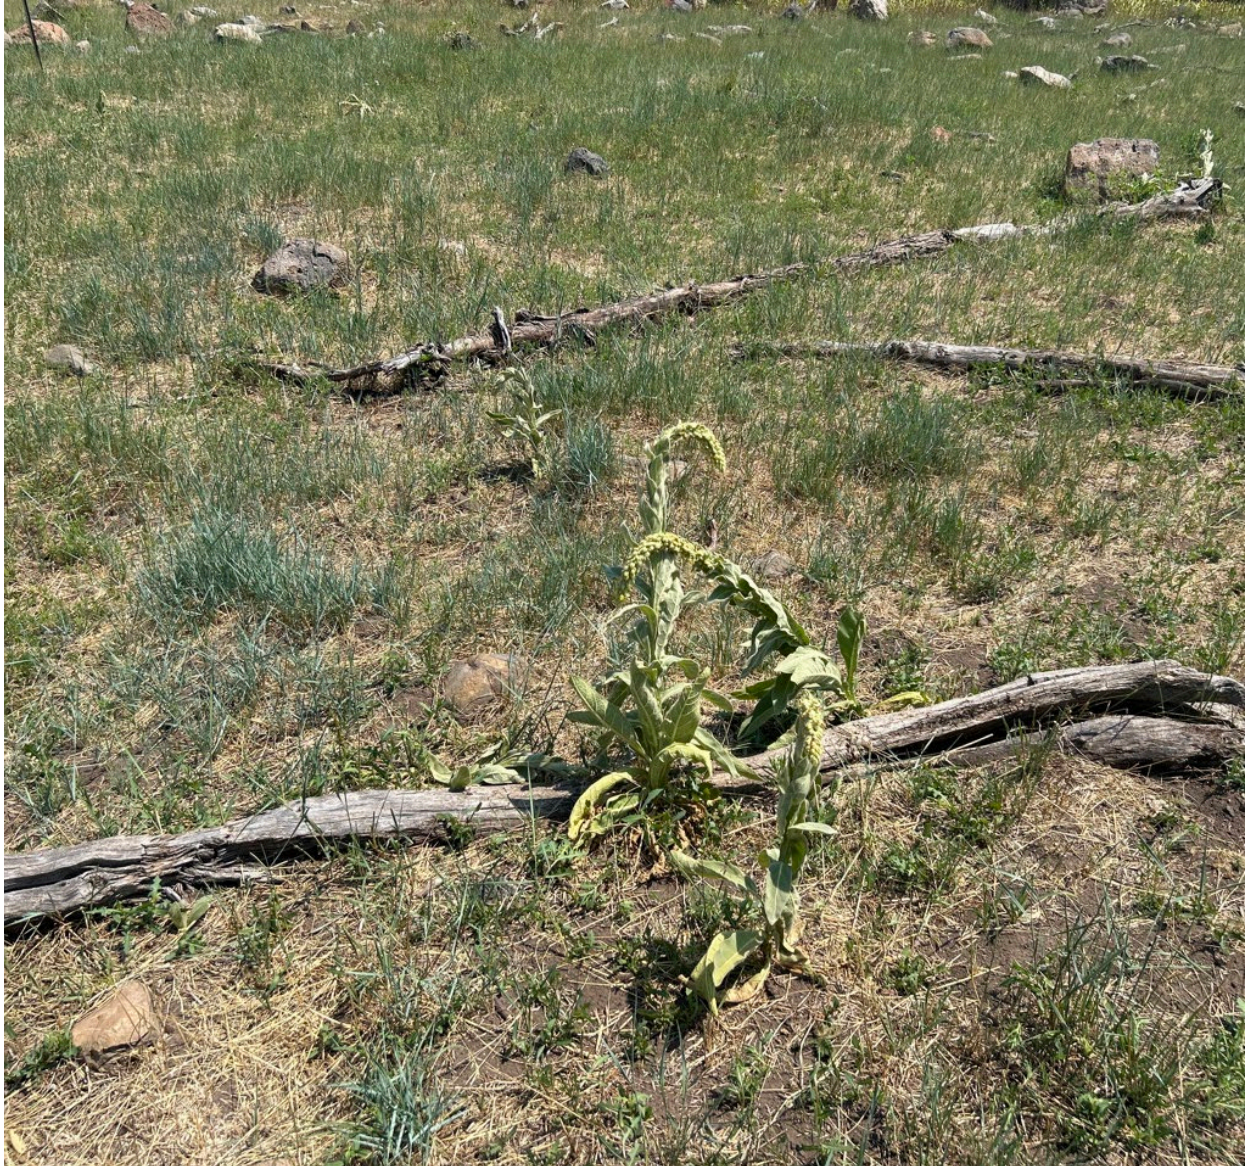
Figure 8: Sprayed Mullein on GVB-LW-18-08

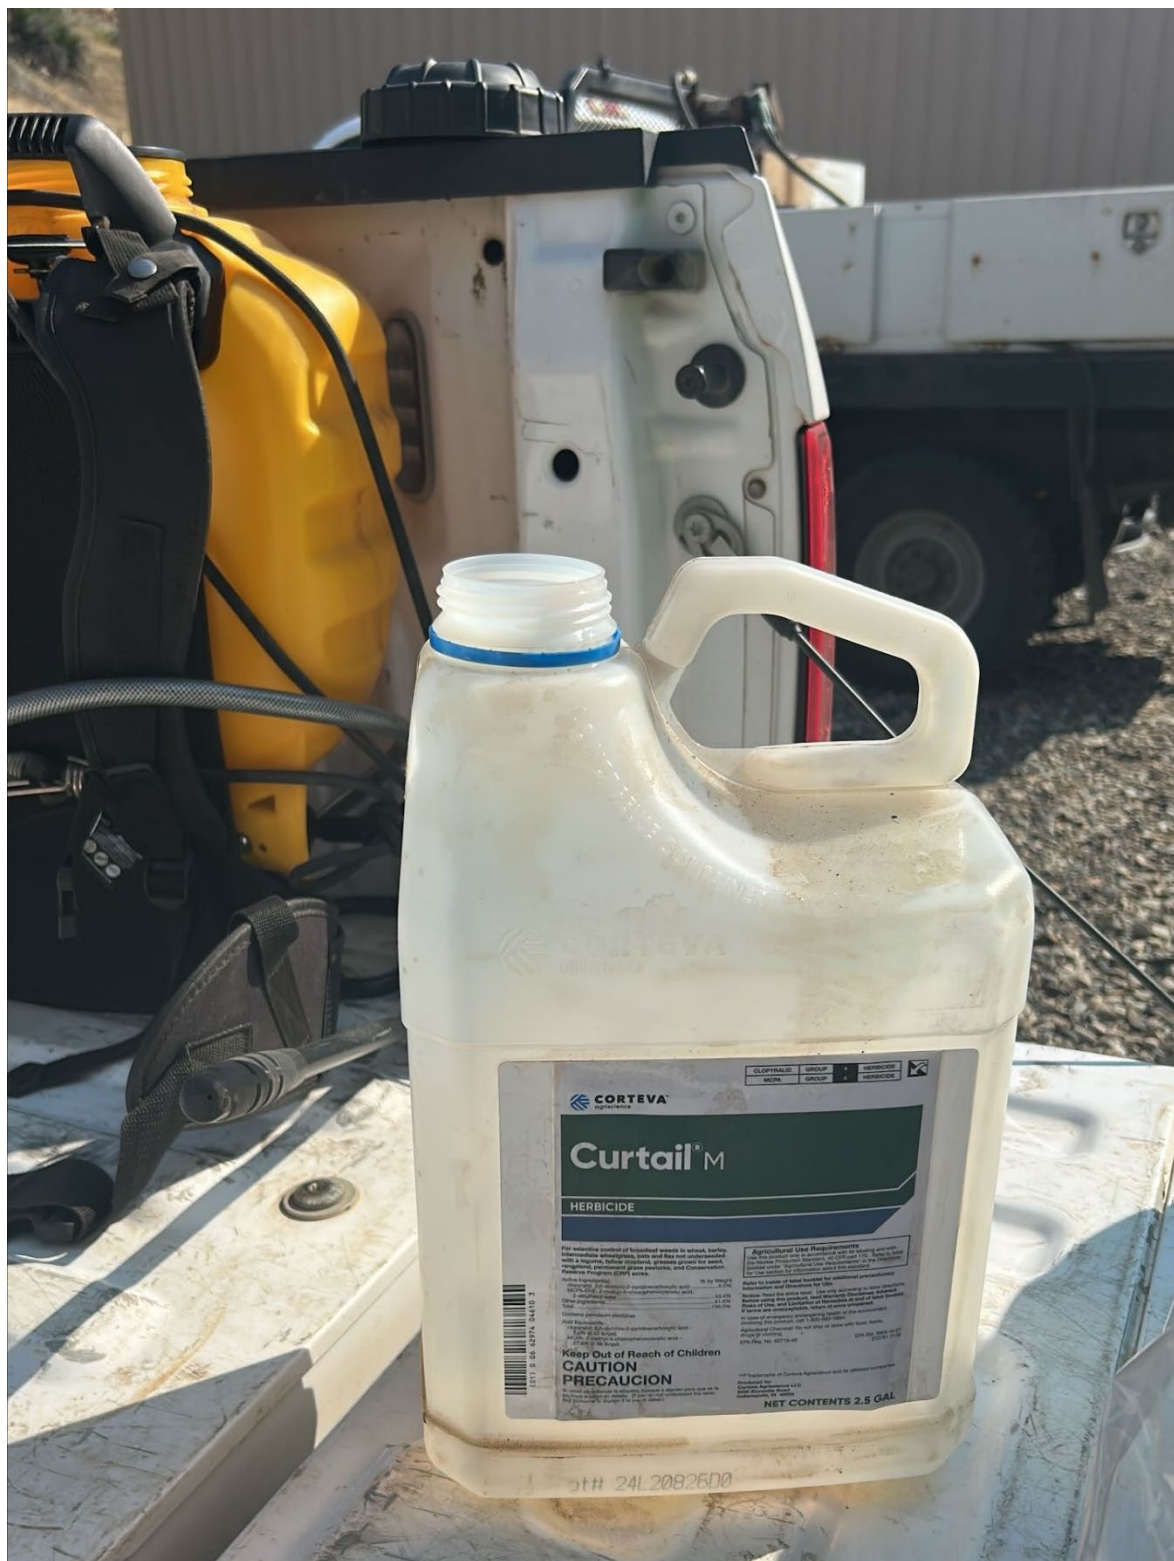
Weed spraying was in progress at the time of the inspection. Curtail, with an added surfactant, was being applied by backpack sprayers on remote reclaimed pads and roads. Vegetation on these areas was generally well developed, with excellent cover and a diverse mixture of perennial grasses, forbs and shrubs, however weeds, particularly Canada thistle, had become quite well established in some spots and a continued effort will be required to control them. Details are given below.

Figure 10: Herbicide (Curtail)

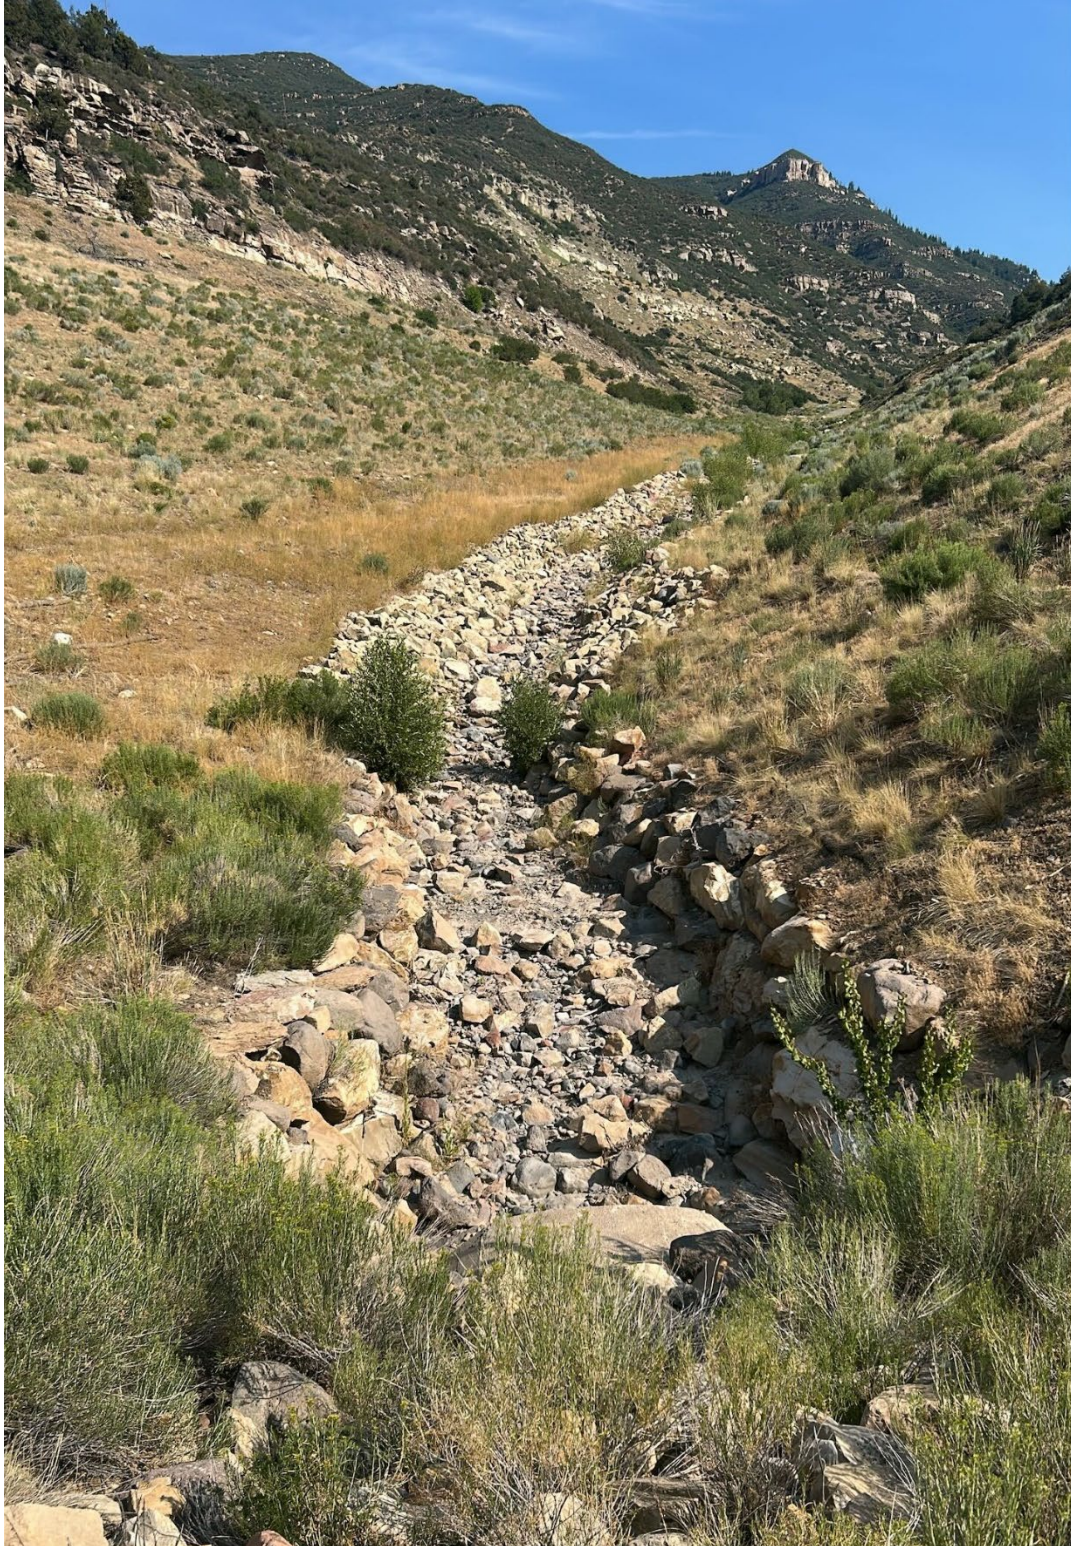
Elk Creek was completely dry.

Figure 11: Elk Creek channel
