Division of Reclamation,  
Mining and Safety

<b>Permit Number:</b> C-1996-084 <b>Mine Name:</b> Lorencito Canyon Mine <b>Operator:</b> New Elk Coal Company, LLC <b>Operator Address:</b> 12250 Highway 12 Weston, CO 81091	<b>County:</b> Las Animas <b>Operation Type:</b> Surface <b>Permit Status:</b> <b>Suspended</b> <b>Ownership:</b> Private
	<b>Operator Representative Present:</b>  None
<b>Operator Representative Signature: (Field Issuance Only)</b>

<b>Inspection Start Date:</b> July 24, 2025 <b>Inspection Start Time:</b> 10:17 <b>Inspection End Date:</b> July 24, 2025 <b>Inspection End Time:</b> 12:15	<b>Inspection Type:</b> Coal Complete Inspection <b>Inspection Reason:</b> Normal I&E Program <b>Weather:</b> Cloudy
<b>Joint Inspection Agency:</b>  None	<b>Joint Inspection Contacts:</b>  
<b>Post Inspection Agency:</b>  None	<b>Post Inspection Contacts:</b>  
<b>Inspector(s):</b>  Amber M. Gibson	<b>Inspector's Signature:</b>

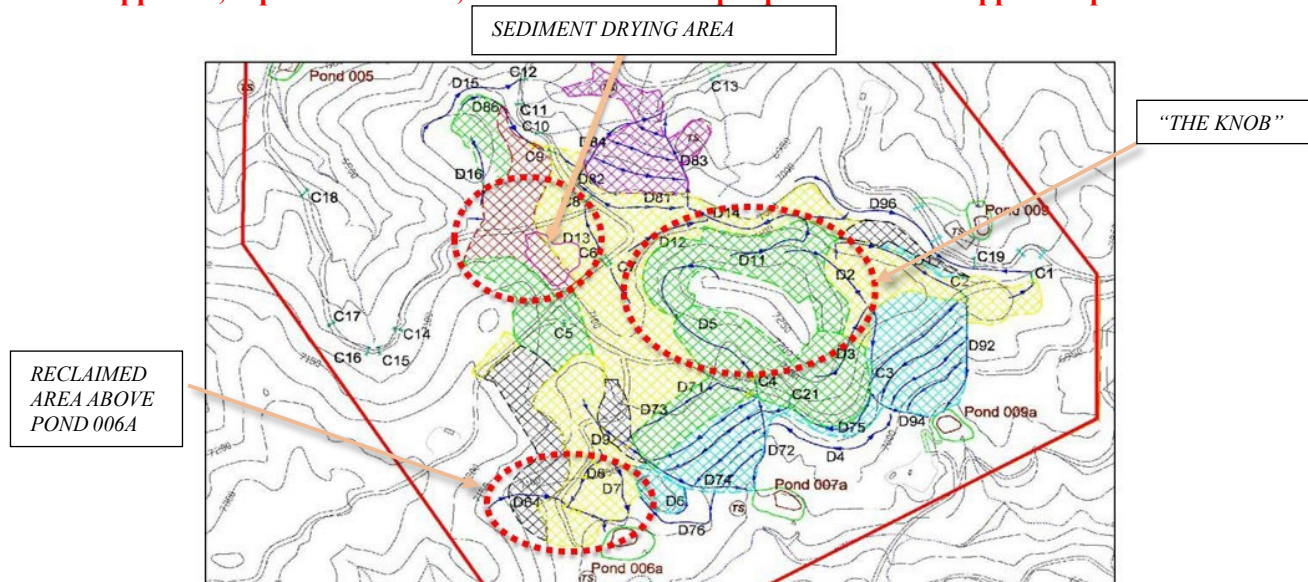
- OMI:** (January 2024 report) Many erosional rills and gullies have formed in the areas shown in Figure 1, that pursuant to Rule 4.14.6 need to be addressed. A Technical Revision will be required to expand on the current Rill and Gully plan in the PAP. **The Operator shall submit the technical revision, obtain approval, repair the erosion, and stabilize the slopes pursuant to the approved plan.**

FIGURE 1. AREAS WHERE RILLS, GULLIES AND SPARSE VEGETATION HAS BEEN FOUND TO BE A PERSISTENT PROBLEM AT THE SITE ARE WITHIN THE DOTTED CIRCLE AREAS. BACKGROUND IMAGE IS THE 2020 ANNUAL REPORT MAP.

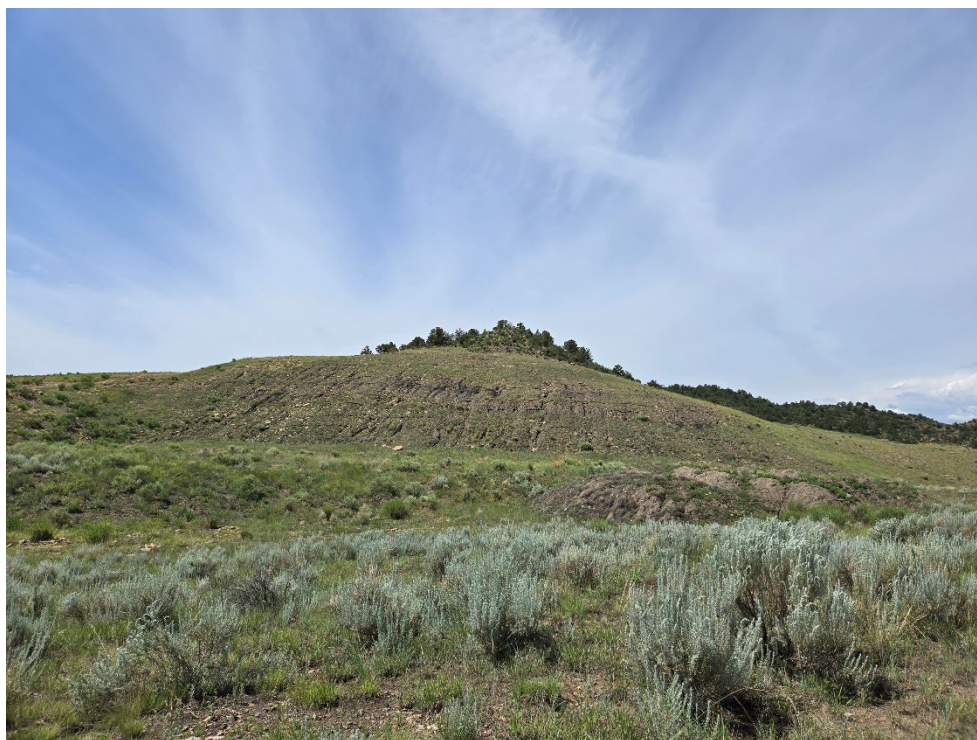
*Photo 1: Looking south at the erosion on the reclaimed area above the sediment drying area.*

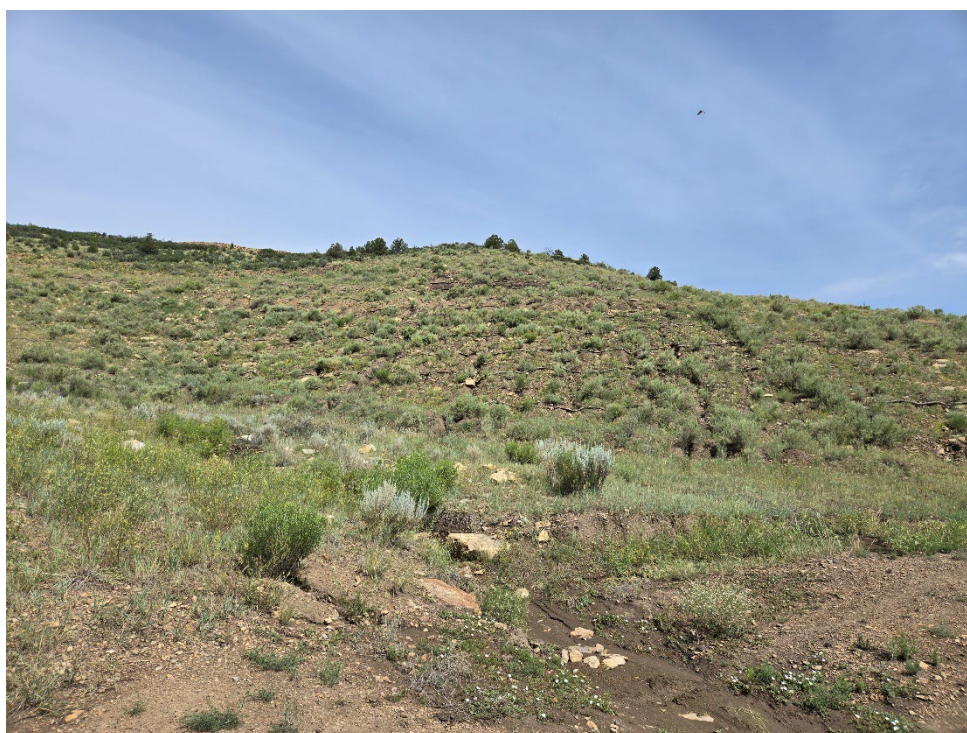
*Photo 2: Looking northwest at the reclaimed area above Pond 006a. Some more vegetation has begun to establish, but the sediment from the rills is still contributing to the sediment*

*within the check dams leading to Pond 006a.*

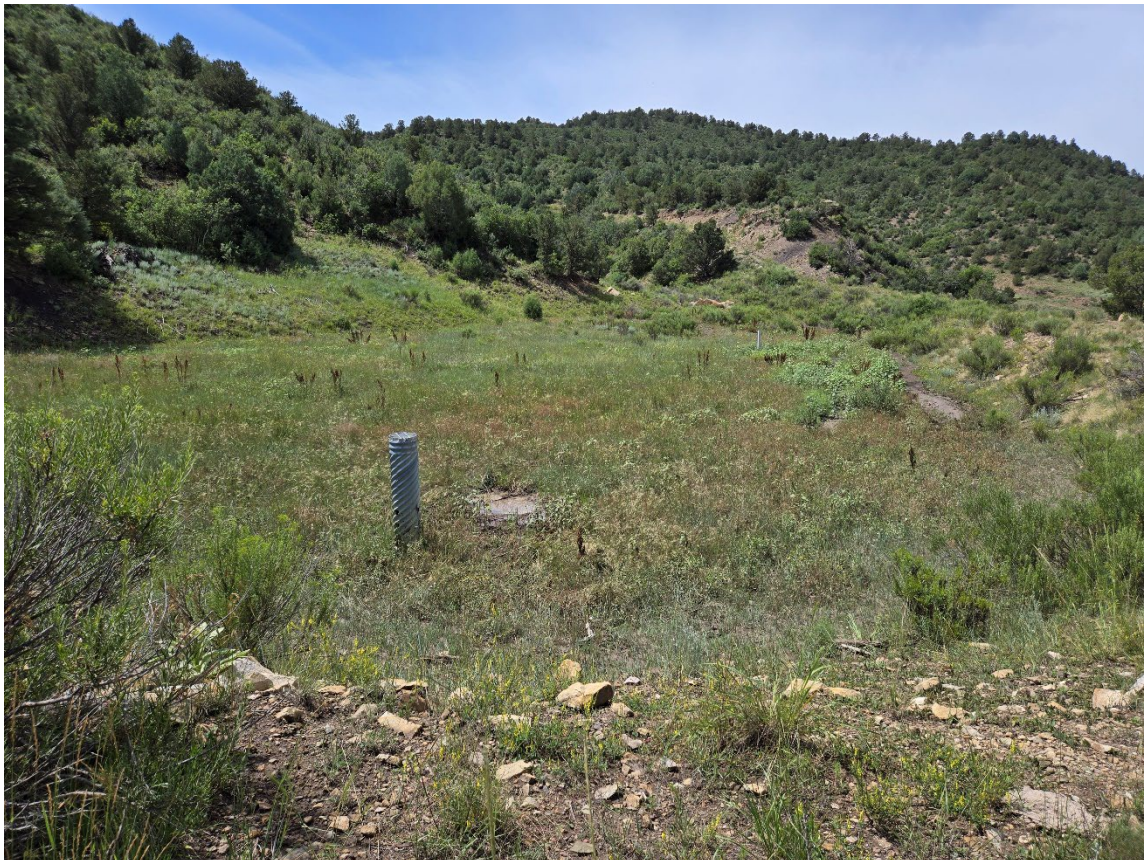
*Photo 3: Pond 005*

- Pond 005:
  - Pond 005 was mostly dry at the time of the inspection.
  - The flume contained some water but was not discharging.
  - The primary and emergency spillways appeared to be clear and functional.

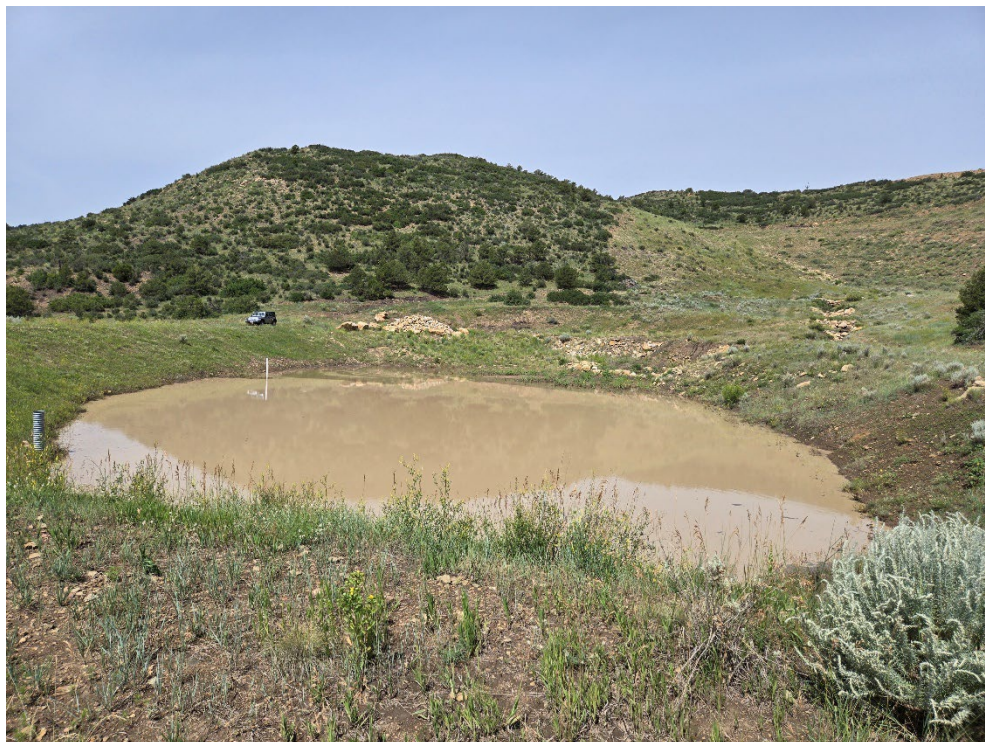
*Photo 5: Pond 006. Looking west.*

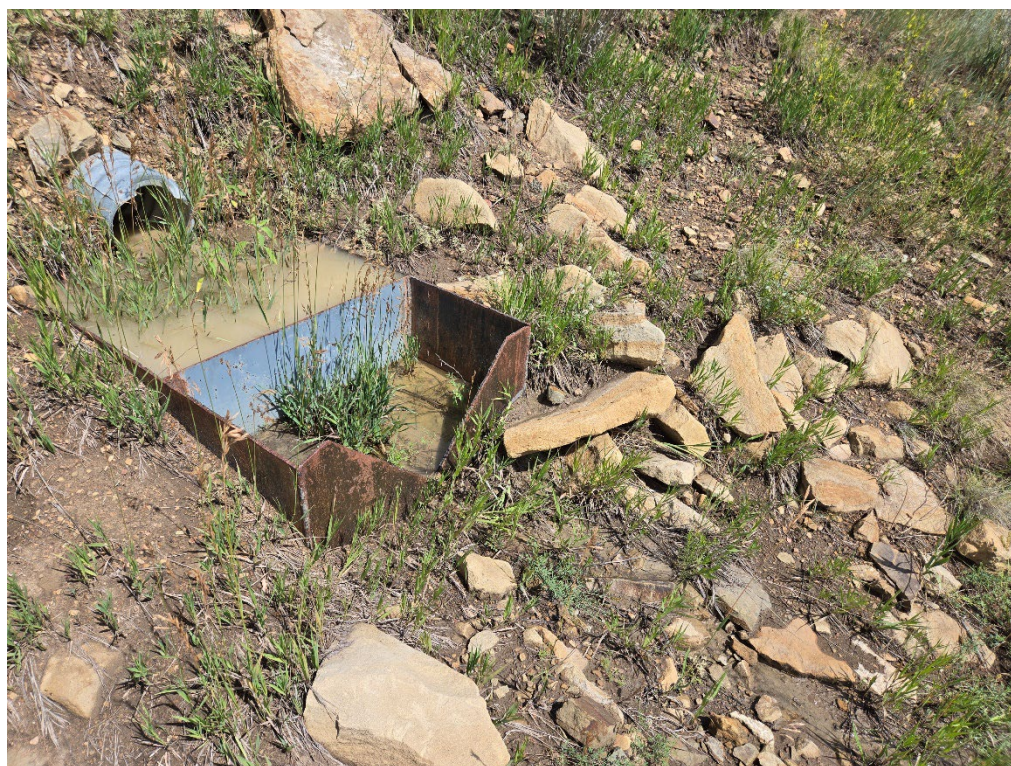
- Pond 006a:
  - The pond held water at the time of the inspection.
  - The flume contained water and was discharging at the time of the inspection.
  - **OMI:** (October 2024 report) Pond 006a - Sediment has built up within the upper portion of the flume. **The Operator shall clean the flume of sediment and vegetation to ensure it functions properly.**

*Photo 6: Discharging flume at Pond 006a. The top part of the flume has filled with sediment and vegetation, causing some of the discharge to escape from the sides of the top.*

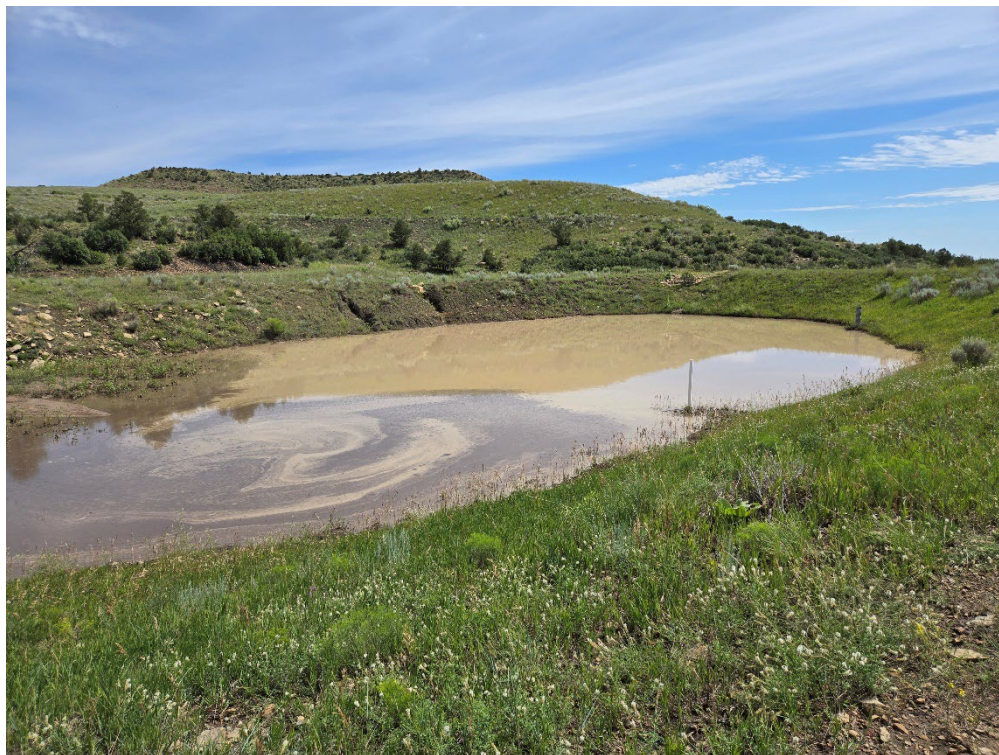
- The pond embankment appeared to be stable and vegetated besides in the areas mentioned in the following OMI bullet.
    - **OMI:** (January 2024) Erosion rills are forming on the north and west banks of Pond 006a. The erosion on the north bank appears to have been addressed at some point, because rebar is placed above the rills. However, it appears that the prior BMPs are no longer functioning adequately. **Pursuant to Rule 4.05.5(1)(c), the Operator shall address the erosion and repair the north bank.** The erosion on the west bank appears to have been caused by runoff from the road located east of Pond 006a. **Pursuant to Rule 4.05.5(1)(c), the Operator shall address the erosion and repair the west bank.**

*Photo 7: Looking at the erosion on the north side of the Pond 006a banks.*

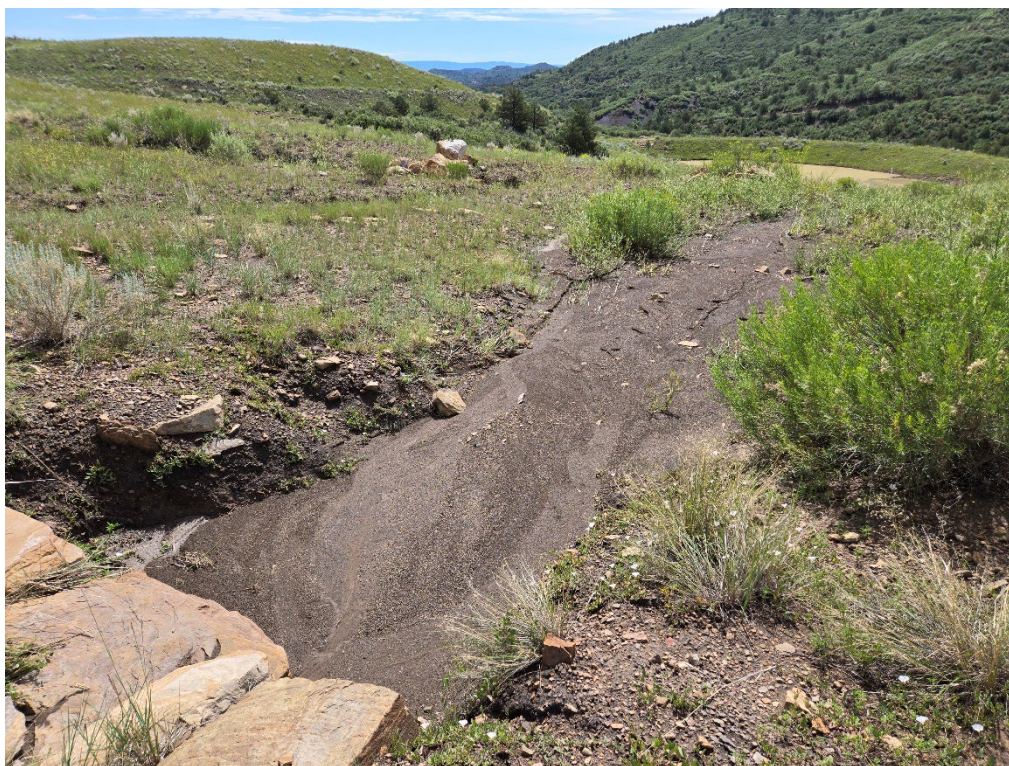
- **OMI:** (February 2024) The check dams leading to Pond 006a, within ditches D8 and D64, are nearly full of sediment. **Pursuant to Rules 4.05.3(1)(c)-(e) and 4.05.5, the Operator shall clean out the sediment from the check dams to prevent excess sediment from entering the pond.**

*Photo 8: Check dam full of sediment leading down to Pond 006a*

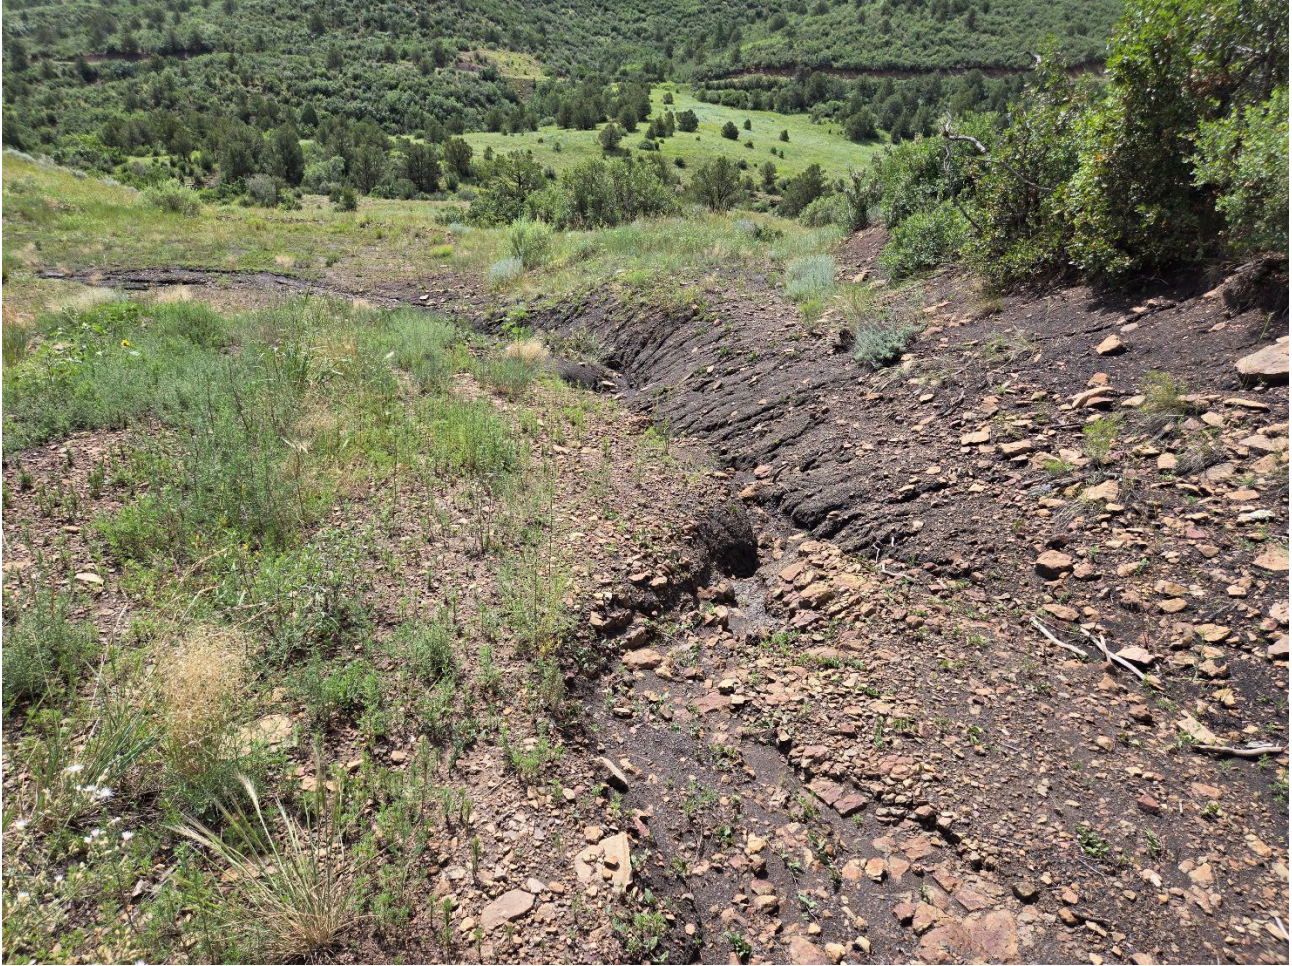
- The primary and emergency spillways appeared clear and functional.
  - **OMI:** (August 2024 report) The check dams within Ditch D9, leading down to Pond 006a, contain an excess amount of sediment. A gully was also observed cutting down from the road and adding sediment to the third check dam. **The Operator shall remove the excess sediment from the check dams within D9.**

*Photo 9: Gully along the west side of the road leading down to Pond 006a, cutting across the road, and contributing to the sediment built up in the check dams that lead to Pond 006a.*

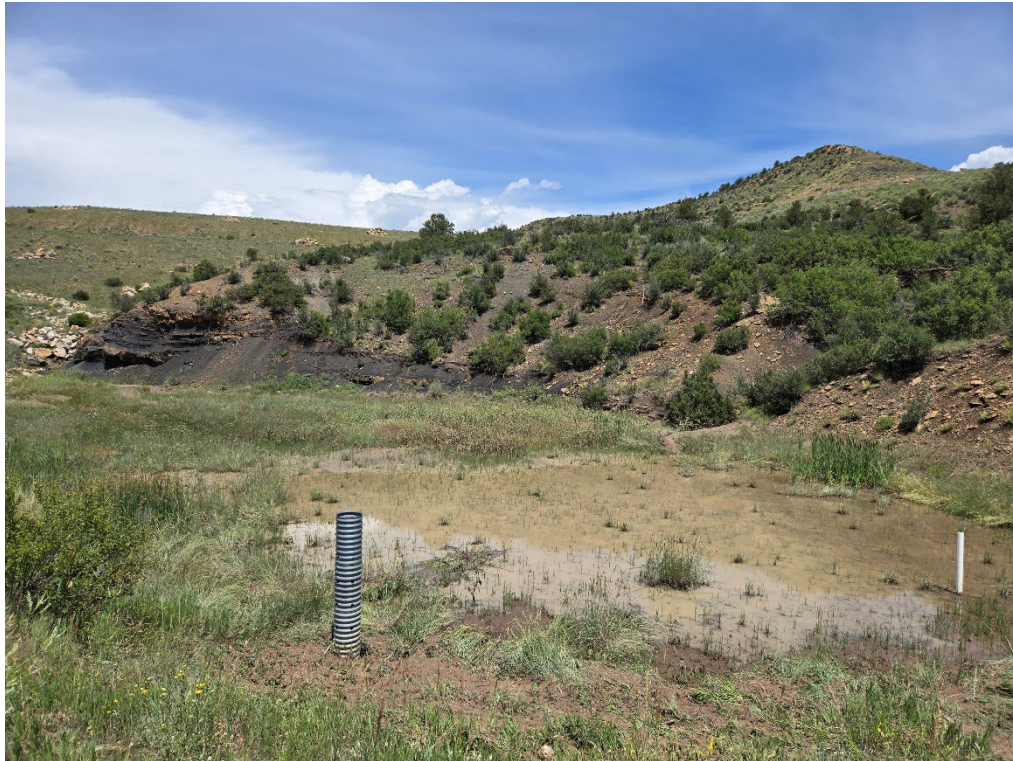
*Photo 10: Pond 007a*

- Pond 007a:
  - The pond held water at the time of the inspection.
  - The pond embankment appeared to be stable and vegetated.
  - The primary and emergency spillways appeared clear and functional.
  - The flume held some water but was not discharging.

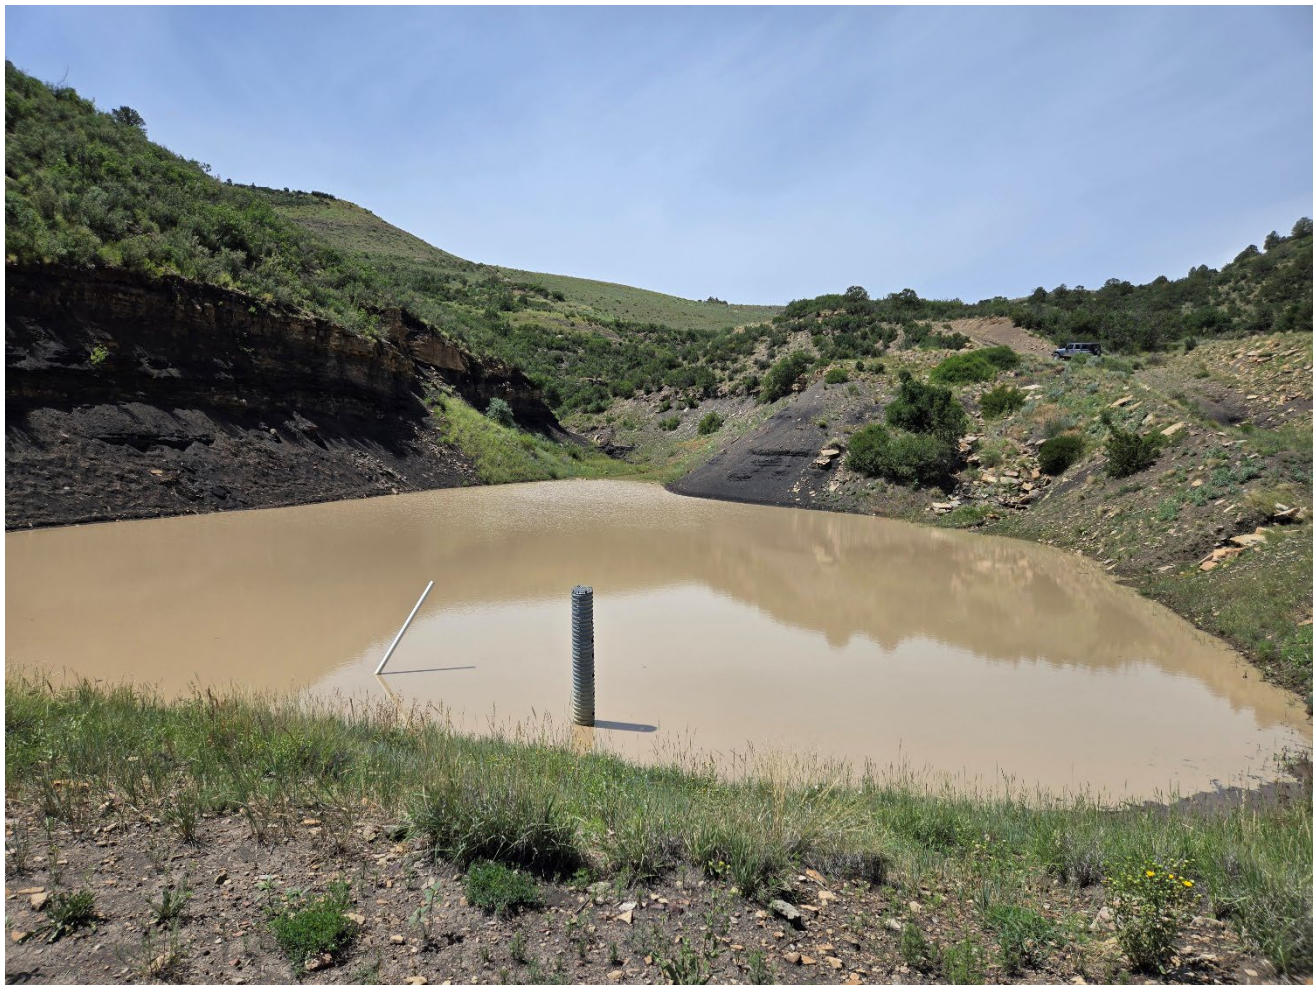
Photo 12: Pond 08

- Pond 08:
  - The pond held water at the time of the inspection.
  - The pond embankment appeared to be stable and vegetated except for the area mentioned in the OMI bullet below.

- **OMI:** (2024 report) The majority of Pond 08's embankment was stable and vegetated; however, the west bank contains some erosion rills and gullies. The erosion appears to have been caused by run-off from the roads above and down to the pond. **Pursuant to Rule 4.05.5(1)(c), the Operator shall repair the erosion and stabilize the west bank of Pond 008.** The Operator stated that they will likely install additional rock berms along the western-most road to help prevent run-off from running down the slopes and into the pond. The Operator also stated that they plan to remove the sediment (deposited as a result of the bank erosion) along the west bank of Pond 08.

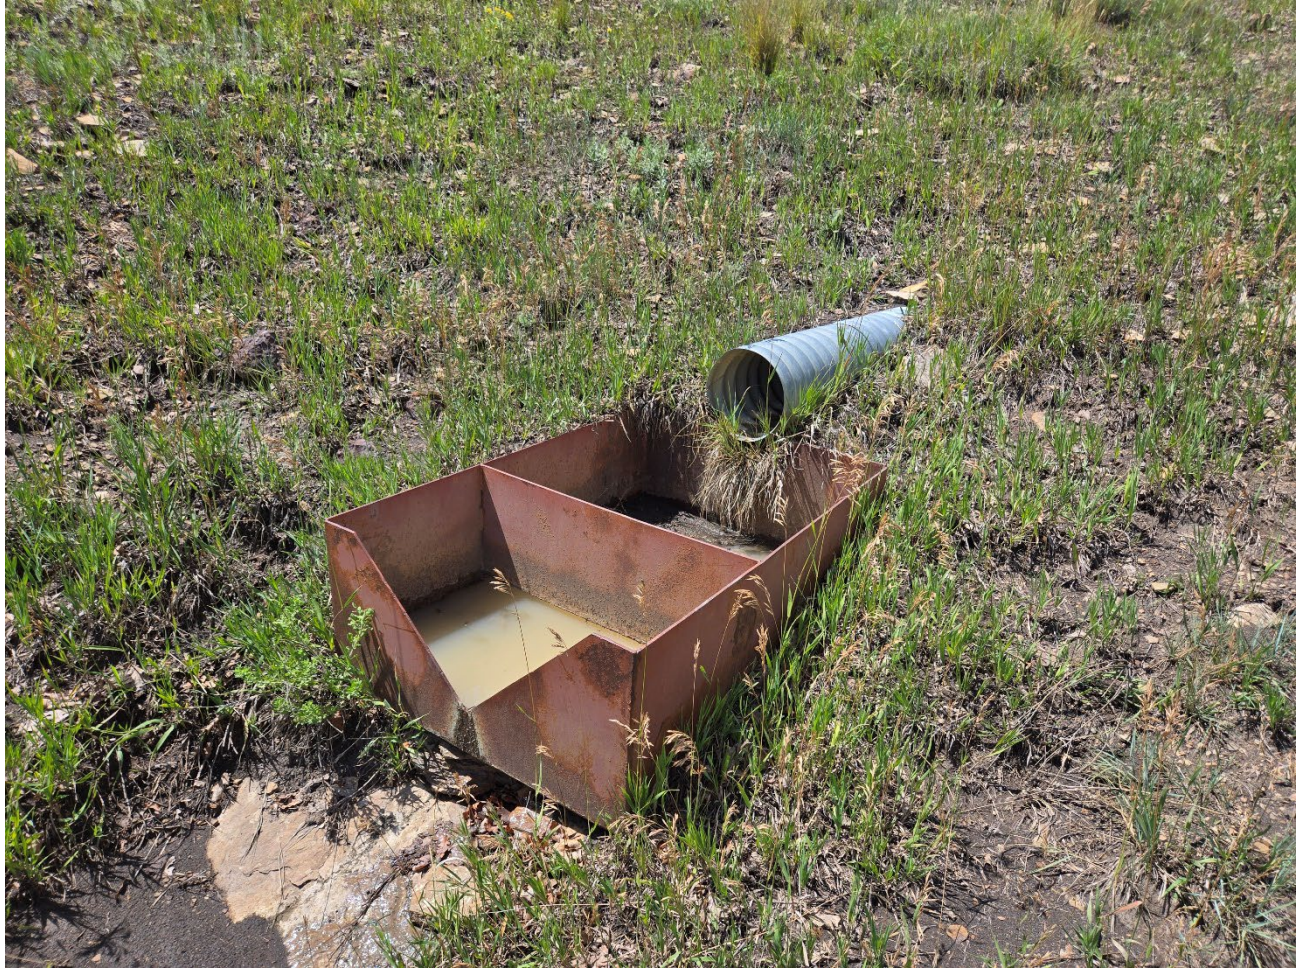
*Photo 13: Flume for Pond 08*

- The primary and emergency spillways appeared clear and functional.
  - The flume held water at the time of the inspection and was discharging.

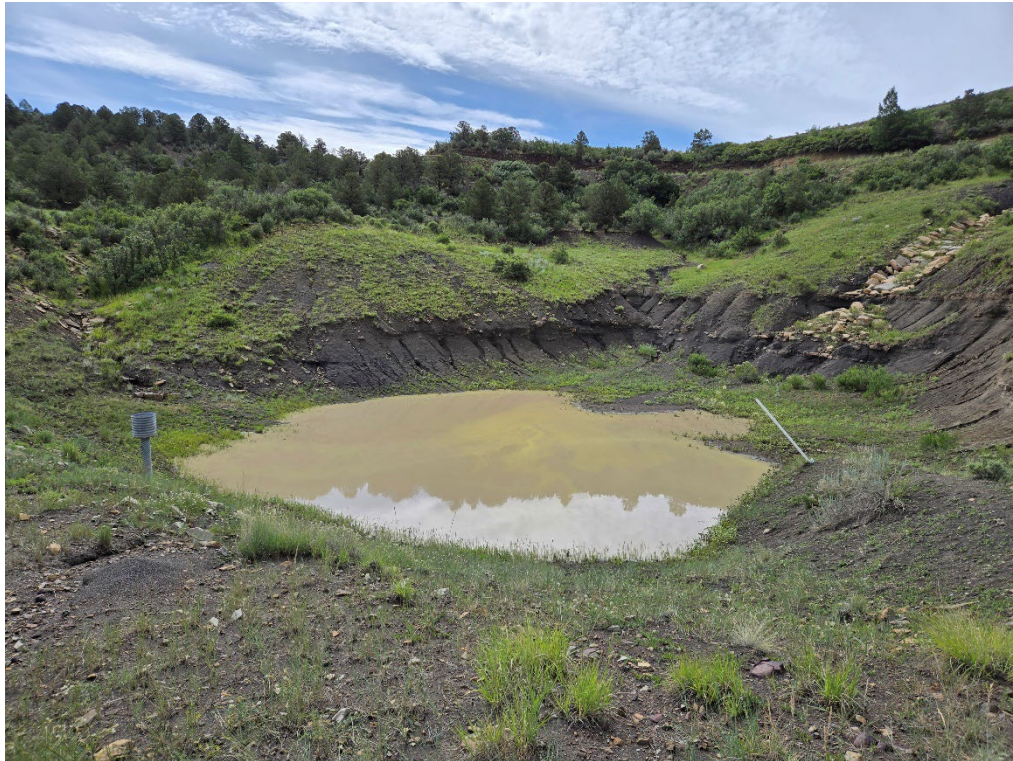
*Photo 14: Pond 009*

- Pond 009:
  - The pond contained some water at the time of the inspection.
  - The pond embankment appeared to be stable and vegetated.
  - **OMI:** (September 2024 report) The rills above the bank do not appear to have worsened, but the **Operator shall continue to monitor this area.**
  - The primary and emergency spillways appeared clear and functional.
  - The flume held some water at the time of the inspection but was not discharging.
  - **OMI:** (November 2024 report) Some vegetation has grown over and into the flume. The **Operator shall clear the excess plant material in the flume.**

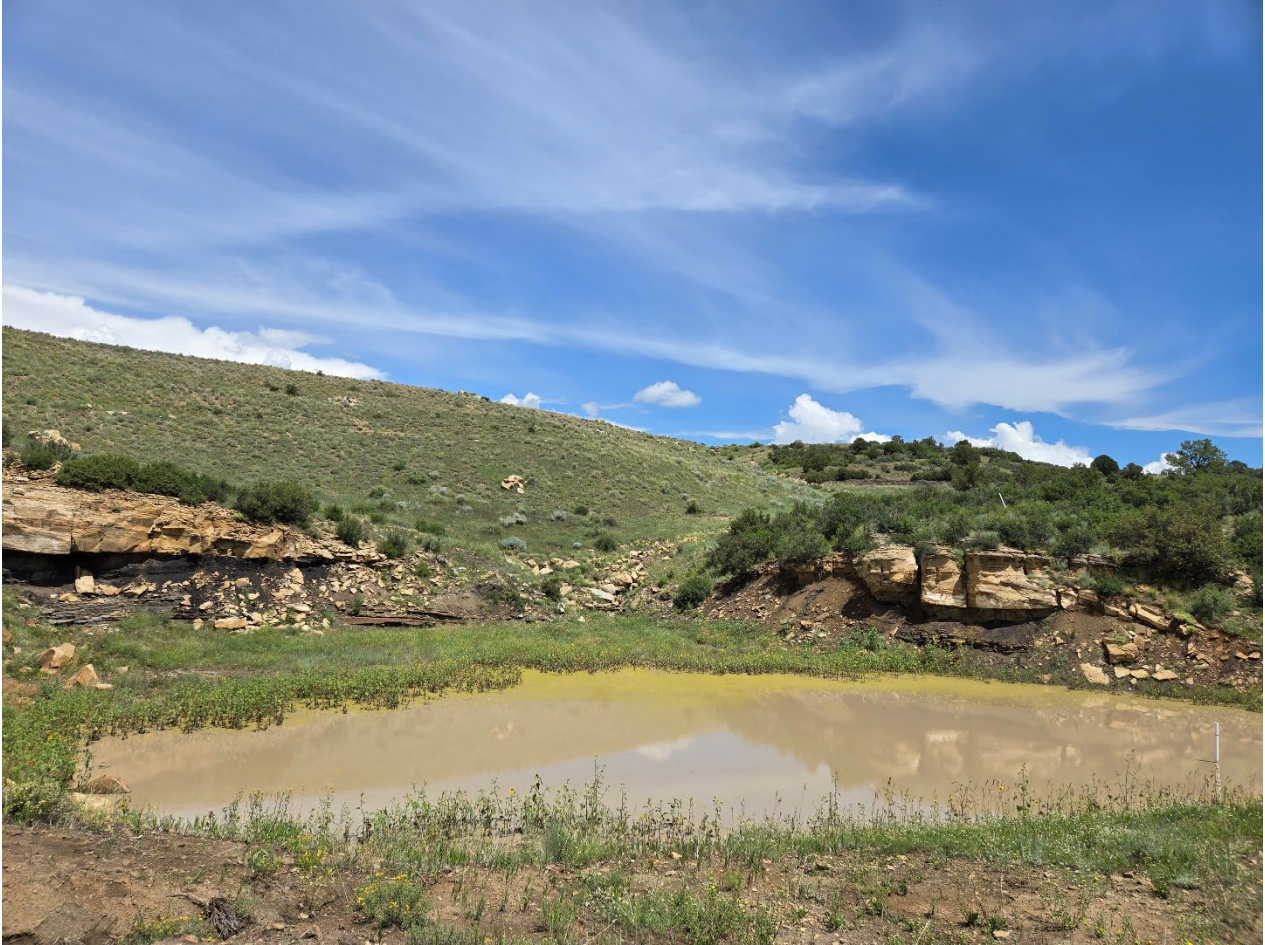
*Photo 16: Pond 009a*

- Pond 009a:
  - The pond contained water at the time of the inspection.
  - The pond embankment appeared to be stable and vegetated.
  - The primary and emergency spillways appeared clear and functional.
  - The flume held a small amount of water and was discharging.

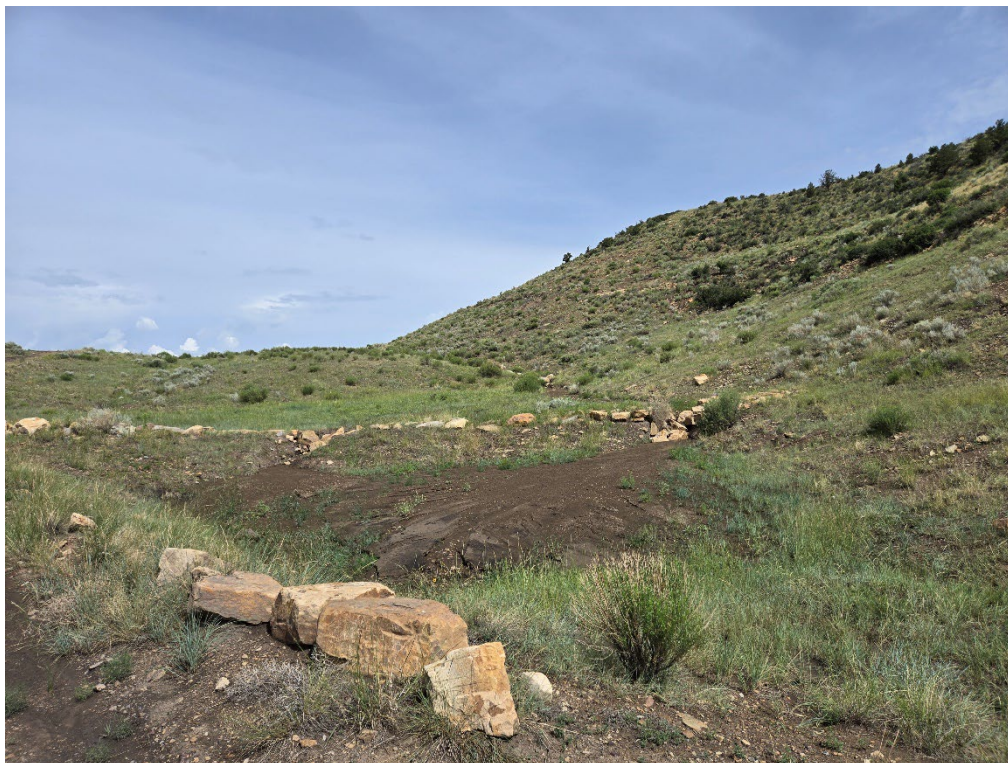
- Ditch D5:
  - **OMI:** (December 2024 report) Ditch D5 is located on the southside of a previously disturbed area referred to as “The Knob”. The Knob is north of Fill 7 and north of the road. Check dams are located throughout D5, and a small sediment catchment area is located at the base of the ditch that leads to culvert C4. The check dams are full and need to be cleaned, and a few need to be repaired. The catchment basin also has an increased sediment load, however C4 appears to still be clear at this time. Still, the Operator **shall clean the sediment out of the check dams and the catchment basin located within D5, north of C4.**

*Photo 18: D5 leading to a catchment basin full of sediment on the south side of "The Knob" and on the north side of the road.*

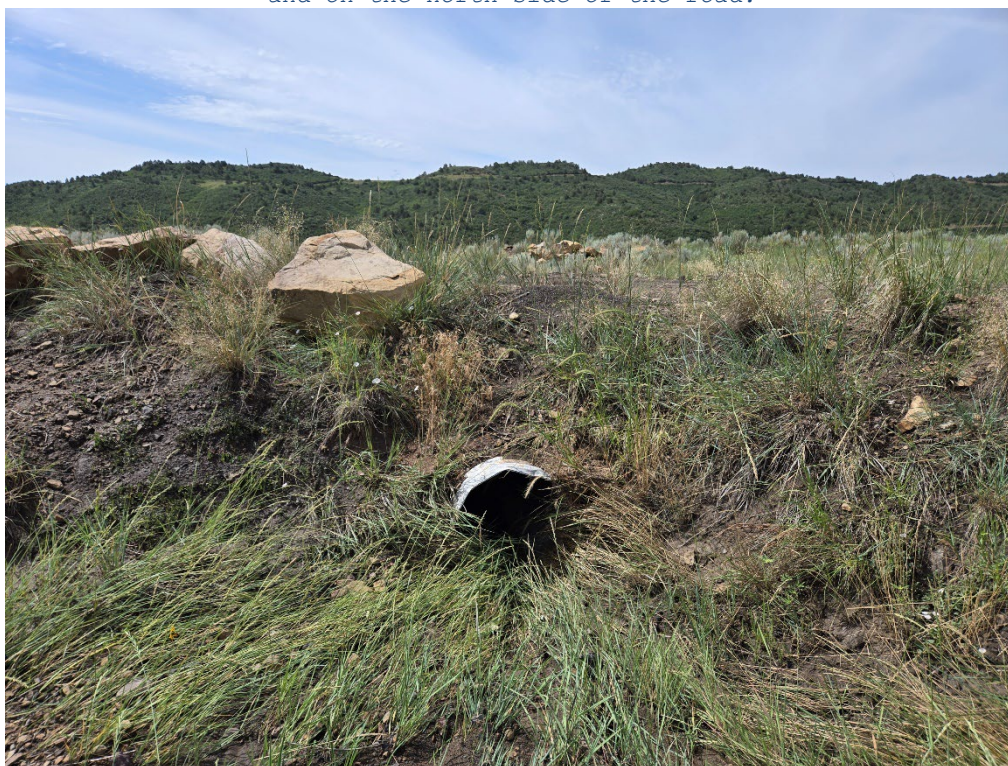
*Photo 19: Inlet side of C4 within the catchment basin on the north side of the road.*

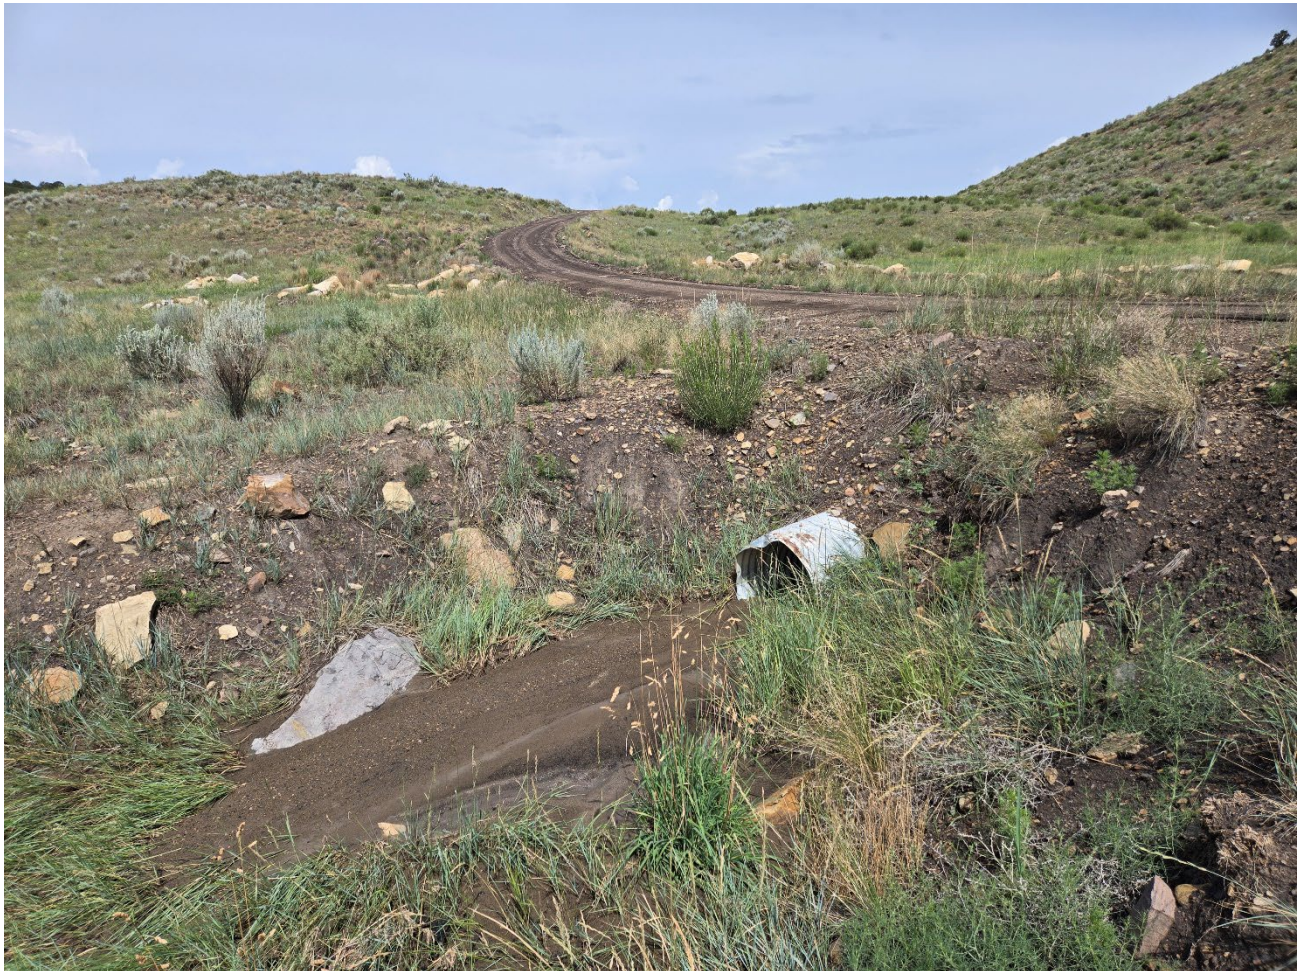
*Photo 20: Outlet for C4*

- Culvert C4:
  - **OMI:** (December 2024 report) The outlet for C4 is located on the south side of the culvert and leads into Ditch D72 along the east side of Fill 7. Sediment has been deposited at the outlet of C4 and has covered small portion of vegetation at the top of Ditch D72. **The Operator shall monitor this area and ensure that sediment deposition in this area is controlled. To help retain the vegetation established in the area, removing the excess sediment may be warranted in the near future.**

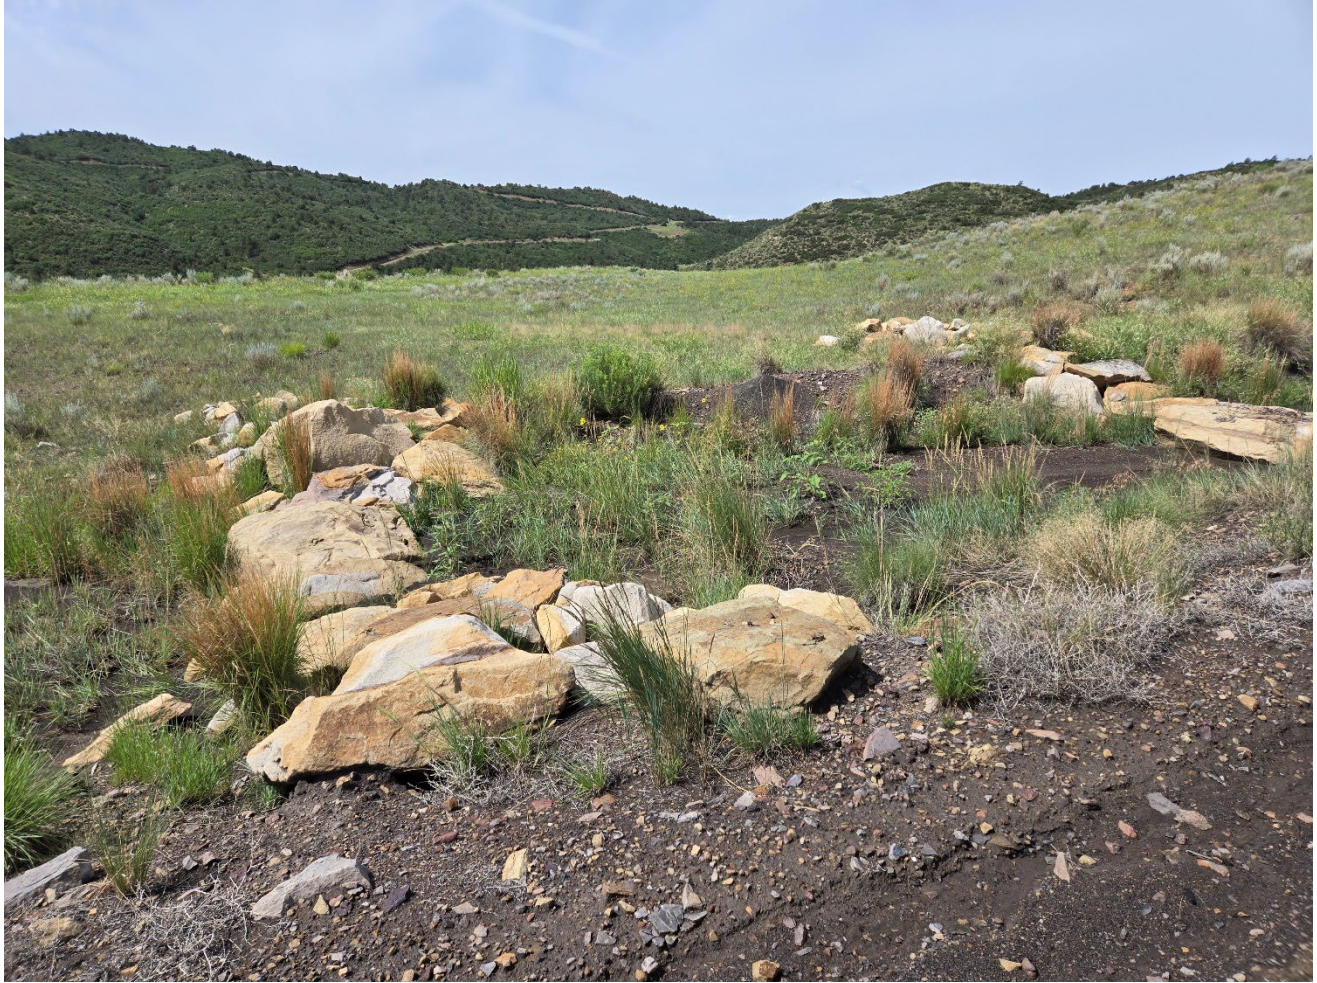
- Ditch D71:
  - **OMI:** (December 2024 report) D71, located along the southside of the road and north side of Fill 7, empties at the west side of the outlet for C4. The check dams within D71 are nearly full of sediment. **The Operator shall clean the sediment from the check dams within D71 and ensure the dams are functioning appropriately.**

*Photo 21: Full check dams within D71*

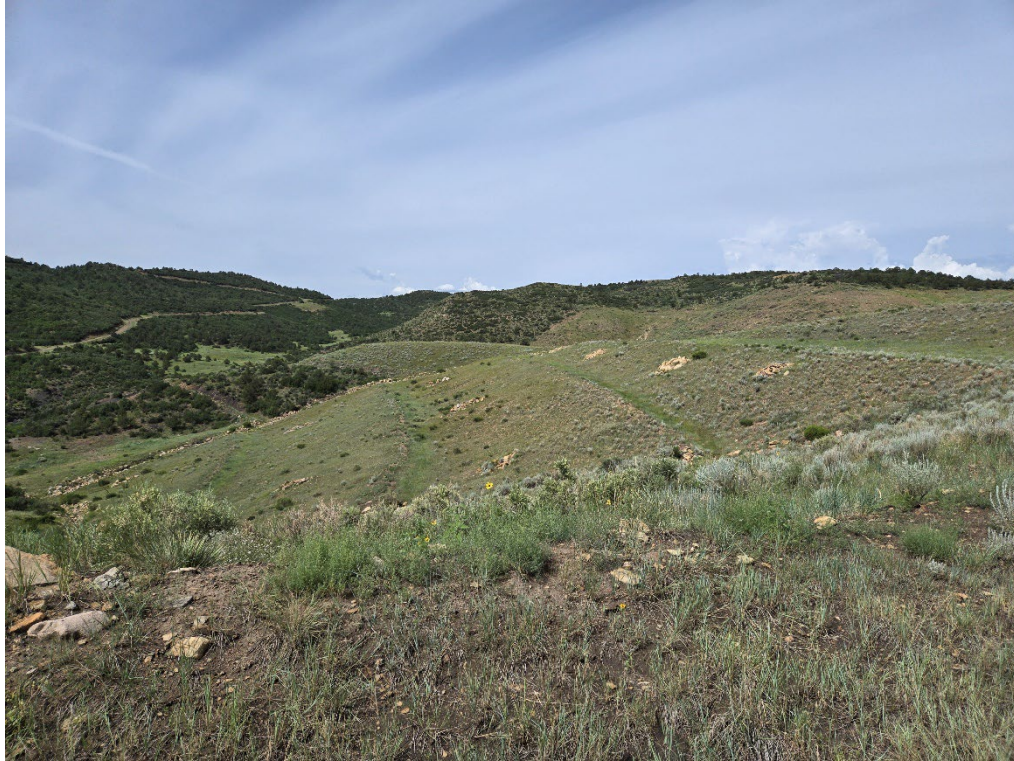
*Photo 22: Fill 7*

- Fill 7 was observed. Fill 7 was well vegetated and appeared stable.
- Fill 8 was observed. Fill 8 was well vegetated and appeared stable.
- Fill 9 was observed (see Photo 16). Fill 9 was well vegetated and appeared stable.

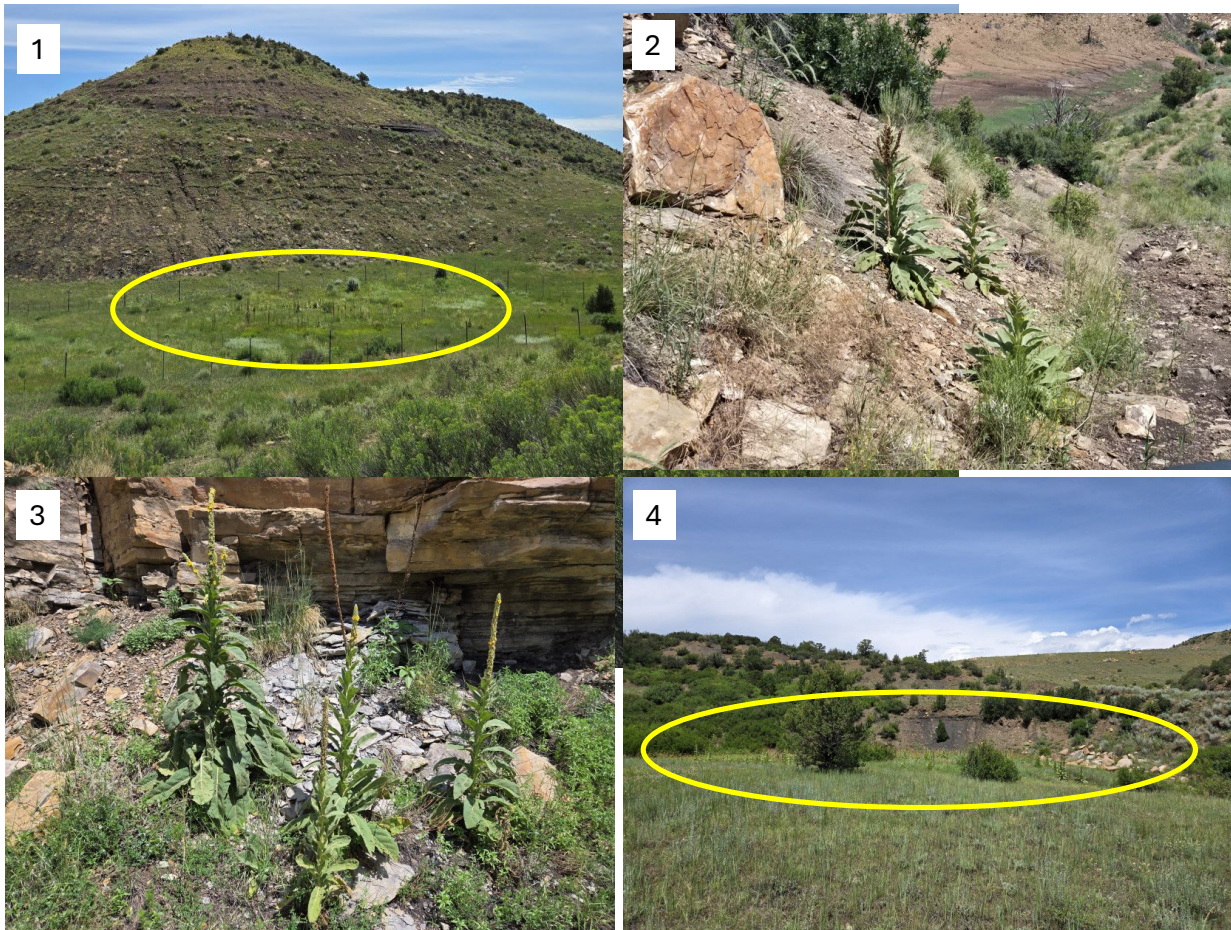
- **OMI:** (August 2024 report) The state listed noxious weed, Mullein, was observed:
  - by the Pond 005 spillway. **The Operator shall treat and/or remove Mullein in this area.**

- in the field to the south and west of Pond 007a, within the permit boundary. **The Operator shall treat/remove Mullein within this area.**
  - along the west bank of Pond 008 where some of it was treated by the Operator during the June inspection. However, more weeds were observed during the August inspection. **The Operator shall treat/remove Mullein within this area**

- in an area designated as a vegetation test plot. **The Operator shall treat and/or remove the Mullein within this area.**
- **OMI:** (June 2025) In addition to the mullein observed around the site, what appears to be the B-listed state noxious weed musk thistle was observed along the west side of Pond 08. **The Operator shall treat/remove musk thistle from this area.**

Photo 24: Mullein observed throughout the site: (1) test plot south of "The Knob". (2) Along and around Pond 005. (3) Along and round Pond 08. (4) In valley south of Fill 7

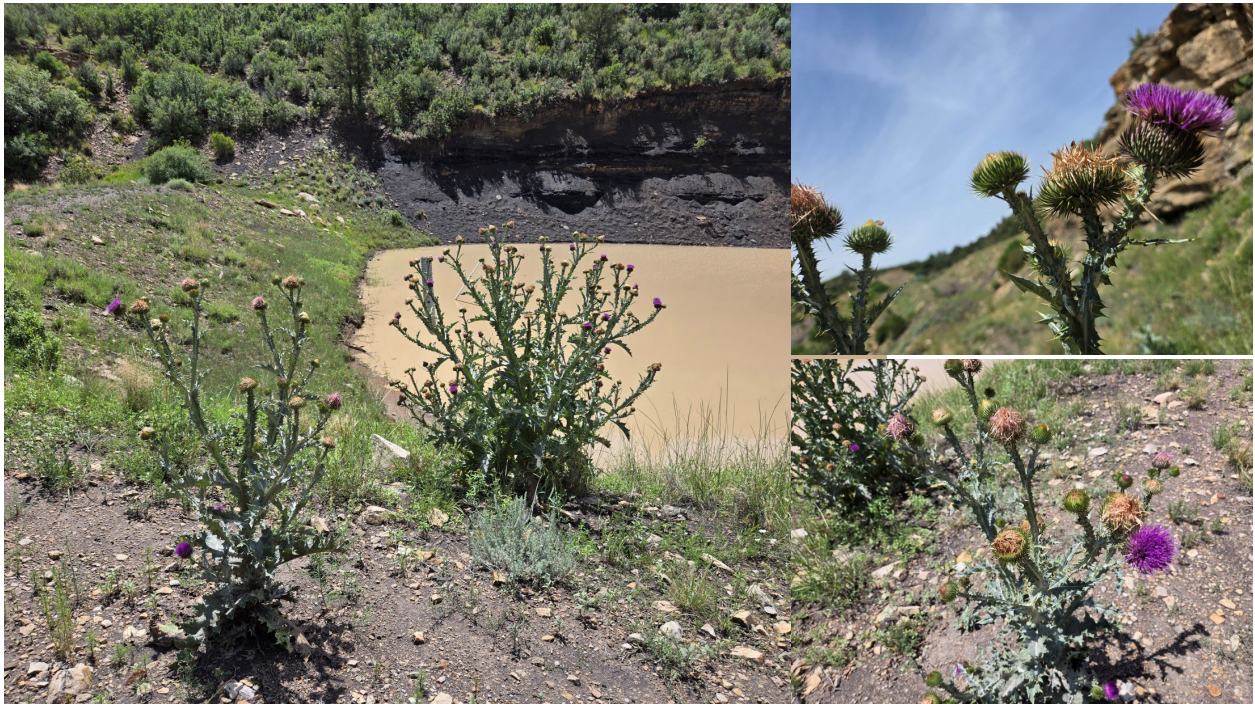
*Photo 25: Musk thistle on the bank of Pond 08.*
