Division of Reclamation,  
Mining and Safety

<b>Permit Number:</b> C-1996-084 <b>Mine Name:</b> Lorencito Canyon Mine <b>Operator:</b> New Elk Coal Company, LLC <b>Operator Address:</b> 12250 Highway 12 Weston, CO 81091	<b>County:</b> Las Animas <b>Operation Type:</b> Surface <b>Permit Status:</b> <b>Suspended</b> <b>Ownership:</b> Private
	<b>Operator Representative Present:</b>  None
<b>Operator Representative Signature: (Field Issuance Only)</b>

<b>Inspection Start Date:</b> July 24, 2025 <b>Inspection Start Time:</b> 10:17 <b>Inspection End Date:</b> July 24, 2025 <b>Inspection End Time:</b> 12:15	<b>Inspection Type:</b> Coal Complete Inspection <b>Inspection Reason:</b> Normal I&E Program <b>Weather:</b> Cloudy
<b>Joint Inspection Agency:</b>  None	<b>Joint Inspection Contacts:</b>  
<b>Post Inspection Agency:</b>  None	<b>Post Inspection Contacts:</b>  
<b>Inspector(s):</b>  Amber M. Gibson	<b>Inspector's Signature:</b>

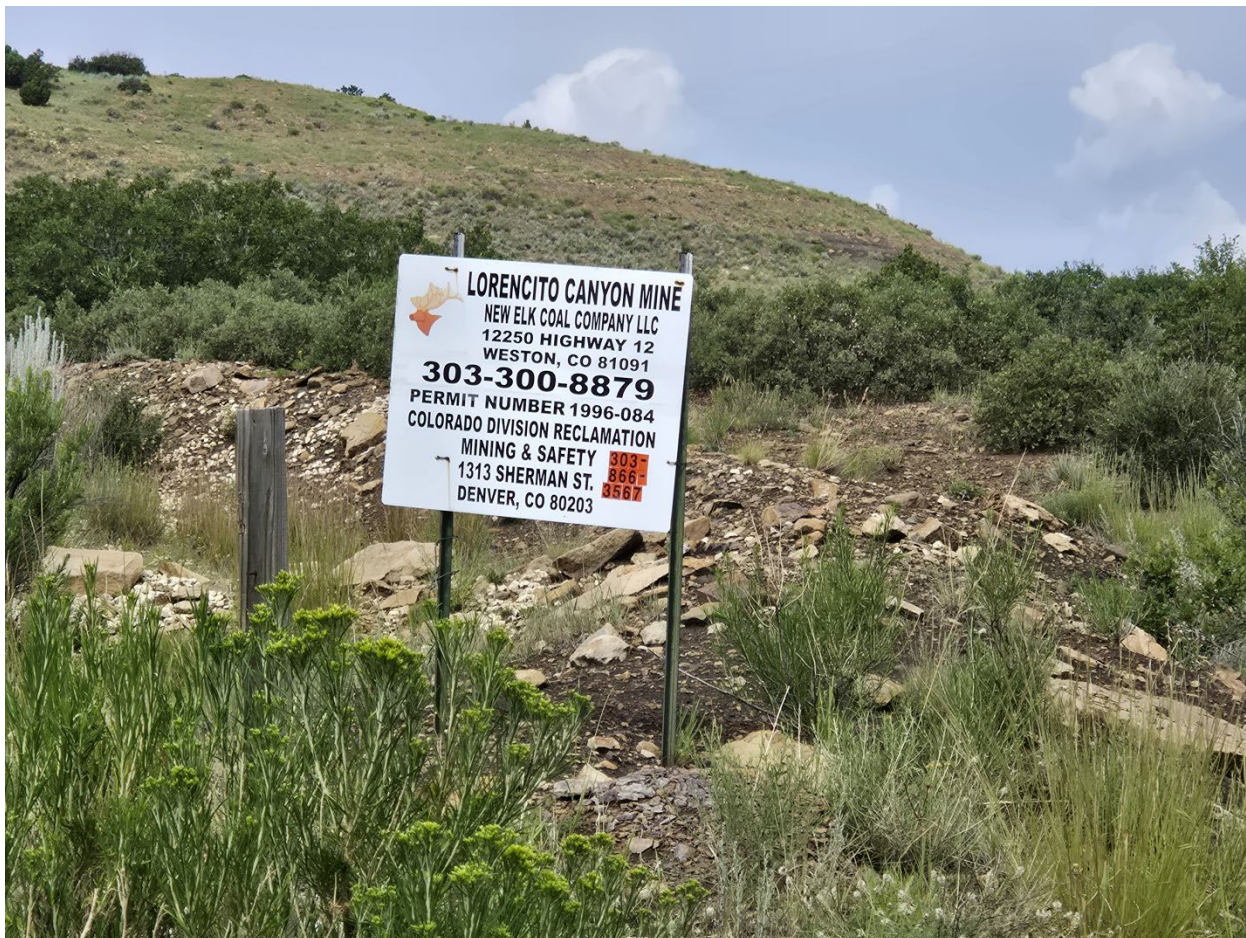
- Mine signs were posted at road entrances and at the entrance to the permit boundary in compliance with Rule 4.02.

*Photo 26: Mine sign posted at the permit boundary.*
