MINERALS PROGRAM INSPECTION REPORT

MINE NAME: Tezak No 2 Pit	MINE/PROSPECTING ID#: M-1981-080	MINERAL: Sand and gravel	COUNTY: Fremont
INSPECTION TYPE: Monitoring	WEATHER: Cloudy	INSP. DATE: June 24, 2025	INSP. TIME: 13:00
OPERATOR: Tezak Stone & Aggregate Supply, Inc.	OPERATOR REPRESENTATIVE: Mr. Mike Tezak & Mr. Nathan Tezak	TYPE OF OPERATION: 112c - Construction Regular Operation

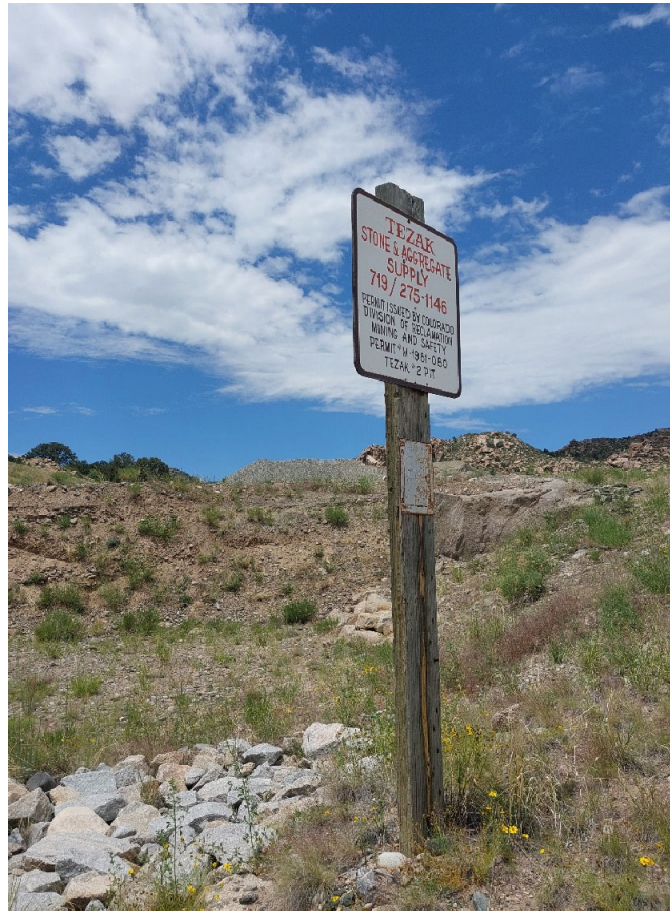
The mine sign was posted on the north side of the access road, along US Hwy 50 and CR 37, see Photo #1. The permit boundary was marked by T-posts, painted with white tops, see Photo #2.

Photo #1: Mine sign posted on the west side of the access road at the intersection of US 50 and CR 37.

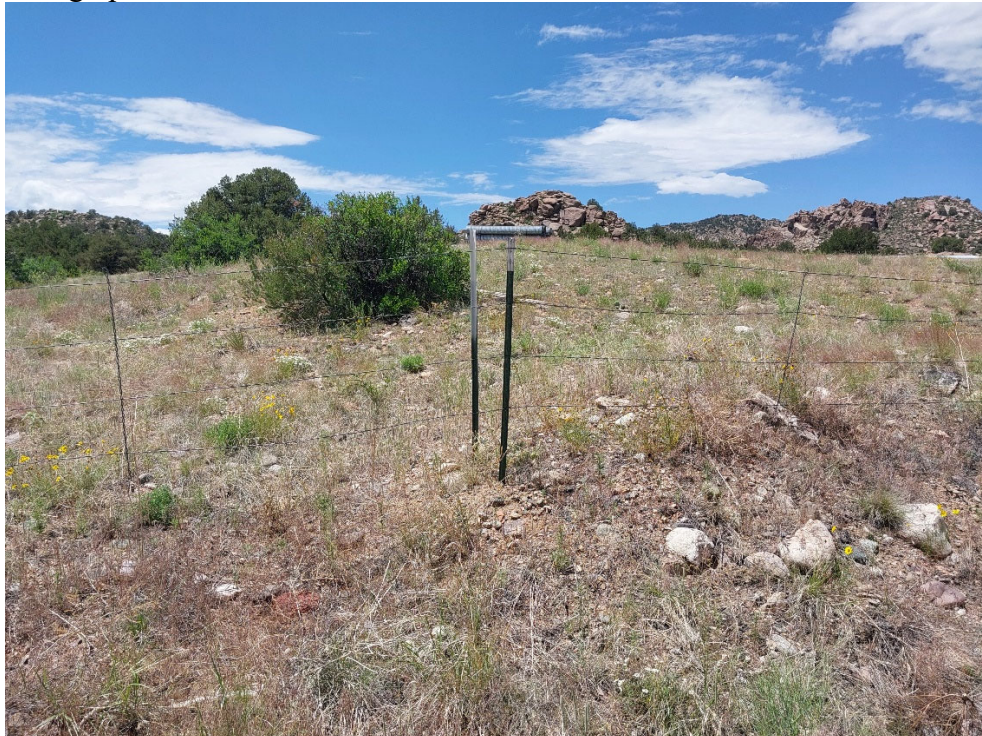
Photo #2: Example of a permit boundary marker viewed in the southeastern portion of the permit area. The white-top T-post behind the wired fence is the boundary marker.

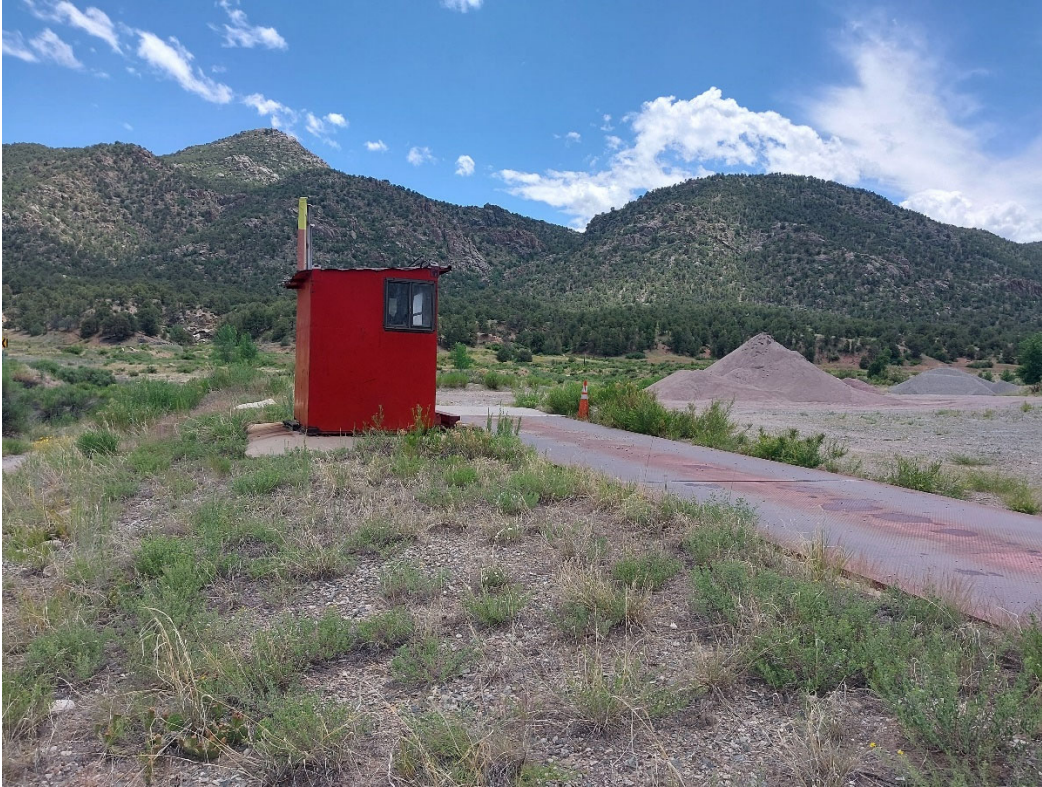
There is a scale with a concrete pad, a recessed concrete loading ramp, and two concrete pads, one with an elevator/hopper on it, located just south of CR 37. According to Mr. Tezak, the elevator/hopper setup is for loading concrete. The two concrete pads associated with the cement loading area appear to be in good condition, see Photos #3 and #4. There is no indication that the two cement pads were to be constructed and therefore no information regarding the reclamation requirements to fit the post-mining land use of rangeland. Details about the concrete pads will need to be provided in the Technical Revision. This issue is being cited as a **General Mining Plan Compliance, Problem #1.**

Photo #3: View of the scale house and scale, looking to the east.

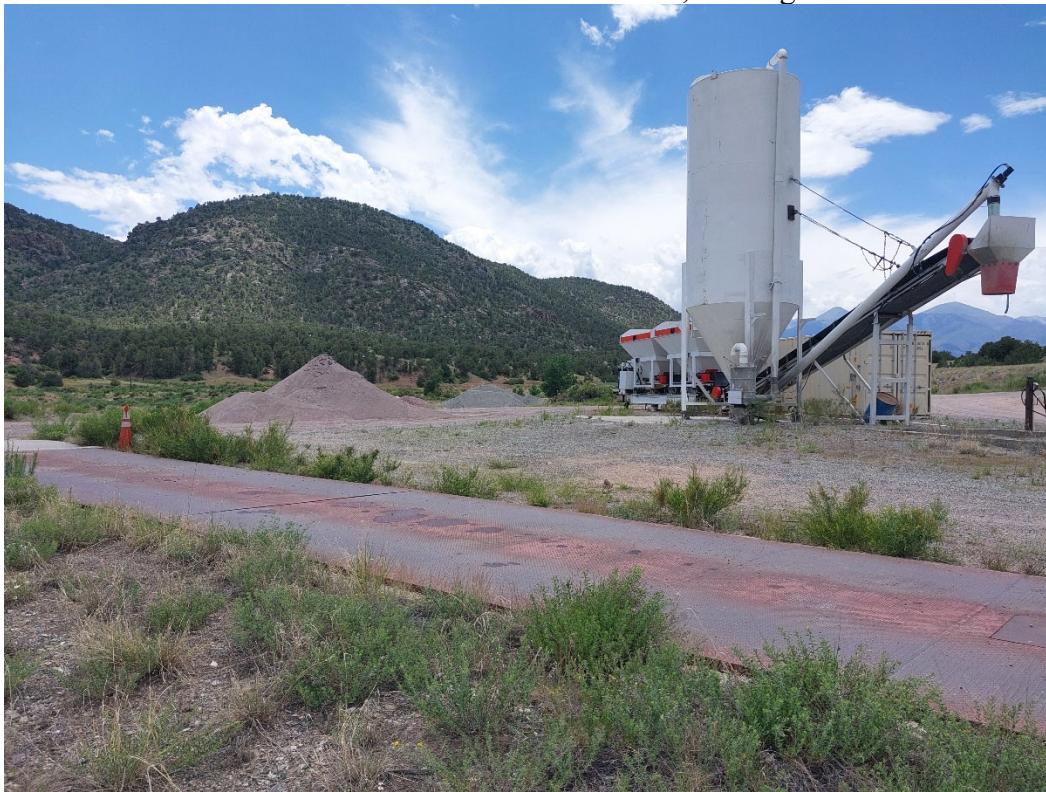
Photo #4: View of the elevator/hopper used for cement loading with a concrete pad, looking to the southeast.

CORRECTIVE ACTIONS: The operator shall submit a Technical Revision, with the required \$216 revision fee, to update and clarify the current approved mine plan, mining plan map, and reclamation plan map to reflect existing and proposed activities by the corrective action date, addressing the four issues outlined.

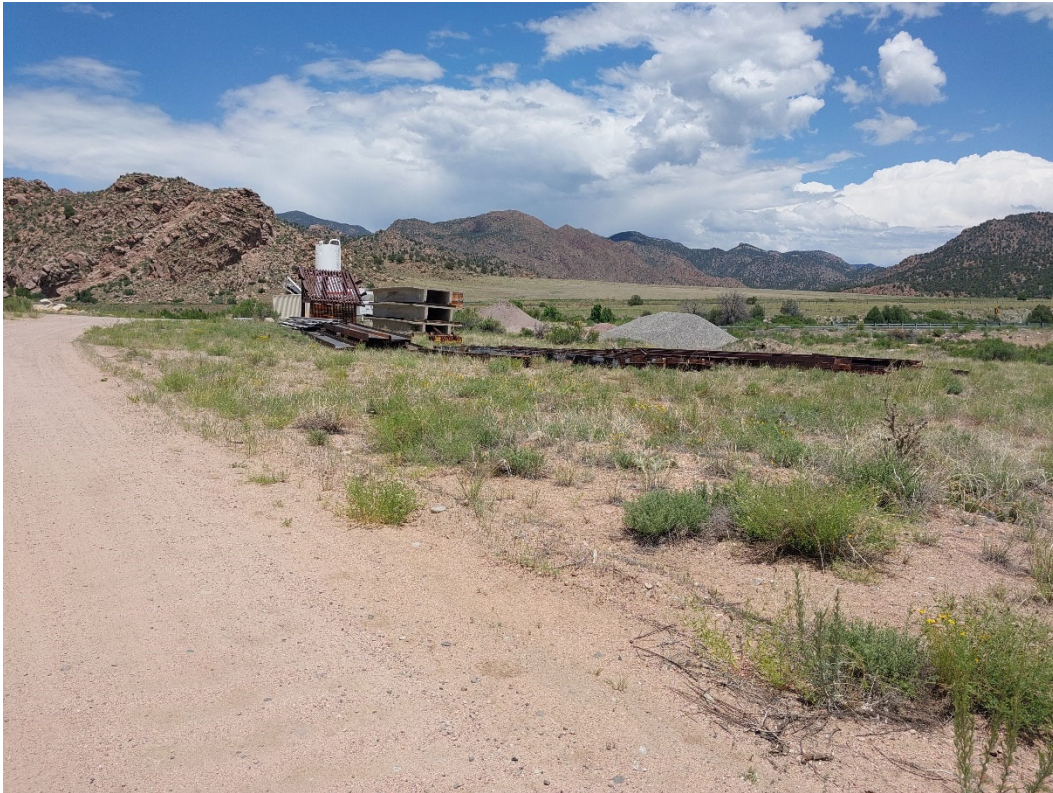
The operation is contained within its approved permit boundary. The operator does have a construction company as well and there are some construction materials, including I-beams, that are stored on the land, see Photo #5. This is non-mining related and not considered to be affected lands per Rule 1.13.

Photo #5: View of the construction materials, including I-beams, being stored on the southeastern portion of the permit boundary.

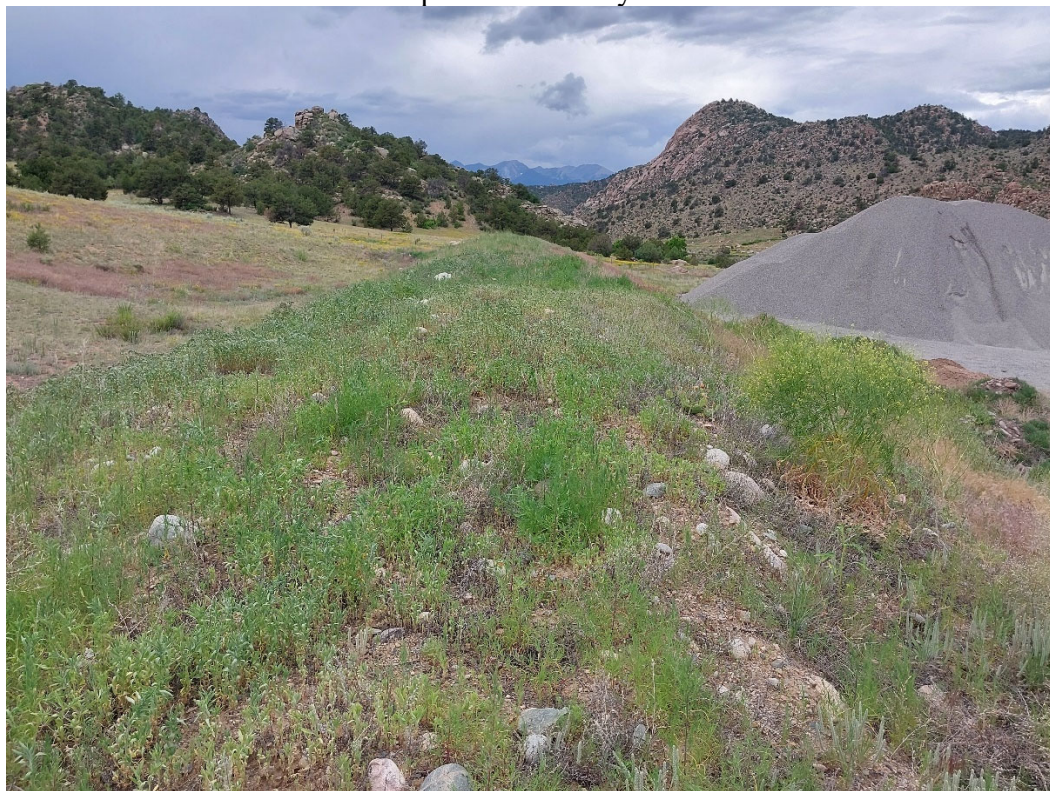
There were two observed topsoil stockpiles, both located along the southern permit boundary on the western half of the permit area, see Photos #6 and #7. The topsoil stockpiles appear to be adequate in size with well vegetated slopes. It does not appear that topsoil stockpiles have been disturbed or re-located. However, there is a discrepancy between where they are located on site versus where they are shown on the approved mining plan map. This issue is cited through the Mining Plan Compliance Problem #1.

Photo #6: View of the topsoil stockpile located at the far western side of the permit area, along the southern boundary, looking west.

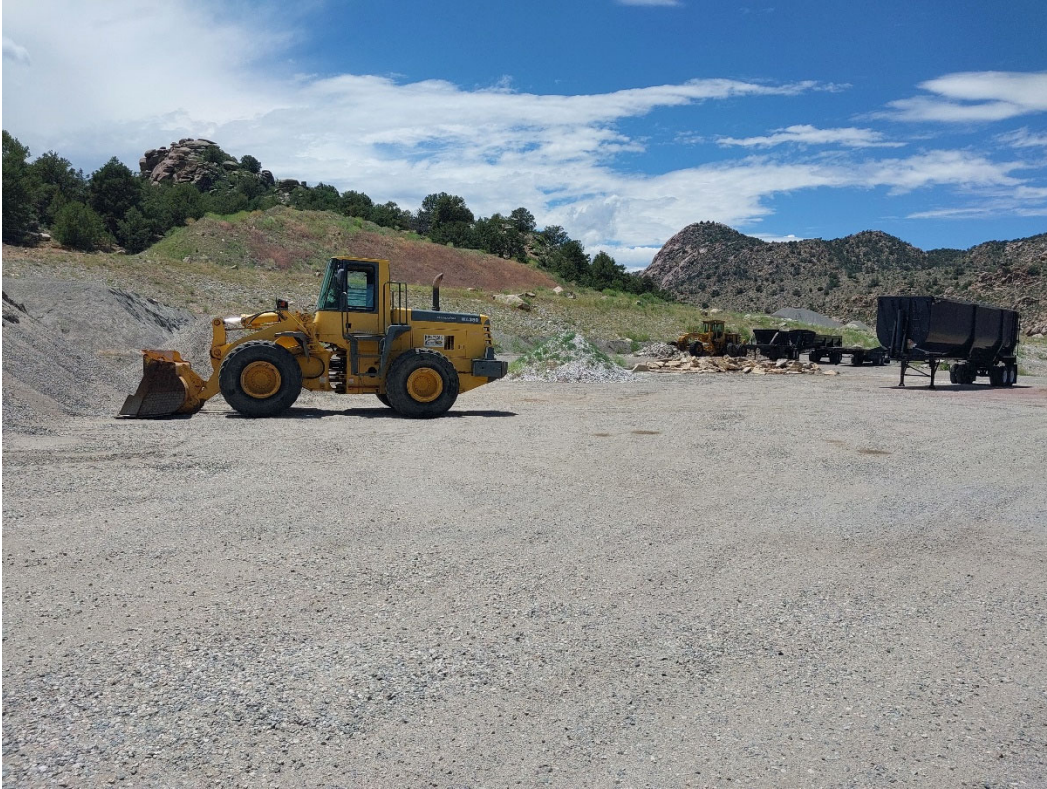
Photo #7: View of the pit floor and some of the equipment that was on site at the time of the inspection. The vegetated stockpile seen in the background on the left center of the picture is one of the topsoil stockpiles situated along the south permit boundary of the permitted area.

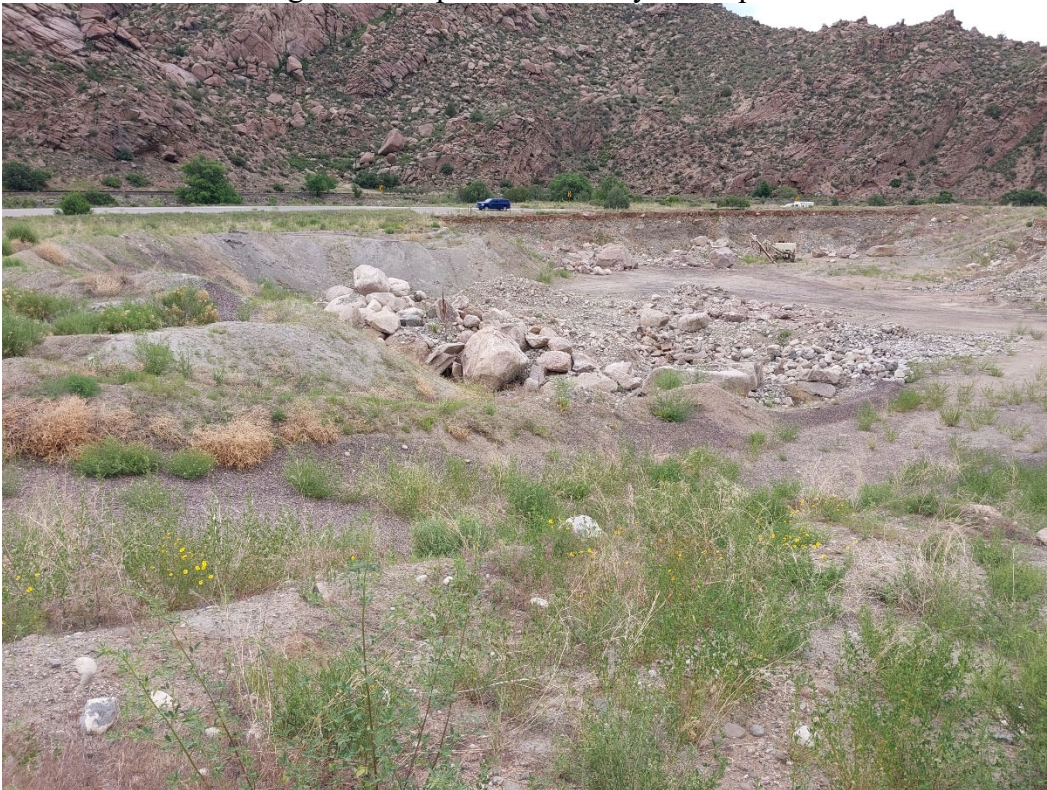
Photo #8: View of the most recent mined area on the northwestern portion of the permitted area. US 50 can be seen in the background.

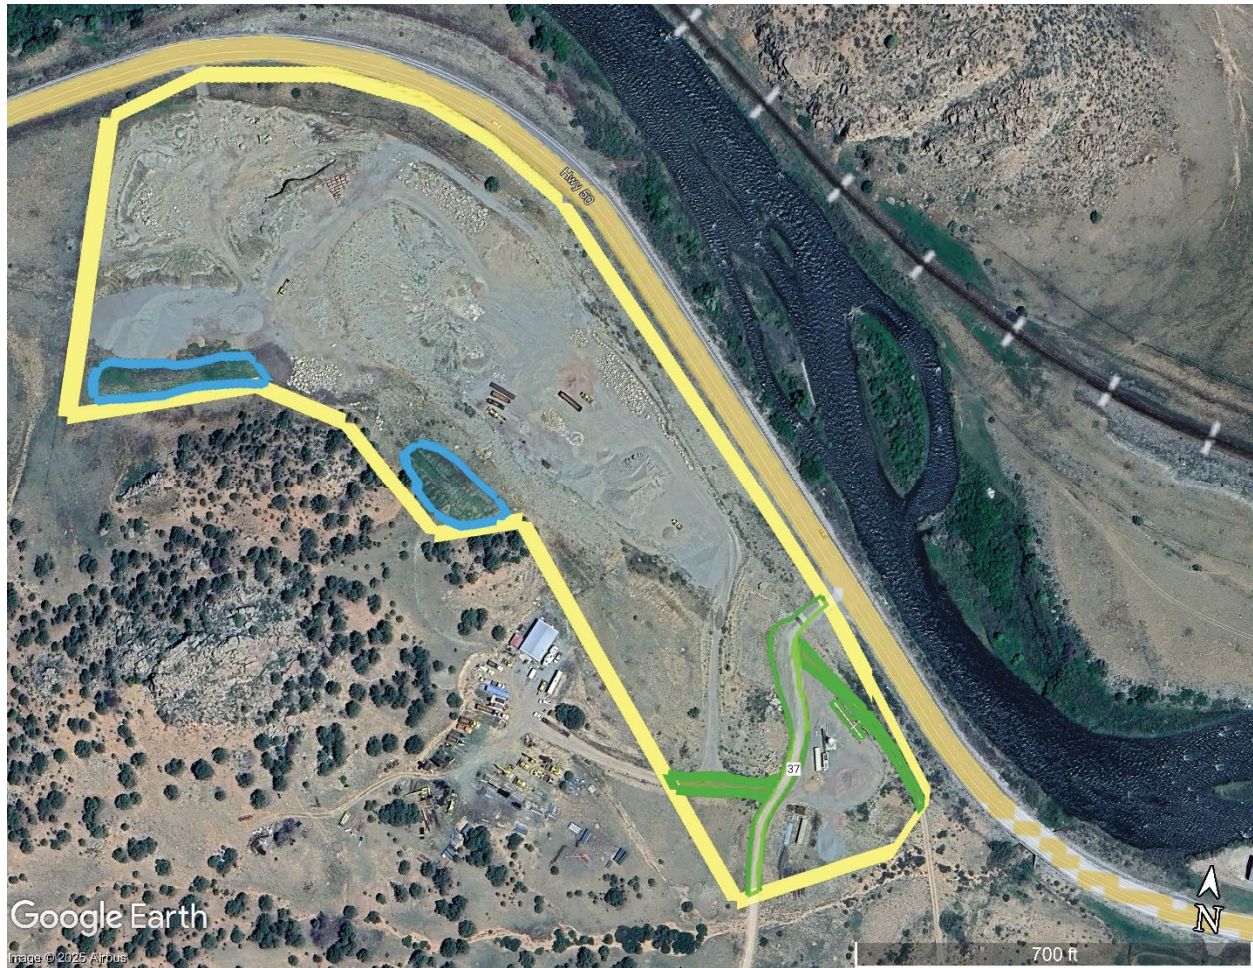
The haul road through the active mining area appears to be stable and in good condition with no erosional issues. There are several roads that are within the permitted area that do not appear to be associated with the mining operation. CR 37 is shown on the mining map and reclamation map to be in place and to remain in place after reclamation activities. Off of CR 37, there appears to be a two-wheel track that leads to a neighboring resident to the south and a more established road that leads to the operator's shop area to the northwest. According to Messrs. Nathan and Mike Tezak, these two road sections will remain in place after mining and reclamation activities and are not associated with the mining operation. This issue is being addressed through the Mining Plan Compliance **Problem #1.**

Figure 1: Satellite image of the permit area, the green areas show where the roads are in the southeastern portion of the permit area. The blue polygons show where the topsoil stockpiles were observed to be located during the site visit.
