Re: Geotechnical Addendum  
Deer Creek Quarry Bi-Annual Report  
Morrison, CO  
KUE Project No. P-24079

Appendix A – Quarry Change Detection Inspection Report

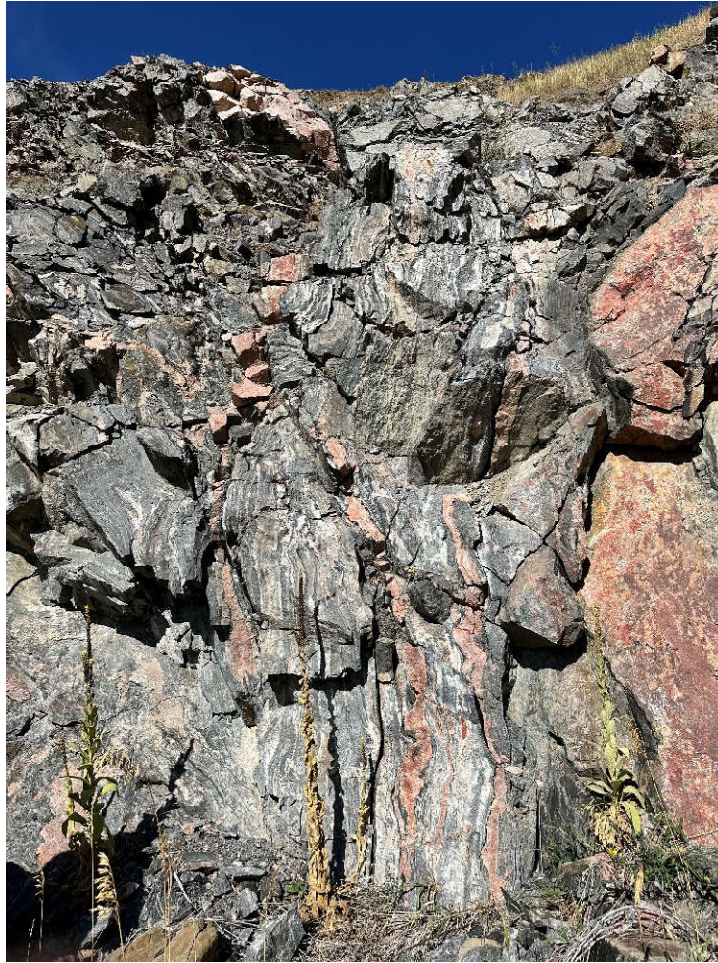
Most of these benches exhibit confined rockfalls from raveling failure. Although sporadic across most of the eastern facing slope, there are a few higher areas with a greater density. Benches 6540, 6640, 6800 display regions of direct toppling failure along where a joint set is dipping into the face near the center of the bench. The crest of the slope has weathered to such an extent that it resembles a residuum soil reducing the width of the catch-bench 6840 to approximately ten feet. Small-scale sloughing and raveling is prevalent. Due to the quarry's inactive status, gauging the frequency of rockfall was not feasible at this time.

**Figure 2: Central East-Facing Bench 6540 Showing Recent Raveling**

The previously identified center benches 6540, 6640, 6800 have been observed and measured to exhibit more extensive raveling than other regions of the eastern facing slopes. Personnel and equipment should stay clear of these areas to mitigate harm and damage, respectively. The dyke on the northern side appears to be a relatively weaker zone of rock mass due to its more extensive weathering of the slope to match that of the overall pit slope. This area should be avoided due to rockfall being able to gain energy by bypassing several catch benches.

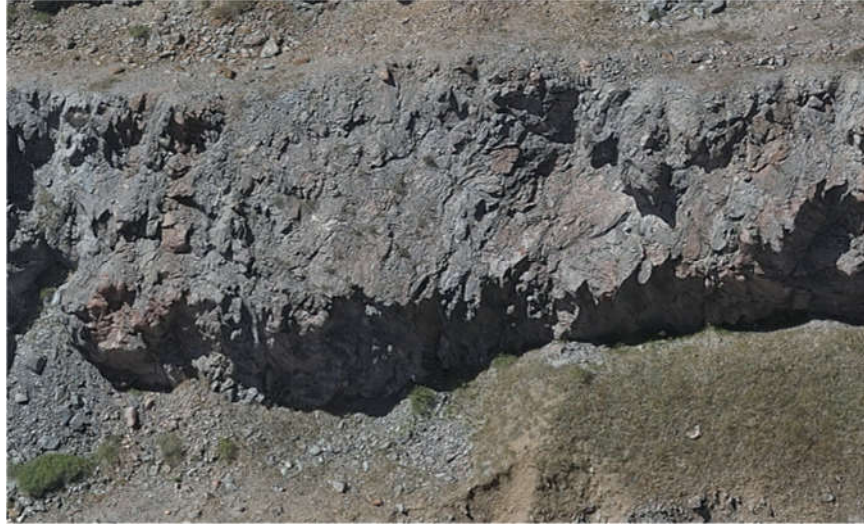
Most of these slopes had been reclaimed, leaving only a few exposed benches which intersect at right angles with previously introduced eastern facing slope. Both of these regions have large overhangs due to its geometry intersecting with a joint set and foliation of the rockmass as shown in Figure 3. This intersection has created large blocks that have fallen off as observed in the catch-rock.

**Figure 3: Eastern Facing Bench 6500 Showing Overhang**

Large overhangs in this area are the largest risk in the area, correlating to the largest risk of direct toppling failure in the quarry, and of the failure modes in general. If reclaimed slopes are removed and mined, care should be taken to prevent disturbance of the buried highwalls to prevent future large direct toppling failure as mining operations are started.

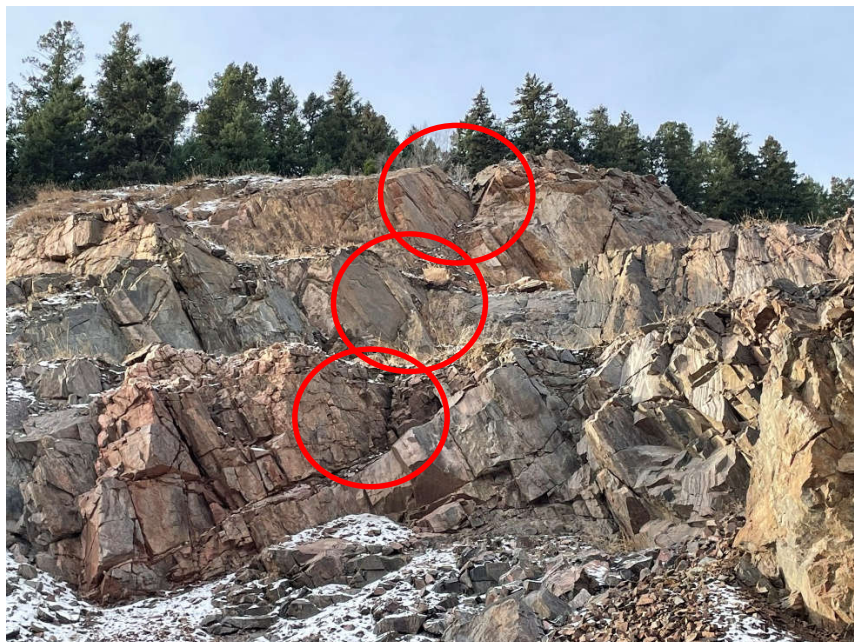
The intersection of the East and North Facing slopes creates the South West Corner. These corner is even more prominent with local wedge failure of two joint sets that run approximately parallel to the perpendicular slopes. Figure 4 shows an example of the wedge failure seen in the southwest corner of bench 6760, 6720, & 6680. The southwest corner has the greatest density of material caught on each bench from localized failures.

**Figure 4: Southwest Corner, Photo taken from Bench 6460, Local Wedge Failure in Red.**

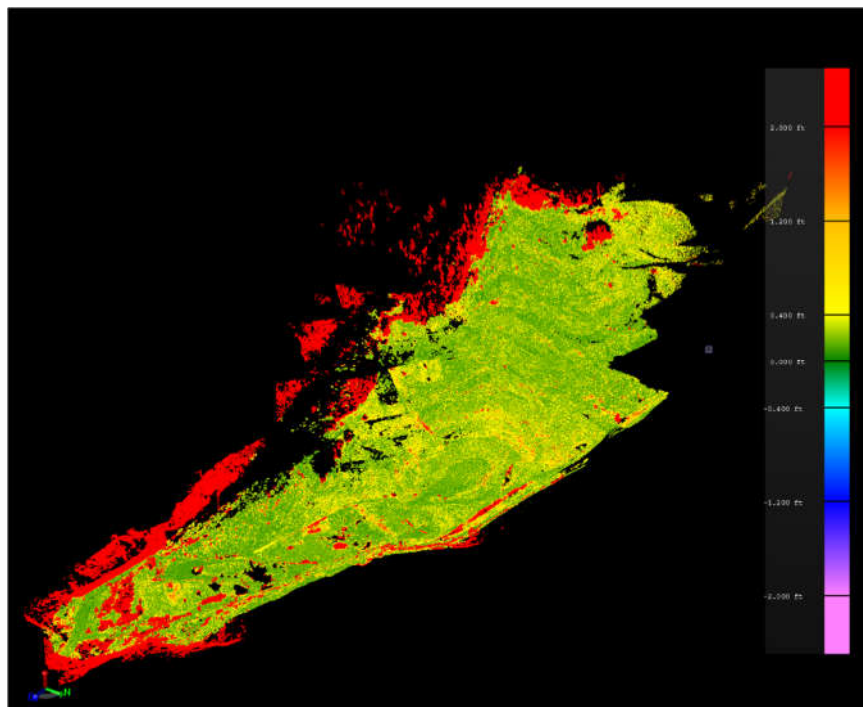
Figure 4: Change Detection Map, Oblique View Looking Southwest-South

Most of the changes measured were less than 0.6 ft and can be attributed to noise generated from the limited points recorded in the 2023 UAV survey. Some notable areas of movement were noted, such as those noted in the previous Observations section. Both the southwest corner and middle of the eastern facing slope show small regions with changes between 1.2 and 2.0 ft and correlate with areas of relatively recent rockfall. No large changes were observed in the model. Changes greater than 2.0 ft are mostly attributed to foliage and vegetation.

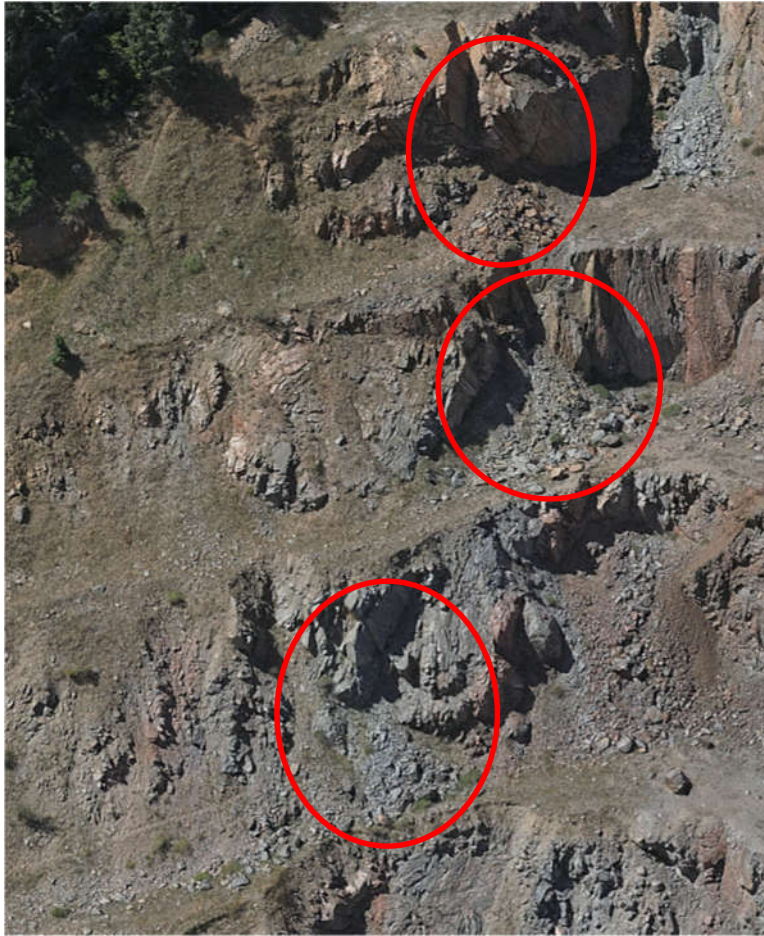
KUE has also identified the previously identified area of movement in the 2023 report to continue progressing. However, with change detection mapping showing changes between 0.6 and 1.2 ft for most of these raveling areas. The corner slope is considered to be relatively unchanged and movements negligible. KUE will further monitor this location for movement during future site visits.

**Figure 9: Southwestern Corner, Catch-Rock Areas of Concern Circled**
