**MINERALS PROGRAM INSPECTION REPORT**  
**PHONE: (303) 866-3567**

| <b>MINE NAME:</b><br>Henderson Mine | <b>MINE/PROSPECTING ID#:</b><br>M-1977-342 | <b>MINERAL:</b><br>Molybdenum | <b>COUNTY:</b><br>Clear Creek |
| <b>INSPECTION TYPE:</b><br>Monitoring | <b>WEATHER:</b> Clear | <b>INSP. DATE:</b><br>June 24, 2025 | <b>INSP. TIME:</b><br>09:00 |

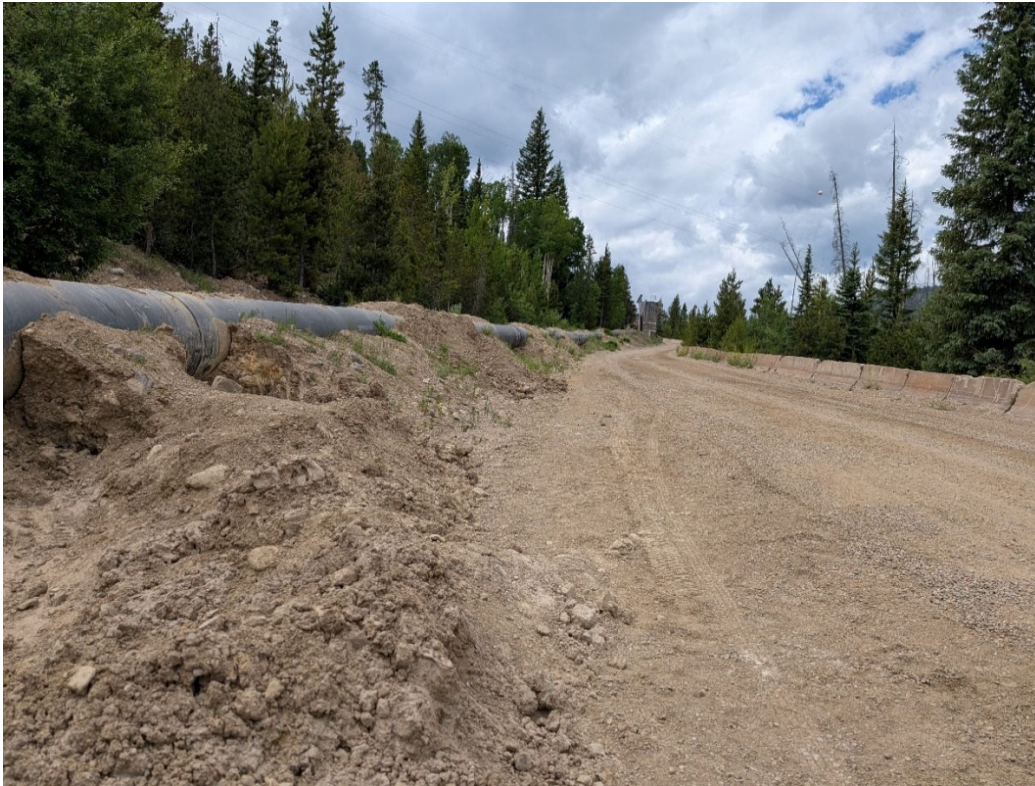
Before the inspection, the Division met with Henderson representatives to discuss the investigation into recent tailings delivery line (TDL) leaks. On June 11-12, 2025, Henderson removed overburden and inspected the pipeline, followed by additional Non-Destructive Testing. The operator surveyed every fuse and found a couple of spots that required new bands. According to Mr. Hickman, the section showing the most accelerated wear was in a steep section above 3-Dam where the turbulence is the highest.

During this inspection, the Division observed the TDL above 3-Dam (Photos 1-3), noting a metal band installed where a hole was discovered during the June investigation (Photo 3).

Photo 1: Looking at the TDL in a steep section above the No. 1 Cutout, just downstream of Drop Tower No. 12.

On July 7, 2025, Mr. Hickman submitted a letter to the Division summarizing the investigations and temporary repair work. The letter also provided a schedule for replacements planned for summer 2025. Henderson intends to replace 500 feet of HDPE pipeline and rotate several sections based on wear rates. The operator reported ordering 1500 feet of pipeline for immediate and future repairs.

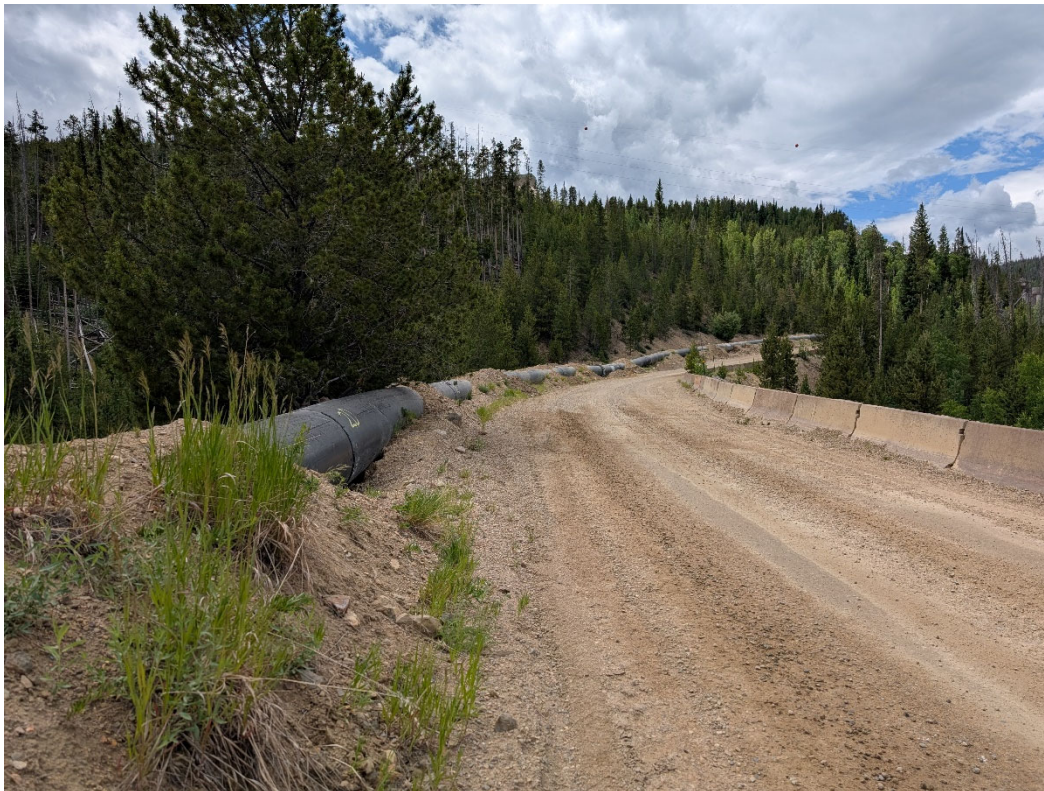
Photo 2: Looking at the TDL along the road, adjacent to the Bear Paw Pipeline.

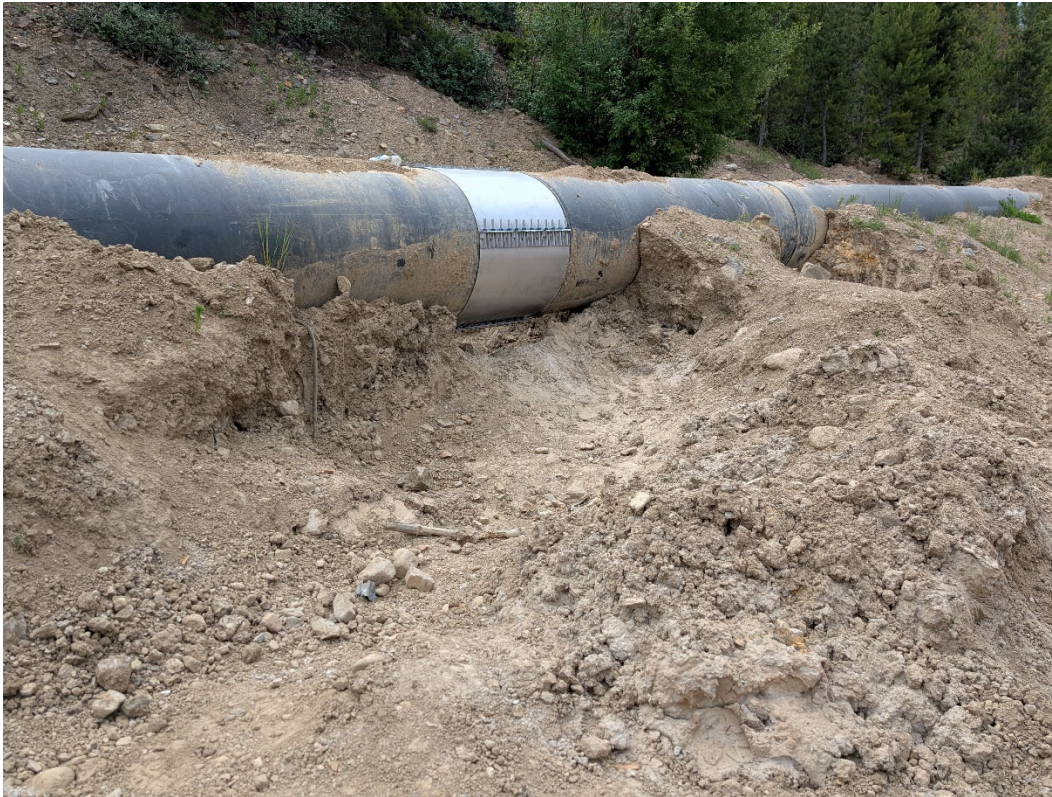
Photo 3: Looking at a temporary metal band installed on the TDL where a leak was observed.

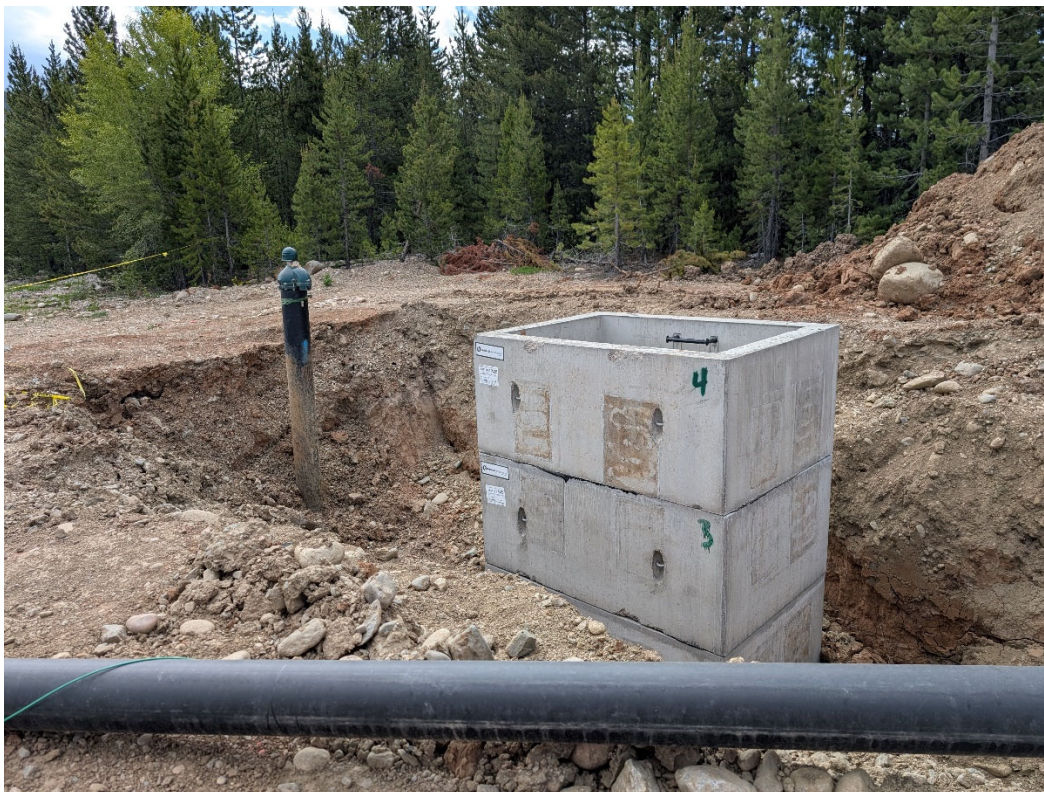
The Division observed a contractor installing the infrastructure for extraction well MLEX-7 within the gravel pit, east of Ute Park (Photos 4-7). Water will be conveyed from the vault via a 6-inch HDPE line and discharged into the seep collection channel adjacent to the Ute Park Pump Station. The contractor was working to install the pipeline beneath County Road 3 (Photo 6). Following pipeline installation, instrumentation will be added to the wellhead, including a down-well transducer and float switches to monitor and maintain water level setpoints, a flow meter located in the vault, a data logger, and a radio transmitter. Photos 8-9 illustrate an example of the instrumentation and vault currently installed at MLEX 1. MLEX 1 is shut down for the installation of a new well (Photo 10). According to Mr. Hickman, within Ute Park, MLEX 4 has the highest average flow, approximately 76 gallons/minute. Flow rates and volumes are continuously measured and recorded electronically. The system is visually checked daily by the pond operator on site. The infrastructure for MLEX-6 on the east side of Ute Park will be installed in July 2025 and the operator will submit the As-Built drawings to the Division once the Phase IV extraction wells are completed.

Photo 4: Looking at extraction well MLEX 7 and vault installed on the south end of the gravel pit.

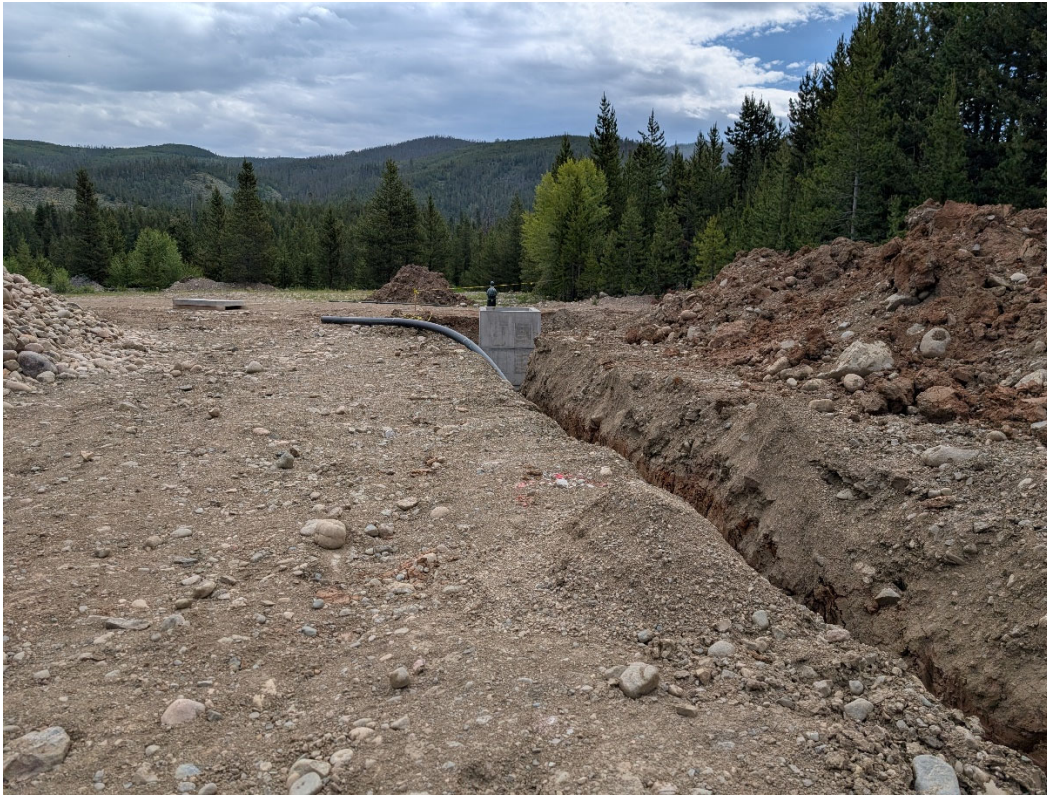
Photo 5: Looking at the excavated trench for the 6-inch pipeline for MLEX-7.

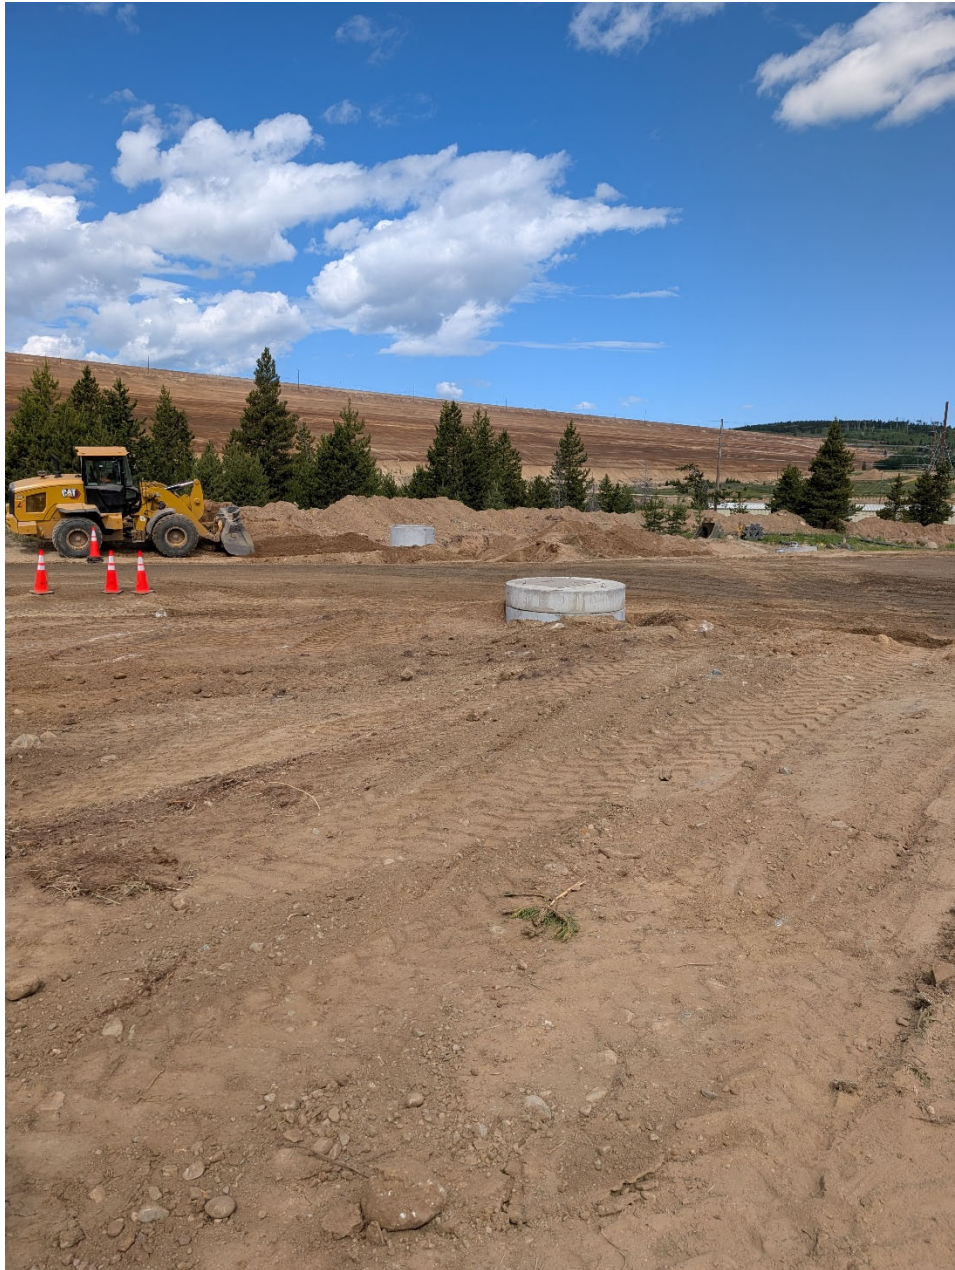
Photo 6: Contractor installing the 6-inch pipeline from MLEX-7 beneath County Road 3 near the Ute Park Pump Station.

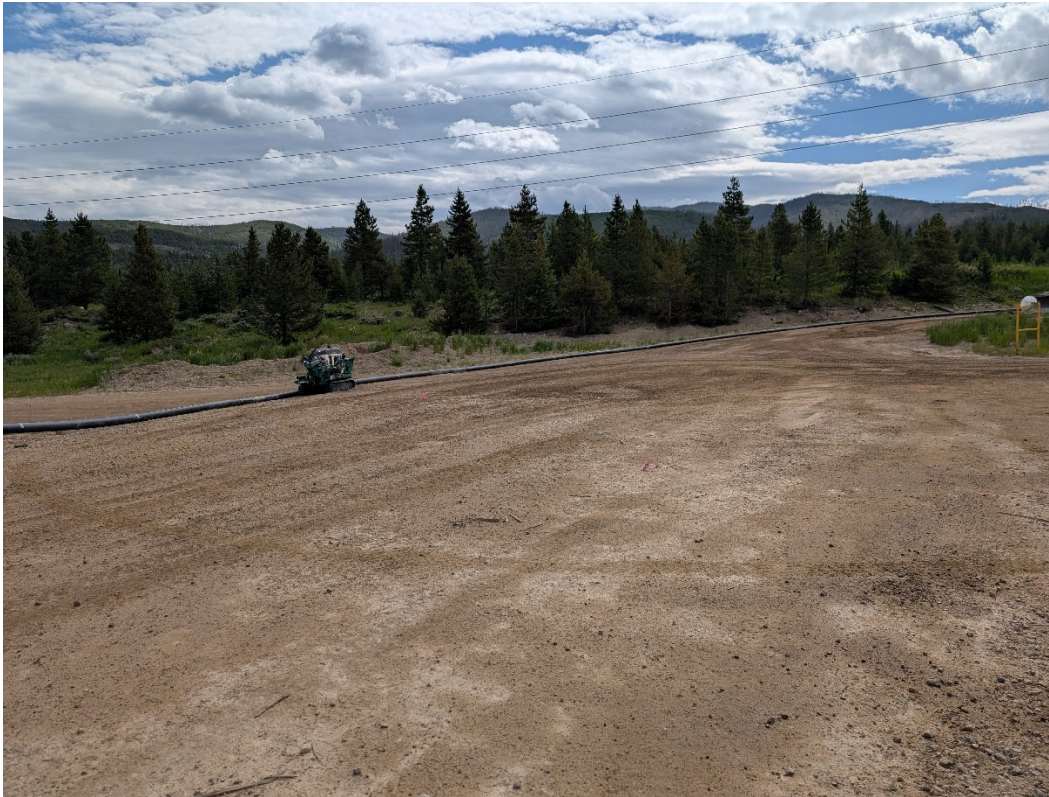
Photo 7: Pipeline laying on the ground that will be installed to discharge water from MLEX-7 into seep collection channel adjacent to the Ute Park Pump Station.

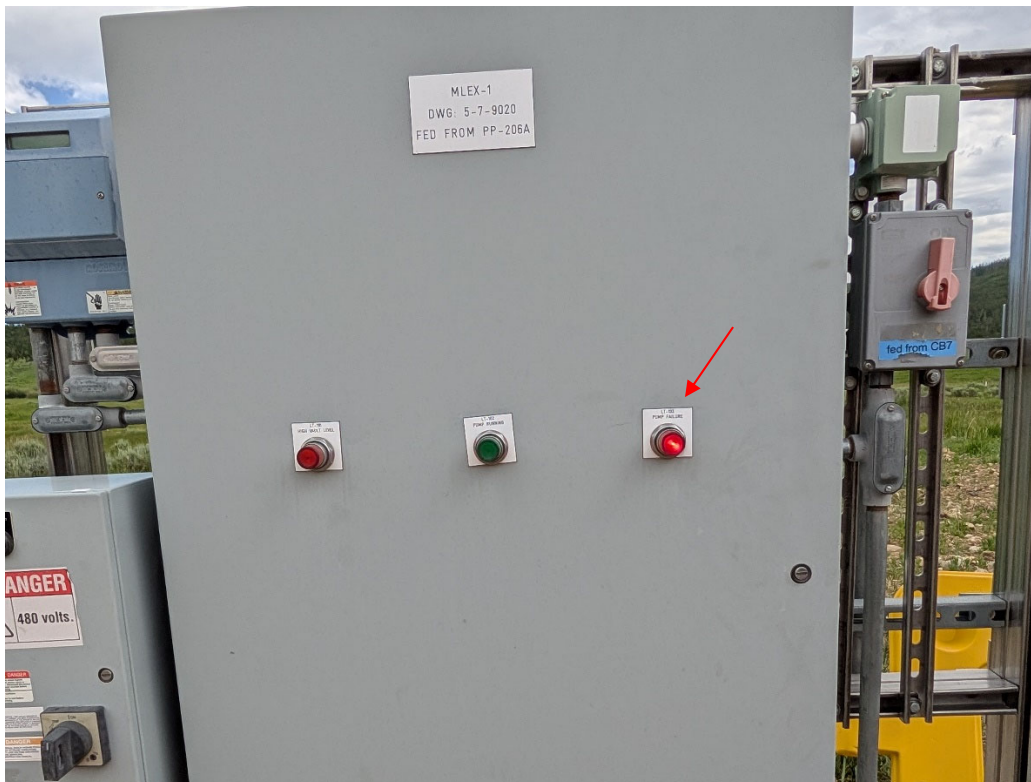
Photo 8: Inspection of extraction well MLEX-01. The well was not operating during the inspection. Red light indicates well is off.

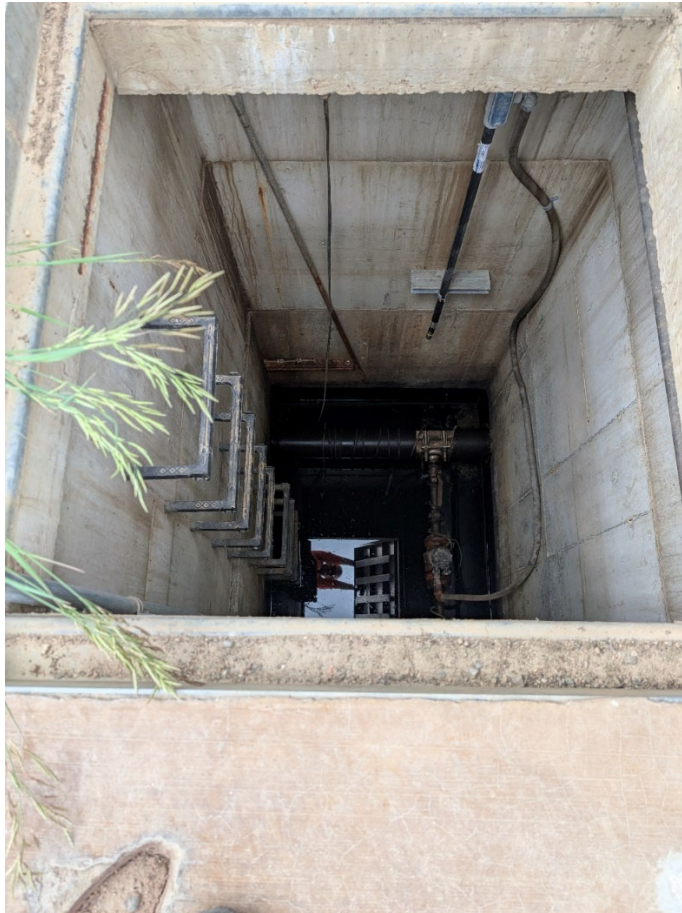
Photo 9: Looking down into the vault at MLEX-1.

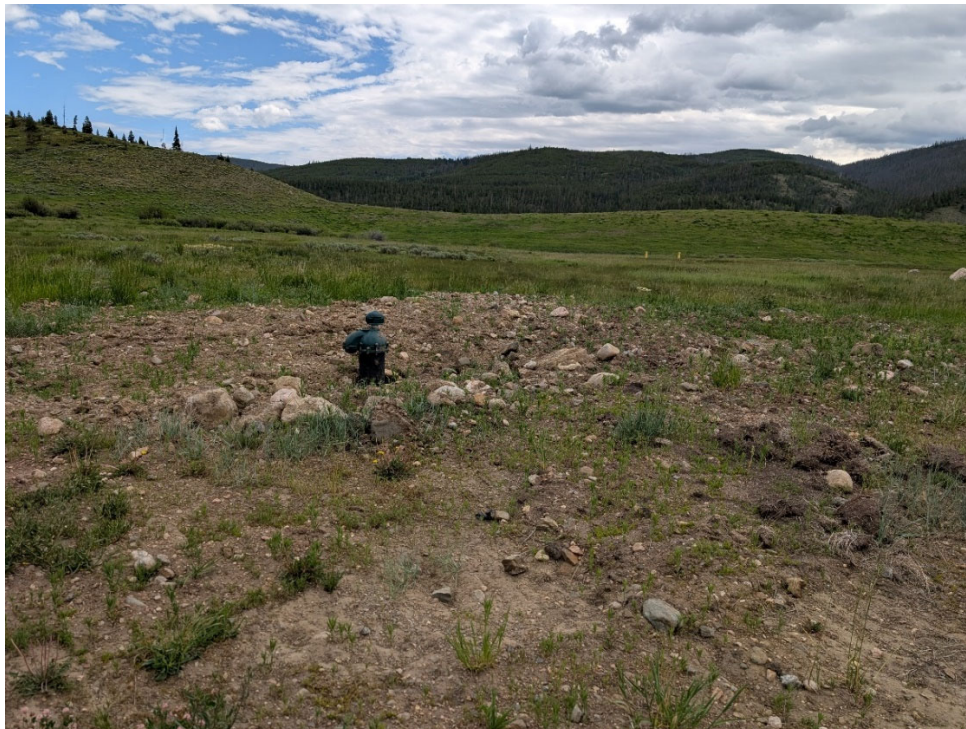
Photo 10: Replacement well drilled at MLEX-1 in Ute Park.

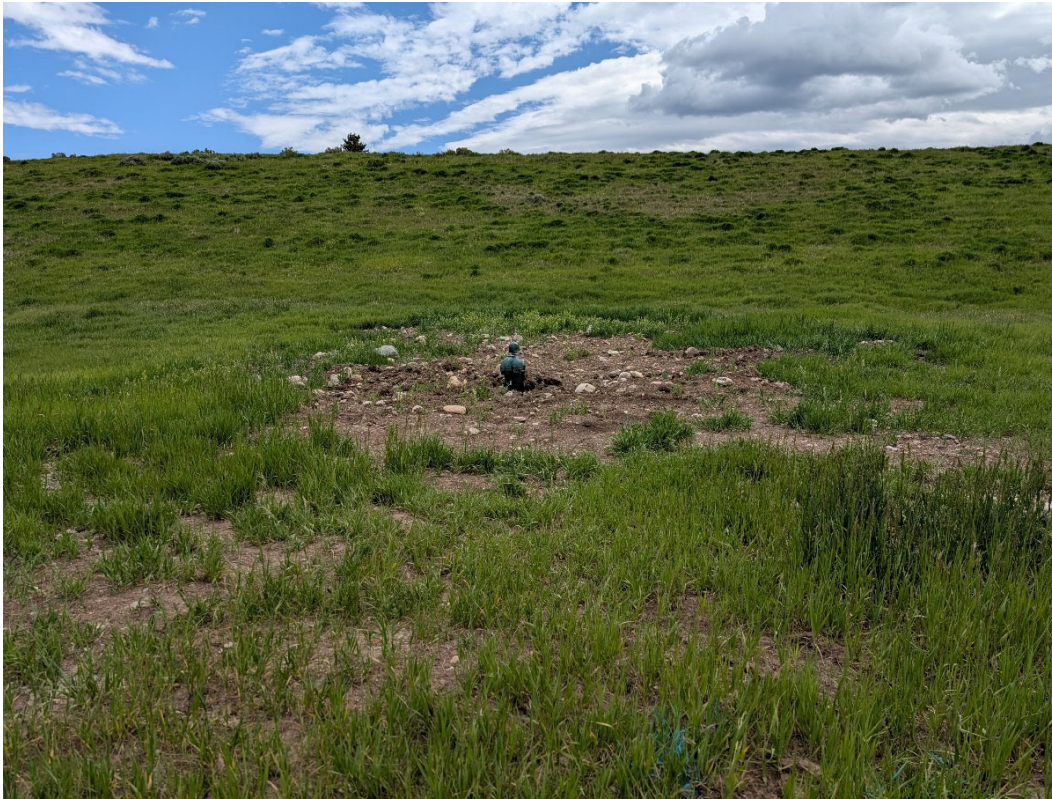
Photo 11: Looking at MLEX-6 on the eastern edge of Ute Park. The infrastructure for this well will be installed in July 2025.

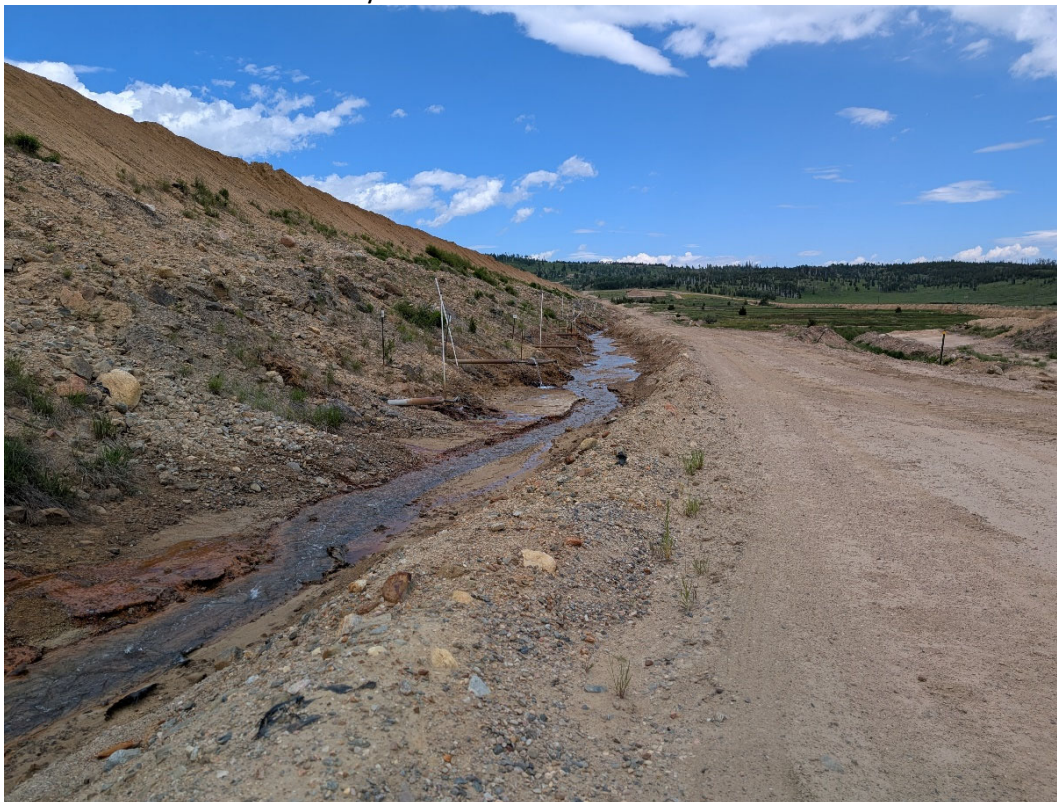
During this inspection, the Division observed the horizontal drains at the base of 1-Dam. Water was observed flowing from multiple drains into the seepage collection channel at the base of the dam into the Ute Park canals. The operator and Division discussed the buried 1-Dam seepwater line and

Photo 12: Observing the groundwater drains along the base of 1-Dam.

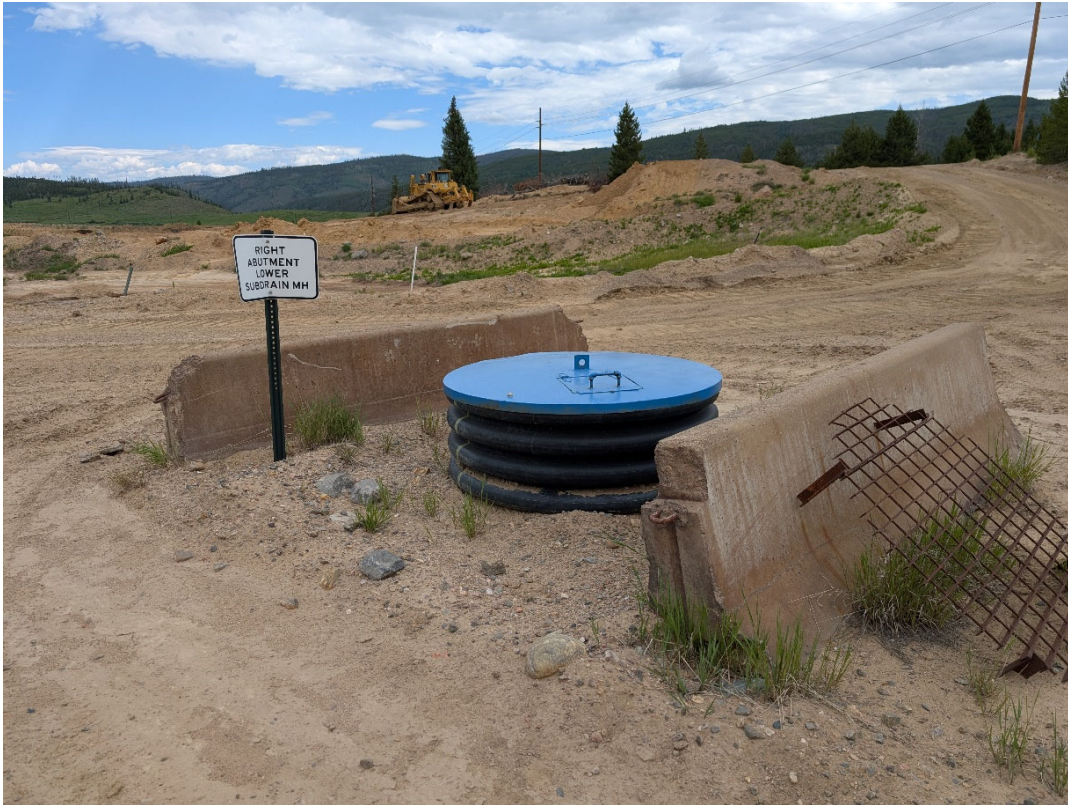
observed the Lower Subdrain manhole in the southwest corner of Ute Park (Photo 13-14). The lower subdrain is tied to the original foundation/abutment drains on 1-Dam. The line never needed replacement; however, plugging is the main concern that requires maintenance. The operator pressure tests the line every year and uses water jets to clean out the iron precipitate that accumulates in the line.

Photo 13: Looking at the Lower Subdrain manhole on the south end of Ute Park below 1-Dam.

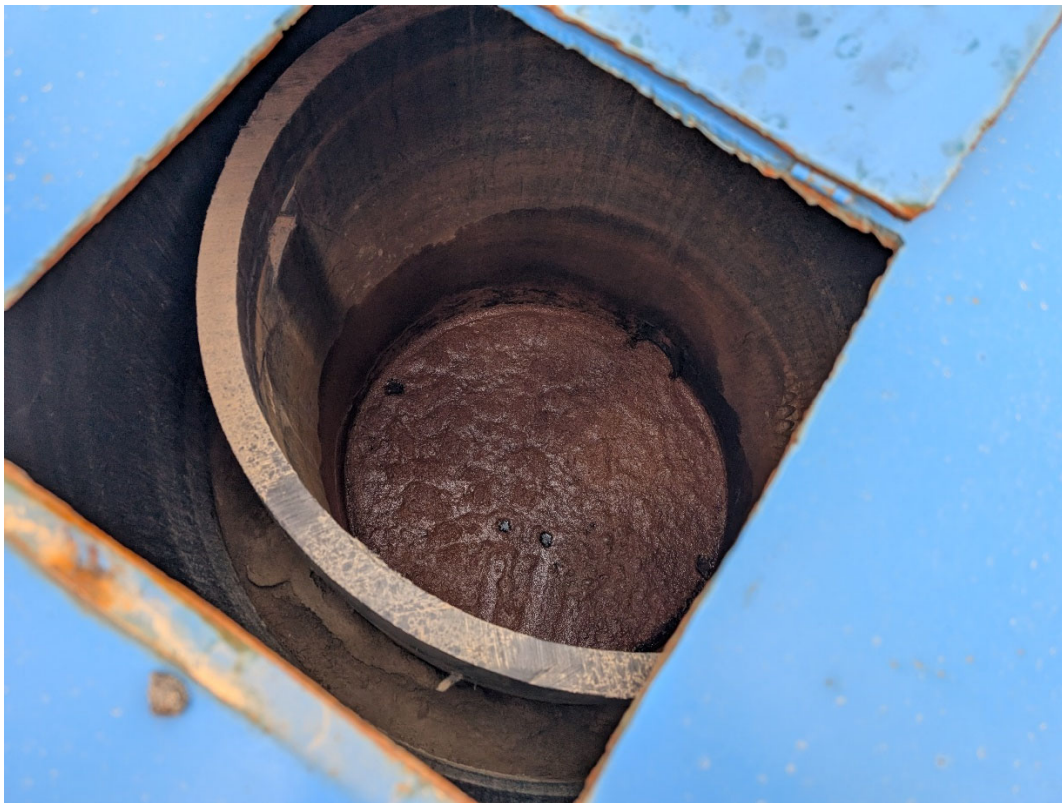
Photo 14: Looking inside the manhole on the Lower Subdrain below 1-Dam.

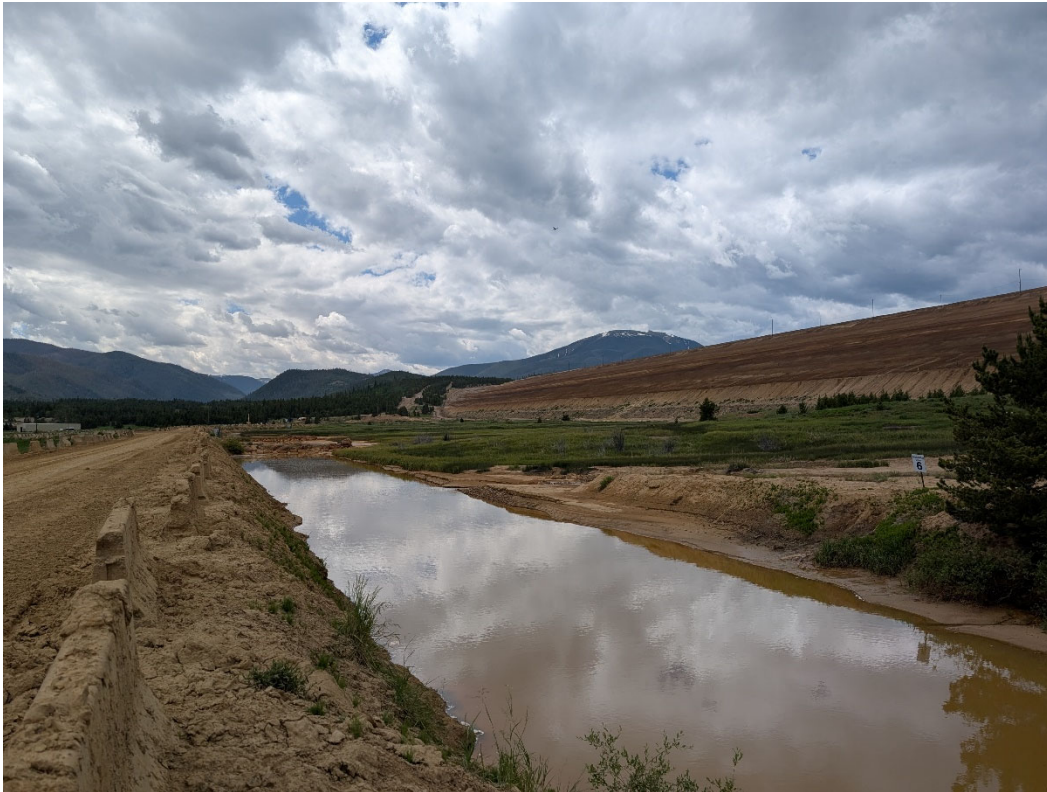
Photo 15: Looking at the north end of the seep water canal below 1-Dam.

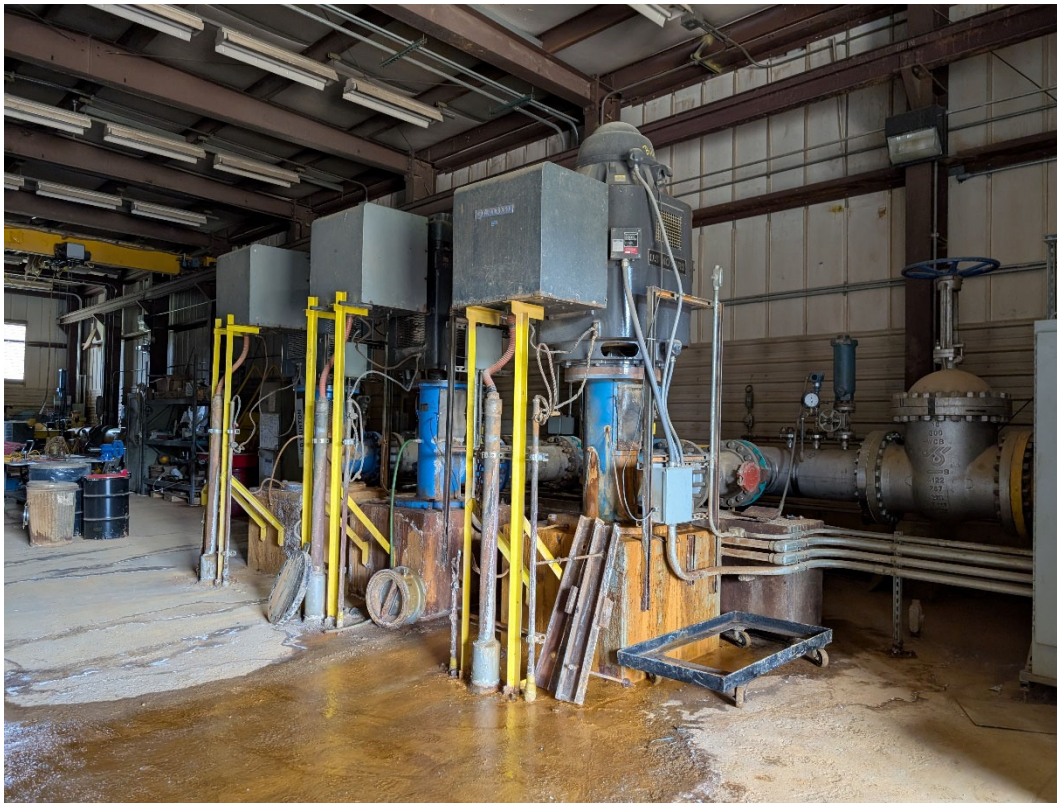
The Division inspected the Ute Park Pump Station (Photo 16). The pumps were not operating during the inspection. Mr. Hickman reported that these pumps, which typically cycle on and off throughout the year based on flow rates, push an average of 1100 gal/min back to the TSF daily. Maintenance on the pumps is performed frequently, as needed.

Photo 16: Looking at the pumps inside the Ute Park Pump Station.

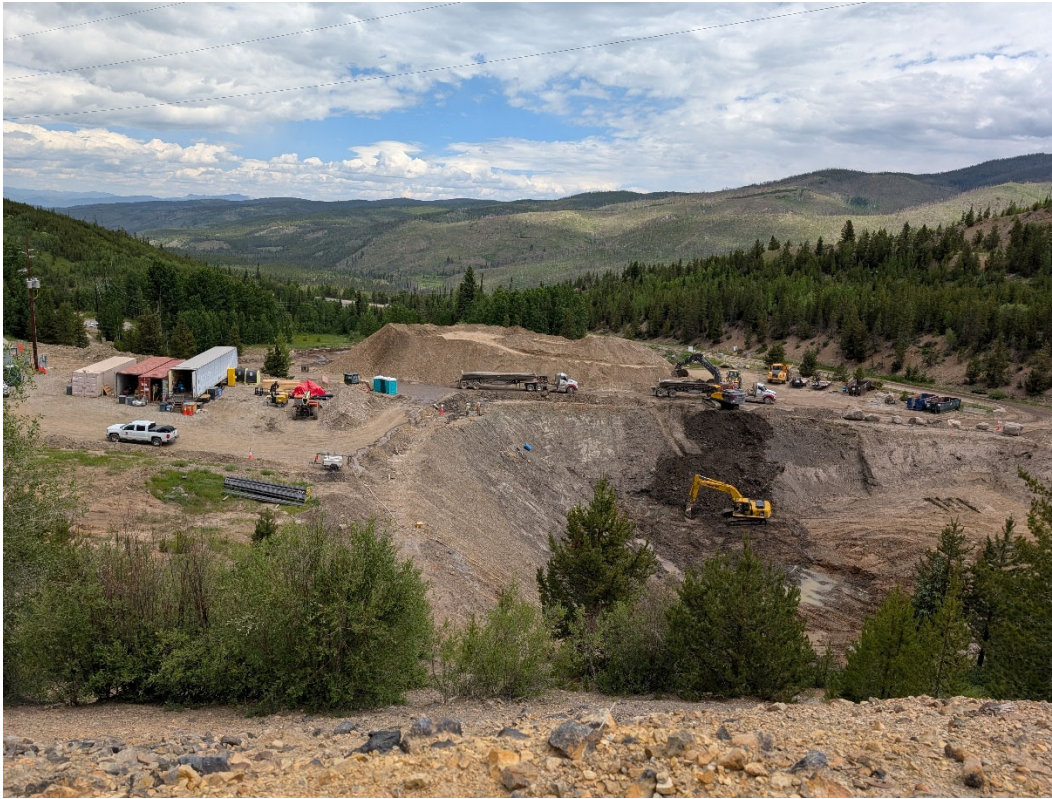
The Division observed the excavation progress for the foundation of the Water Treatment Facility (Photo 17). Material is trucked to the gravel pit for storage. Excavation work is almost complete.

Photo 17: Looking at the progress of the excavation work for the foundation of the future Water Treatment Plant.
