## Inspection Reports 2025 July

**COLORADO**  
 Division of Reclamation,  
 Mining and Safety  
 Department of Natural Resources

**30 July 2025**

| <b>Permit Number:</b> C-1981-044<br><b>Mine Name:</b> Williams Fork Mines<br><b>Operator:</b> Moffat County Mining, LLC<br><br><b>Operator Address:</b><br>Ms. Miranda Kawcak<br>29515 Routt County Road #27<br>Oak Creek, CO 80467 | <b>County:</b> Moffat<br><b>Operation Type:</b> Underground<br><b>Permit Status:</b> Active<br><b>Ownership:</b> Private<br><br><b>Operator Representative Present:</b><br><br>Miranda Kawcak |

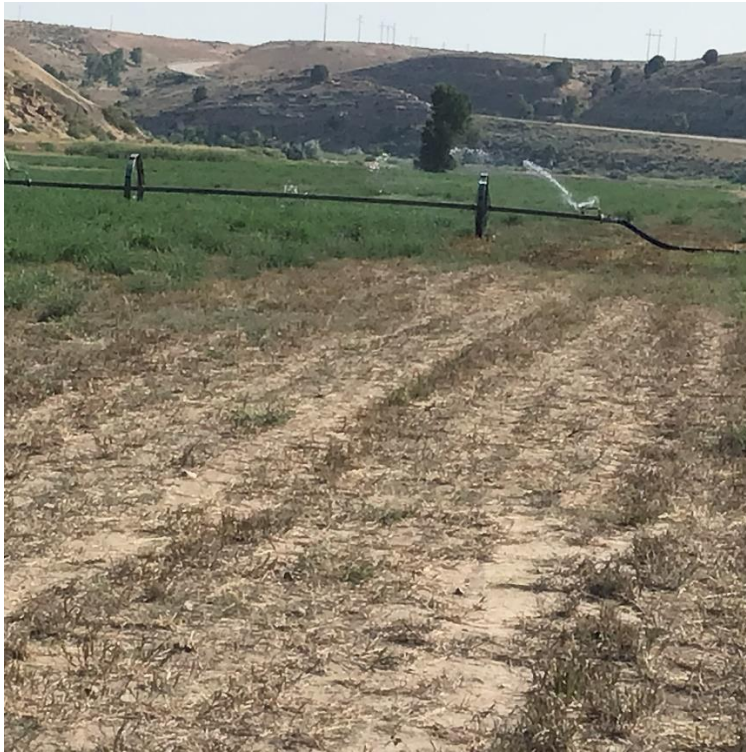
**Photo 1:** *Irrigation system operating in the south cropland area.*

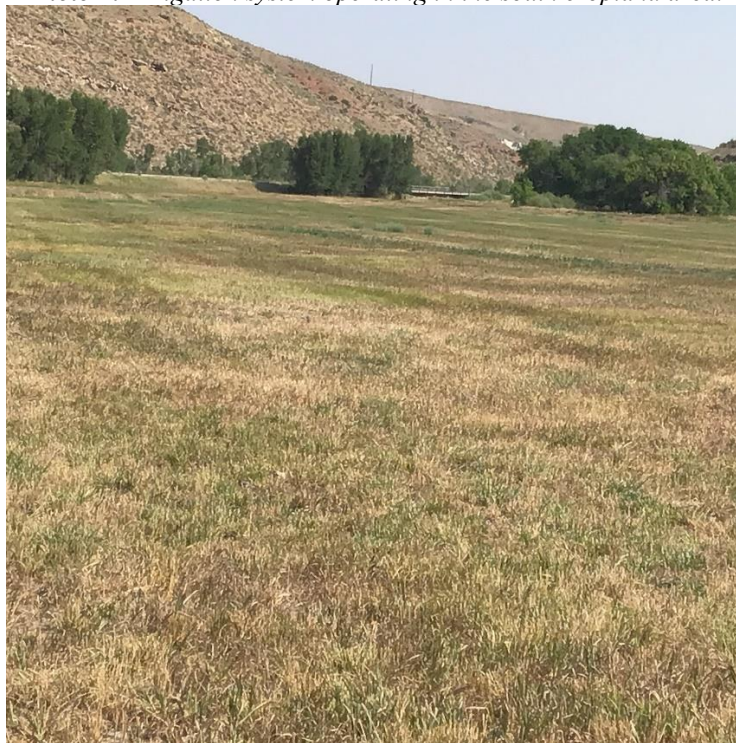
**Photo 2:** *Overview of south portion of the Williams Fork bottom lands, looking southeast. Hay has been cut and brown stubble is apparent.*

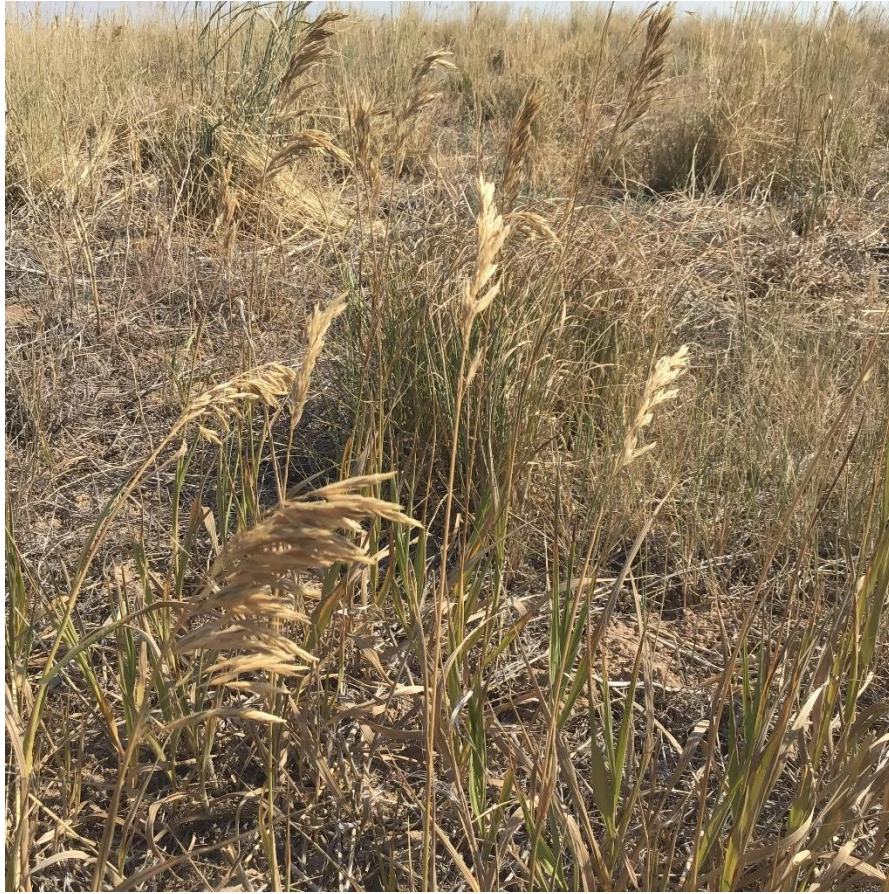
**Photo 3:** *Grass species diversity in the reclamation sloping down to portal Pond 9A.*

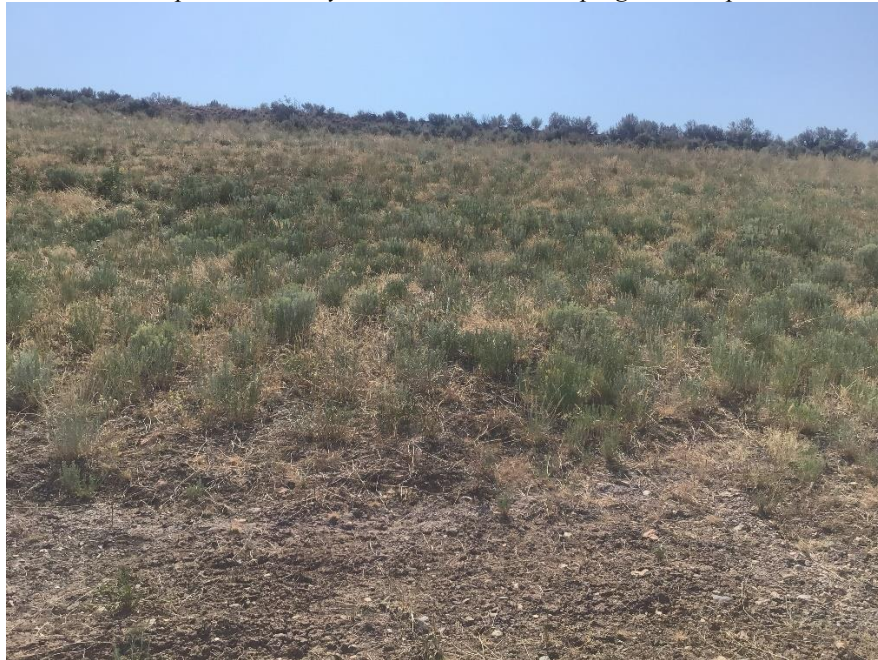
**Photo 4:** *Portal slopes exhibiting healthy shrub establishment amongst the grasses, looking northeast.*
