MINERALS PROGRAM INSPECTION REPORT
PHONE: (303) 866-3567

MINE NAME: C Road Pit	MINE/PROSPECTING ID#: M-2016-050	MINERAL: Sand and gravel	COUNTY: Mesa
INSPECTION TYPE: Monitoring	WEATHER: Clear	INSP. DATE: July 16, 2025	INSP. TIME: 12:00
OPERATOR: Kilgore Companies LLC dba Elam Construction	OPERATOR REPRESENTATIVE: Jon Muller	TYPE OF OPERATION: 112c - Construction Regular Operation	
REASON FOR INSPECTION: Normal I&E Program	BOND CALCULATION TYPE: Complete Bond	BOND AMOUNT: \$351,000.00	
DATE OF COMPLAINT: NA	POST INSP. CONTACTS: DRMS	JOINT INSP. AGENCY: None	
INSPECTOR(S): Amy Yeldell	INSPECTOR'S SIGNATURE:

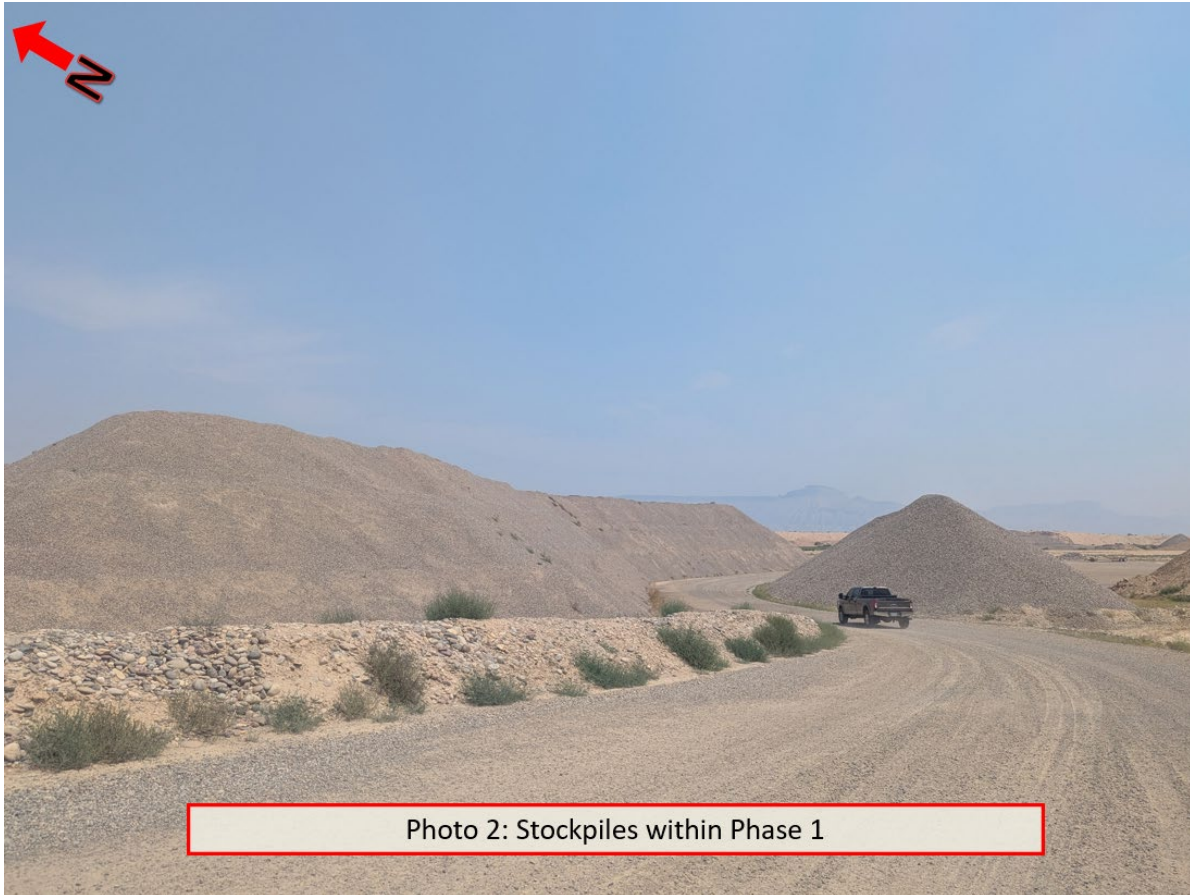
There are several extremely large stockpiles of processed material which are neatly stored throughout the pit floor in Phase 1. Overall the site is clean and free of trash and other miscellaneous debris

Photo 2: Stockpiles within Phase 1

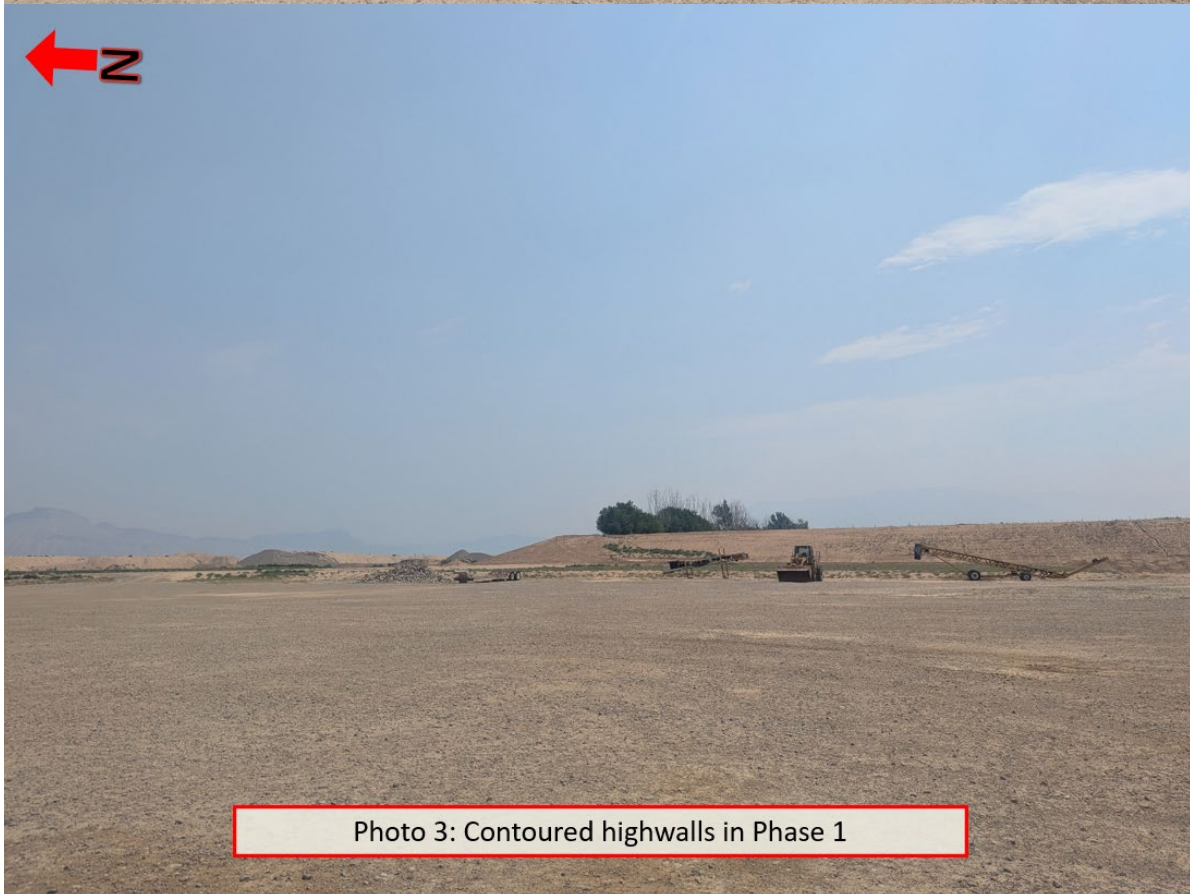
Phase 1 is completely mined out. Approximately 800 LF of highwall along the south requires grading prior to topsoiling. All other slopes within Phase 1 have been contoured to a 3H: 1V or less. Placement of backfill and topsoil material is also still required within Phase 1.

Photo 3: Contoured highwalls in Phase 1

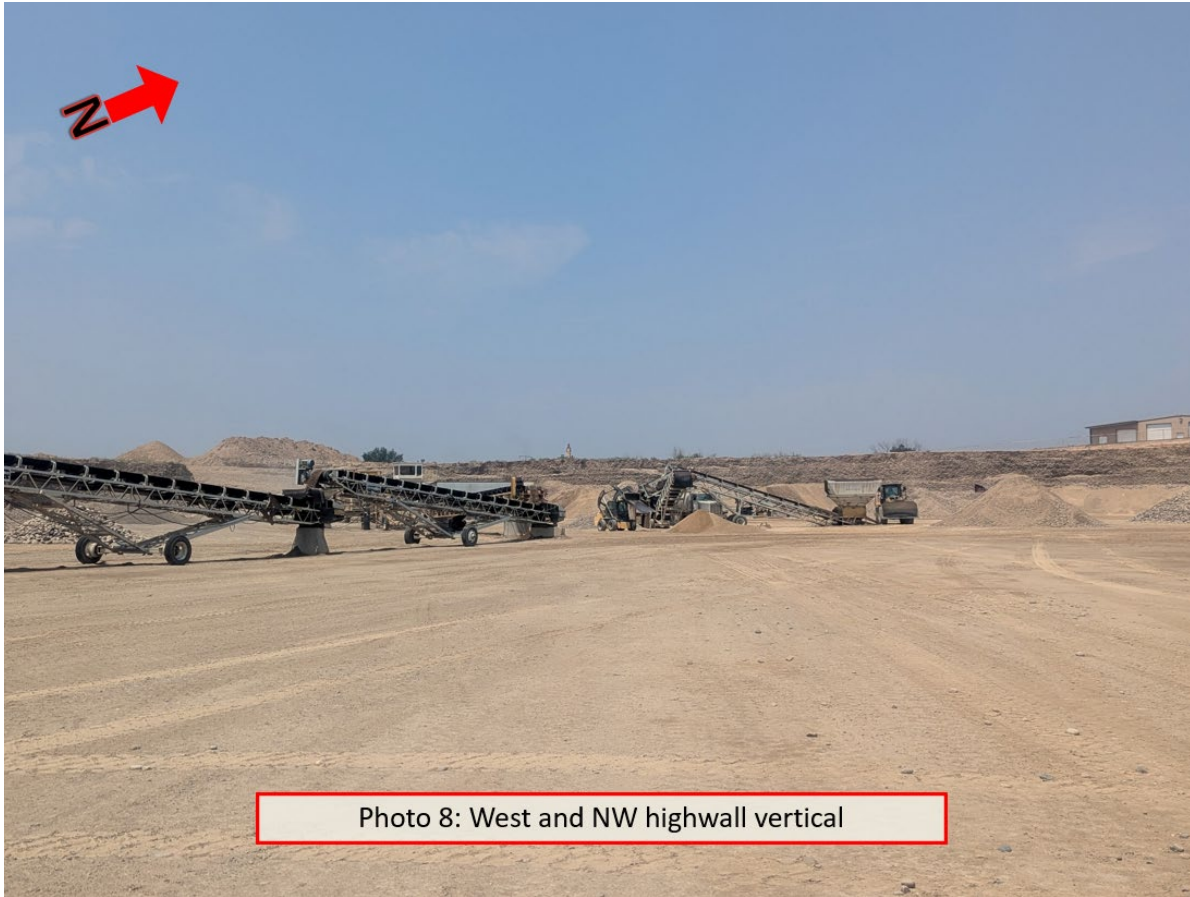
The active highwall is within Phase 2 and is being pushed to the west. Slopes along the north side will require backfill given their proximity to the permit boundary (approx. 1,000 LF). The west and south highwall may be cut/fill for grading (1,800 LF). Active walls within Phase 2 are near vertical and approximately 30 ft high.

Photo 8: West and NW highwall vertical

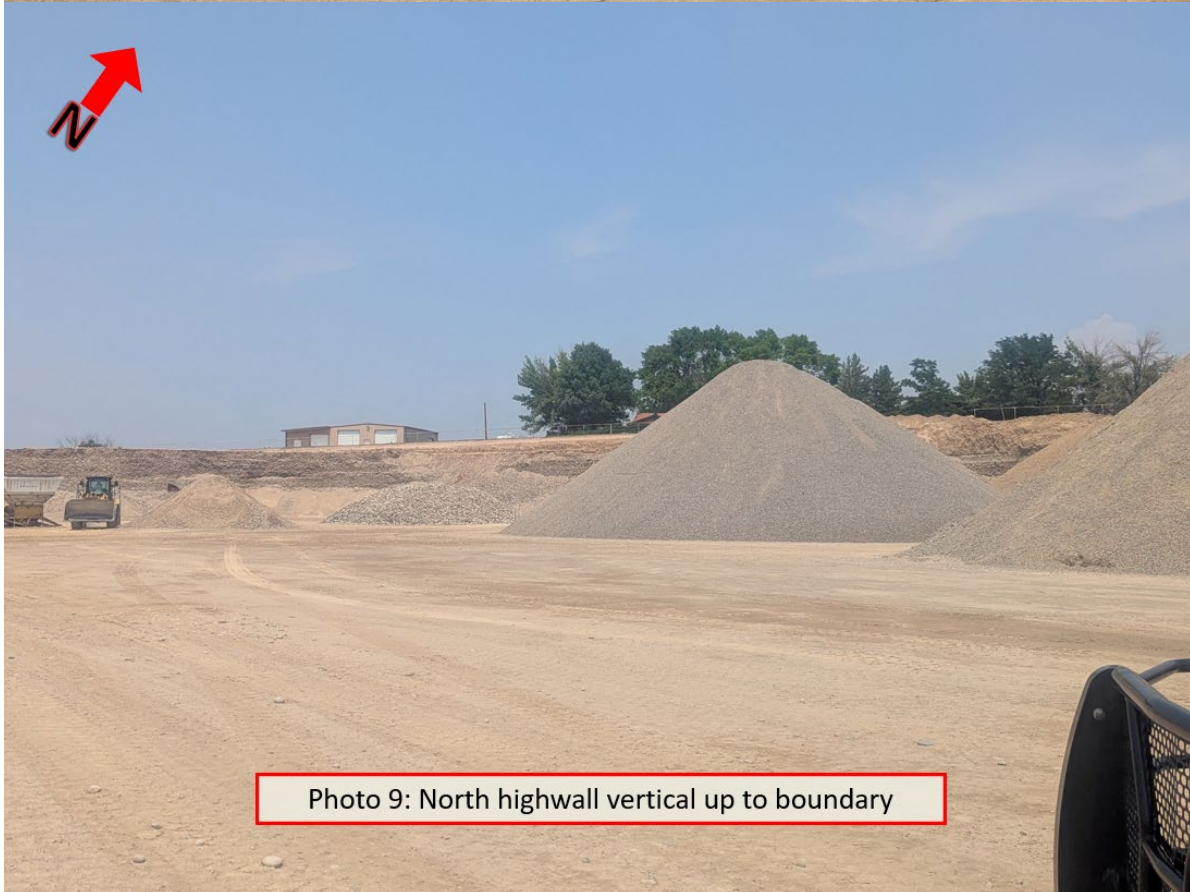
Photo 9: North highwall vertical up to boundary
