MINERALS PROGRAM INSPECTION REPORT
PHONE: (303) 866-3567

MINE NAME: SH 69 Gravel Pit	MINE/PROSPECTING ID#: M-2018-010	MINERAL: Sand and gravel	COUNTY: Fremont
INSPECTION TYPE: Monitoring	WEATHER: Cloudy	INSP. DATE: July 17, 2025	INSP. TIME: 09:40
OPERATOR: Fremont County	OPERATOR REPRESENTATIVE: Mr. Scott Hileman	TYPE OF OPERATION: 110c - Construction Limited Impact	
REASON FOR INSPECTION: Normal I&E Program	BOND CALCULATION TYPE: None	BOND AMOUNT: \$0.00	
DATE OF COMPLAINT: NA	POST INSP. CONTACTS: None	JOINT INSP. AGENCY: None	
INSPECTOR(S): Jocelyn Carter	INSPECTOR'S SIGNATURE:

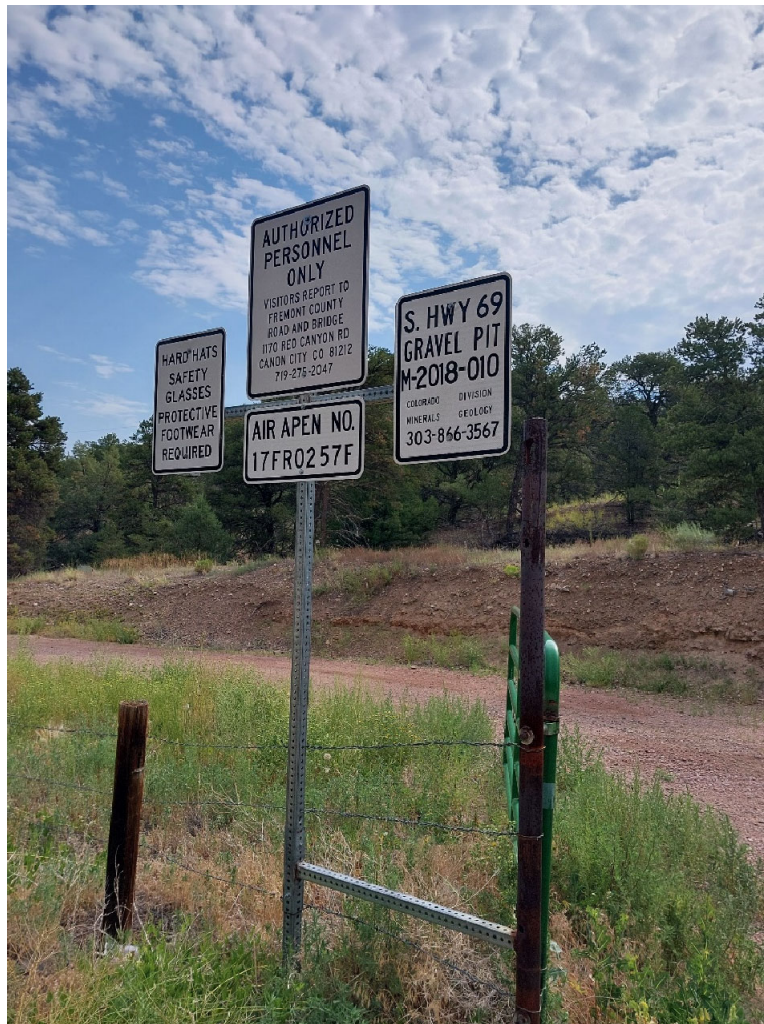
The mine sign is posted along the access road and CO 69 and is accurate according to Rule 3.1.12(1), see Photo #1. The corners are appropriately marked by a combination of T-posts and white PVC piping, see Photos #2, #3, and #4.

Photo #1: Mine sign posted along access road and CO 69.

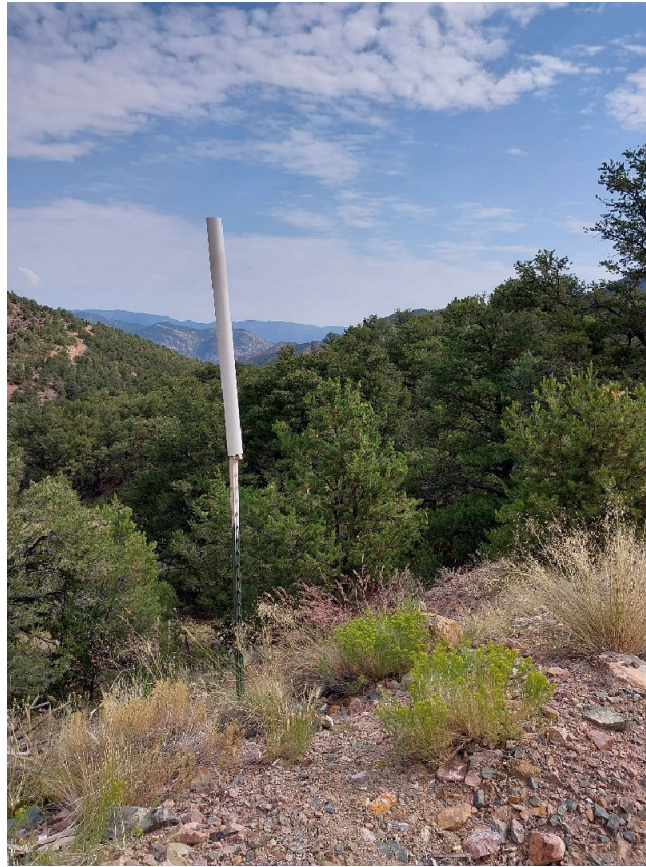
Photo #2: Permit boundary marker at the northwest corner.

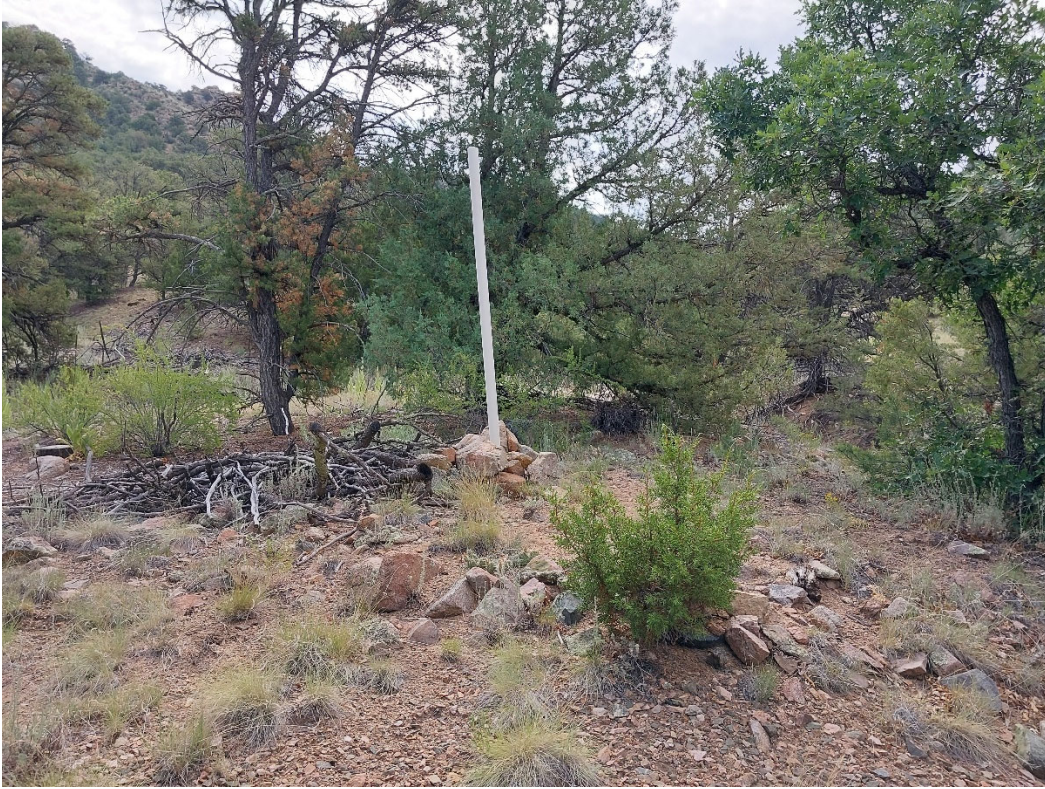
Photo #3: Permit boundary marker at the southeast corner.

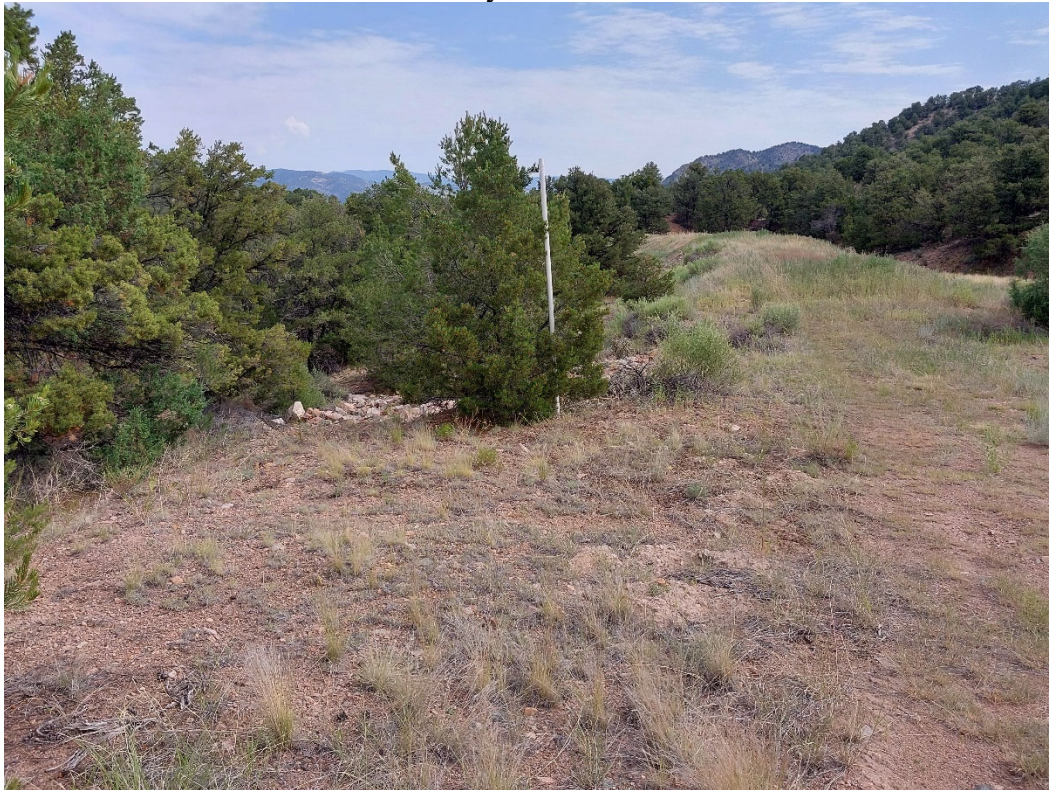
Photo #4: Permit boundary marker at the northeast corner.

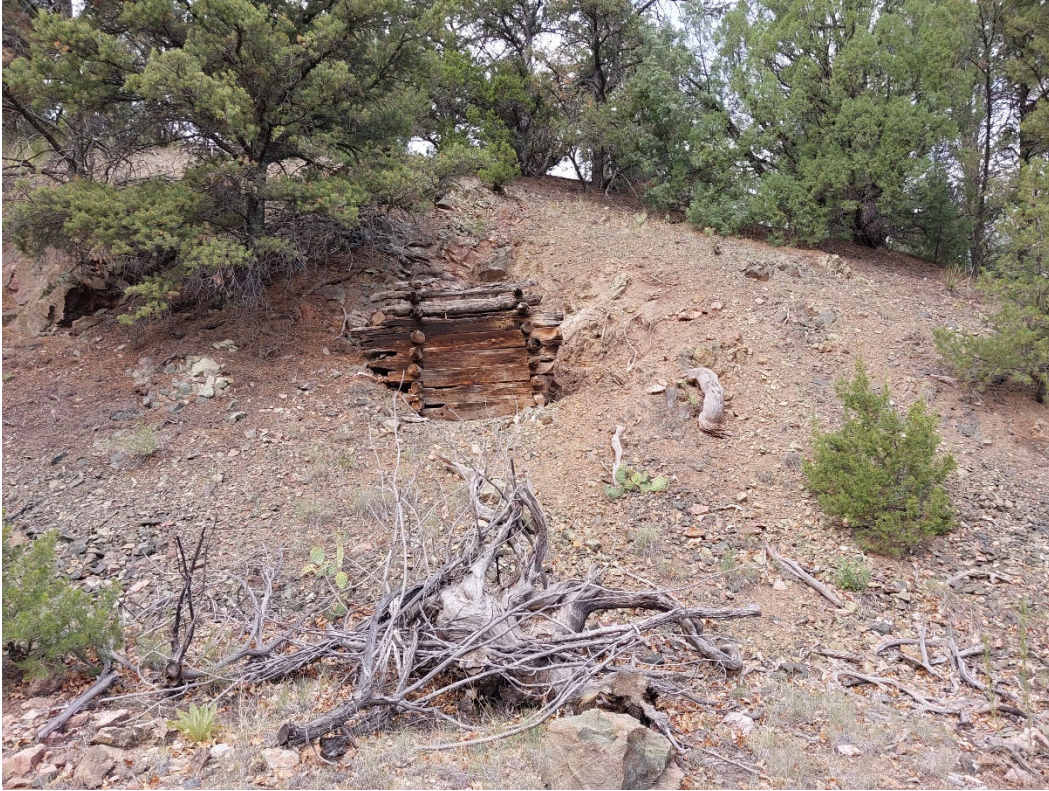
SH 69 Gravel Pit is located on the east side on Colorado State Highway 69 (CO 69), the access road is approximately 2.5 miles south of the town of Texas Creek in Fremont County. The operation is permitted for 8.93 acres and extracts gravel material for road base by surface mining. The post-mining land use is rangeland. At the time of the inspection, there was no mining activity or equipment on site, two small stockpiles of material were on site. According to Mr. Hileman, material has been removed within the last year, and the exposed slope will need to be ripped again to produce more gravel material for harvesting. There is an abandoned mine shaft located in the northeast area of the permit, see Photo #5.

Photo #5: The abandoned mine shaft in the northeast area of the permitted area.

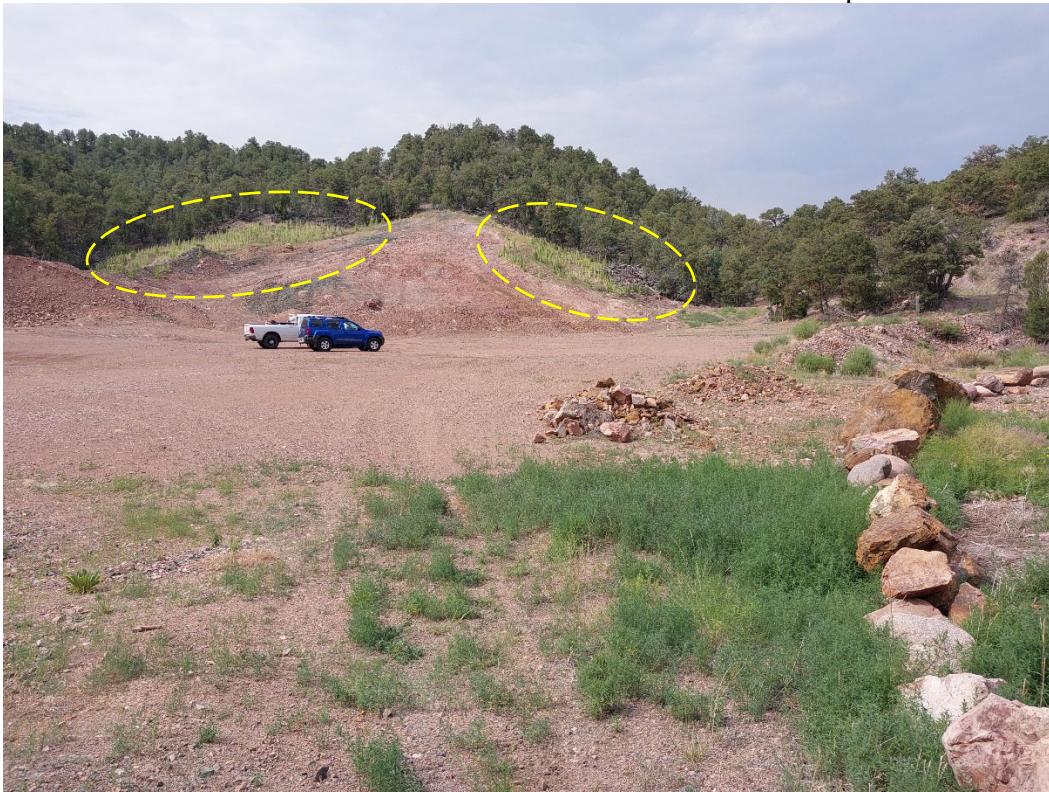
Common mullein, a List C noxious weed, was observed on the upper portions of the exposed mining area where material is scarped out. Mr. Hileman stated that the common mullein would be treated mechanically within the next two weeks from the date of the inspection.

Photo #6: View of the pit floor and the exposed area where material is scarped, looking south. A few small stockpiles of material can be seen on the right side of the picture. Areas of common mullein is circled yellow.

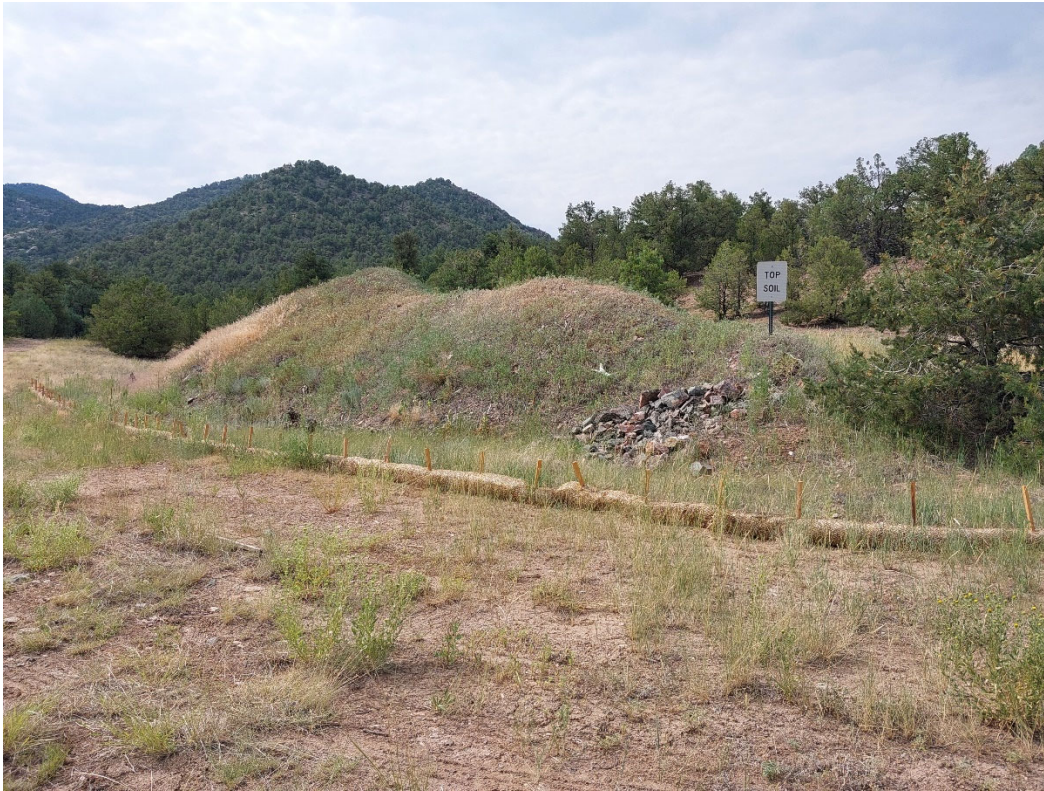
The topsoil is stored in the northwest portion of the permit area. It is segregated, well vegetated, and labeled as topsoil. There appears to be an adequate amount for reclamation of the disturbed areas. The topsoil stockpile is also surrounded by hay waddles for further protection from being washed out.

Photo #7: View of the topsoil stockpile on the northwestern portion of the permit area.
