**MINERALS PROGRAM INSPECTION REPORT**  
**PHONE: (303) 866-3567**

<b>MINE NAME:</b> Ellison Pit	<b>MINE/PROSPECTING ID#:</b> M-1978-170	<b>MINERAL:</b> Sand and gravel	<b>COUNTY:</b> Delta
<b>INSPECTION TYPE:</b> Monitoring	<b>WEATHER:</b> Cloudy	<b>INSP. DATE:</b> July 23, 2025	<b>INSP. TIME:</b> 07:40
<b>OPERATOR:</b> Delta County	<b>OPERATOR REPRESENTATIVE:</b> Timothy Hunter, Anthony Hunter, Hunter Voss	<b>TYPE OF OPERATION:</b> 112c - Construction Regular Operation

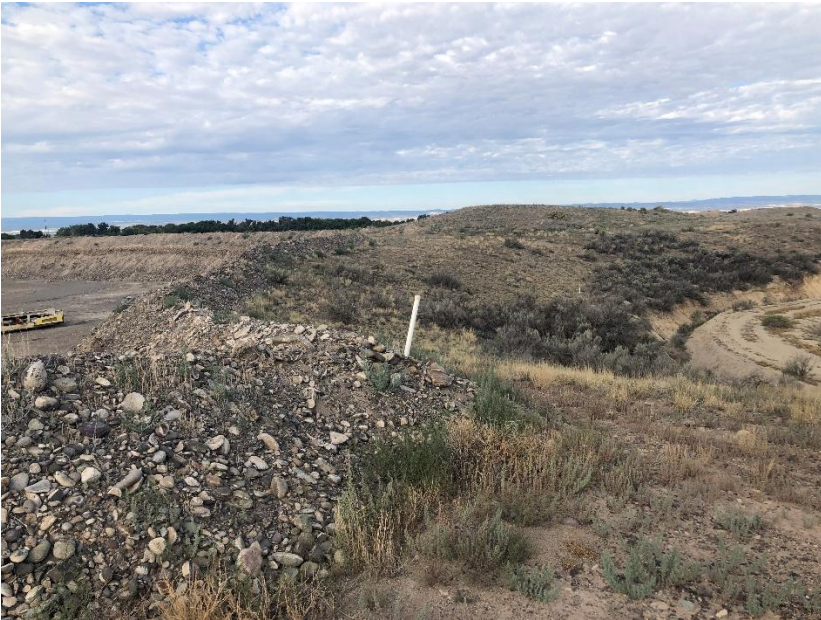
**Affected area boundary, looking southwest from northwest corner of site**

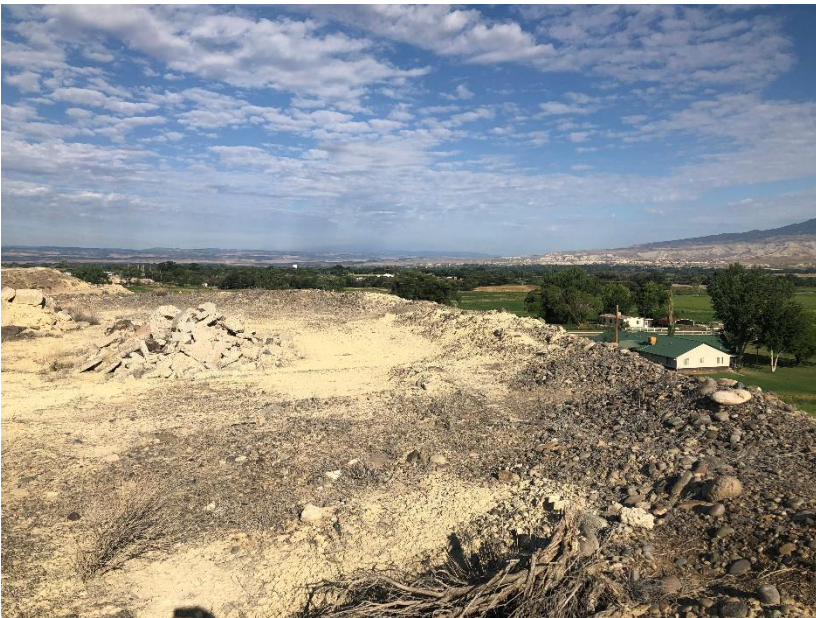
**Berm at northeast corner of site**

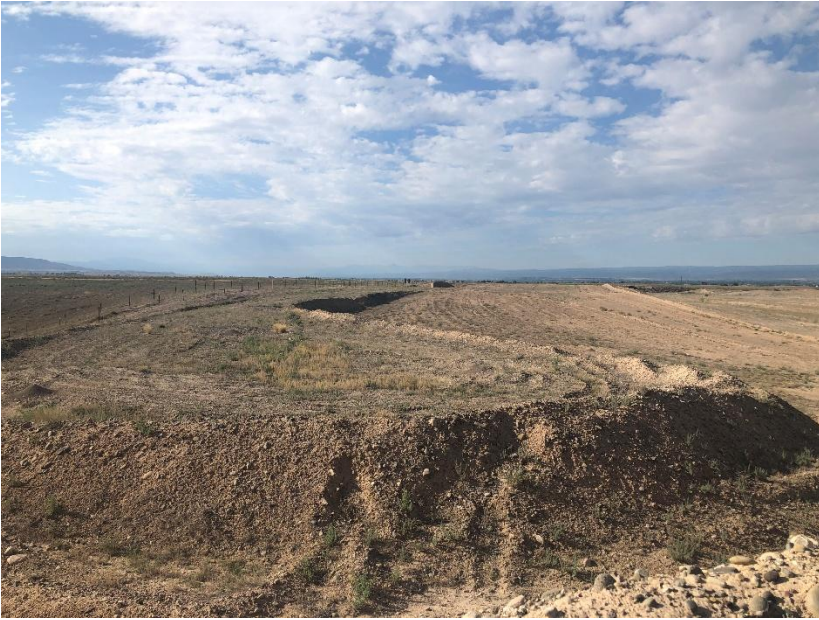
**PROBLEM/POSSIBLE VIOLATION:** Problem: The affected area boundary markers were not observed in some areas, namely the east side of the site and near the asphalt plant. These need to be added per the requirements of Rule 3.1.12.

The entrance sign was clearly visible at the entrance, and it was large enough and contained the necessary information, per Rule 3.1.12(1). The affected boundary was generally marked well with posts, fencing, and berms (as required by Rule 3.1.12(2)). However, there are some areas that require additional markers. One area needing more markers is the east side of the site. Another area is near the asphalt plant (which is not in the permit area). This second area requires some discussion between the Division and the County, because placing markers at this boundary could be problematic, since it is in the middle of a road. The Division would like to discuss the options for marking this area, such as markers with a stated offset (any use of alternative markers should be stated in the Mining Plan).

**East end of site, looking south – affected area markers missing**

**CORRECTIVE ACTIONS:** The boundaries of the affected area must be marked by monuments or other markers that are clearly visible and adequate to delineate such boundaries. These must be present along the entire affected area boundary. Near the asphalt plant, boundaries may be problematic, and the Division will consider alternative options.

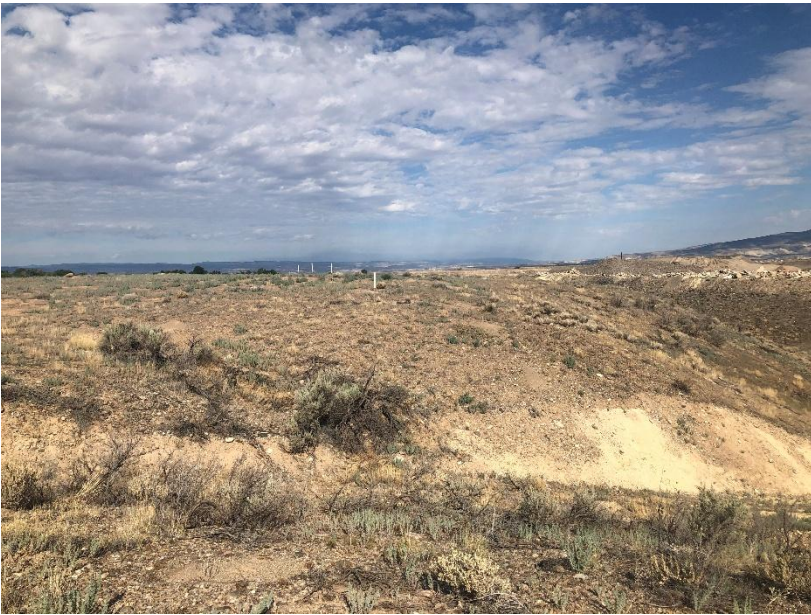
**South end of site, looking west – affected area markers visible**

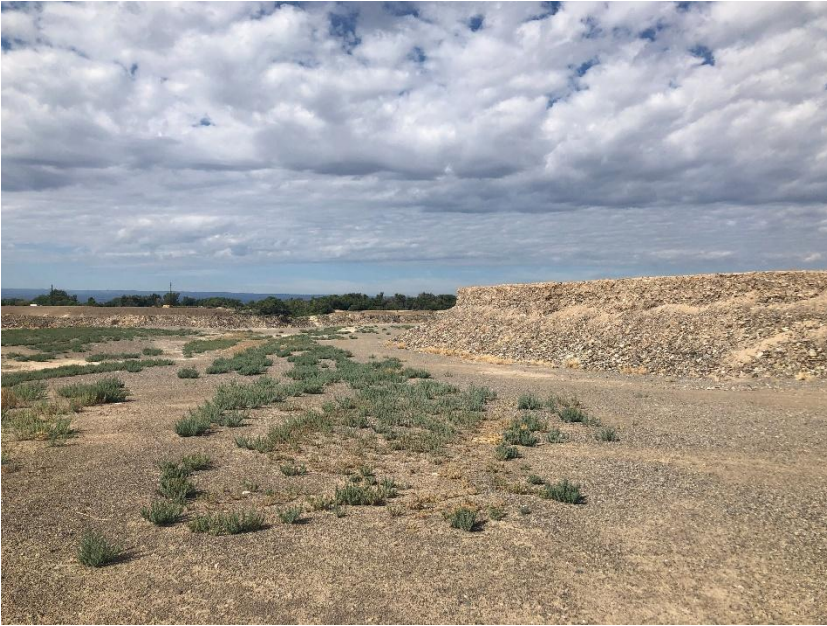
**PROBLEM/POSSIBLE VIOLATION:** Problem: There are state-listed noxious weeds present on site, primarily halogeton. This is a problem for failure to employ weed control methods for state listed noxious weed species within the permitted area, and to reduce the spread of weeds to nearby areas as required by Section 3.1.10 (6) of the rule.

The primary weed issue that was identified was the presence of halogeton around the site, especially near the pit and along the east and south sides of the site. Halogeton is a listed noxious species in Colorado and should be controlled by the County.

**Mining area with halogeton**

**CORRECTIVE ACTIONS:** Implement approved weed control plan and provide proof to the Division that this has been done. If a weed control plan is not already in place, the operator shall develop a weed control and management plan in accordance with Section 3.1.10 (6) of the Rule. This plan should be developed in consultation with the county extension agency, or weed control district office and should include specific control measures to be applied, a schedule for when control measures will be applied and a post-treatment monitoring plan. This weed control plan shall be submitted to the Division as a Technical Revision to the approved plan with the appropriate Technical Revision fee of \$216.00 by the corrective action date.

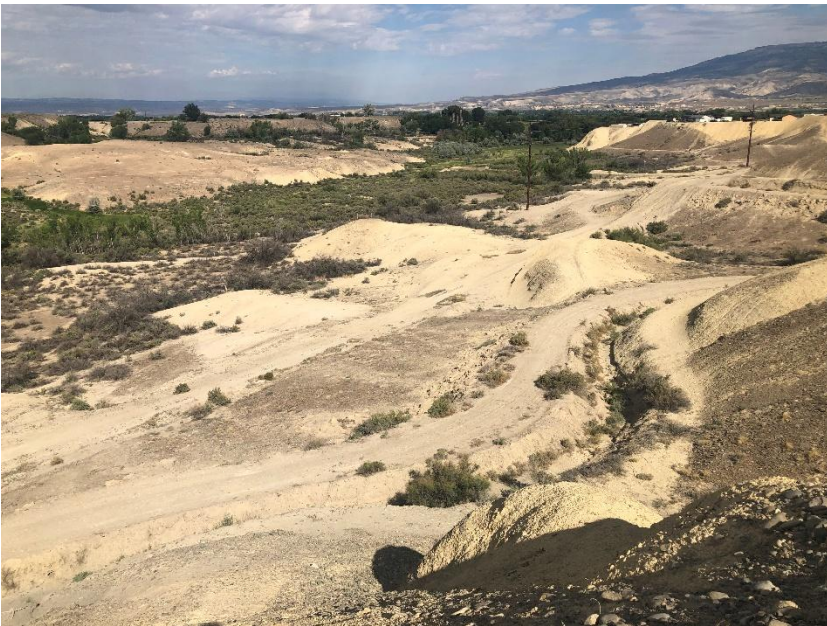
**Southwest part of site – disturbance does not appear to be mining related**
