**MINERALS PROGRAM INSPECTION REPORT**  
**PHONE: (303) 866-3567**

<b>MINE NAME:</b> Stirrup Pit	<b>MINE/PROSPECTING ID#:</b> M-1990-138	<b>MINERAL:</b> Gravel	<b>COUNTY:</b> Fremont
<b>INSPECTION TYPE:</b> Monitoring	<b>WEATHER:</b> Cloudy	<b>INSP. DATE:</b> July 17, 2025	<b>INSP. TIME:</b> 12:45
<b>OPERATOR:</b> Fremont County	<b>OPERATOR REPRESENTATIVE:</b> Mr. Scott Hileman	<b>TYPE OF OPERATION:</b> 110c - Construction Limited Impact	
<b>REASON FOR INSPECTION:</b> Normal I&E Program	<b>BOND CALCULATION TYPE:</b> None	<b>BOND AMOUNT:</b> \$0.00	
<b>DATE OF COMPLAINT:</b> NA	<b>POST INSP. CONTACTS:</b> None	<b>JOINT INSP. AGENCY:</b> None	
<b>INSPECTOR(S):</b> Jocelyn Carter	<b>INSPECTOR'S SIGNATURE:</b>

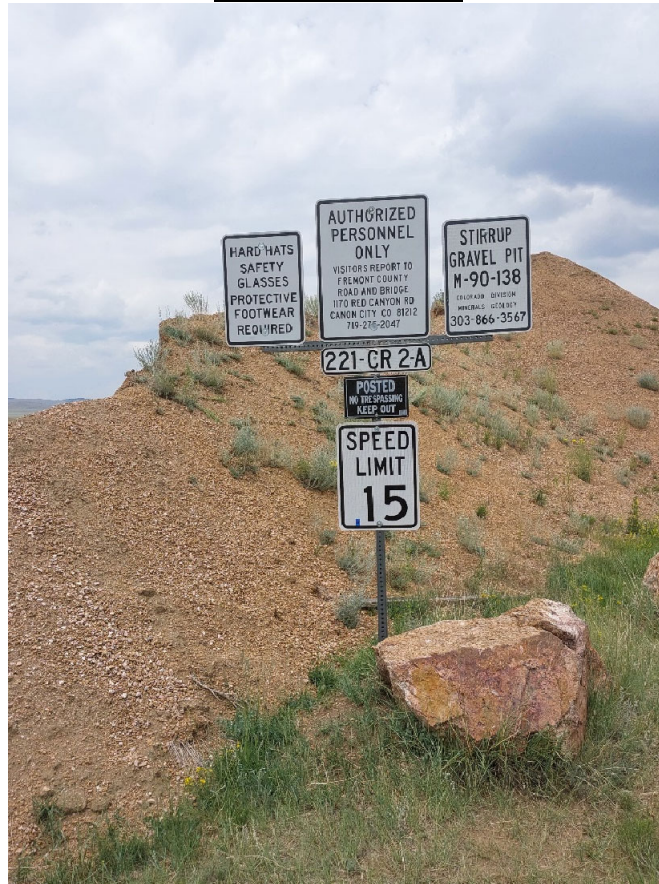
The mine sign is posted with accurate information in accordance with Rule 3.1.12(1), see Photo #1. The boundary markers were verified during the time of the inspection, see Photos #2, #3, and #4. An inspection map is included with this report, see Figure #1, showing where the markers were observed and a subsequent permit boundary based on the locations of the markers.

Photo #1: Mine sign posted at the pit entrance and CR 2a.

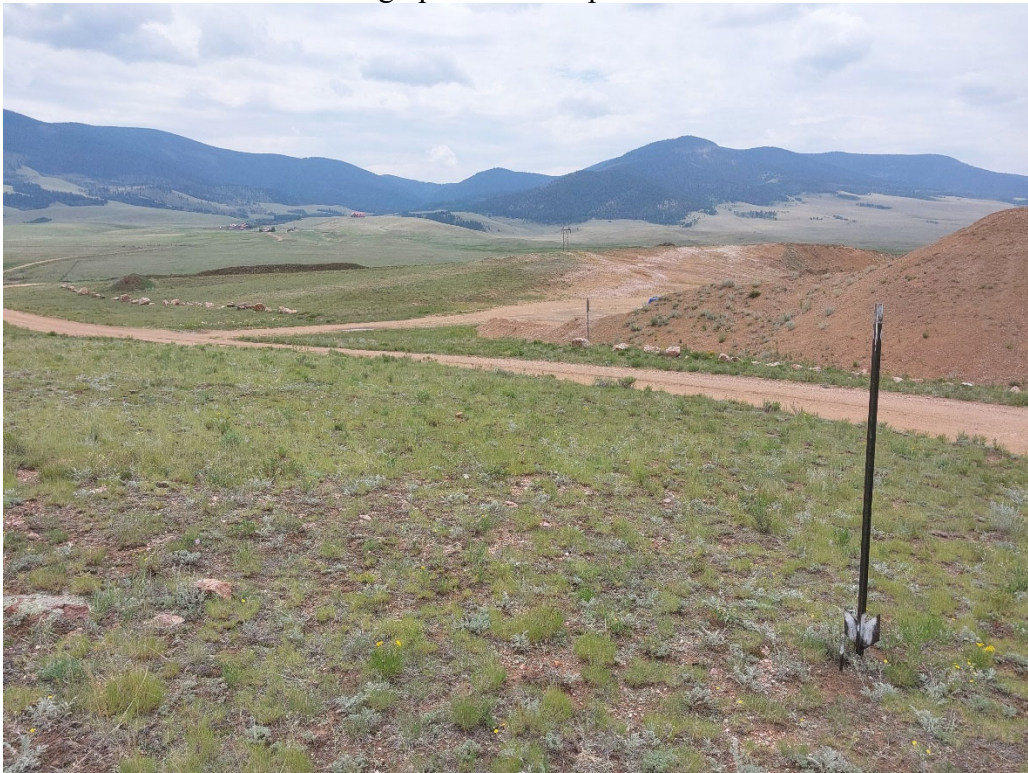
The access road is relatively short, about 85 feet in length, but is in good condition and does not appear to be eroding. The section of CR 2a that is within the permit area was stable and well maintained with no apparent issue with erosion or sedimentation along the road, see Photo #2.

Photo #2: Permit boundary marker #1 on map below, looking southwest. The section of CR 2a within the permitted area can be seen.

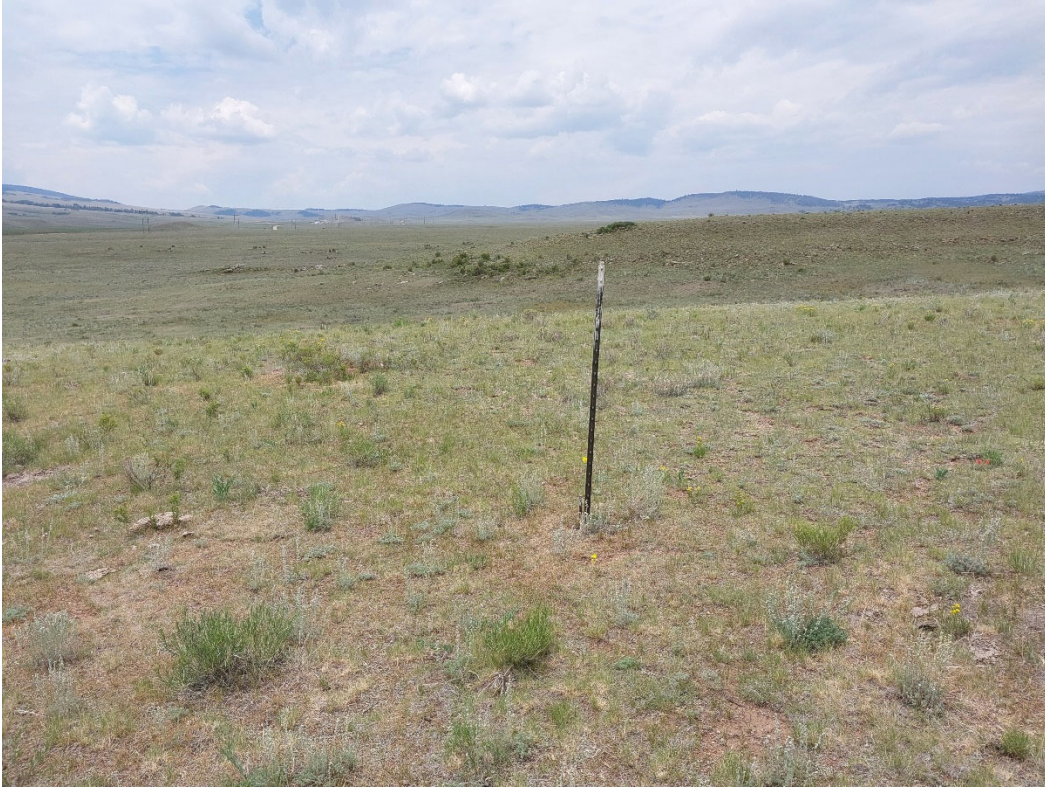
Photo #3: Permit boundary marker #2 on map below, looking west.

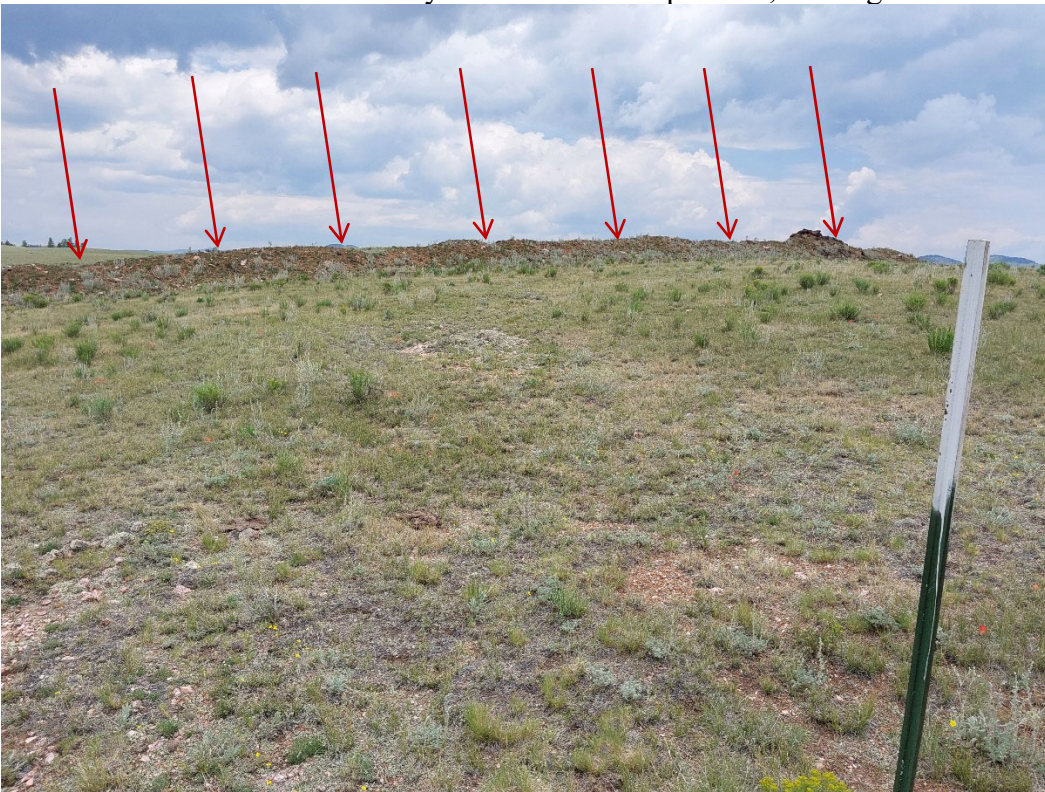
Overburden and topsoil are stockpiled as a berm surrounding the gravel pit. The berm appears to be stable with well vegetated slopes, see Photos #4, and #5.

The topsoil material is stockpiled as a berm surrounding the gravel pit, see Photos #4 and #5. The berm slopes appear to be stable and well vegetated. The amount of topsoil available on site appears to be adequate for reclamation tasks as well.

Photo #4: Permit boundary marker #5 on map below, looking to the northwest. The overburden and topsoil berm can be seen in the background.

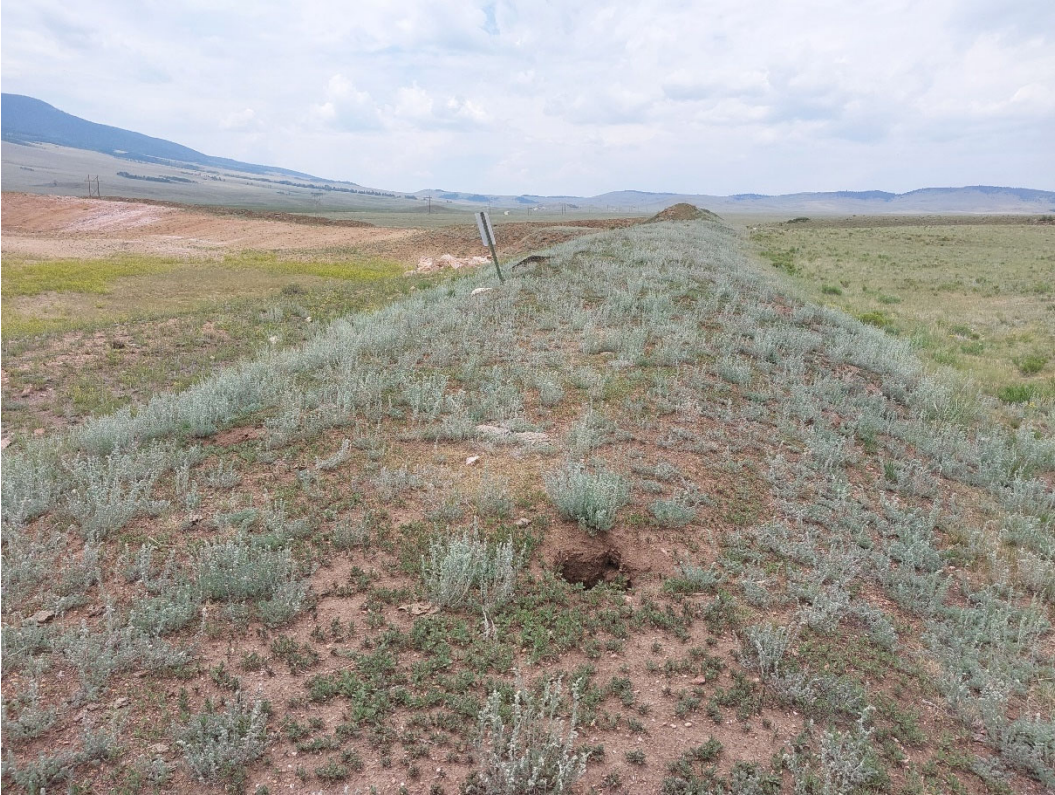
Photo #5: View along the top of the overburden and topsoil berm along the northern boundary of the pit, looking west.

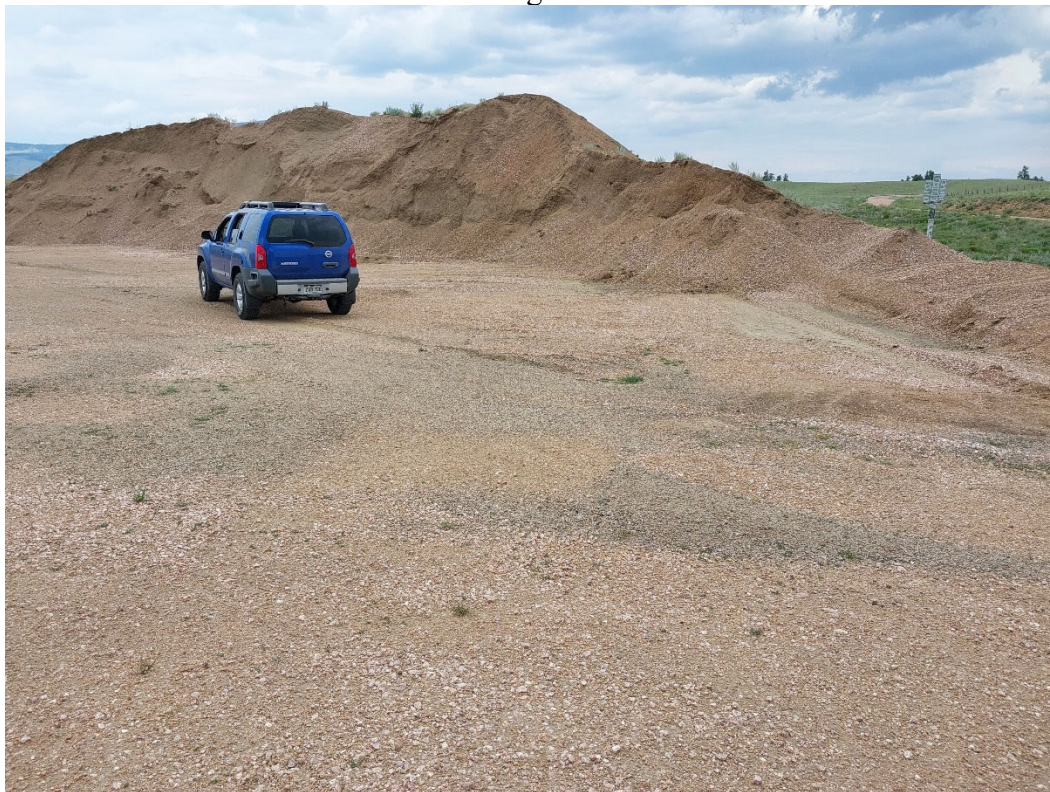
At the time of the inspection, mining activity was not occurring. There was a stockpile of material ready to be loaded, see Photo #6, however, there was no equipment on site at the time of the inspection. The operation does have intermittent status and according to Mr. Hileman, material has been removed from the site within the last year.

Photo #6: Stockpile of product material located on the north side of the pit near the entrance.

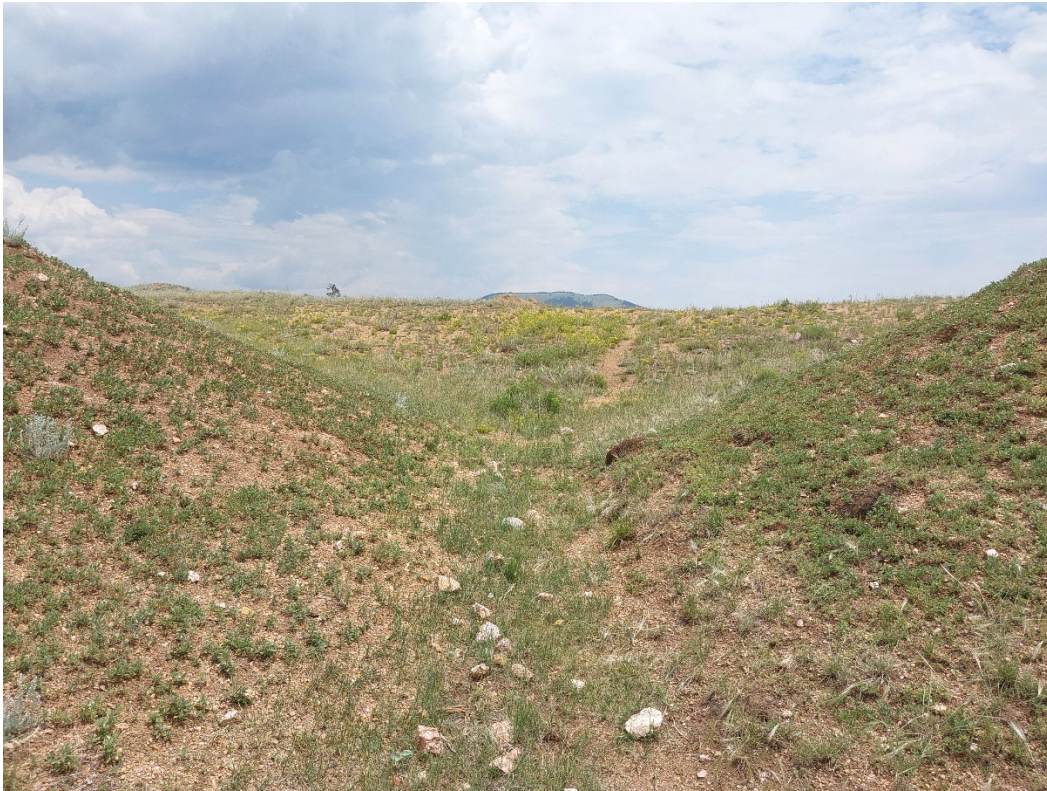
The cut in the overburden and topsoil berm surrounding the pit appeared to be in good condition and effective at draining stormwater from the pit, see Photo #7.

Photo #7: View of the stormwater drainage cut in the berm, on the west side of the pit area, looking east.

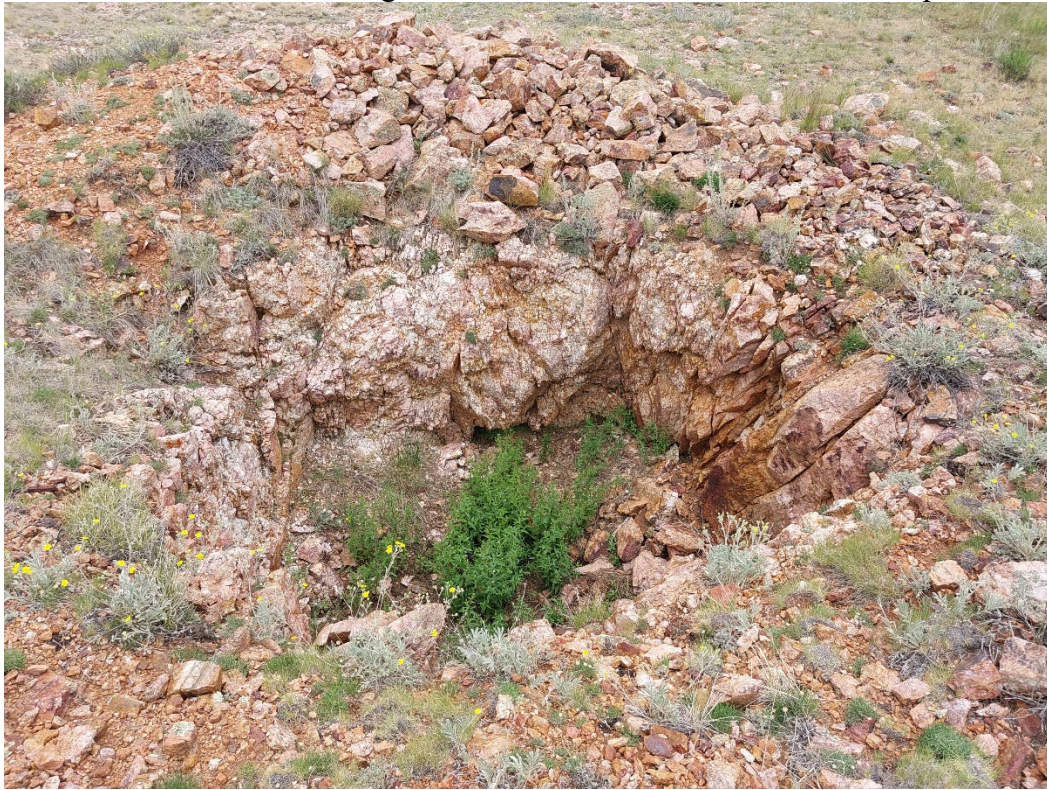
The Stirrup Pit is located approximately 17.5 miles north of the town of Texas Creek in Fremont County; near the intersection of Fremont County Road 2 (CR 2) and County Road 2a (CR 2a). The entrance to the site is on the west side of CR2a; CR 2a cuts across the northeast corner of the permitted area. The permit covers 9.61 acres and is for the extraction of gravel by surface mining for the purpose of maintaining county roads in the area. There is a pre-law mining pit that is within the permit area but is not disturbed by this operation, see Photo #8.

Photo #8: Per-law mining pit located between the southern boundary of the pit and the southern permit boundary.

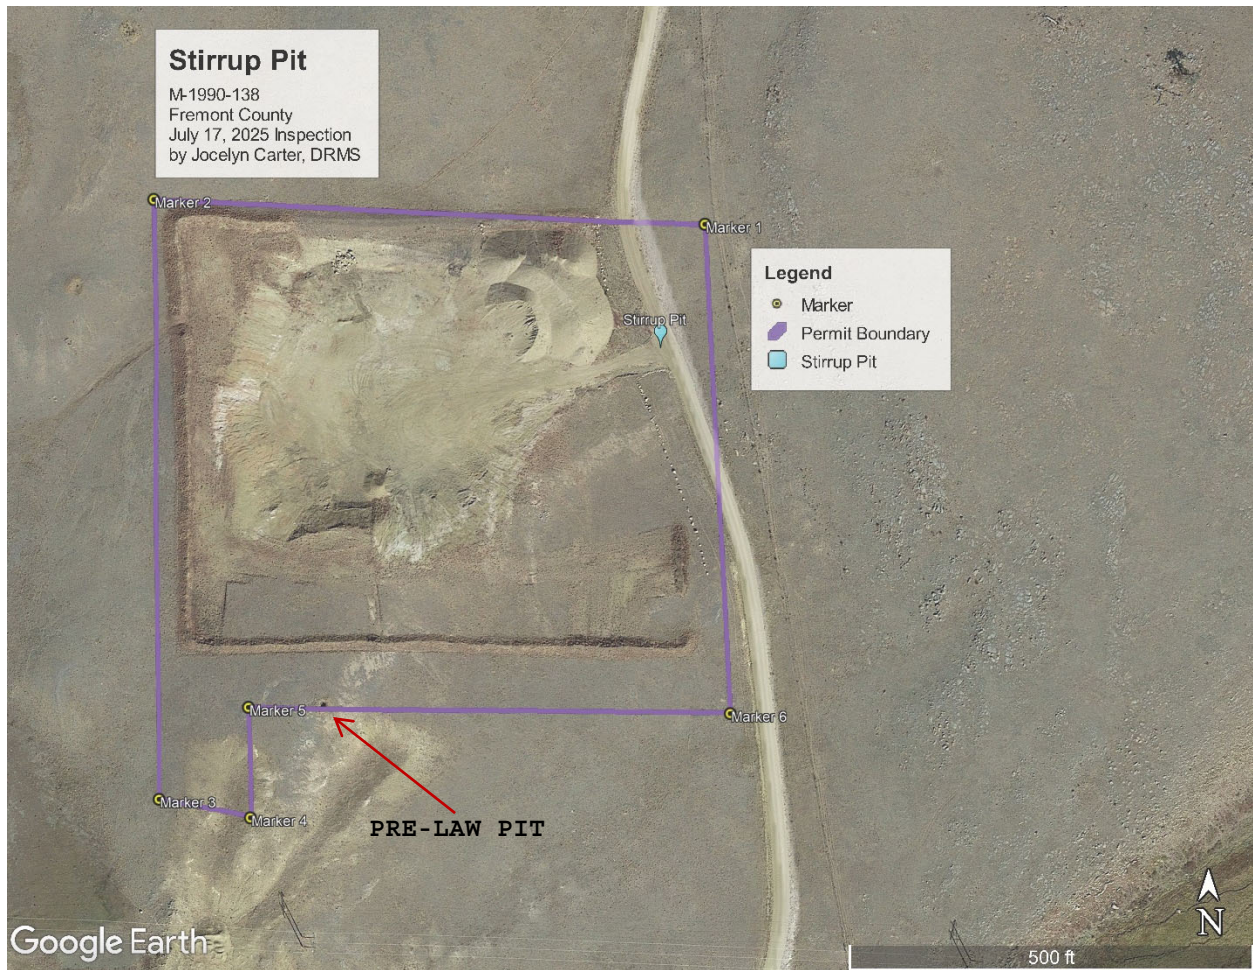
Figure #1: Map created based on inspection observations, the purple permit boundary was created based on the coordinates collected during the inspection for each of the permit boundary markers.
