MINERALS PROGRAM INSPECTION REPORT
PHONE: (303) 866-3567

MINE NAME: Quagmire Creek	MINE/PROSPECTING ID#: M-1990-047	MINERAL: Gravel	COUNTY: Fremont
INSPECTION TYPE: Monitoring	WEATHER: Cloudy	INSP. DATE: July 17, 2025	INSP. TIME: 11:45
OPERATOR: Fremont County	OPERATOR REPRESENTATIVE: Mr. Scott Hileman	TYPE OF OPERATION: 110c - Construction Limited Impact	
REASON FOR INSPECTION: Normal I&E Program	BOND CALCULATION TYPE: None	BOND AMOUNT: \$0.00	
DATE OF COMPLAINT: NA	POST INSP. CONTACTS: None	JOINT INSP. AGENCY: None	
INSPECTOR(S): Jocelyn Carter	INSPECTOR'S SIGNATURE:

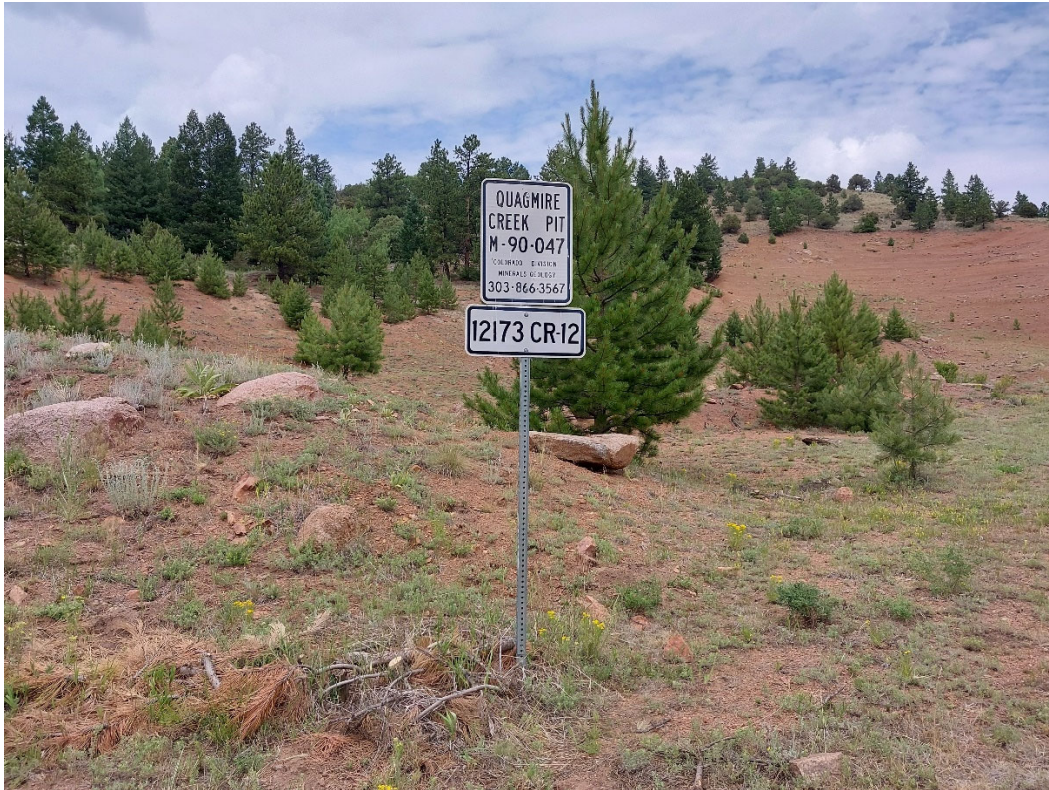
The mine sign is posted with accurate information in accordance with Rule 3.1.12(1), see Photo #1.

Photo #1: Mine sign posted in accordance with Rule 3.1.12(1).

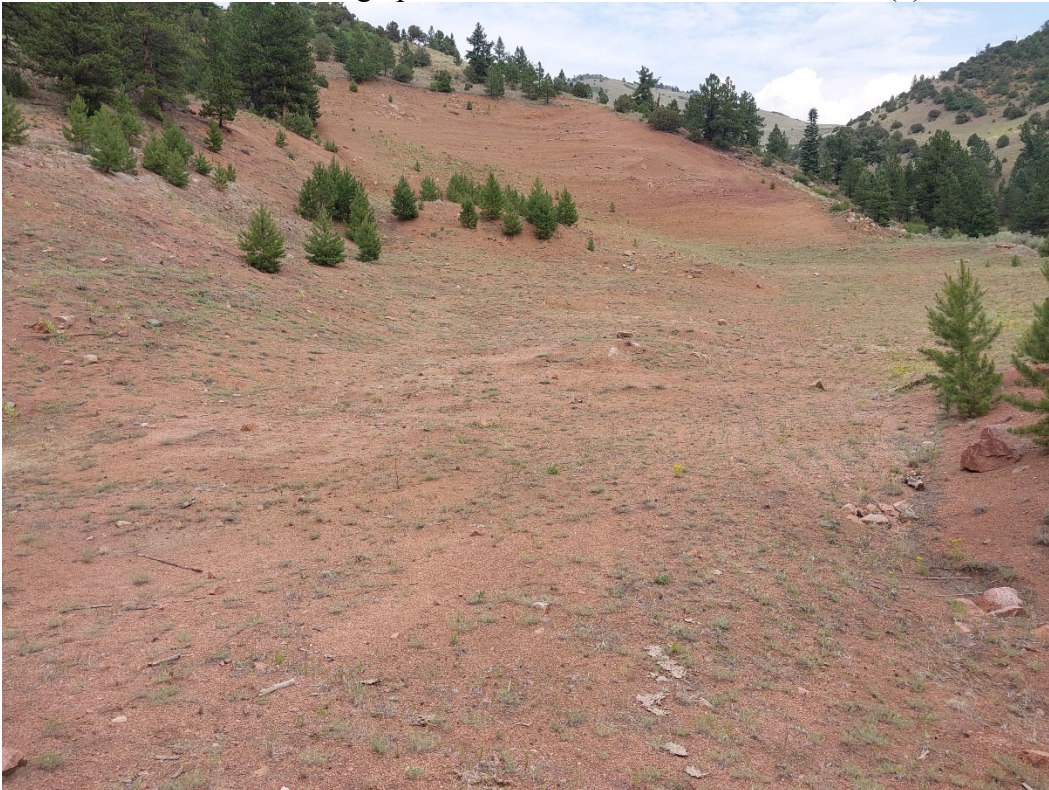
The reclaimed pit floor shows to have a better revegetation success with respect to frequency and diversity of species. There are still a few areas with sparse vegetation on the pit floor in the southern area. However, the regrowth of pine trees also shows to be more successful in the same areas.

Photo #2: From the southern portion of the old pit, looking north. The pit floor can be seen with the contoured old high wall in the background.

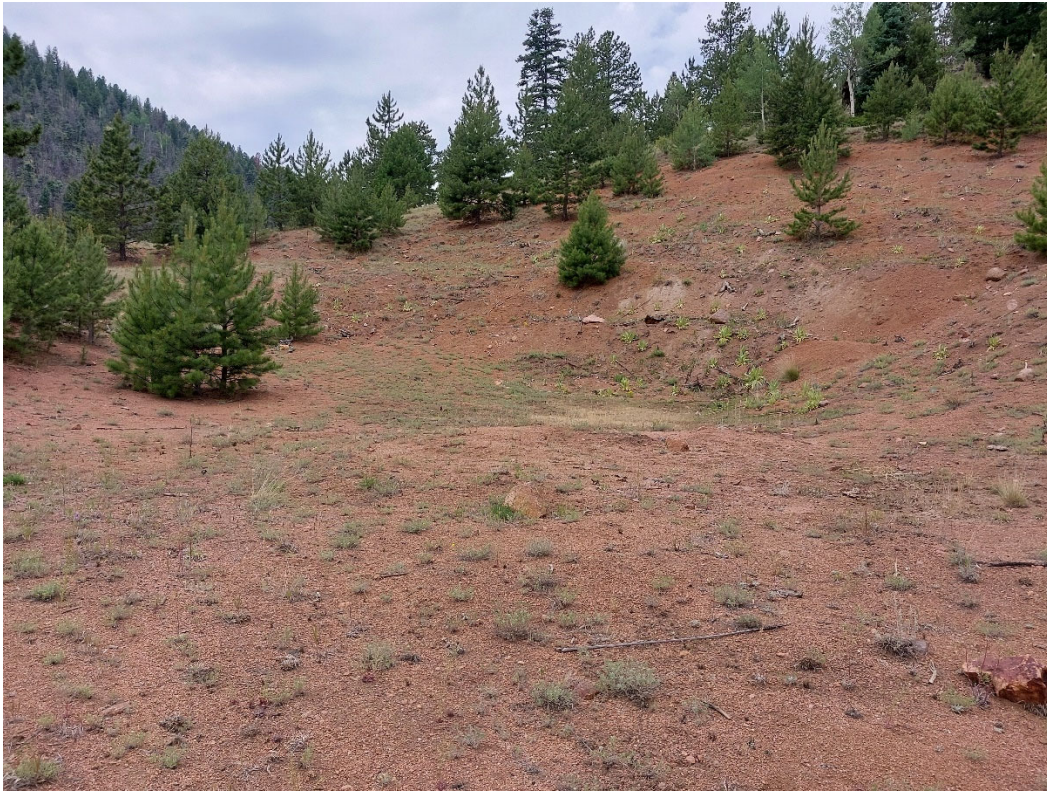
Photo #3: View of the southern portion of the permit area, looking south.

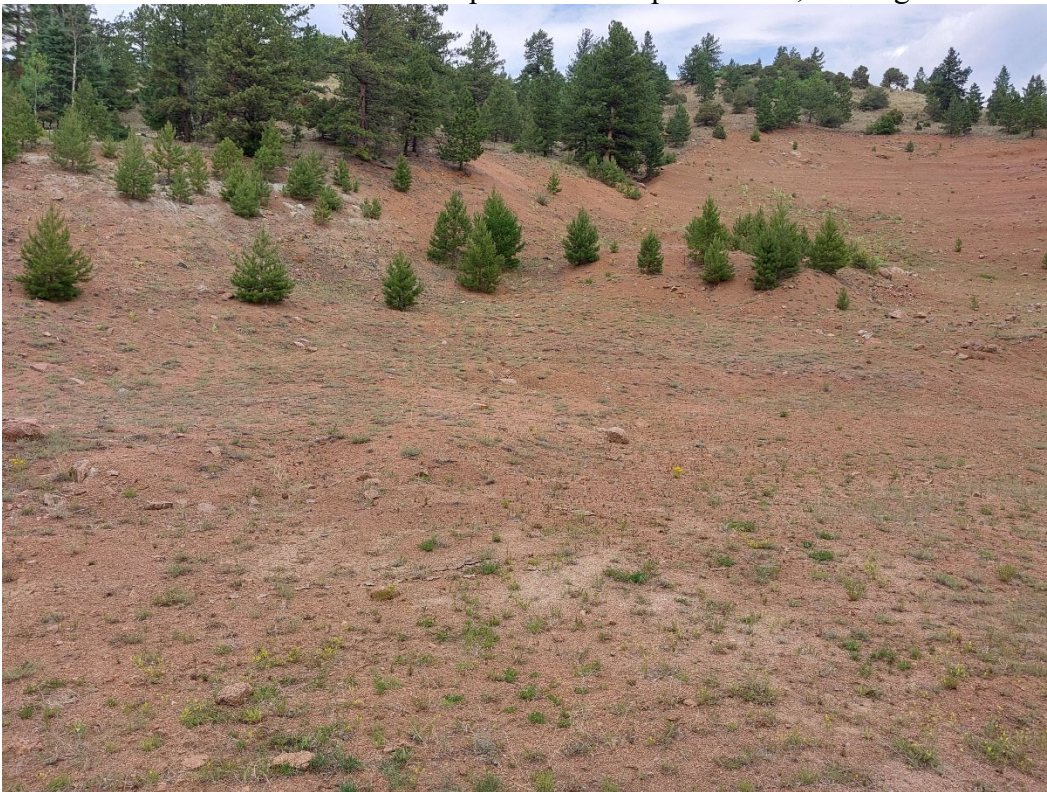
Common mullein, a List C noxious weed, was observed on the slopes of the regraded and contoured highwall. Mr. Hileman stated that he would be removing the common mullein within two weeks from the date of the inspection.

The regraded high wall has been contoured and furrowed, as stated in the previous inspection report. There is no evidence of erosion occurring on the slope. The vegetation is still slow to take to the slope, and it appears that the observed common mullein has had the most success establishing itself on the sloped area. There are a few small saplings that have become established on the slopes, but the upper, steeper portions of the contoured slope show to have the least amount of vegetation.

Photo #4: View of the contoured high wall, saplings can be seen with some common mullein in the background.
