**MINERALS PROGRAM INSPECTION REPORT**  
**PHONE: (303) 866-3567**

<b>MINE NAME:</b> Meadow Hollow Quarry	<b>MINE/PROSPECTING ID#:</b> M-2009-006	<b>MINERAL:</b> Sandstone (silica, stone, quartzite)	<b>COUNTY:</b> Larimer
<b>INSPECTION TYPE:</b> Preoperation Inspection	<b>WEATHER:</b> Cloudy	<b>INSP. DATE:</b> July 16, 2025	<b>INSP. TIME:</b> 10:15
<b>OPERATOR:</b> Colorado Quarry I, LLC	<b>OPERATOR REPRESENTATIVE:</b> Bryce Bohl, Bret Ludwick, & Jat Panzarella	<b>TYPE OF OPERATION:</b> 110c - Construction Limited Impact	
<b>REASON FOR INSPECTION:</b> Preoperation Inspection	<b>BOND CALCULATION TYPE:</b> None	<b>BOND AMOUNT:</b> \$29,723.00	
<b>DATE OF COMPLAINT:</b> NA	<b>POST INSP. CONTACTS:</b> None	<b>JOINT INSP. AGENCY:</b> None	
<b>INSPECTOR(S):</b> Jocelyn Carter	<b>INSPECTOR'S SIGNATURE:</b>

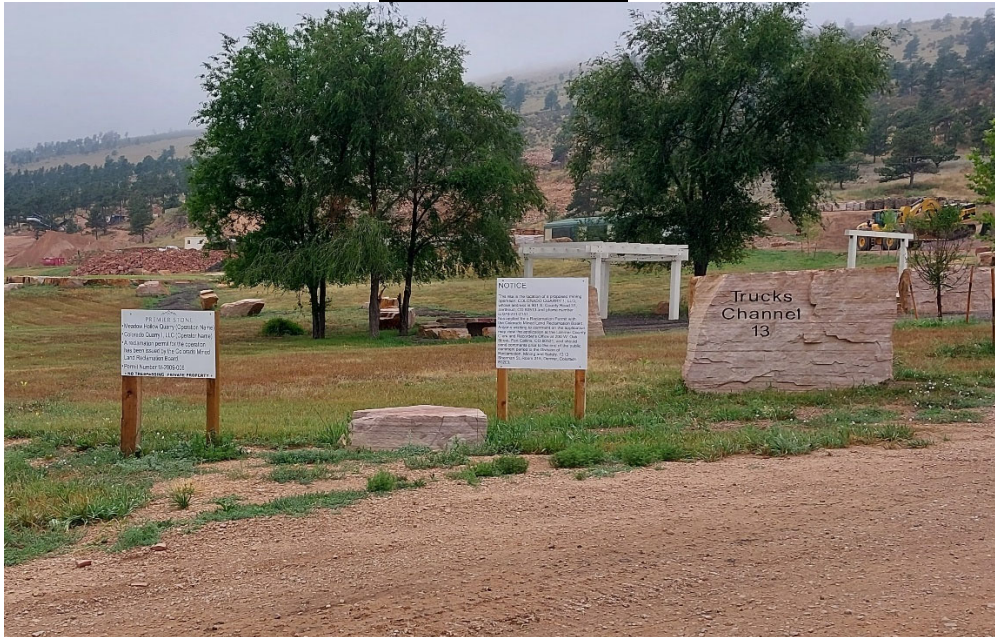
There is a posted notification of the CN application as well as the permit sign posted just inside the permit boundary. The updated boundary markers are in place and the coordinates of the markers were collected by me during the inspection. The following table gives the coordinates collected:

Photo #1: Mine sign and CN notification posted near the entrance of the permitted area.

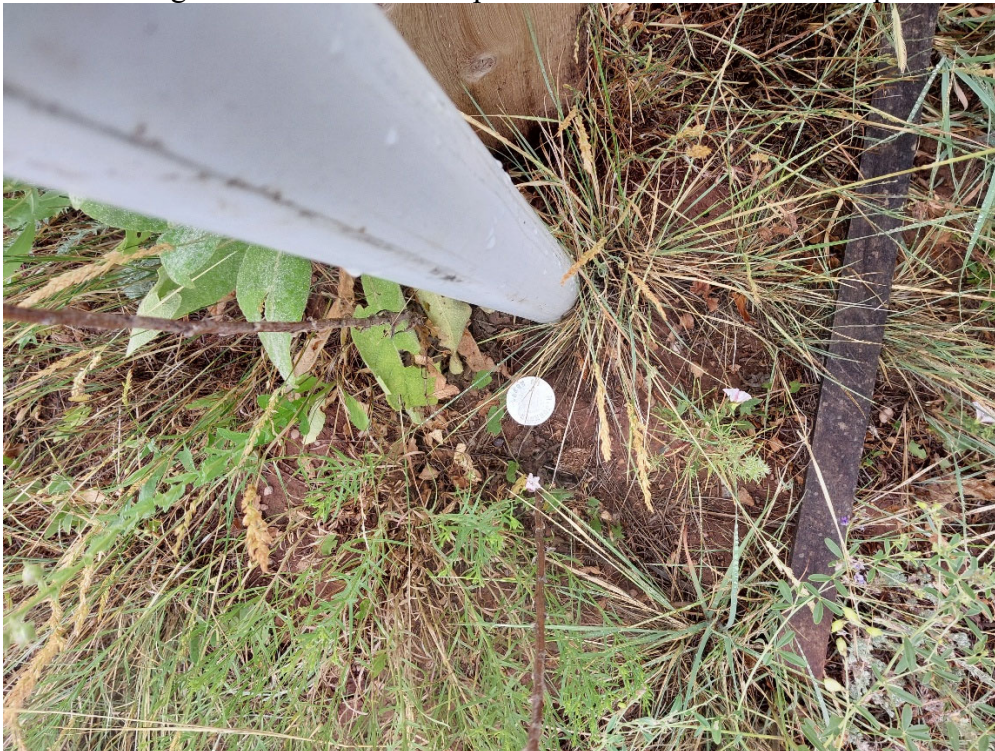
Photo #2: Proposed permit boundary marker at NE corner.

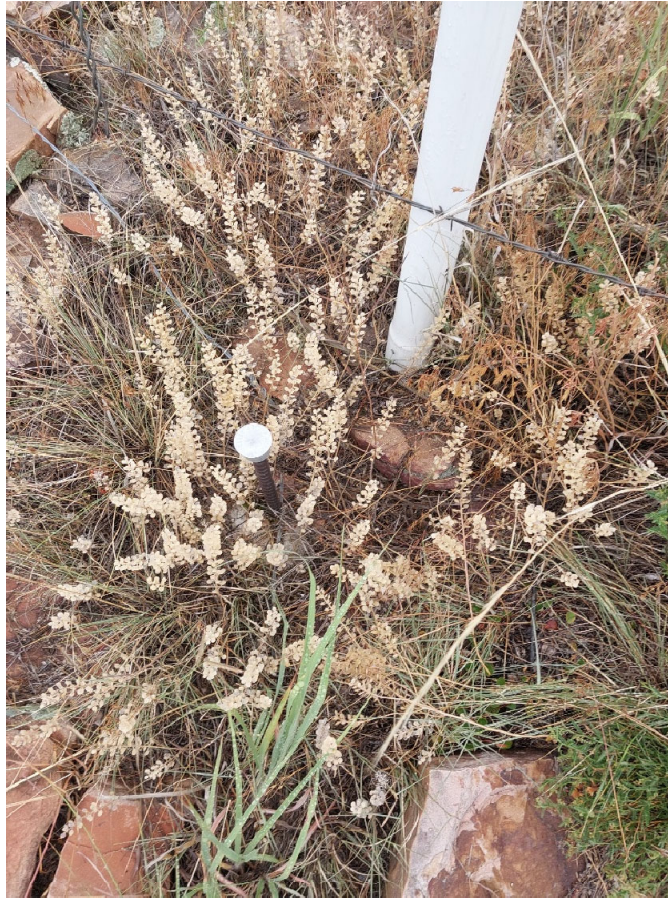
Photo #3: Proposed permit boundary marker at SE corner.

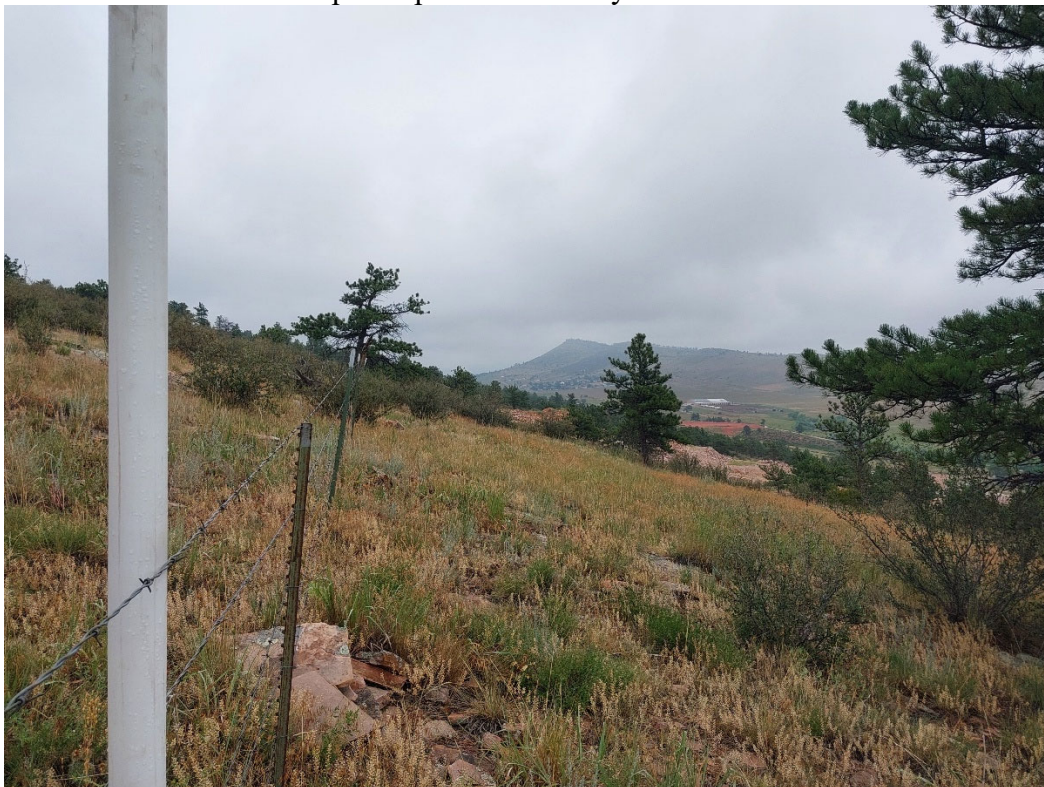
Photo #4: Proposed permit boundary marker at the SW corner, looking to the north.

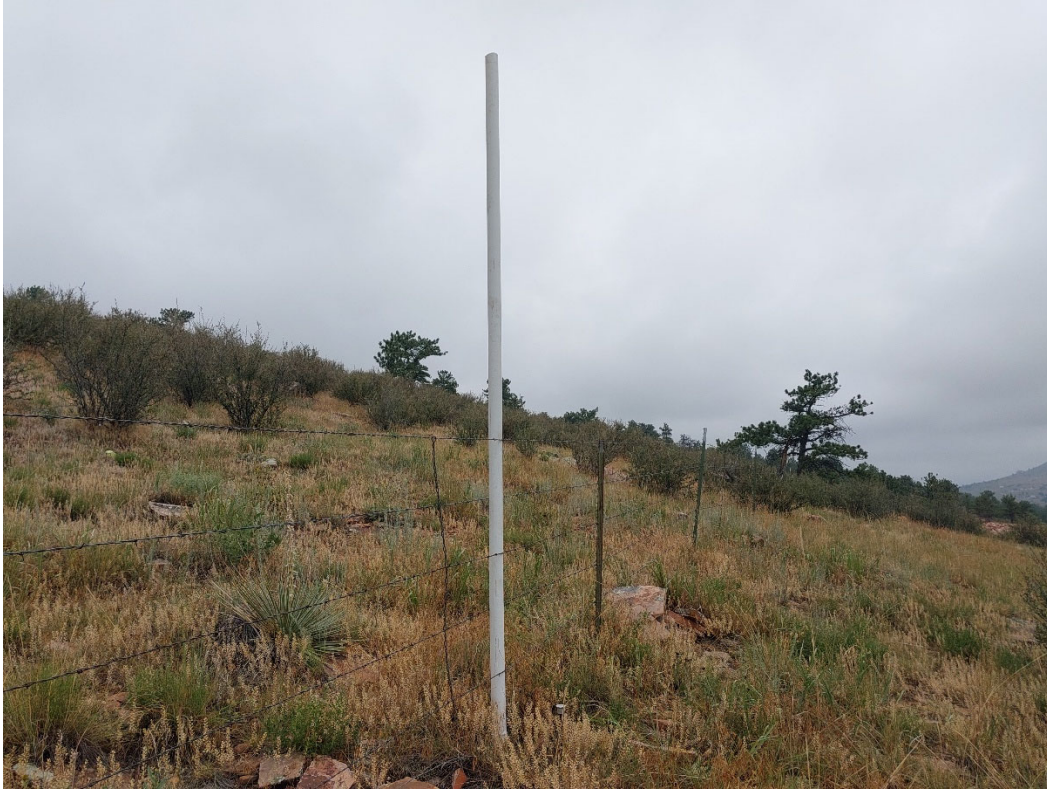
Photo #5: Proposed permit boundary marker at the NW corner, looking to the north.

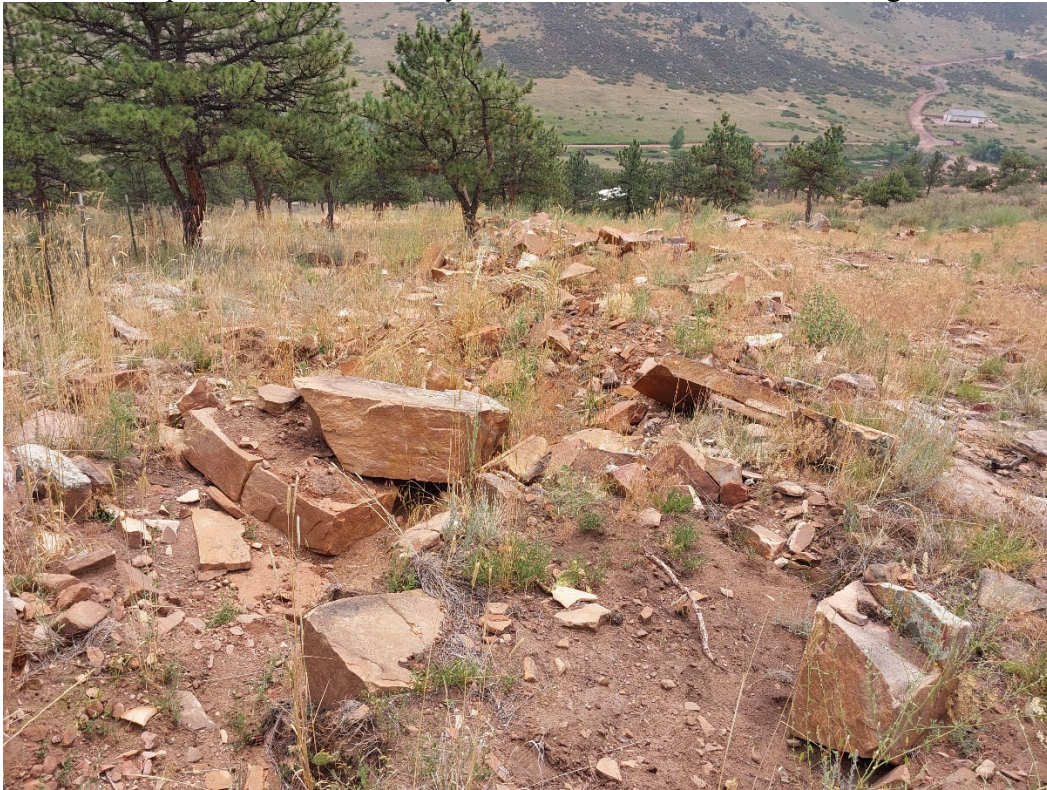
Meadow Hollow Quarry is currently permitted for 9.90 acres, extracting sandstone for landscape and construction materials by surface mining. The operator submitted the CN application requesting to add 34.18 acres to the permit for a total of 44.08 acres. While inspecting the proposed additional lands, there was an area of pre-law disturbance in the northwestern portion of the permitted area. During conversations with the operators, they do not intend to further disturb the area currently. If the operator does intend to disturb this area in the future, they may submit a revision request to the Division to update mining, and reclamation plans for the area.

Photo #6: Pre-law disturbance observed in the northwestern portion of the proposed permitted area, looking east, down slope.

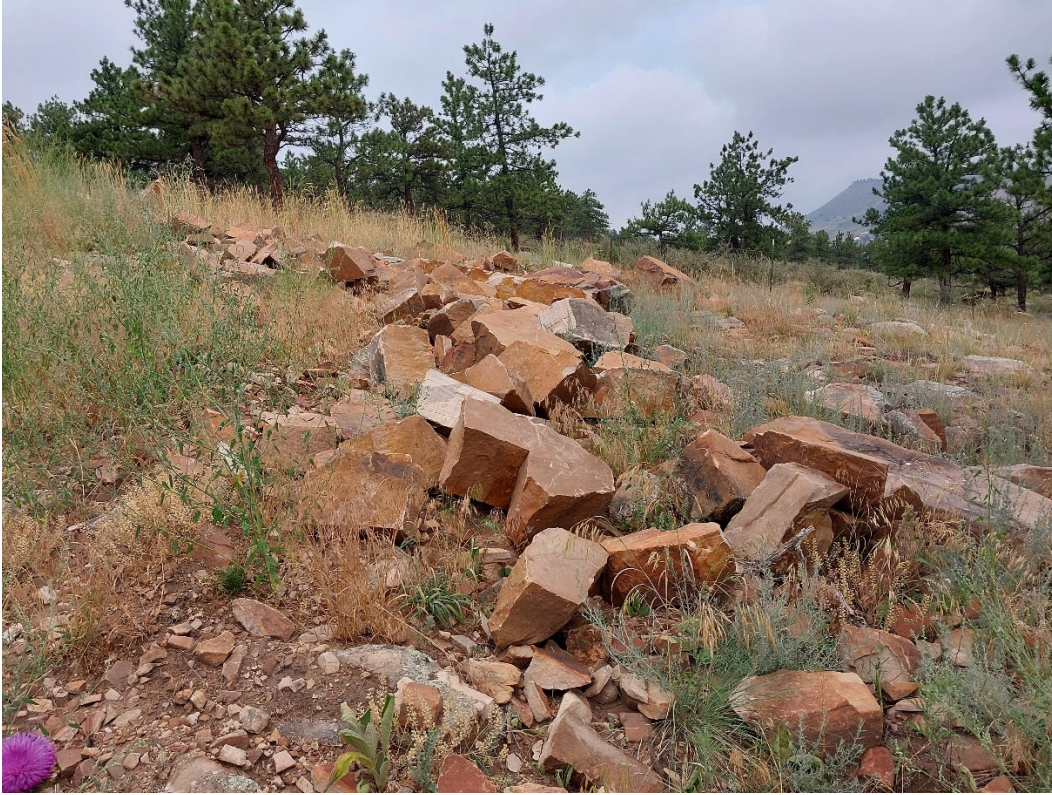
Photo #7: Pre-law disturbance observed in northwestern portion of the permitted area, looking northwest, up slope.
