**MINERALS PROGRAM INSPECTION REPORT**  
**PHONE: (303) 866-3567**

<b>MINE NAME:</b> Indian Springs Park Pit	<b>MINE/PROSPECTING ID#:</b> M-2001-087	<b>MINERAL:</b> Gravel	<b>COUNTY:</b> Fremont
<b>INSPECTION TYPE:</b> Monitoring	<b>WEATHER:</b> Cloudy	<b>INSP. DATE:</b> July 17, 2025	<b>INSP. TIME:</b> 10:20
<b>OPERATOR:</b> Fremont County	<b>OPERATOR REPRESENTATIVE:</b> Mr. Scott Hileman	<b>TYPE OF OPERATION:</b> 112c - Construction Regular Operation	
<b>REASON FOR INSPECTION:</b> Normal I&E Program	<b>BOND CALCULATION TYPE:</b> None	<b>BOND AMOUNT:</b> \$0.00	
<b>DATE OF COMPLAINT:</b> NA	<b>POST INSP. CONTACTS:</b> None	<b>JOINT INSP. AGENCY:</b> None	
<b>INSPECTOR(S):</b> Jocelyn Carter	<b>INSPECTOR'S SIGNATURE:</b>

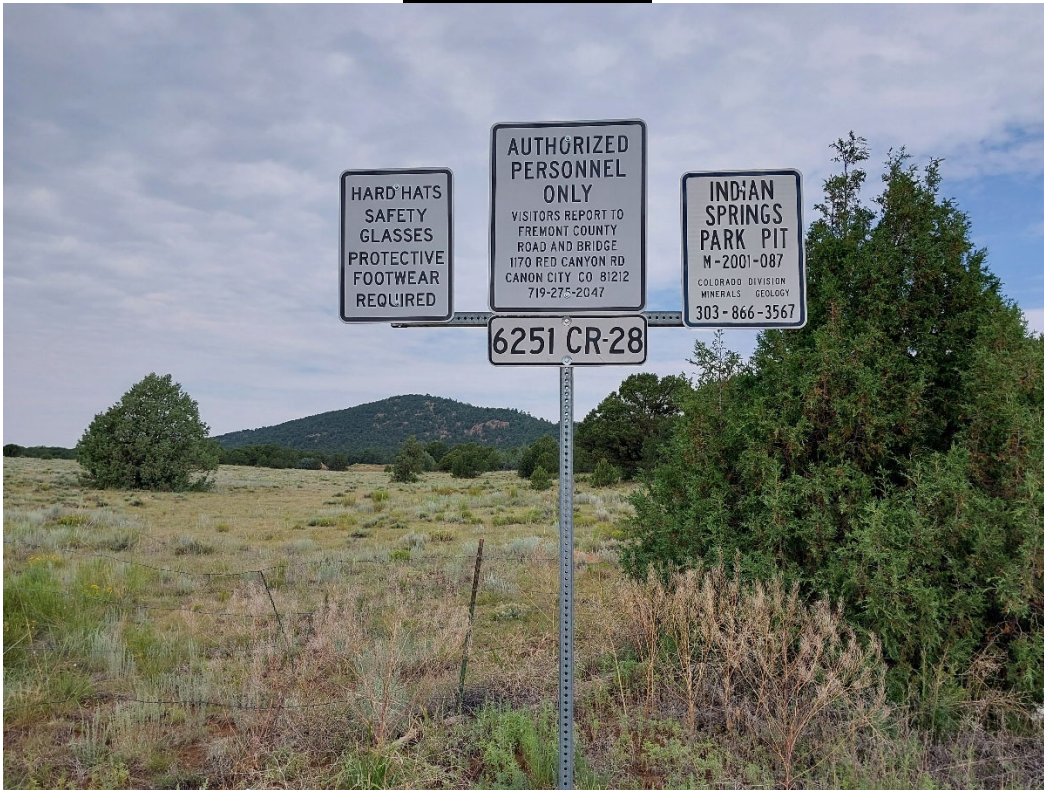
The required mine sign is posted at the entrance of the permitted area and is accurate according to the requirements of Rule 3.1.12(1). Boundary markers are placed at the corners of the permit, marked with white PVC tubing.

Photo #1: Mine sign posted at the entrance of the permitted area.

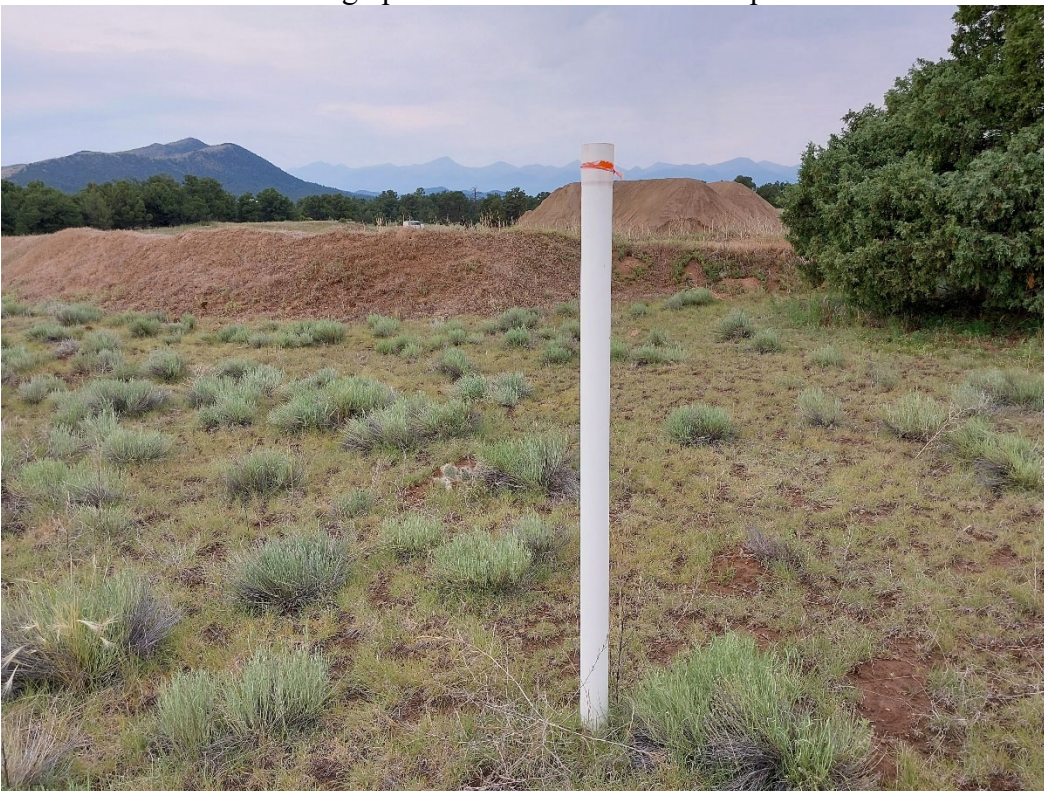
Photo #2: Example of a permit boundary marker set at the corners of the permitted area.

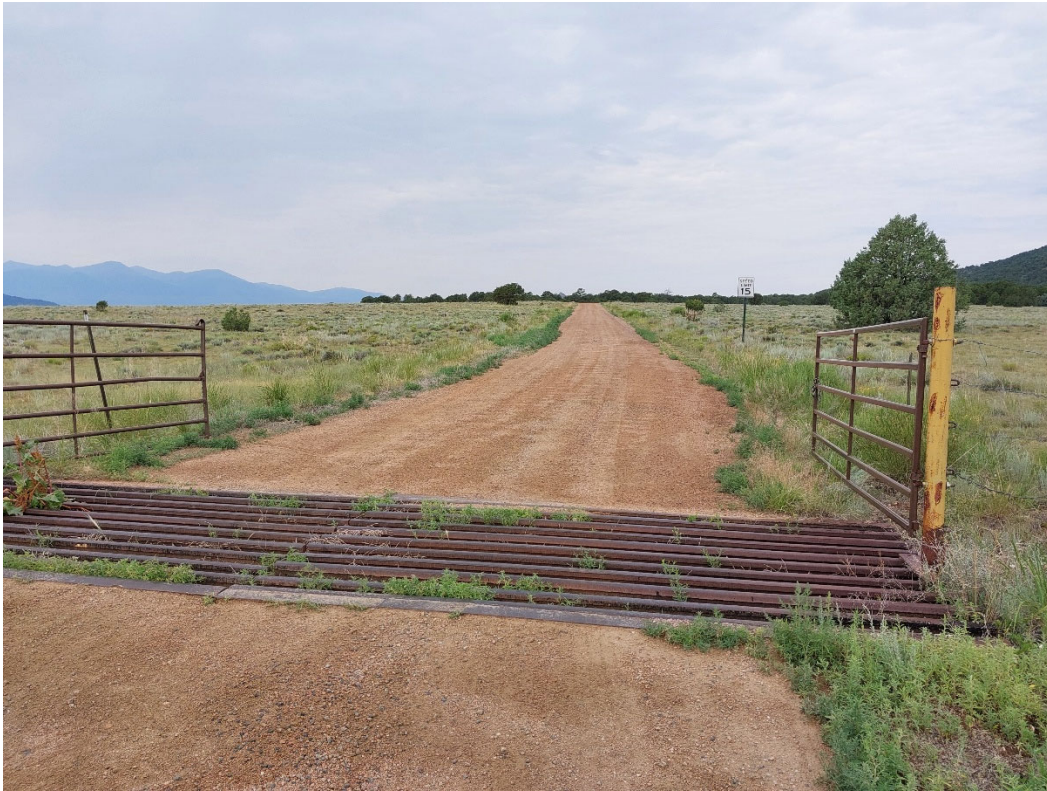
The roads appear to be stable and in good condition.

Photo #3: View of the access road from Gulch Road.

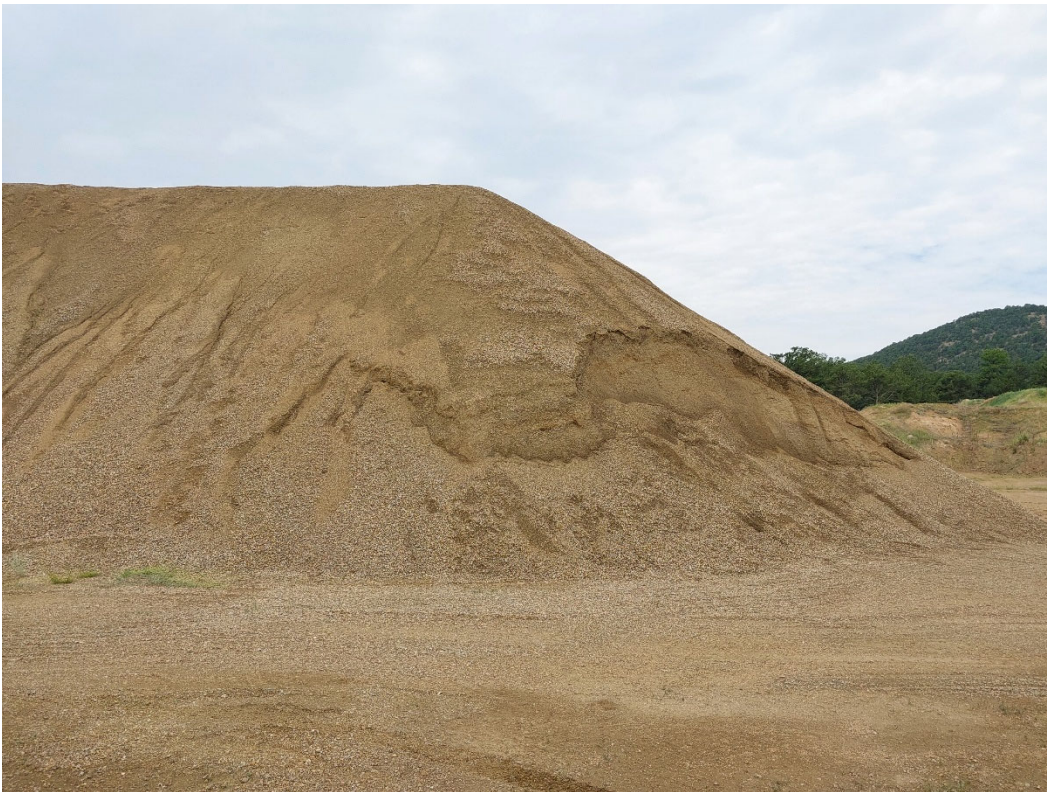
Photo #4: Stockpile of product material located on the pit floor.

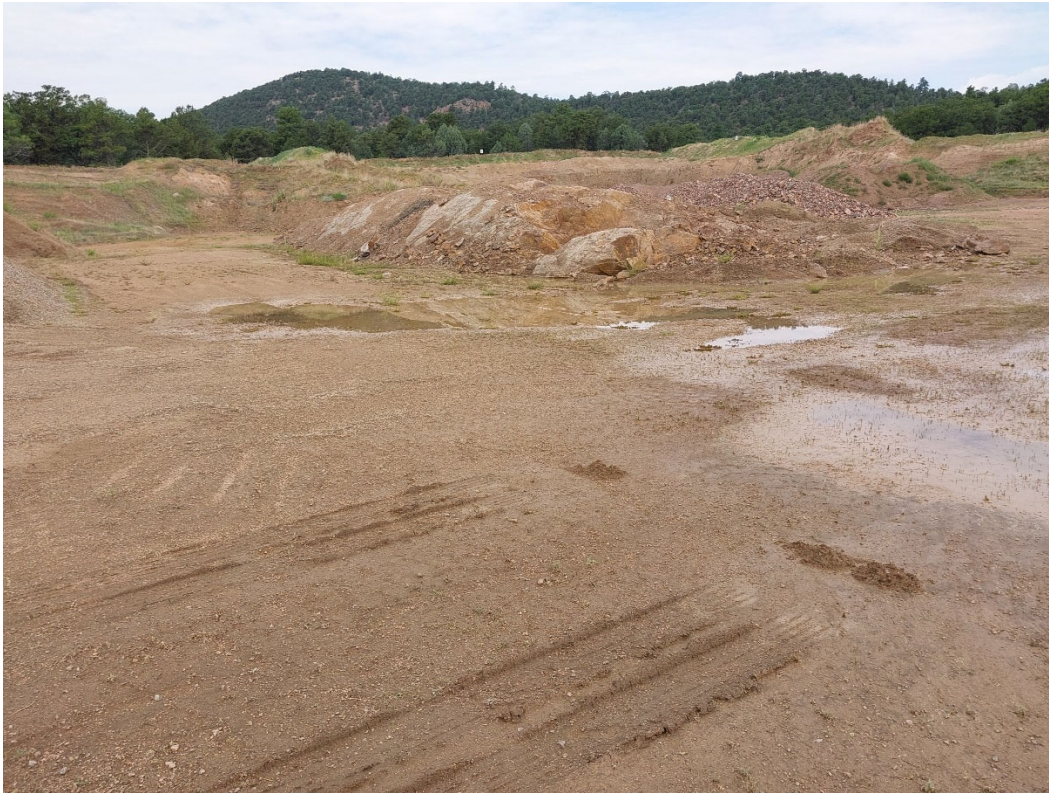
Photo #5: View of the current mining area from the pit floor.

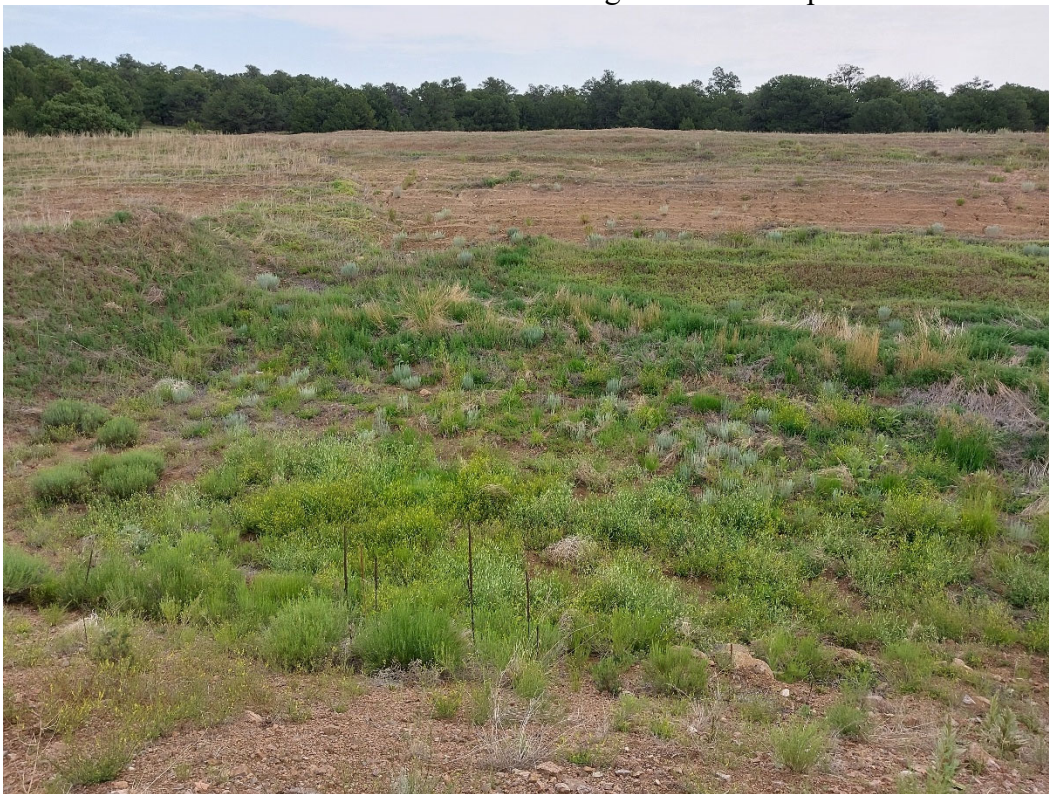
Areas that have been backfilled and graded appear to be sloped to the appropriate reclaimed slope of approximately 4H:1V. The slopes are stable and there did not appear to be erosion occurring.

Photo #6: Areas that have been backfilled, graded, and seeded in the southeastern area of the permitted area.

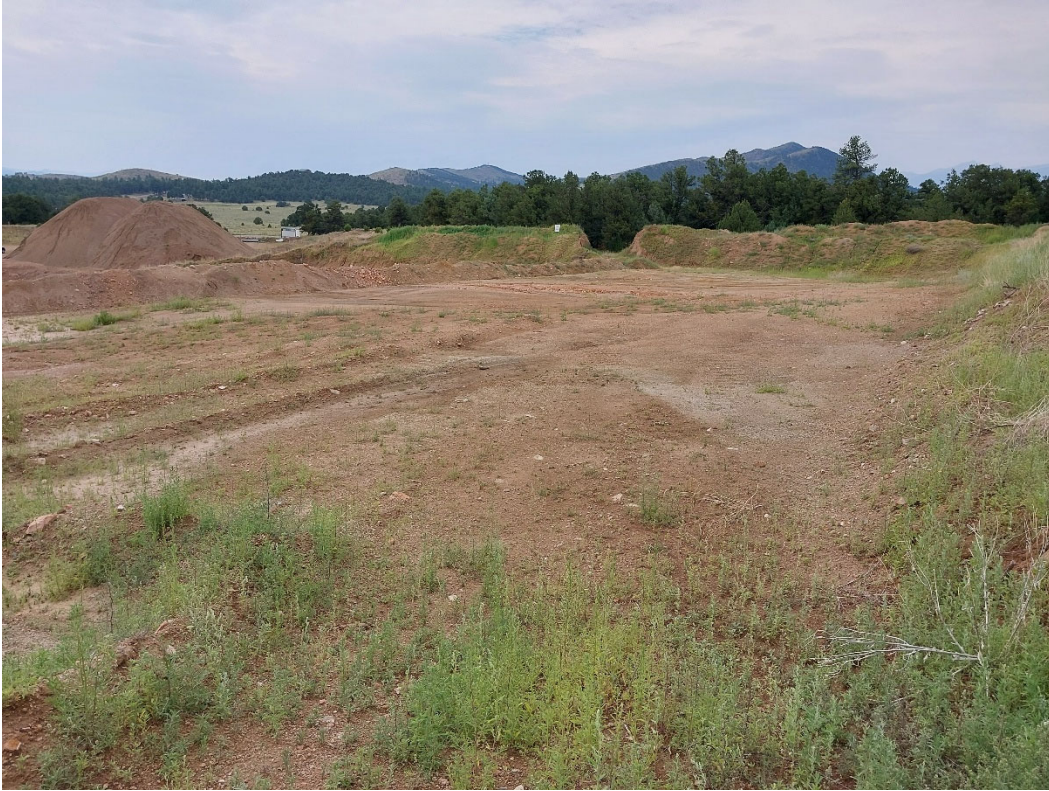
There are breaks in the surrounding berms around the active mining area for stormwater drainage. The breaks appear to be stable and effective.

The topsoil is stockpiled on the south portion of the active mining area. It is segregated from mining activity and is stable with well vegetated slopes. The topsoil is also labeled and does not appear to have been disturbed.

Photo #7: View of the current mining area with the topsoil stockpile along the back with the stormwater break in the berm and the topsoil sign visible. The stockpile of product material can be seen in the background on the left side of the picture.

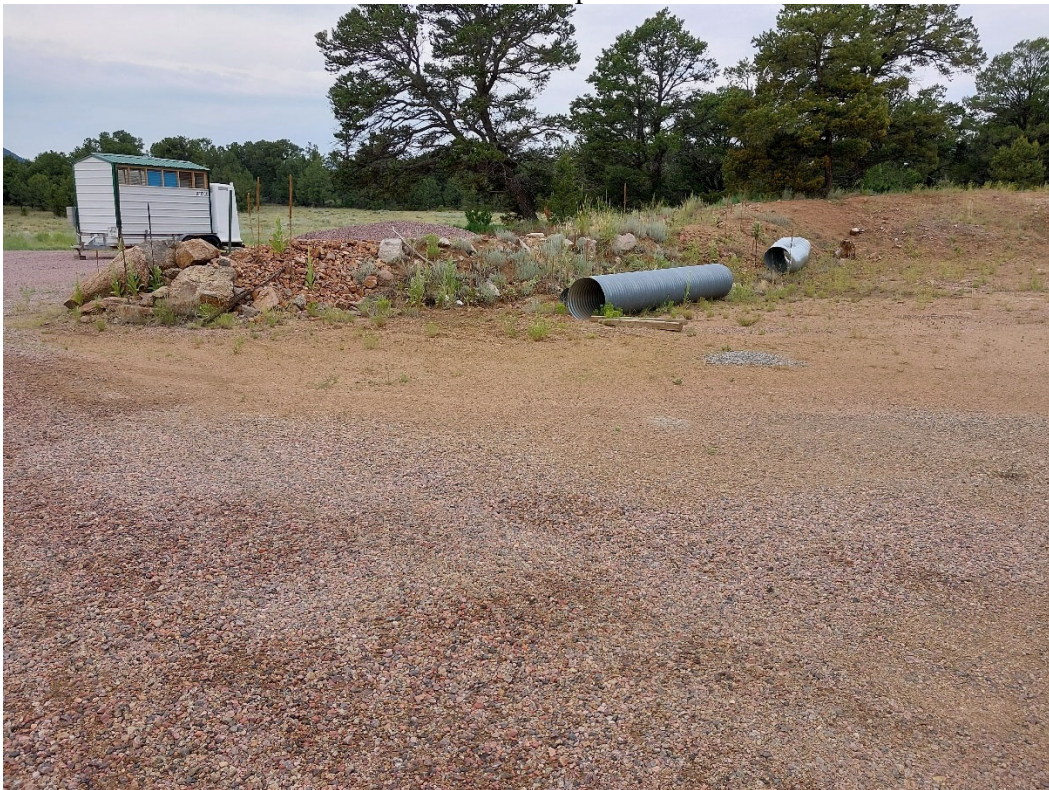
Photo #8: The culverts and the trailer structure observed near the pit entrance on the south side of the permit area.
