New Horizon Mine, C-1981-008, SL-29 Bond Release Inspection Report

PERMIT INFORMATION

Permit Number: C-1981-008 Mine Name: New Horizon Mine Operator: Elk Ridge Mining and Reclamation, LLC Operator Address: Mr Tony Tennyson P.O. Box 628 27646 West 5th Avenue Nucla, CO 81424	County: Montrose Operation Type: Surface Permit Status: Active Ownership: Private
	Operator Representative Present: Tony Tennyson
Operator Representative Signature: (Field Issuance Only)

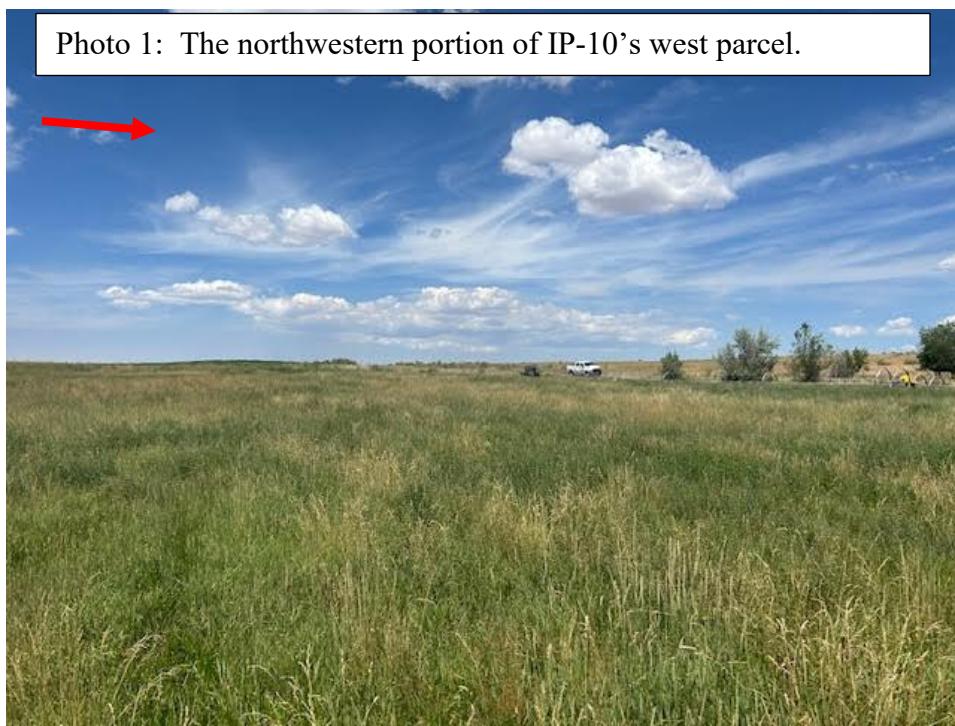
The inspection of IP-10 started at the western portion of the parcel (Photos 1-5). The site was covered with grass and some alfalfa. Vegetative growth on the western portion of the reclamation parcel was consistent. Vegetation was roughly knee to hip height. Thistle that had been sprayed earlier in the season were noted to be dead. No live thistles were identified in the western portion of IP-10. Buffalo Burr, a known noxious plant species toxic to livestock, was found within the western portion of IP-10 (Photo 6). Buffalo Burr(Solanum Rostratum) is a State recognized noxious weed; however, is not listed Class A, Class B or Class C noxious weed in Colorado. Colorado also has a list of noxious weeds that require management by landowners. Buffalo Burr is also not on this state list. Throughout the inspection of the western portion of IP-10 Mr. Guire and Mr. Tennyson hand picked the Buffalo Burr that was spotted. The central portion of IP-10 has a swale running from north to south. The swale was covered with cattails and other grasses (Photos 7 and 8). The eastern portion of IP-10 was also covered with grass and Alfalfa (Photos 9 through 12). Buffalo Burr was identified and hand picked by Mr. Guire and Mr. Tennyson. Buffalo Burr was identified in fair amounts throughout the bond release area. The approved Weed Control Plan is located within Section 2.05.4(2)(e) of the C-1981-008 Permit. Seed mixes used for Irrigated Pastures can be viewed in Section 2.05.4(2)(e).

Photo 1: The northwestern portion of IP-10's west parcel.

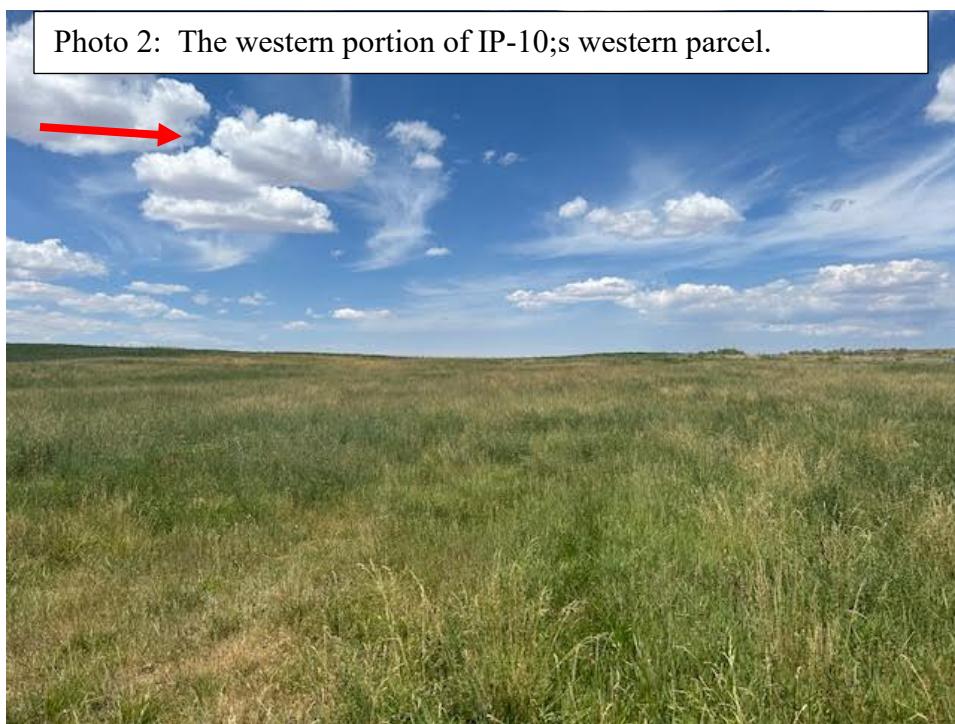
Photo 2: The western portion of IP-10;s western parcel.

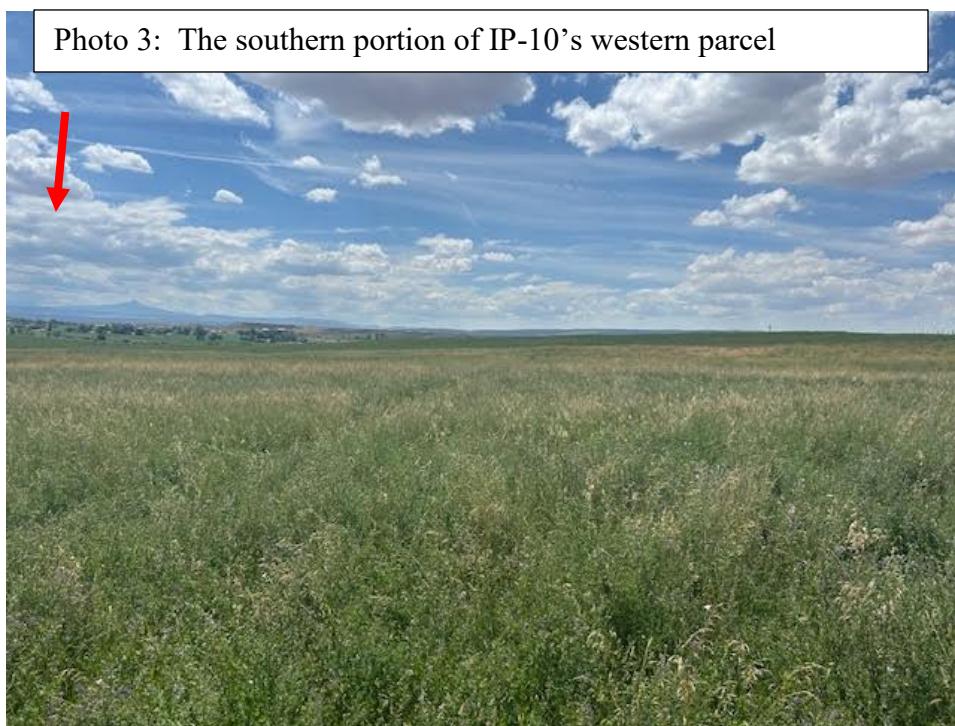
Photo 3: The southern portion of IP-10's western parcel

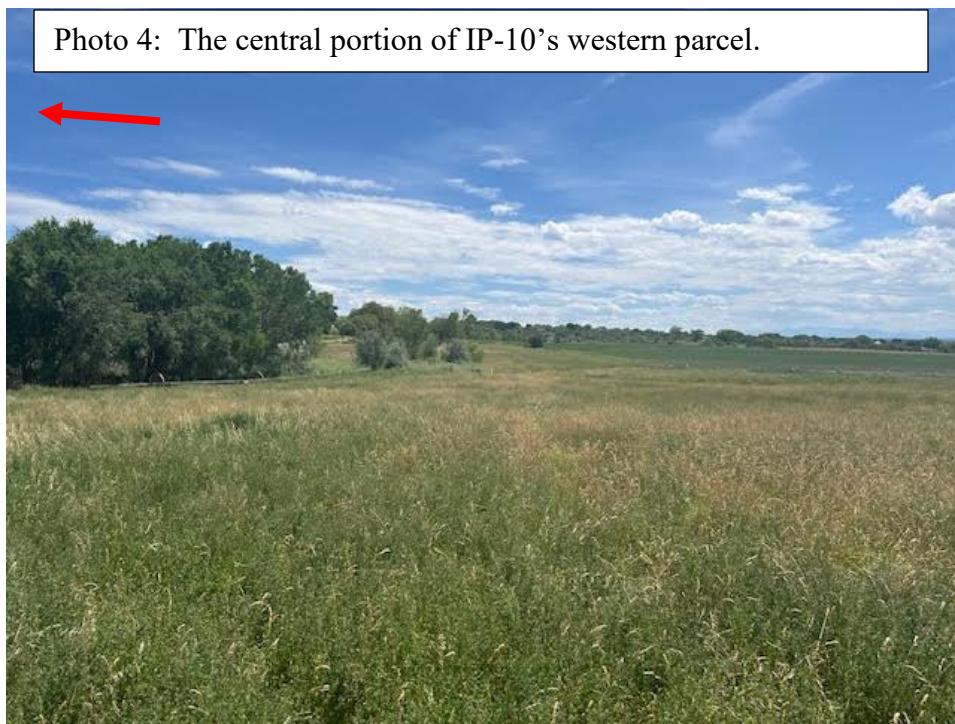
Photo 4: The central portion of IP-10's western parcel.

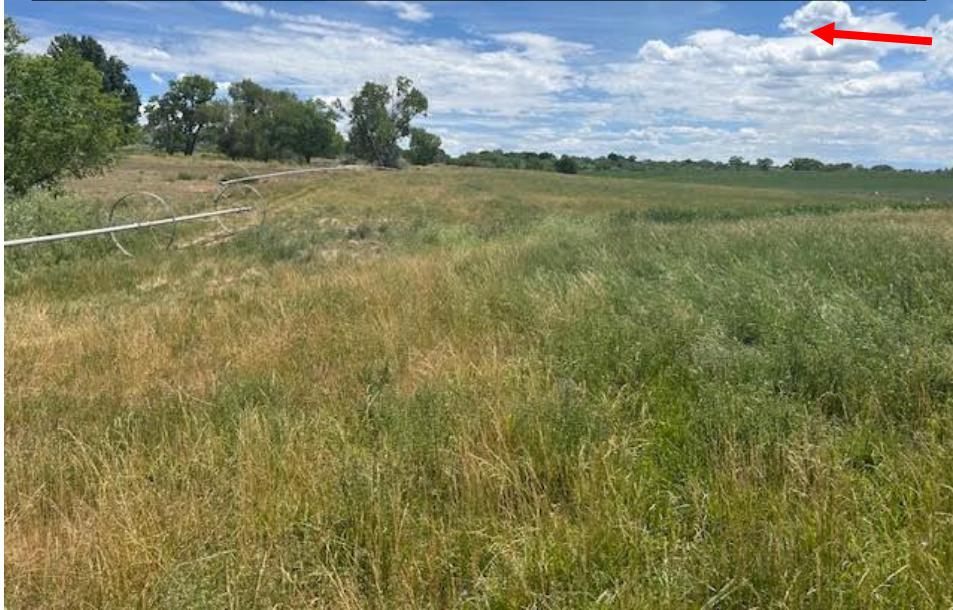
Photo 5: The eastern portion of IP-10's western parcel and the western portion of IP-10's eastern parcel.

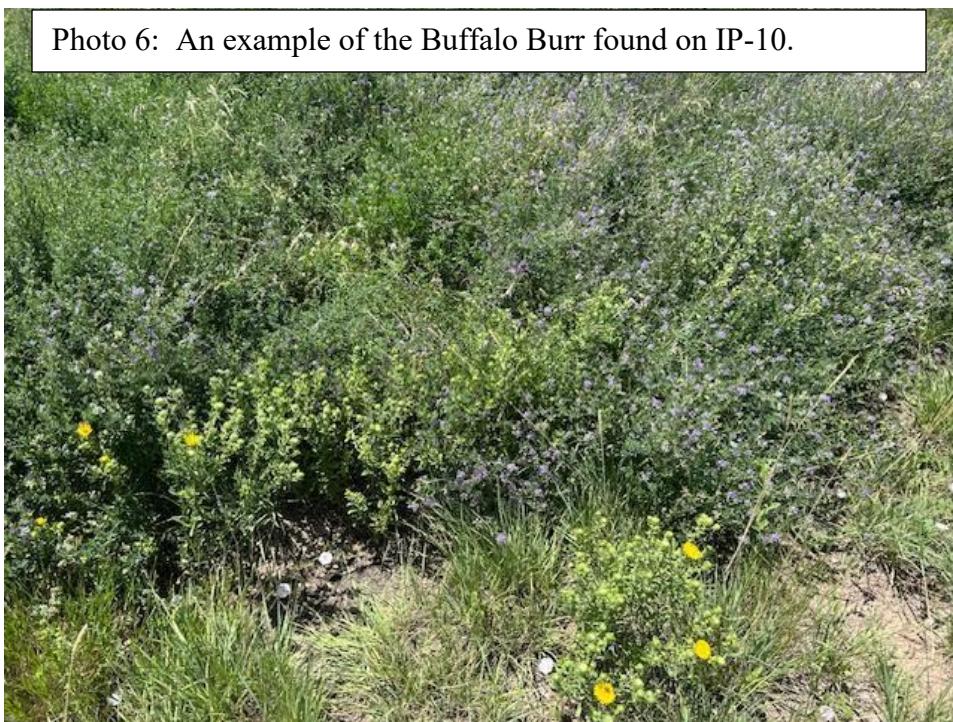
Parties to the inspection met at the New Horizon Mine's office located on 5th Street at 12:00. Mr. Guire informed the Division of the amounts of Buffalo Burr that had been identified on the acreage located within the SL-29 bond release request. Mr. Guire requested the Division take a look this plant species during the SL-29 inspection. Mr. Guire also discussed with the Division his concerns about the agreement between ERMR and GW46 Revocable Trust to leave the side roll irrigation equipment. The inspection party then visited IP-10, the 2.9 acres of Land applied for Phase III Bond Release under SL-29.

Photo 6: An example of the Buffalo Burr found on IP-10.

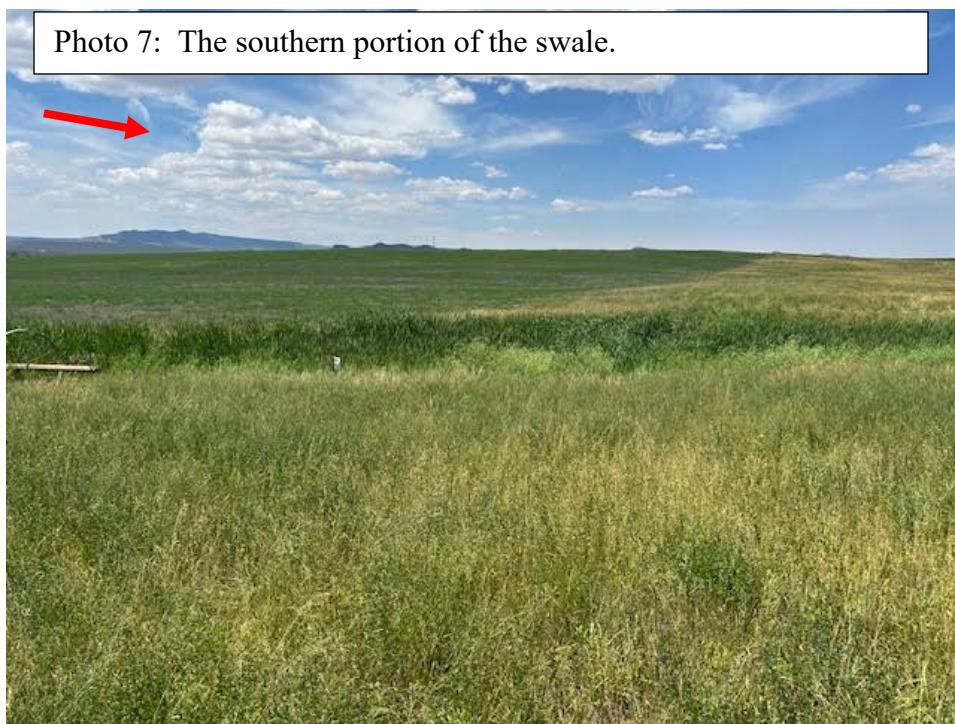
Reclamation on the western portion of IP-10 generally slopes down to the east/northeast. The reclamation was stable with vegetative cover. There were no indications of erosional features identified. The swale extends generally from the north downgradient to the south. The swale was observed to be stable with no erosional concerns. The eastern portion of IP-10 slopes from the northeast downgradient to the swale at the southwest. The eastern portion of IP-10 was covered with vegetation and was stable. There were no indications of erosional features. Side Roll irrigation equipment was located at the northern permit boundary of the eastern portion of IP-10. The equipment was inactive during the inspection (Equipment can be seen in the middle left portion of photos 5, 9 and 10). The approved post mining topography for IP-10 can be viewed on Map 2.05.4-1 of the C-1981-008 Permit.

Photo 7: The southern portion of the swale.

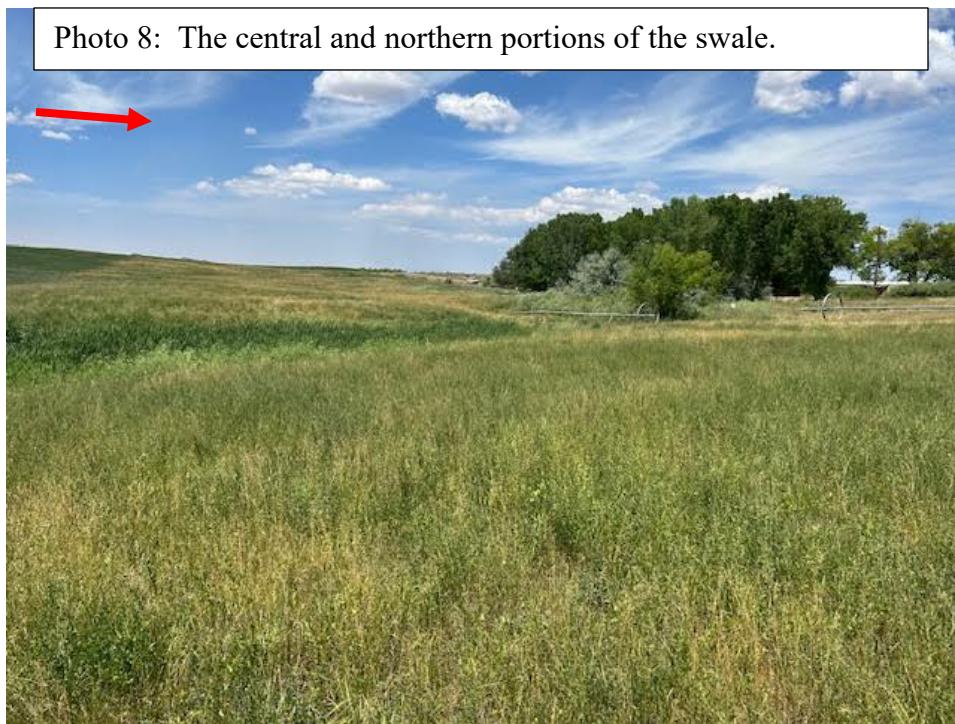
Photo 8: The central and northern portions of the swale.

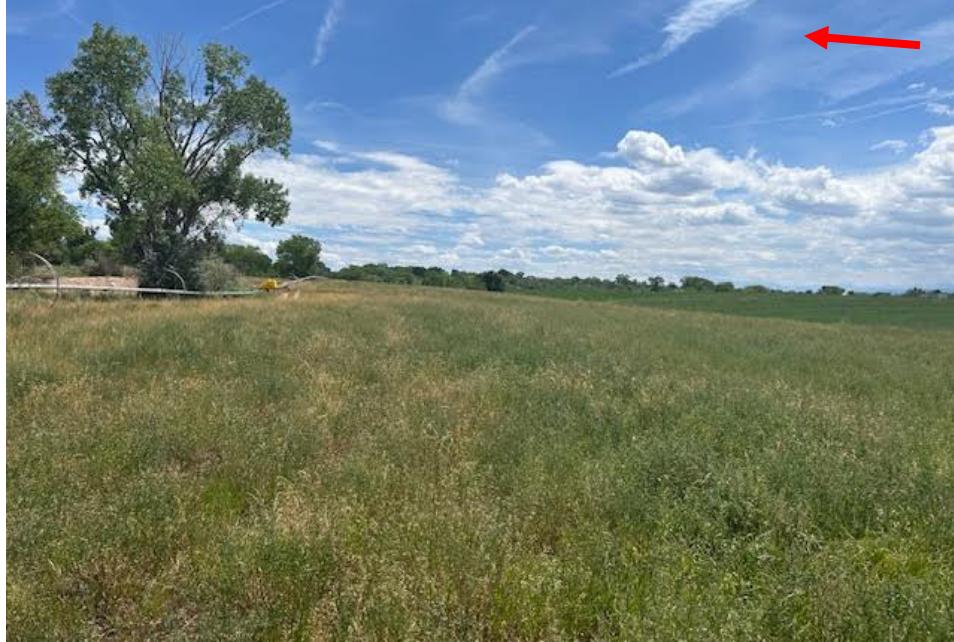
Photo 9: The western portion of IP-10's eastern parcel.

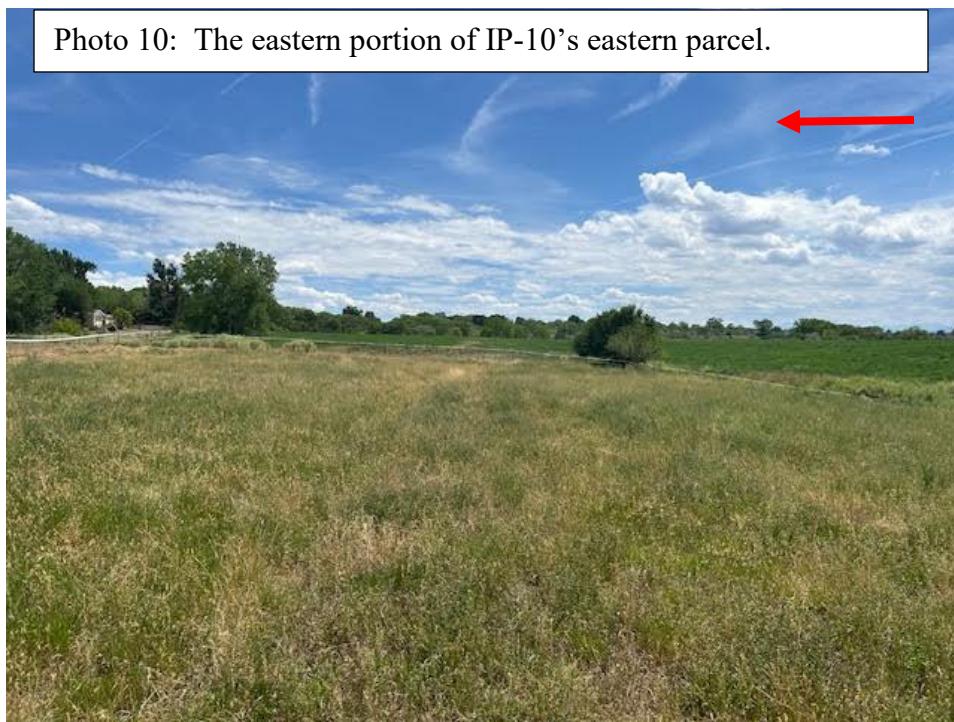
Photo 10: The eastern portion of IP-10's eastern parcel.

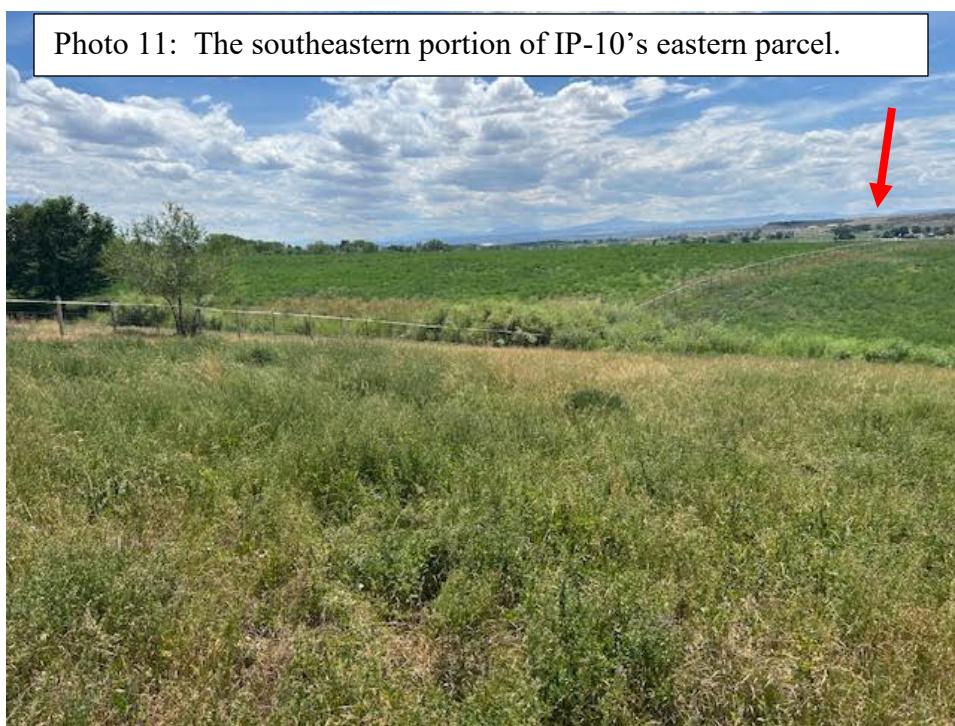
Photo 11: The southeastern portion of IP-10's eastern parcel.

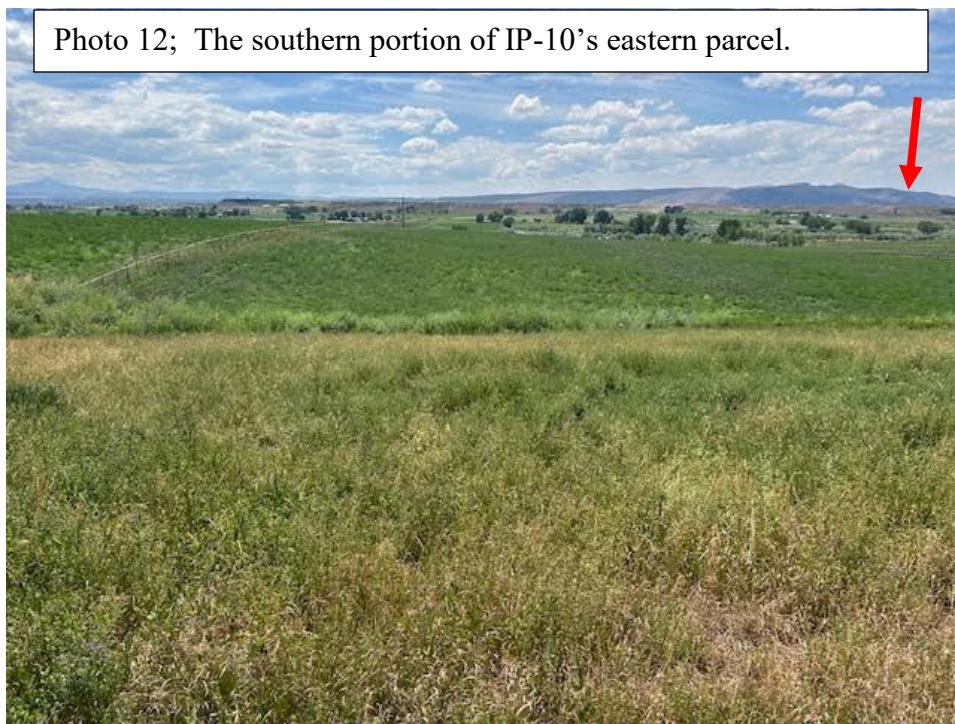
Photo 12; The southern portion of IP-10's eastern parcel.
