New Horizon Mine, C-1981-008, SL-29 Bond Release Inspection Report

PERMIT INFORMATION

Permit Number: C-1981-008 Mine Name: New Horizon Mine Operator: Elk Ridge Mining and Reclamation, LLC Operator Address: Mr Tony Tennyson P.O. Box 628 27646 West 5th Avenue Nucla, CO 81424	County: Montrose Operation Type: Surface Permit Status: Active Ownership: Private
	Operator Representative Present: Tony Tennyson
Operator Representative Signature: (Field Issuance Only)

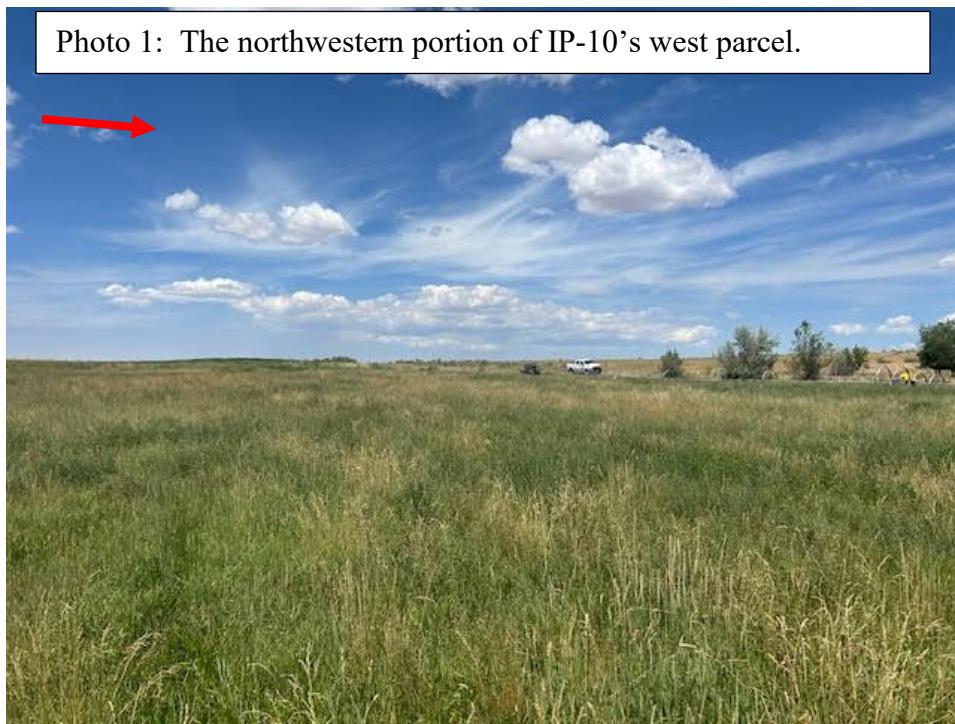
The inspection of IP-10 started at the western portion of the parcel (Photos 1-5). The site was covered with grass and some alfalfa. Vegetative growth on the western portion of the reclamation parcel was consistent. Vegetation was roughly knee to hip height. Thistle that had been sprayed earlier in the season were noted to be dead. No live thistles were identified in the western portion of IP-10. Buffalo Burr, a known noxious plant species toxic to livestock, was found within the western portion of IP-10 (Photo 6). Buffalo Burr(Solanum Rostratum) is a State recognized noxious weed; however, is not listed Class A, Class B or Class C noxious weed in Colorado. Colorado also has a list of noxious weeds that require management by landowners. Buffalo Burr is also not on this state list. Throughout the inspection of the western portion of IP-10 Mr. Guire and Mr. Tennyson hand picked the Buffalo Burr that was spotted. The central portion of IP-10 has a swale running from north to south. The swale was covered with cattails and other grasses (Photos 7 and 8). The eastern portion of IP-10 was also covered with grass and Alfalfa (Photos 9 through 12). Buffalo Burr was identified and hand picked by Mr. Guire and Mr. Tennyson. Buffalo Burr was identified in fair amounts throughout the bond release area. The approved Weed Control Plan is located within Section 2.05.4(2)(e) of the C-1981-008 Permit. Seed mixes used for Irrigated Pastures can be viewed in Section 2.05.4(2)(e).

Photo 1: The northwestern portion of IP-10's west parcel.

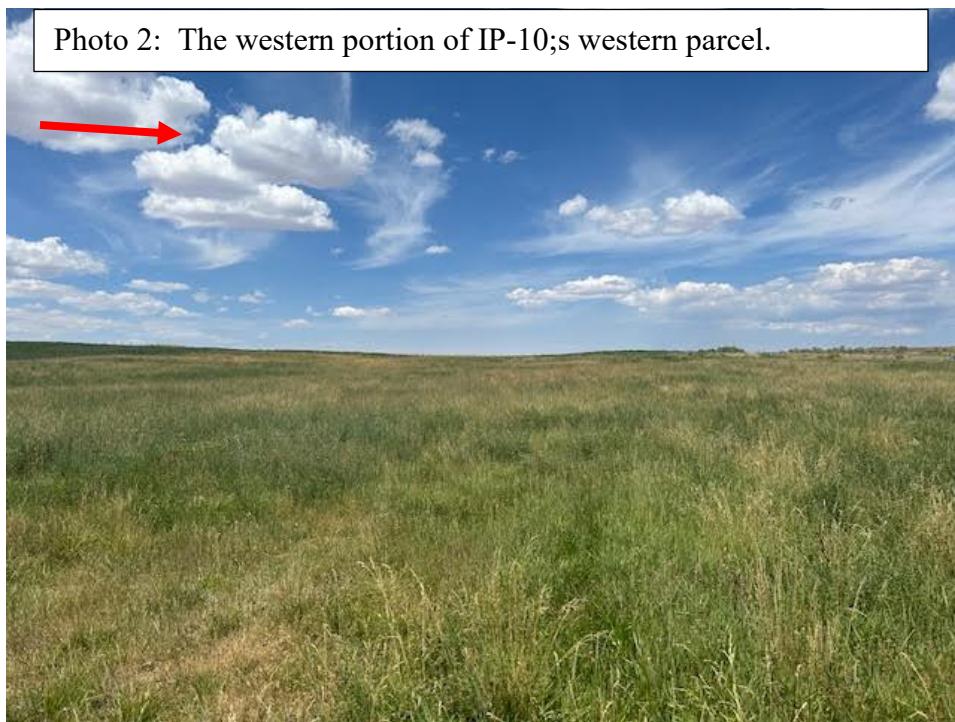
Photo 2: The western portion of IP-10;s western parcel.

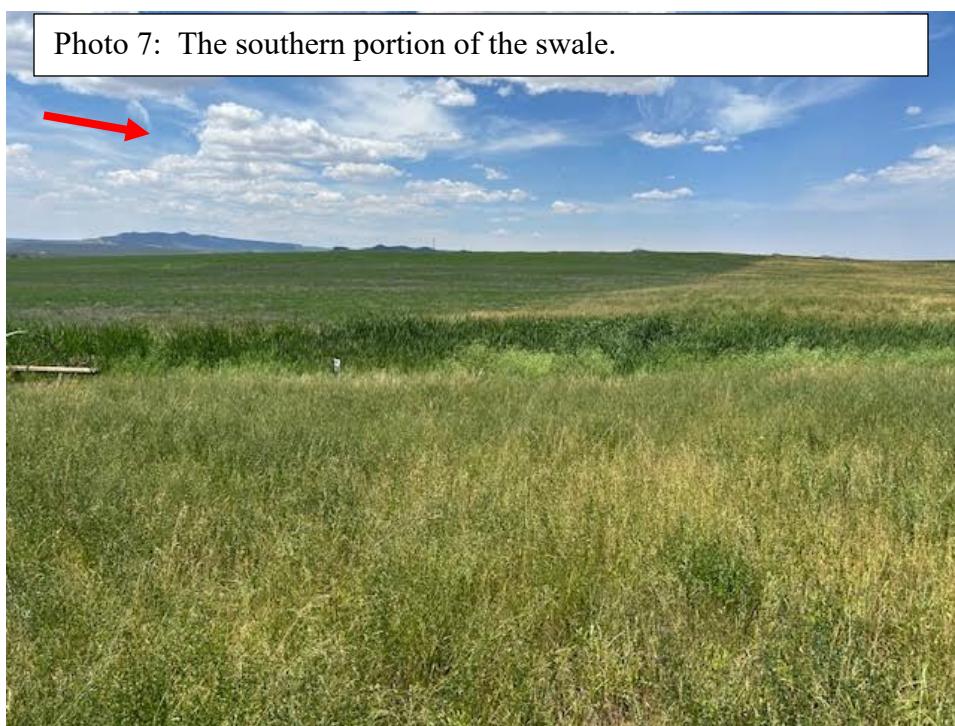
Reclamation on the western portion of IP-10 generally slopes down to the east/northeast. The reclamation was stable with vegetative cover. There were no indications of erosional features identified. The swale extends generally from the north downgradient to the south. The swale was observed to be stable with no erosional concerns. The eastern portion of IP-10 slopes from the northeast downgradient to the swale at the southwest. The eastern portion of IP-10 was covered with vegetation and was stable. There were no indications of erosional features. Side Roll irrigation equipment was located at the northern permit boundary of the eastern portion of IP-10. The equipment was inactive during the inspection (Equipment can be seen in the middle left portion of photos 5, 9 and 10). The approved post mining topography for IP-10 can be viewed on Map 2.05.4-1 of the C-1981-008 Permit.

Photo 7: The southern portion of the swale.

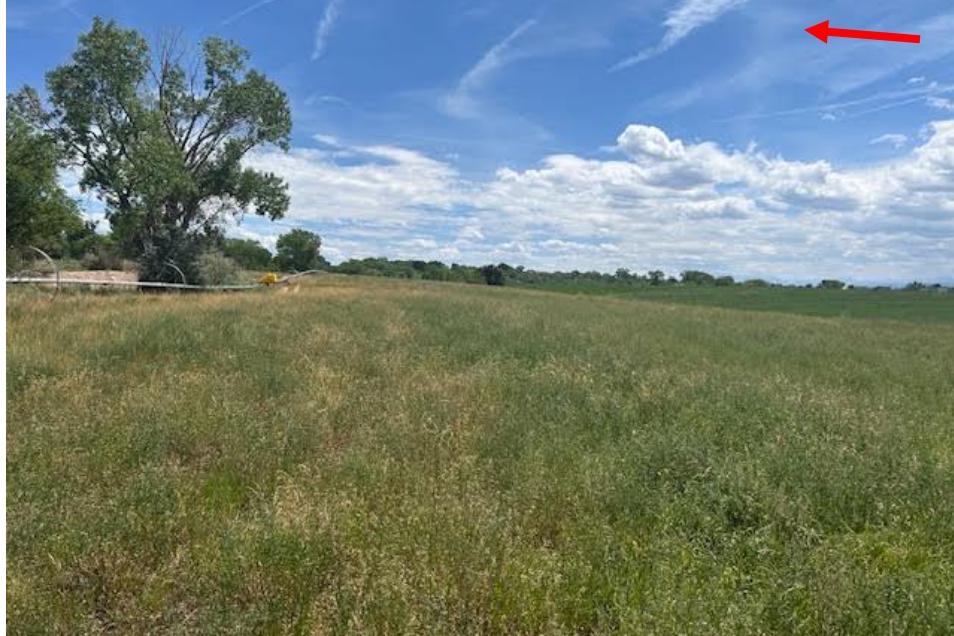
Photo 9: The western portion of IP-10's eastern parcel.

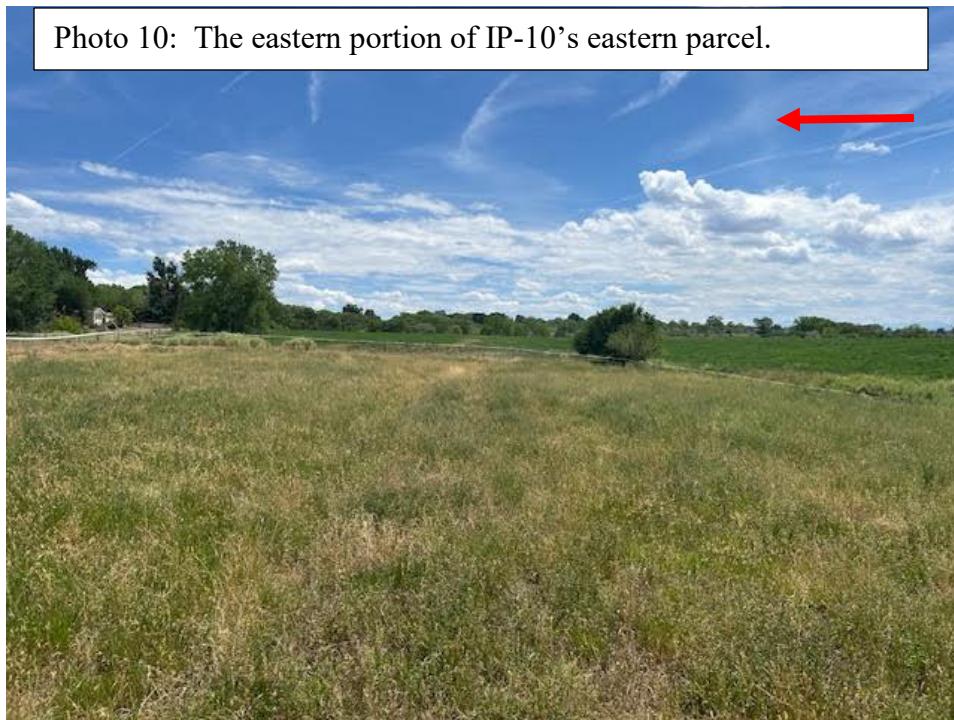
Photo 10: The eastern portion of IP-10's eastern parcel.
