## Tierra Piedra Gravel Pit M2009081- June 2025 Inspection Report

### MINERALS PROGRAM INSPECTION REPORT

<b>MINE NAME:</b> Tierra Piedra Gravel Pit	<b>MINE/PROSPECTING ID#:</b> M-2009-081	<b>MINERAL:</b> Sand and gravel	<b>COUNTY:</b> Archuleta
<b>INSPECTION TYPE:</b> Monitoring	<b>WEATHER:</b> Clear	<b>INSP. DATE:</b> June 17, 2025	<b>INSP. TIME:</b> 14:30
<b>OPERATOR:</b> Tierra Piedra Ranch LLC	<b>OPERATOR REPRESENTATIVE:</b> Brian Abeln	<b>TYPE OF OPERATION:</b> 110c - Construction Limited Impact

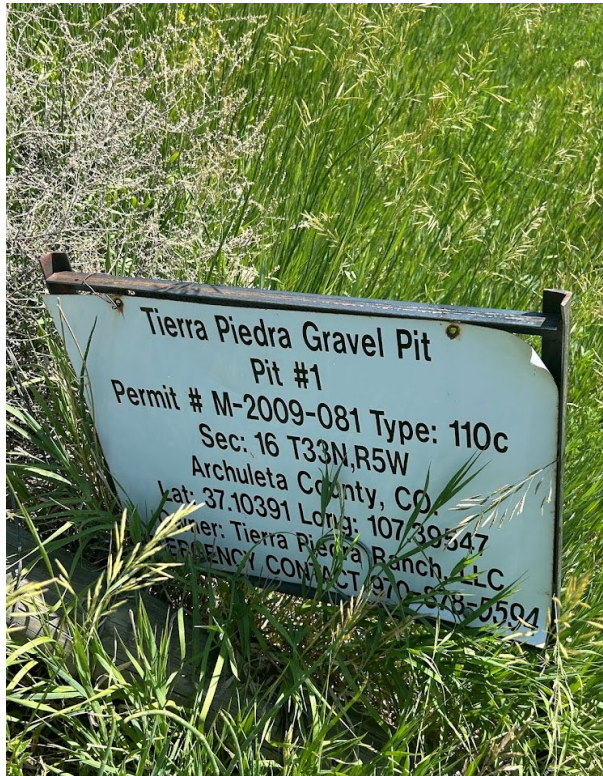
A mine identification sign was located at the entrance to the site in compliance with Rule 3.1.12(1) (see Photo 1). Affected area markers were not observed delineating the entire affected land boundary. This is cited as a problem at the beginning of the report. Pursuant to Rule 3.1.12(2), please mark the affected area boundaries.

Photo 1: Mine entrance sign along access road to the north of the permit area.

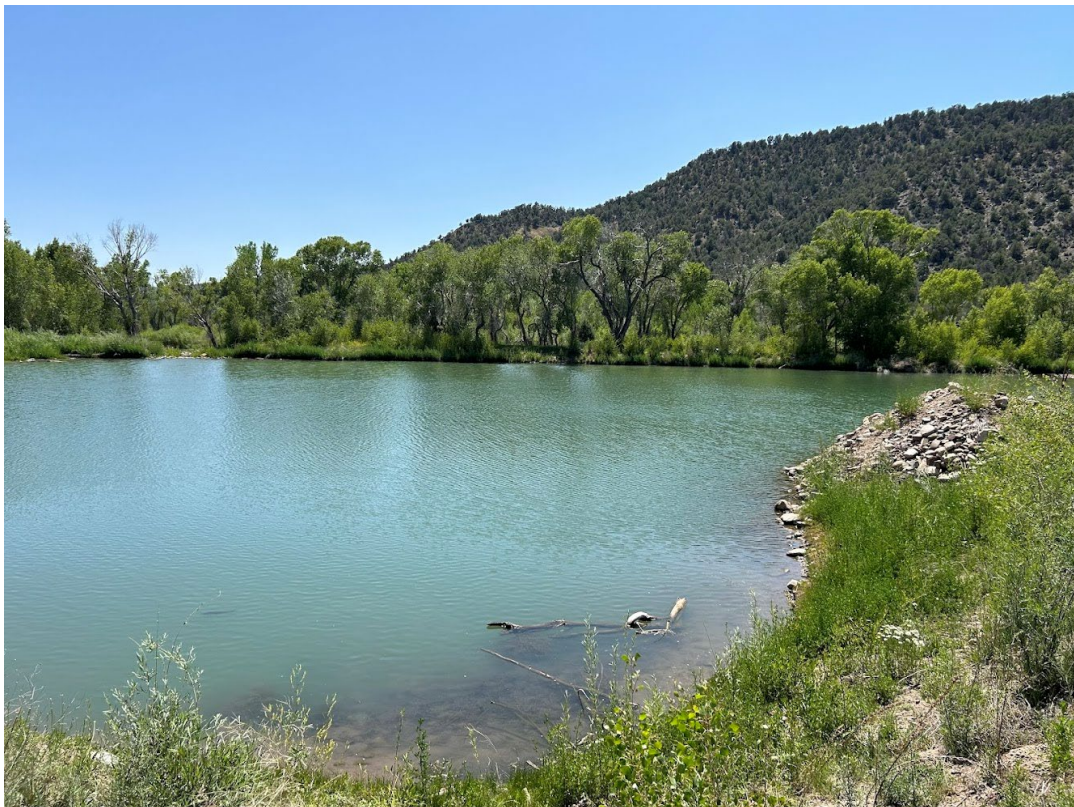
The site is located on the eastern side of Piedra River, which cuts through the San Juan Mountains before discharging into Navajo Reservoir to the south. The site was not active at the time of the inspection. All mining equipment has been removed. The Operator has mined a pit into the alluvium, which is now filled with water and is a pond approximately 2.2 acres in size (see Photos 2-3). Due to its proximity to the Piedra River, water fills into the pit/pond. The mining plan allows for excavation down to a depth of thirty (30) feet. Groundwater is anticipated to be encountered between twenty-five (25) to 30 feet below ground surface in the area, thus exposing groundwater during excavation of the pit. In a memo (dated 11/19/2009) from the Colorado Division of Water Resources (DWR), the Operator is not required to obtain an augmentation plan. The Division will verify this is still the case during the review process for the AM-1 application. The pond shoreline slopes are relaxed, with slopes at 3H:1V configuration or less steep (see Photos 2-3). No evidence of erosion was observed.

Photo 2: View of water-filled pit/pond, facing southwest.

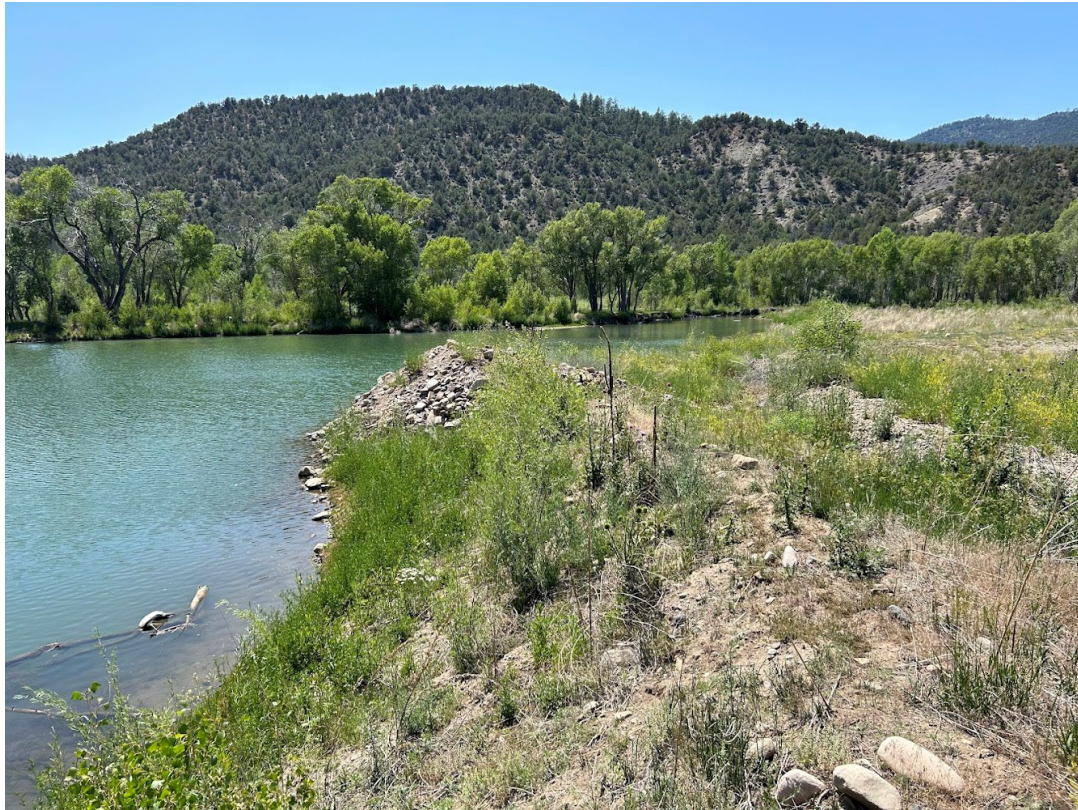
Photo 3: View of pond shoreline and vegetation, facing west.

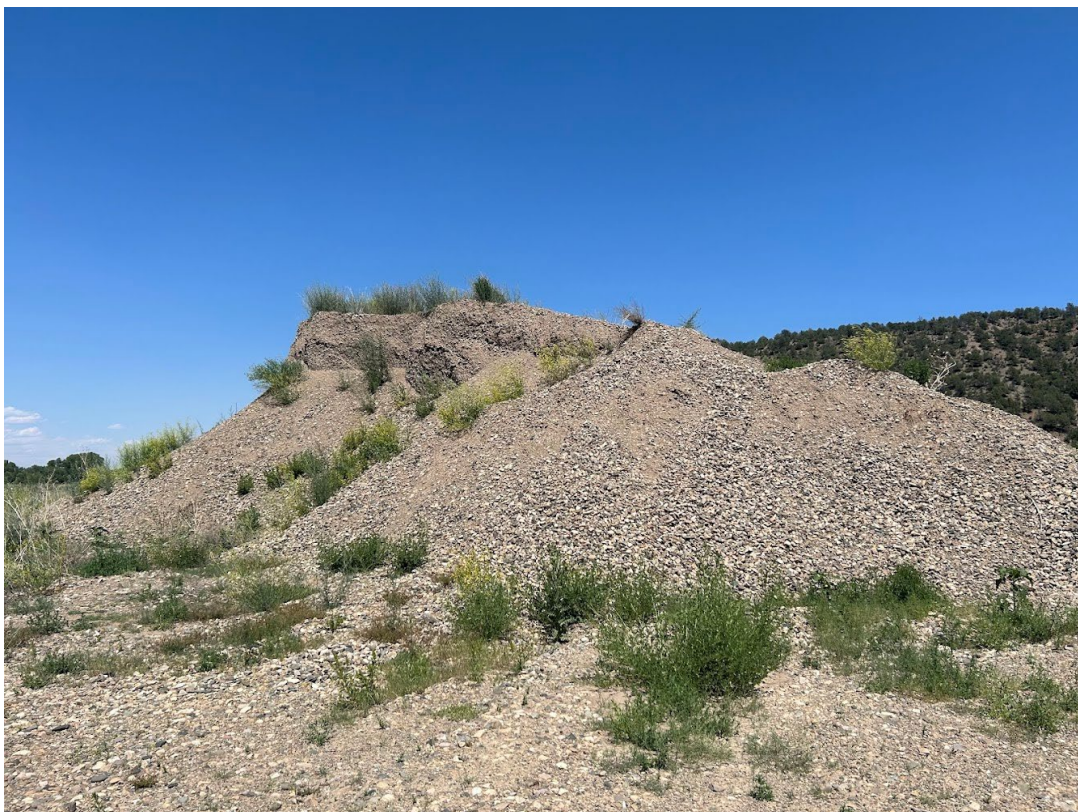
A stockpile of sand and gravel is located to the north of the pond and along the fence (see Photo 4). Along the pond shorelines and to the north, vegetation has established in thick patches, which include predominantly Yellow sweet clover, Smooth brome, and weeds. Noxious weeds observed include a significant amount of Common mullein along the pond shoreline, and Musk thistle throughout the site (see Photos 3, 5-8). Vegetated topsoil stockpiles were observed to the east of the pond and appeared to be stable with adequate vegetation cover, including some weeds. In accordance with Rule 3.1.10(6) of the Construction Materials Rules and Regulations governing weed control, the DRMS will require the Operator to develop a weed control plan to be employed to control the current infestation and prevent the spread of weeds to the surrounding area.

Photo 4: Material stockpile north of the pond, facing northeast.

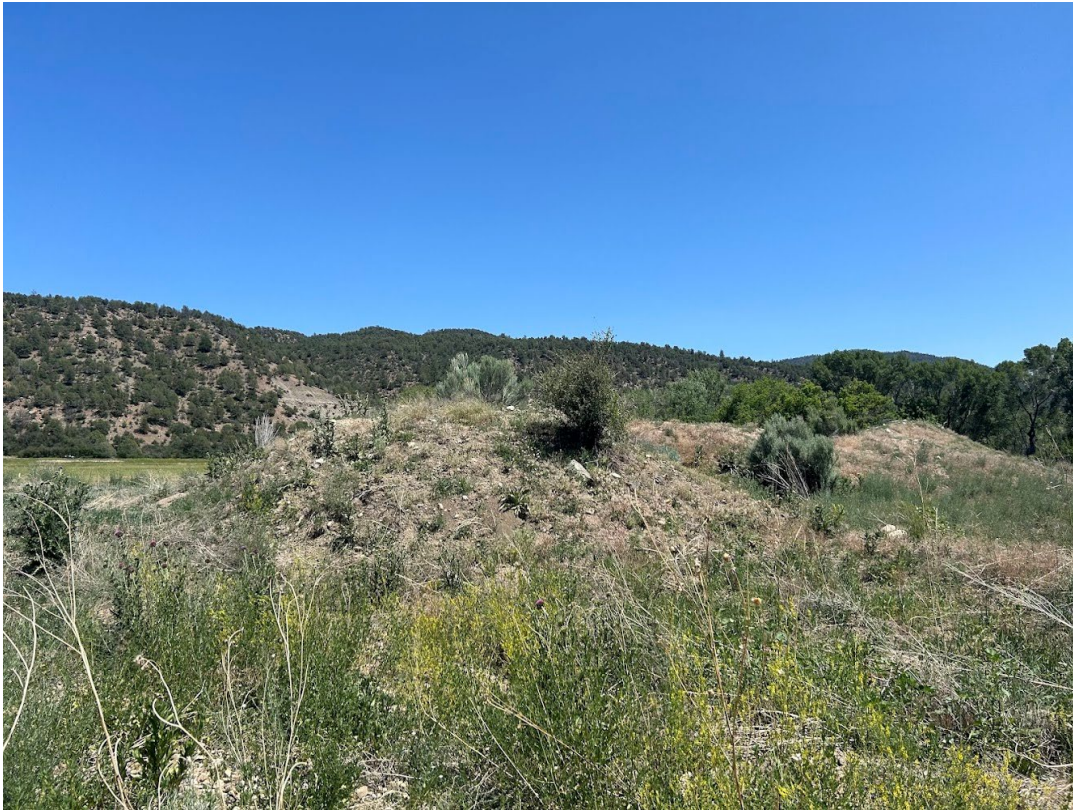
Photo 5: View of vegetated topsoil stockpile along the eastern shoreline of the pond, facing southwest.

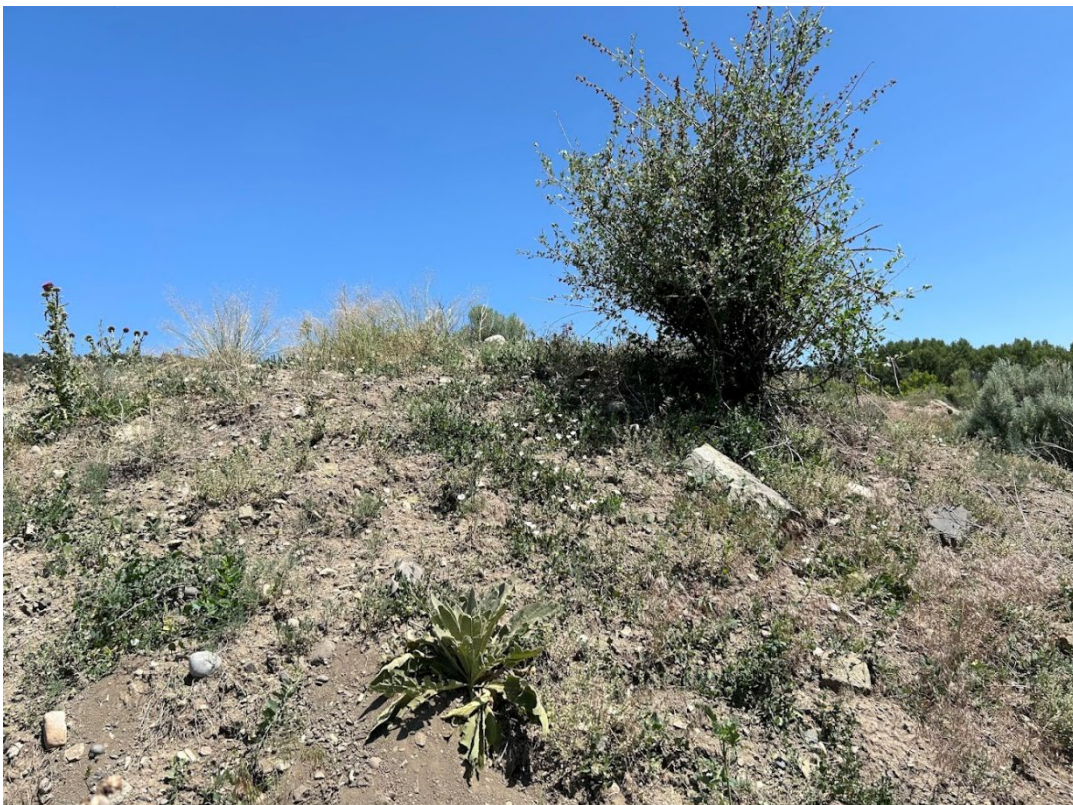
Photo 6: View of noxious weeds, including Common mullein, Oxeye daisy, and Musk thistle on the topsoil stockpile.

The Operator submitted an Amendment Application (AM-1) on July 1, 2025, to increase the permit area from 6.4 acres to 9.99 acres. AM-1 was deemed complete on July 21, 2025, and a preliminary Adequacy Review letter was sent by DRMS on August 11, 2025. In the AM-1 Adequacy Review letter, the Division requested the Operator include a weed control plan as an addendum to AM-1, so the weed control issue will be addressed through the AM-1 permitting action.

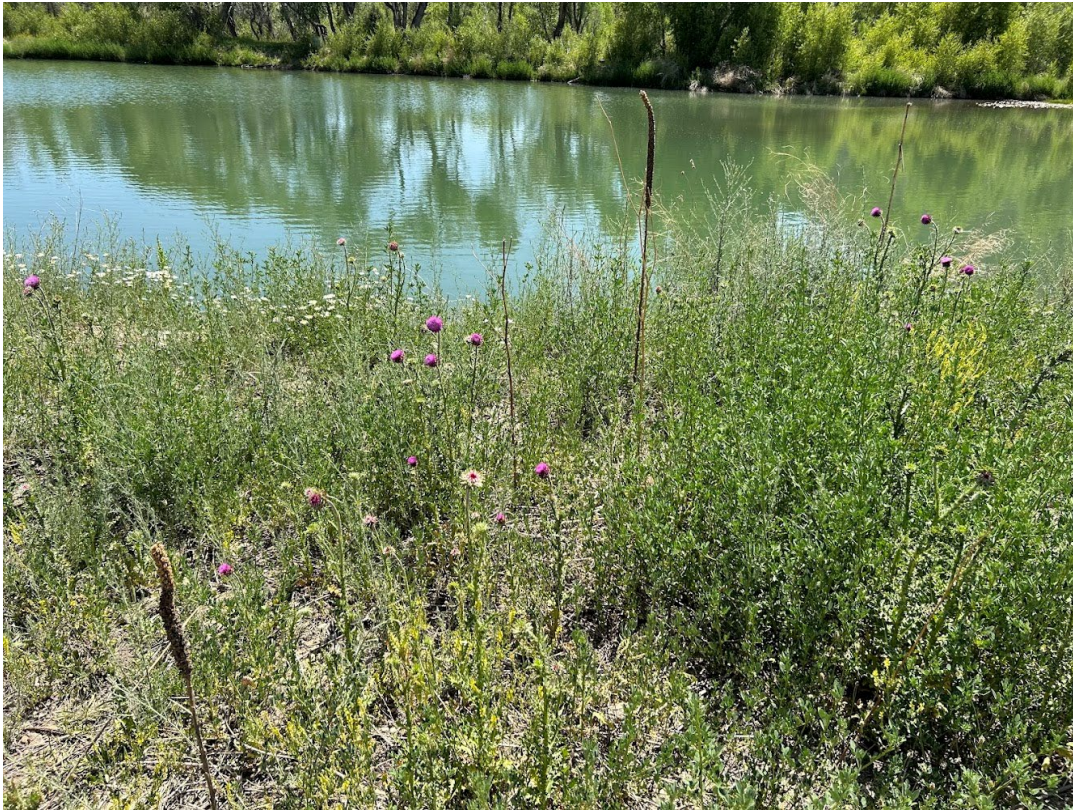
Photo 7: View of noxious weeds along the pond shoreline, facing south.

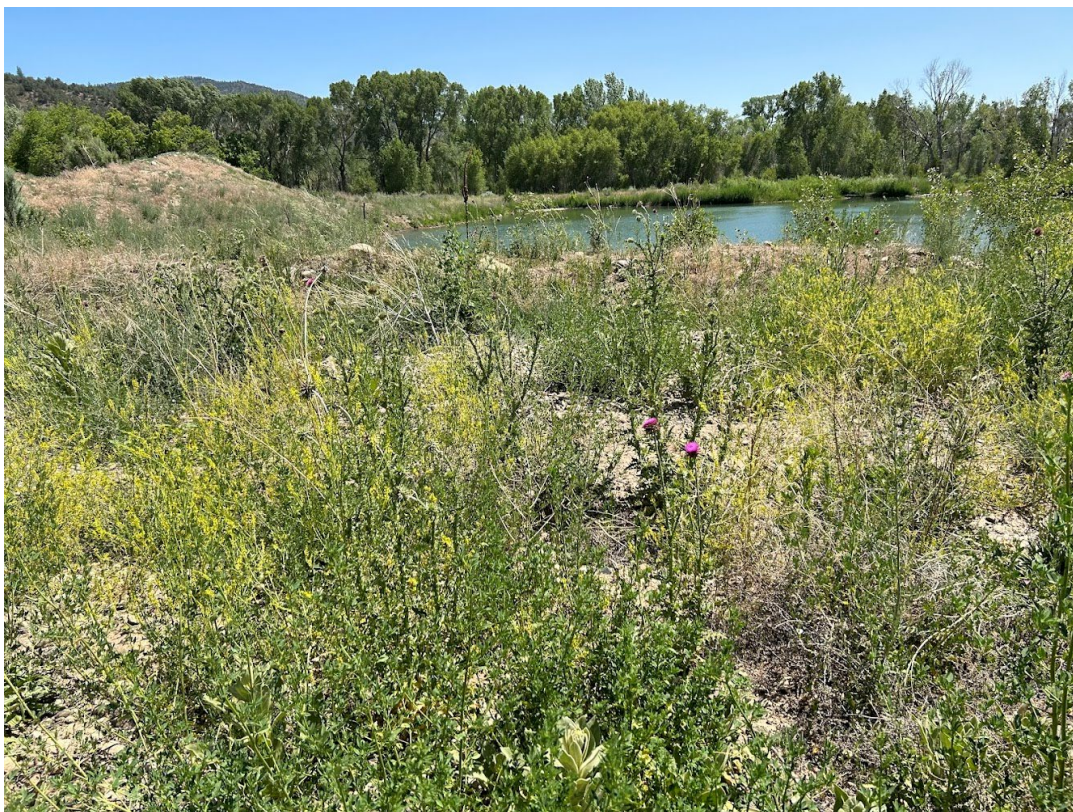
Photo 8: View permit area with noxious weeds north of the pond, facing southeast.
