**MINERALS PROGRAM INSPECTION REPORT**  
**PHONE: (303) 866-3567**

| <b>MINE NAME:</b><br>Climax Mine | <b>MINE/PROSPECTING ID#:</b><br>M-1977-493 | <b>MINERAL:</b><br>Molybdenum | <b>COUNTY:</b><br>Lake |
| <b>INSPECTION TYPE:</b><br>Monitoring | <b>WEATHER:</b> Clear | <b>INSP. DATE:</b><br>August 4, 2025 | <b>INSP. TIME:</b><br>13:30 |

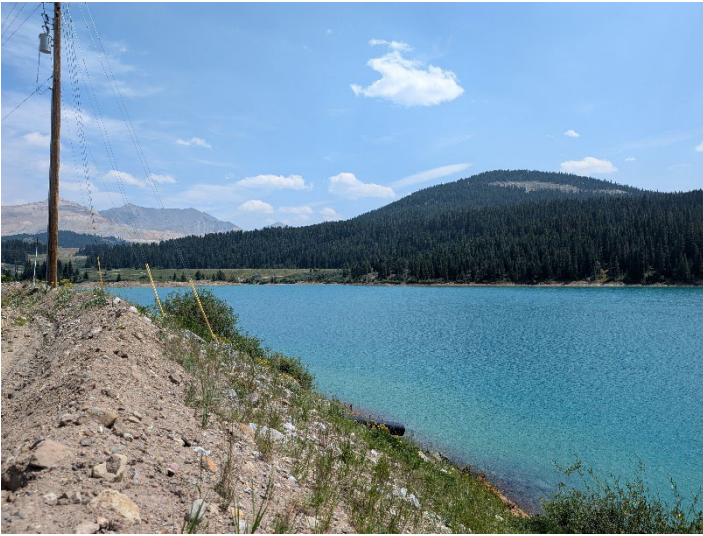
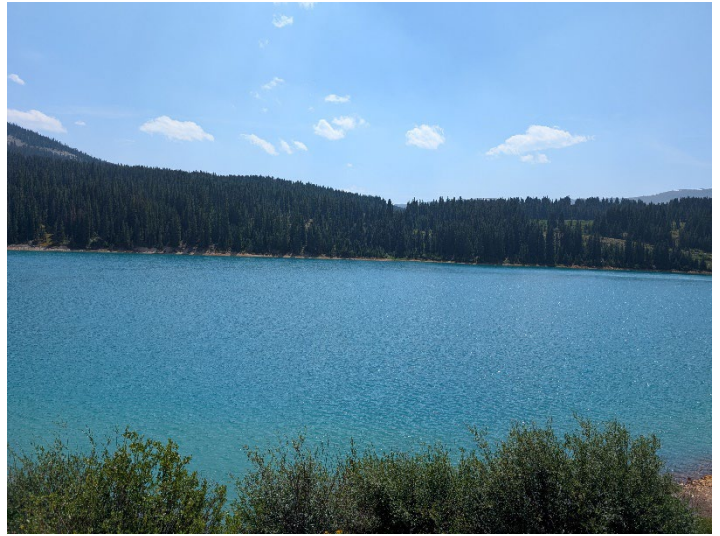
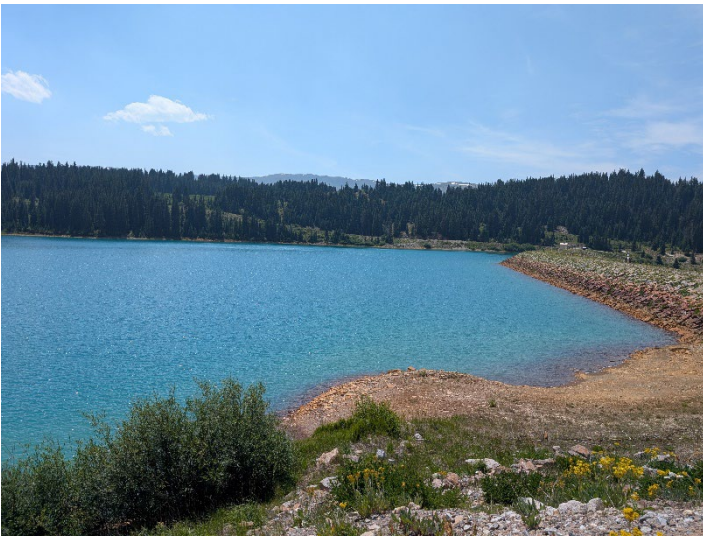
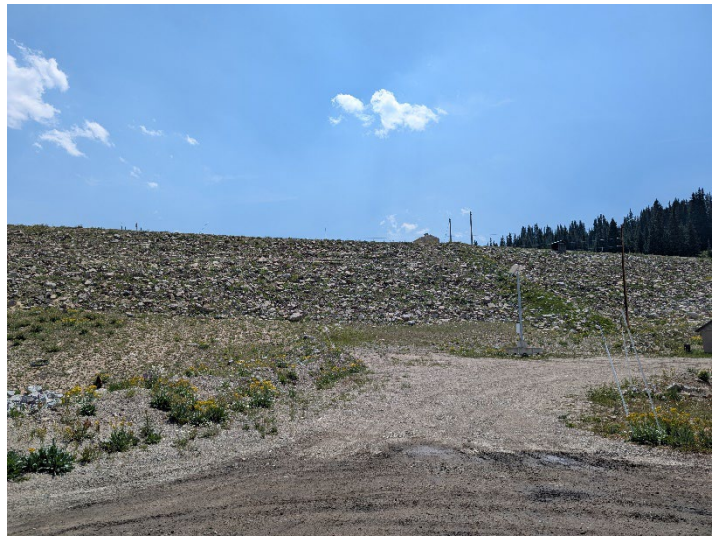
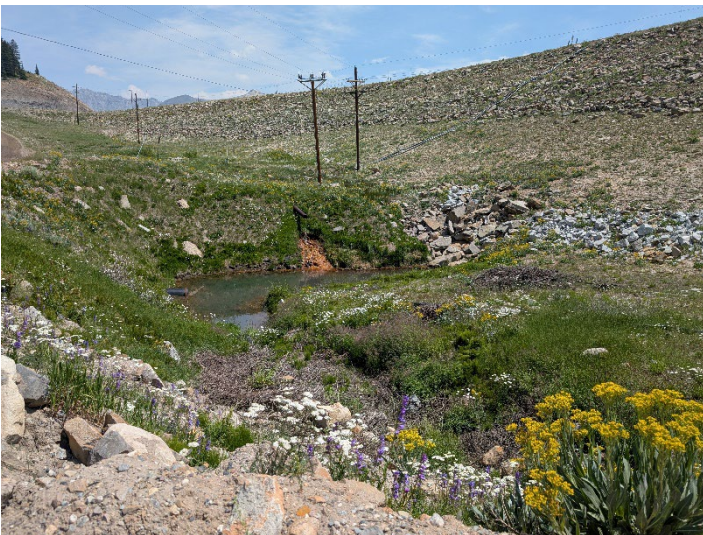
### **Robinson Lake and Dam**

Robinson Lake is located below 1 Dam and above the Eagle Park Reservoir. The Robinson Lake system, including the reservoir and Robinson Dam, are considered Environmental Protection Facilities. Robinson Lake is designed as a zero-discharge facility to prevent overflow to Eagle Park Reservoir and the east fork of the Eagle River. Robinson Lake stores process water, which is routed into the lake through the Tenmile Tunnel and delivered by the Robinson Lake Pump Station back to the mill facilities. Robinson Lake also receives seepwater pumped from the Robinson Dam and 4 Dam seepwater collection systems. Robinson Lake is to be operated in such a way as to prevent process water from entering Eagle Park reservoir. This means maintaining surcharge storage capacity throughout the year to contain the probable maximum precipitation event plus five days of seepwater inflow from the 1 Dam, Robinson Dam, and 4 Dam seepage collection systems, plus two days of diverted inflow from the Tenmile Tunnel. Robinson Lake utilizes water level indicators with automated alarms to warn of high-water levels, and a seepwater collection system with a backup generator to collect and pump embankment seepage back into the reservoir. The system appeared in good working condition and no problems were noted.

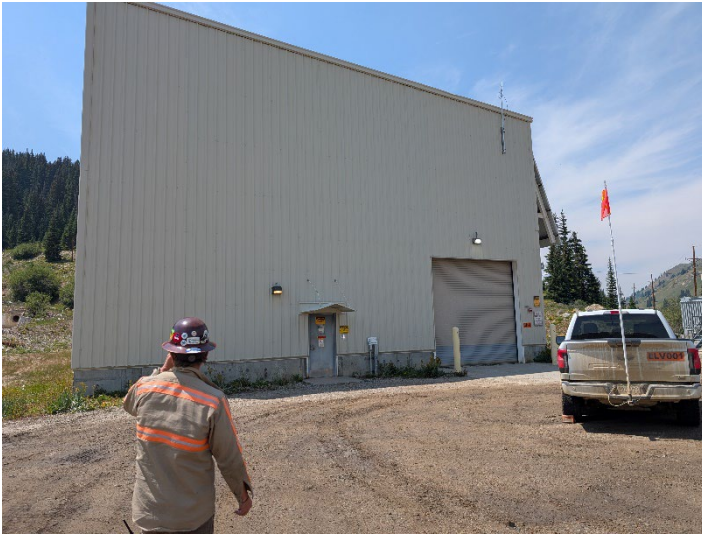
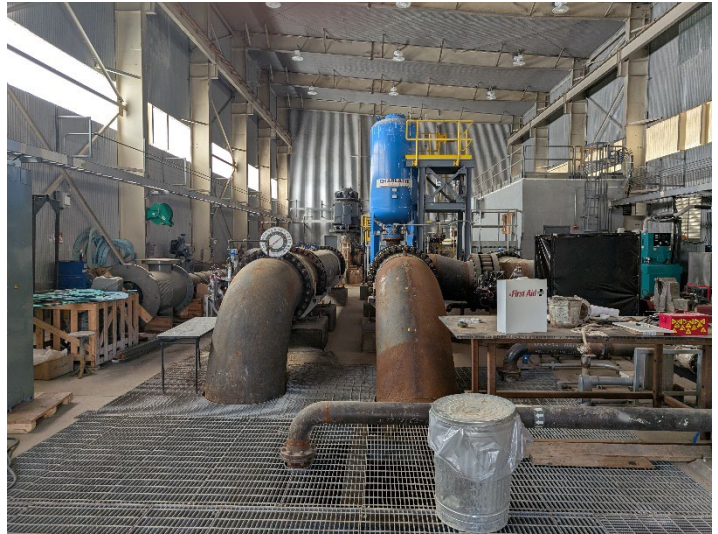
### Robinson Lake Seepage Pump System

The Robinson Lake Seepage Pump System is an Environmental Protection Facility that contains and collects impacted seepage water from the downstream toe of Robinson Dam for conveyance back to Robinson Lake. A collection pond below the dam provides detention storage for the seepage, from which it enters the pump system. The pump station is electrically powered but also includes a backup generator power source. The system appeared in good working condition and no problems were noted.

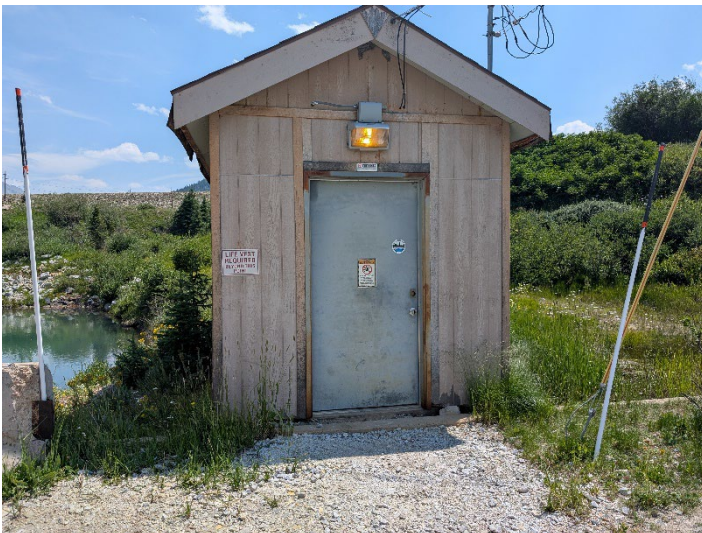
### Warren's Pump Station

Warren's Pump Station is located on the north bank of Robinson Lake and is considered an Environmental Protection Facility. The pump station operates to reduce the flow of impacted seepage water from 1 Dam into Robinson Lake. A collection pond, "Tim's Pond", captures and contains 1 Dam seepage, which is then piped to Warren's Pump Station, from which it is pumped back to the Tenmile system via the 2 Dam pipeline. The system appeared in good working condition and no problems were noted.
