MINERALS PROGRAM INSPECTION REPORT
PHONE: (303) 866-3567

MINE NAME: Brown Derby Mine	MINE/PROSPECTING ID#: M-1999-074	MINERAL: Gemstones, lithium, ore unknown commodity	COUNTY: Gunnison
INSPECTION TYPE: Monitoring	WEATHER: Clear	INSP. DATE: August 5, 2025	INSP. TIME: 09:30
OPERATOR: Precious Offerings Mineral Exchange, Inc.	OPERATOR REPRESENTATIVE: Jake Wilkinson	TYPE OF OPERATION: 110(2) - Hard Rock Limited Impact	
REASON FOR INSPECTION: Normal I&E Program	BOND CALCULATION TYPE: None	BOND AMOUNT: \$6,600.00	
DATE OF COMPLAINT: NA	POST INSP. CONTACTS: None	JOINT INSP. AGENCY: None	
INSPECTOR(S): Dustin Czapla	INSPECTOR'S SIGNATURE:

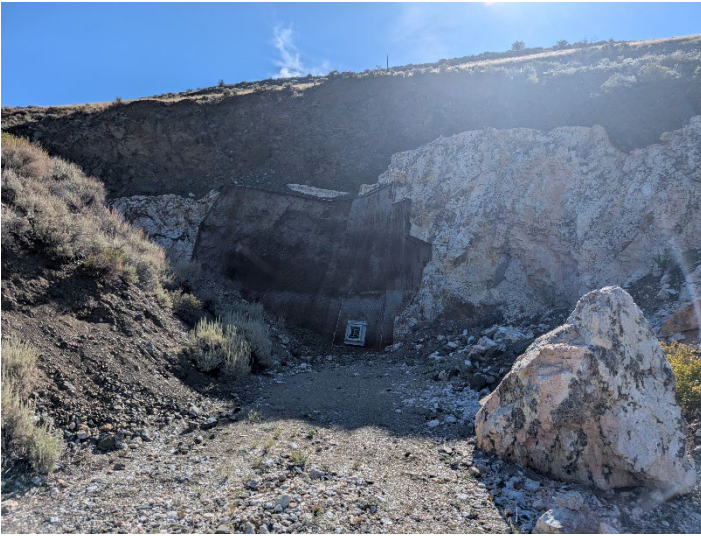
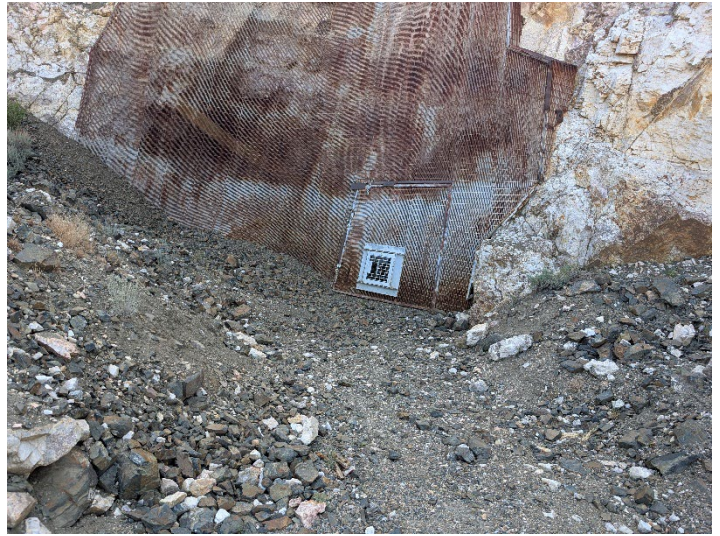
The mine sign which has historically been posted just inside the mine has been torn down by trespassers and will need to be replaced so that it is again visible.

The site consists of a headwall cut into the west facing slope of the hill, where a grated portal is located. The portal was locked and appeared secure, although the operator's lock had been removed and new locks were placed by trespassers. A flat bench and stockpile area is located just outside the portal.

The site routinely experiences problems with trespassers and vandals. The large boulders that were placed by the operator across the access road to prevent unauthorized vehicles from entering the site have been removed by trespassers. The boulders and soil that were placed in front of the mine entrance to prevent unauthorized access have also been removed by trespassers.
