**MINERALS PROGRAM INSPECTION REPORT**  
**PHONE: (303) 866-3567**

| <b>MINE NAME:</b><br>Carter Mine | <b>MINE/PROSPECTING ID#:</b><br>M-2020-014 | <b>MINERAL:</b><br>Silver and gold | <b>COUNTY:</b><br>Gunnison |

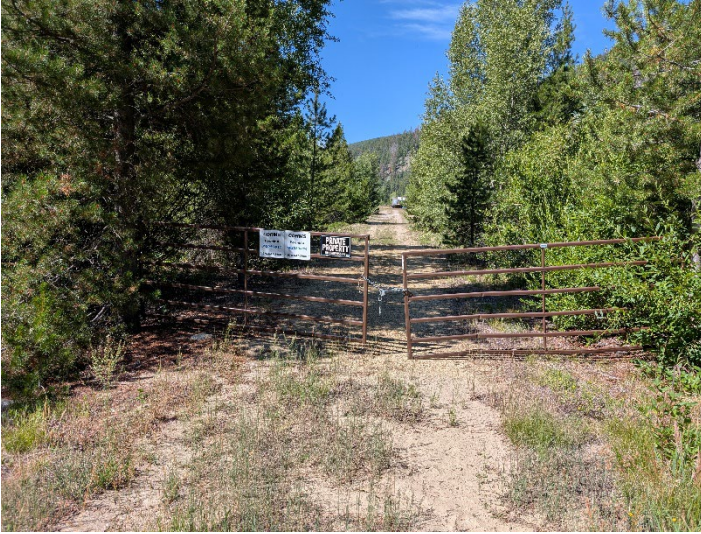
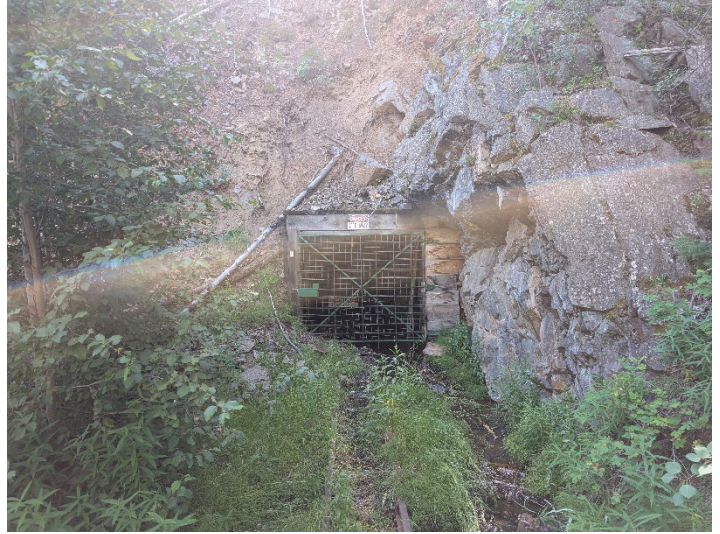
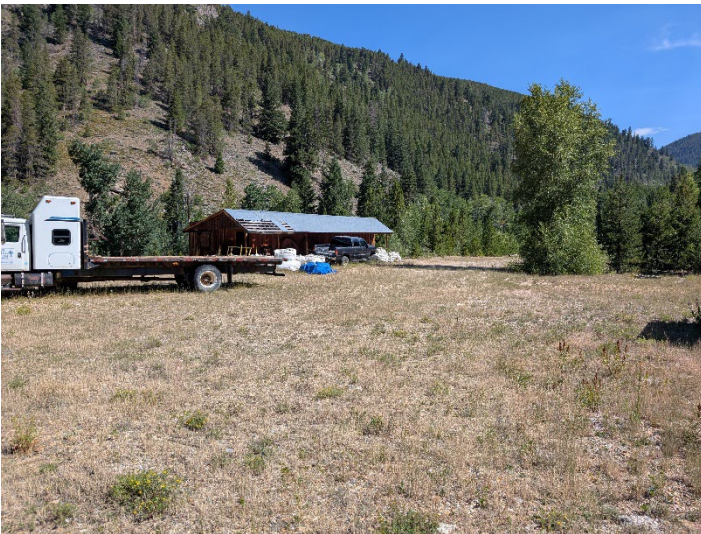
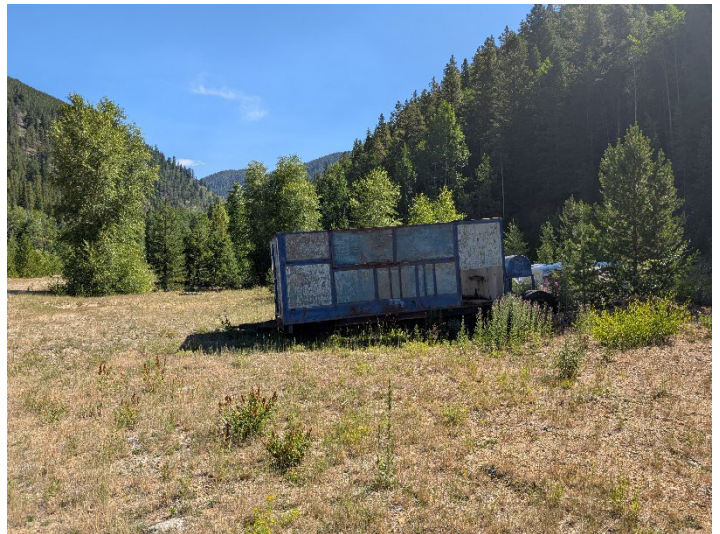
Adequate mine identification signage was noted on the gate at the entrance to the site.

The Carter Mine portal is secured with a locked grate. No problems or violations were noted during this inspection.
