**PERMIT INFORMATION**

| <b>Permit Number:</b> C-1981-012<br><b>Mine Name:</b> New Elk Mine<br><b>Operator:</b> New Elk Coal Company, LLC<br><b>Operator Address:</b><br>12250 Highway 12<br>Weston, CO 81091 | <b>County:</b> Las Animas<br><b>Operation Type:</b> Underground<br><b>Permit Status:</b> Suspended<br><b>Ownership:</b> Private |

| <b>Inspection Start Date:</b> August 5, 2025<br><b>Inspection Start Time:</b> 13:04<br><b>Inspection End Date:</b> August 5, 2025<br><b>Inspection End Time:</b> 16:36 | <b>Inspection Type:</b> Coal Complete Inspection<br><b>Inspection Reason:</b> Normal I&E Program<br><b>Weather:</b> Cloudy |

This was a complete inspection of the New Elk Mine, Colorado Division of Reclamation, Mining and Safety ("DRMS" or "Division") permit number C-1981-012, operated by New Elk Coal Company, LLC. ("NECC"). Amber Gibson, with the Division, conducted the inspection. During the inspection, I was unaccompanied by an Operator representative for the Permittee -- New Elk Coal Company, LLC (NECC). The weather was warm and the sky was cloudy.

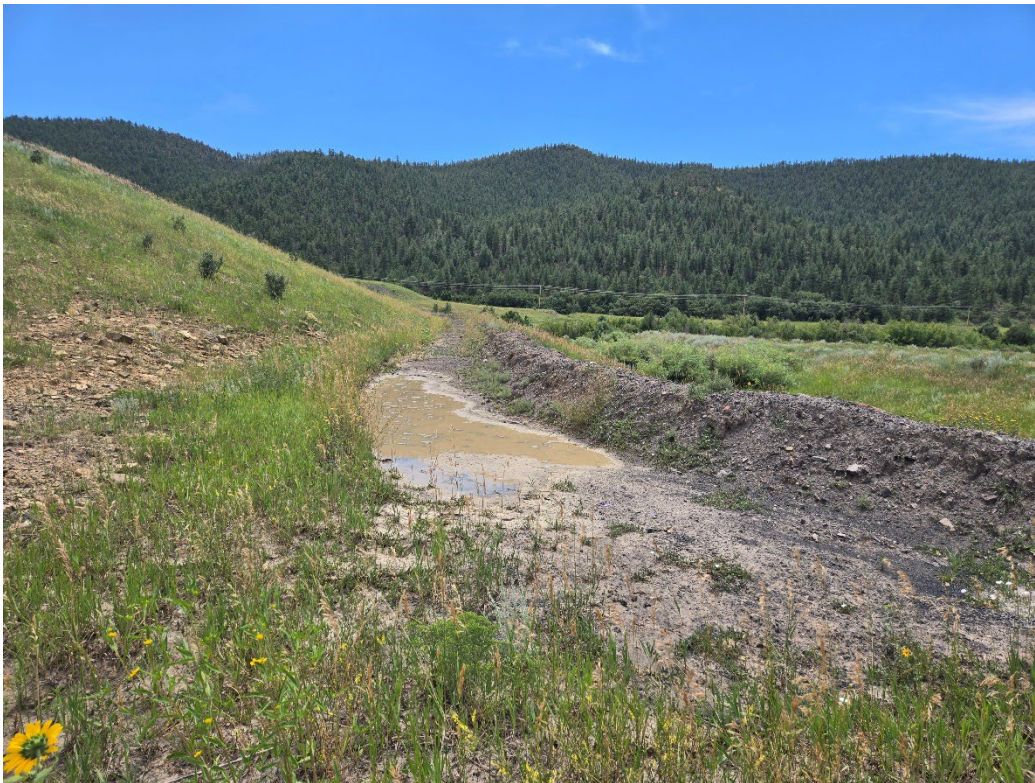
- No signs of erosion were observed along the slopes of DWDA #1. The slopes appear to be well vegetated and stable.
- Ditch D3 on the west and south side of DWDA #1 held some water at the time of the inspection. The Division walked along the berm on the outside of D3 and D4. The ditches were clear and the berm appeared to be intact, with no observed erosional areas.
- Ditch D2 on the northside of DWDA #1 held water at the time of the inspection.
- **OMI:** (October 2024 report) Areas along D2, located to the north of DWDA #1, have begun to fill with sediment. Some erosion along the road leading to Pond 004A was also observed. **The Operator shall clean this ditch and stabilize the road.**

*Photo 1: Looking south along the Ditch D3 on the west side of DWDA #1.*

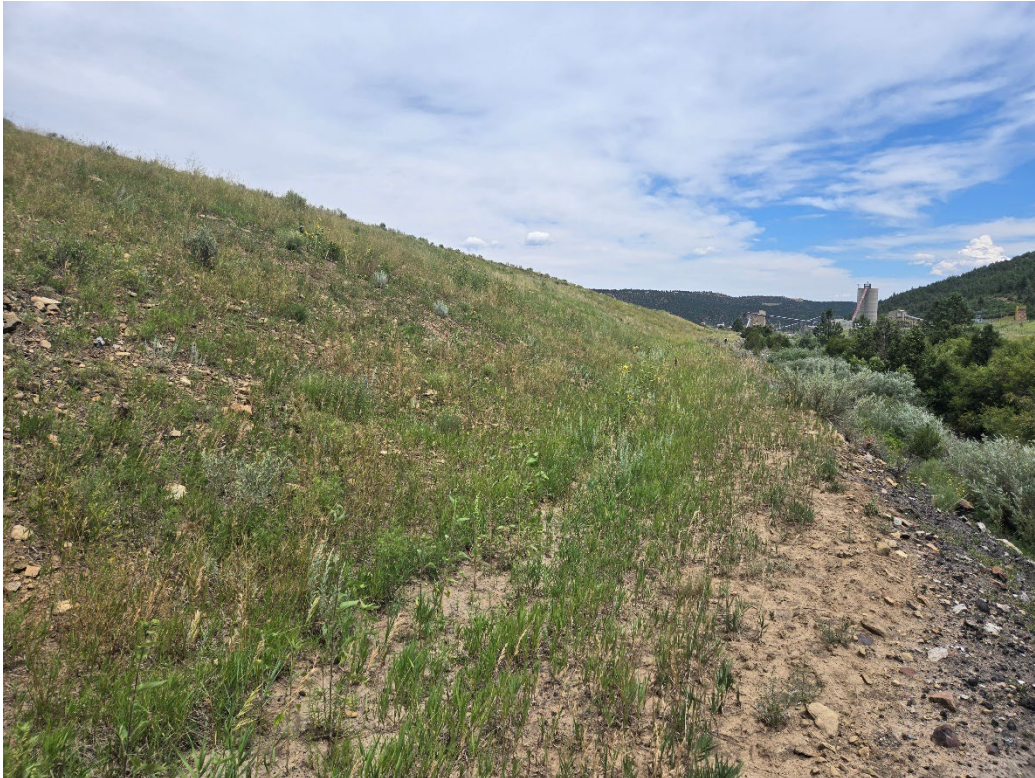
*Photo 2: Looking east along the ditch D4 on the south side of DWDA #1.*

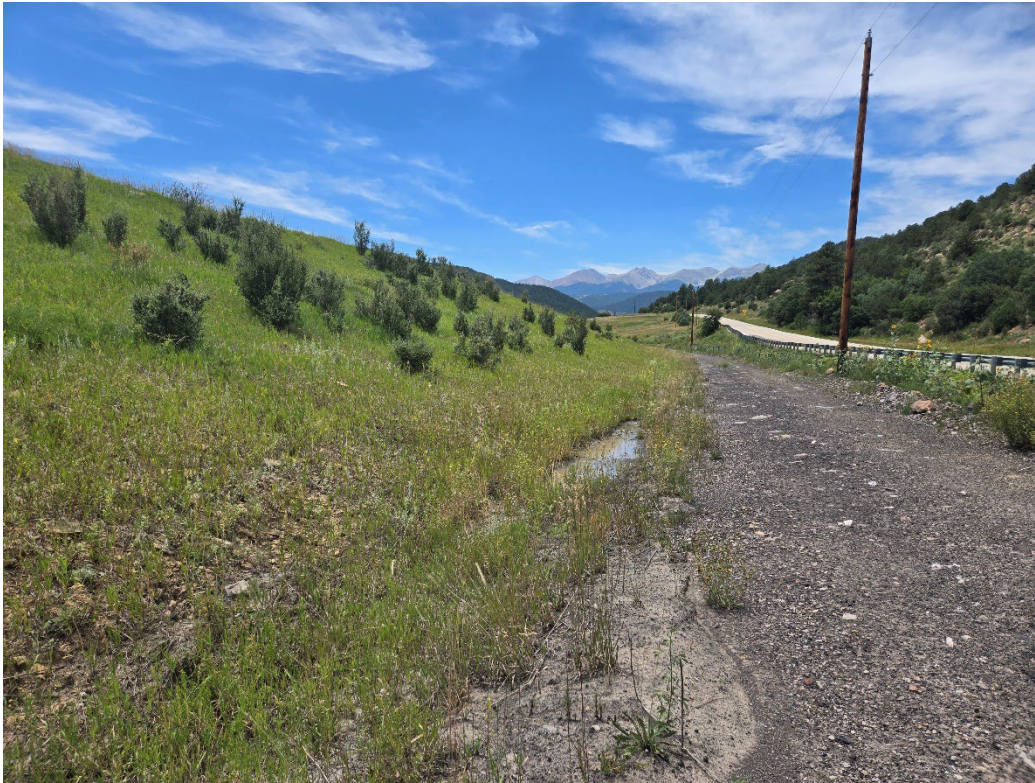
*Photo 3: Looking west at an area where sediment from ditch D2 has begun to erode the road leading to Pond 004a.*

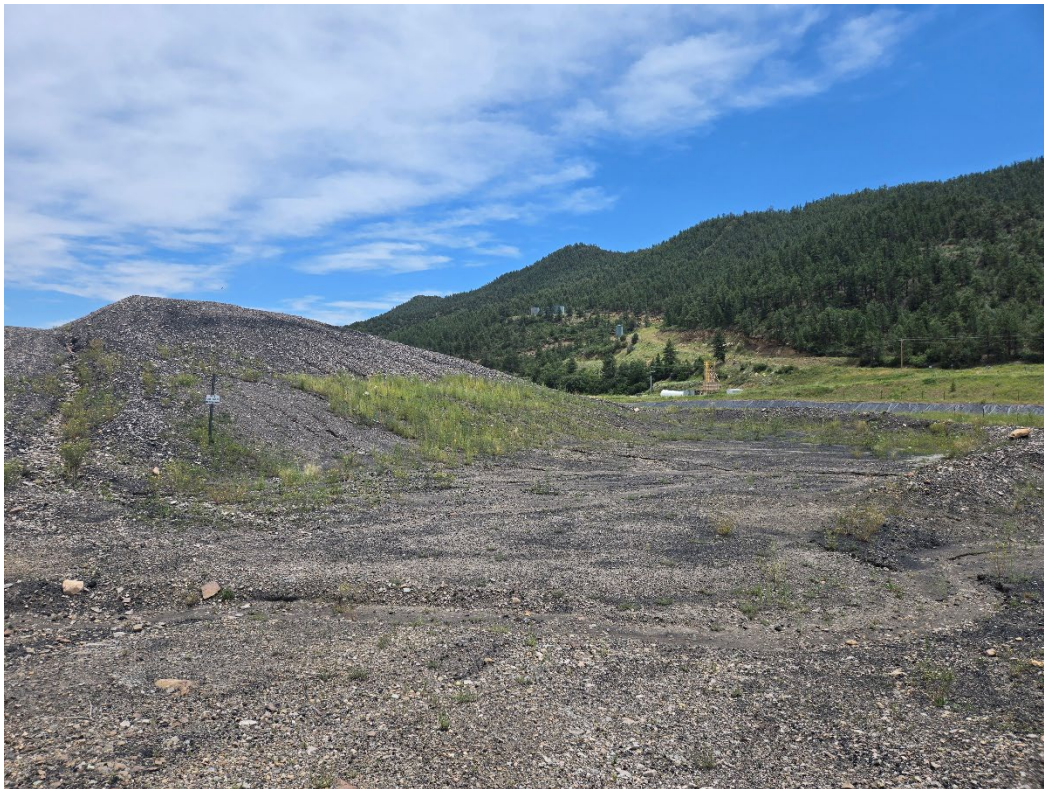
- The sediment basin and sediment drying area on the north and west sides of DWDA #2 were dry at the time of the inspection. All water appeared to be contained within the bermed areas round DWDA #2.

*Photo 4: Looking east at the west side of DWDA #2/sediment drying area.*

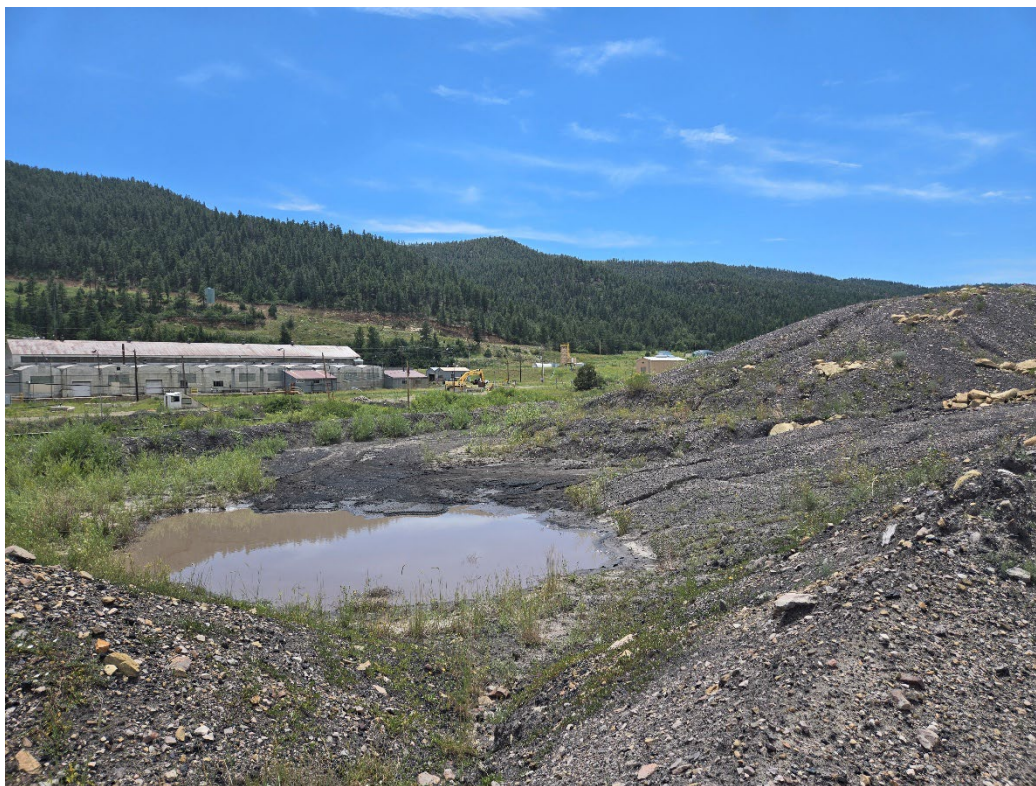
- The sediment basin at the east end of DWDA #2 held water at the time of the inspection.
- The inlet for culvert C13, located within the sediment basin for DWDA #2, was clear of obstructions.

*Photo 5: Sediment basin on east side of DWDA #2.*

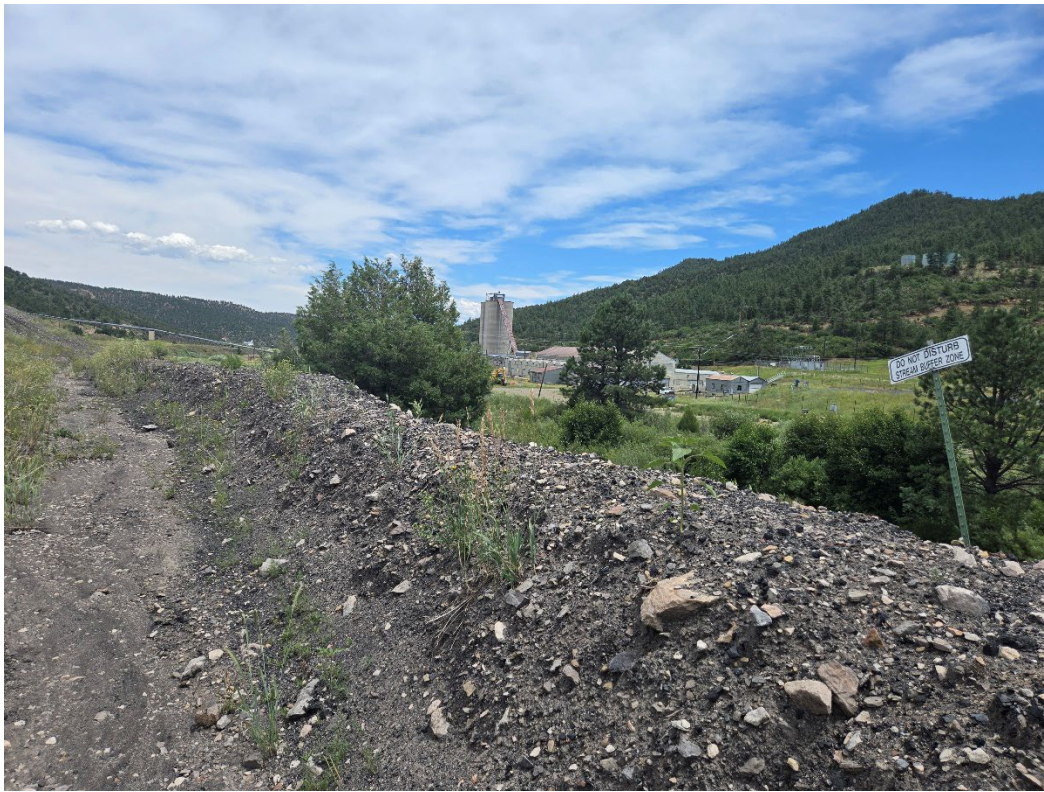
- The Inspector walked along ditch D14 on the south side of the DWDA #2. The ditch was clear of debris and there were no signs of excessive erosion.
- **OMI:** (October 2024 report) The check dams along the north side of the sediment basin at DWDA #2 have filled with sediment. **The Operator shall clean the check dams of sediment and ensure that the sediment control structures are functioning appropriately.**

*Photo 6: Looking east along ditch D14.*

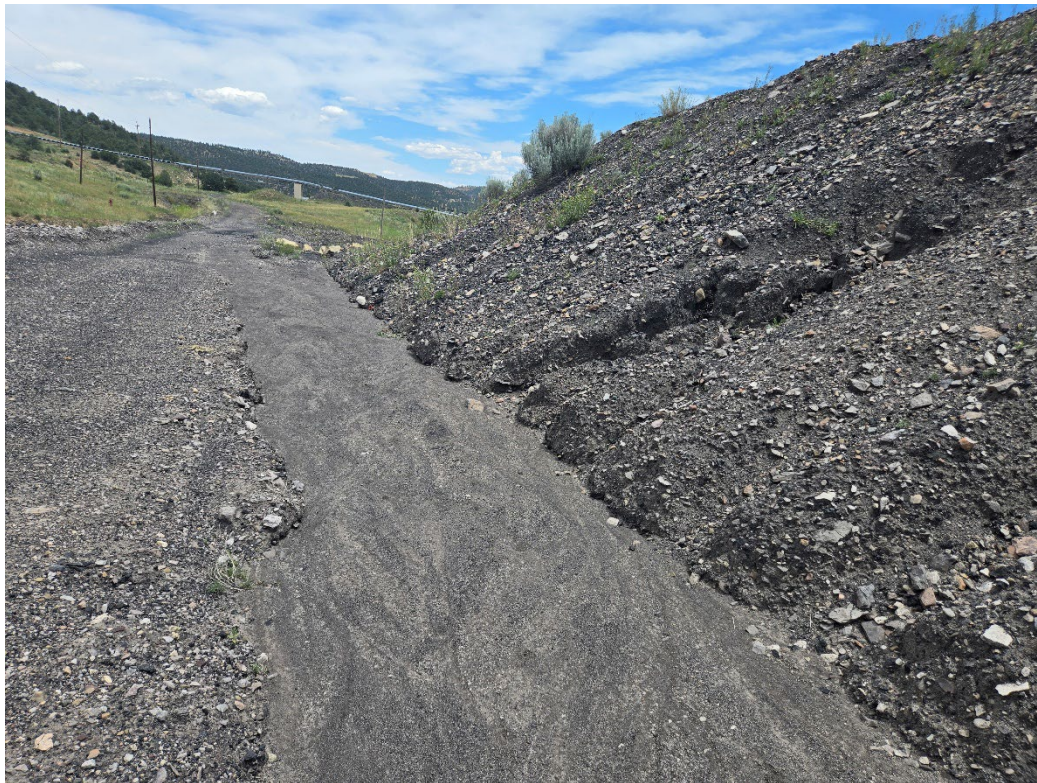
- **OMI:** (July 2025 report) Ditch 12 on the north side of DWDA #2 has filled with sediment. **The Operator shall remove this sediment and stabilize the ditch and road to ensure that the sediment control structures are functioning appropriately.**

*Photo 7: Sediment in D12 along the north side of DWDA #2.*

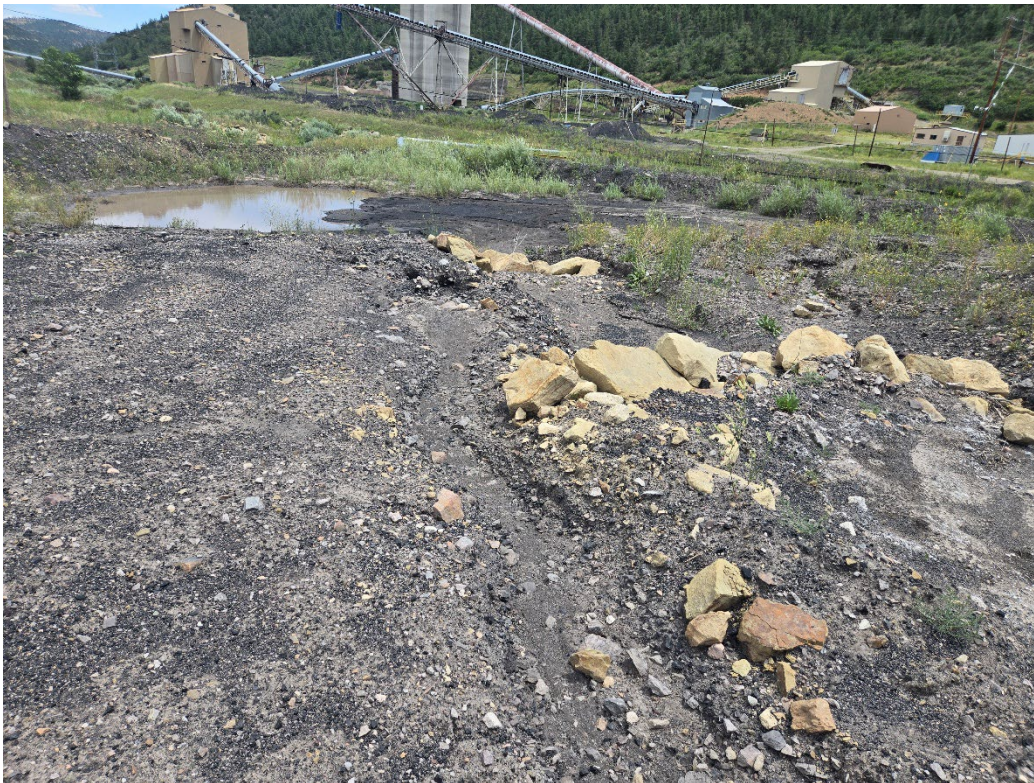
*Photo 8: Check dam full of sediment at the east end of ditch D12. The sediment has overflowed and cut around the check dams, but is still being deposited in the sediment basin.*

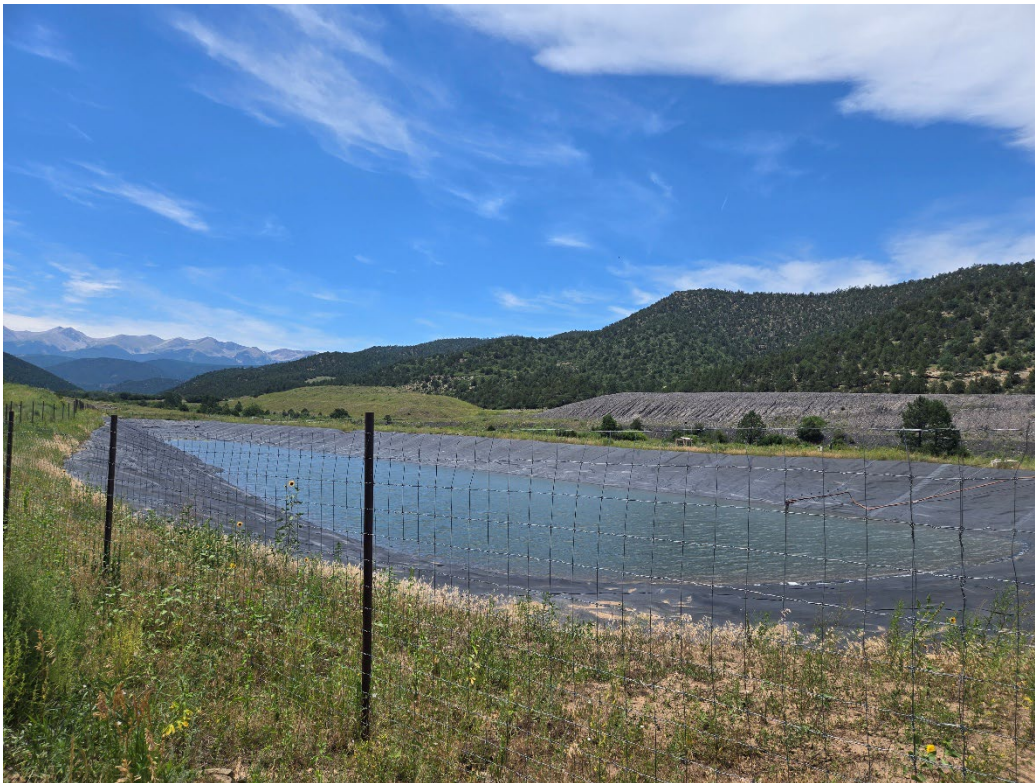
- Pond 001A - held some water at the time of the inspection. No tears were observed in the pond lining.
- Pond 004A - contained some water, located within the southeast corner, at the time of the inspection. The banks of the pond appeared stable and vegetated.
- Pond 006A - contained some water at the time of the inspection. The banks of the pond appeared to be stable.
- Pond 007A - the water was high at the time of the inspection but had plenty of capacity before reaching the blue marker on the white PVC pipe. The water level is below the top few holes of the principal spillway. The pond was not discharging. The banks appeared stable and the emergency spillway was clear.
- Pond 08 - contained some water at the time of the inspection and was below its capacity. The spillways appeared clear, and the banks were stable. Pond 08 was not discharging.

*Photo 9: Pond 001a*

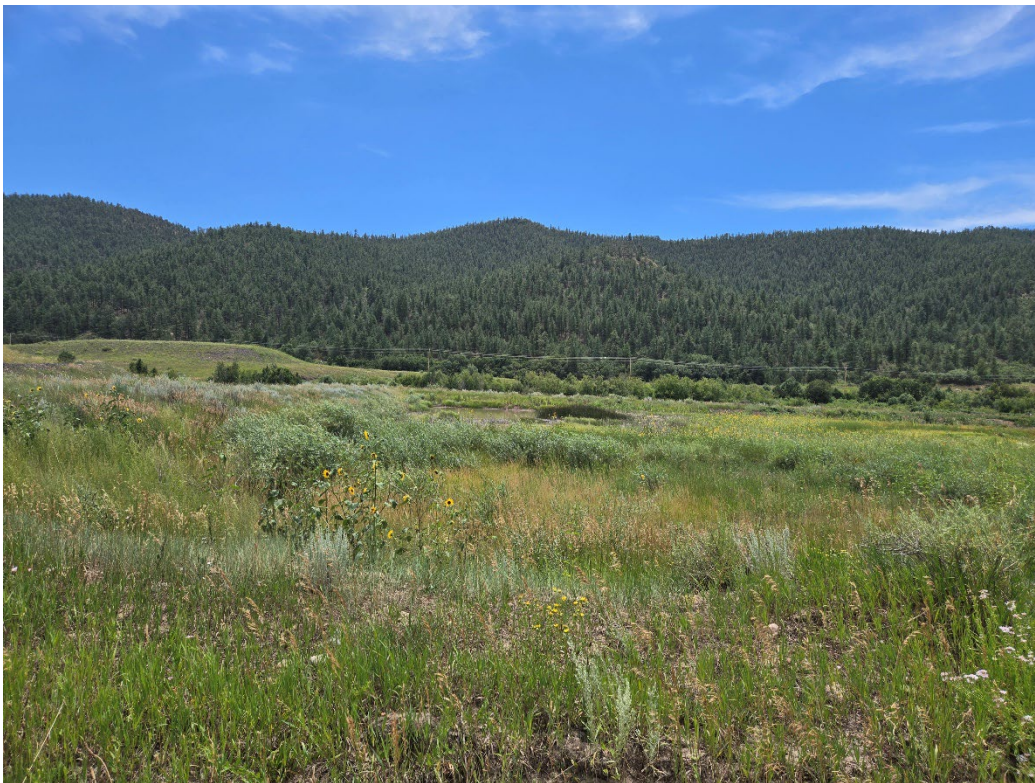
*Photo 10: Pond 004a*

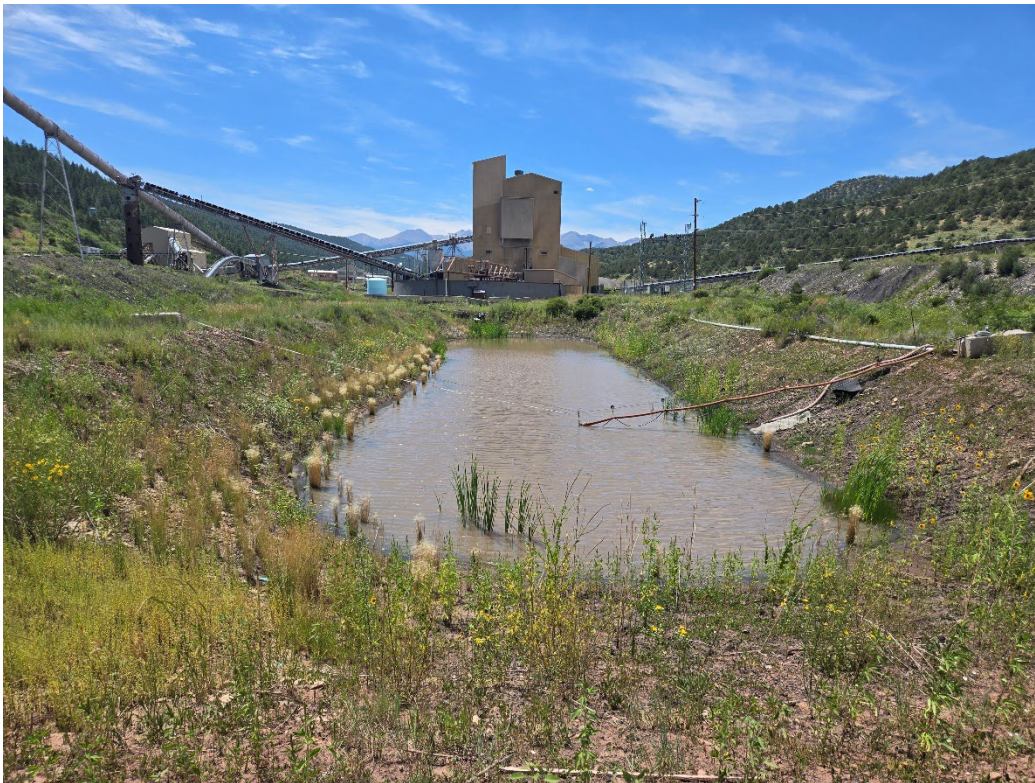
*Photo 11: Pond 006a*

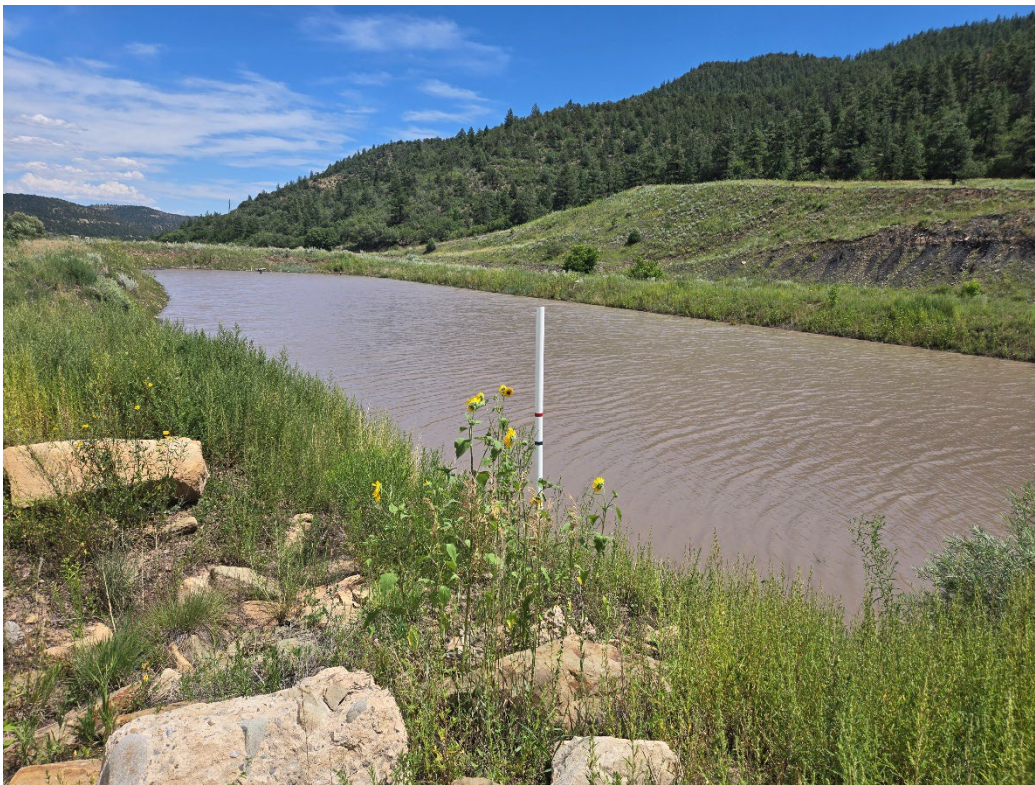
*Photo 12: Pond 007a*

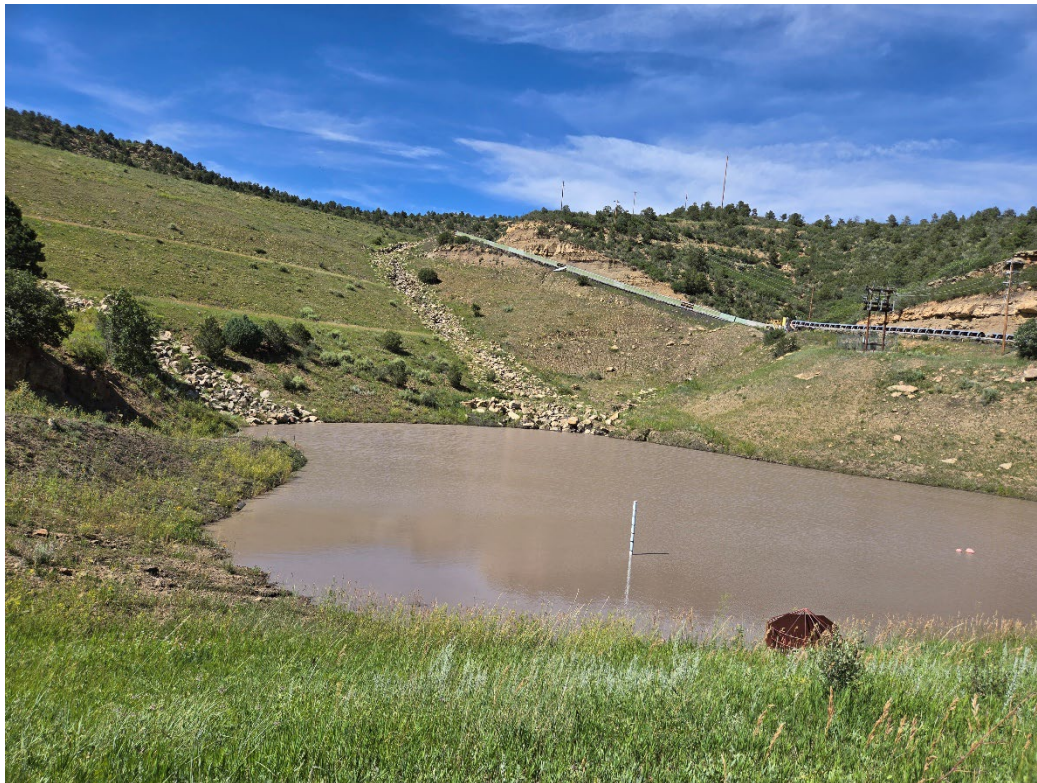
*Photo 13: Pond 08*

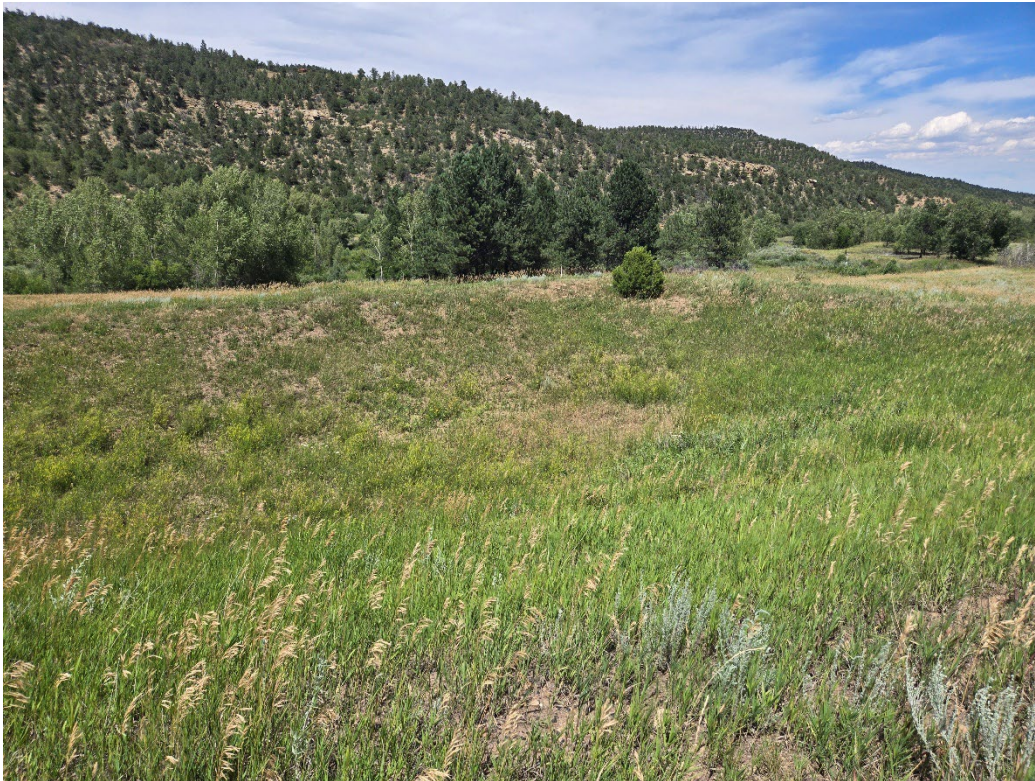
*Photo 14: Containment Area #2*

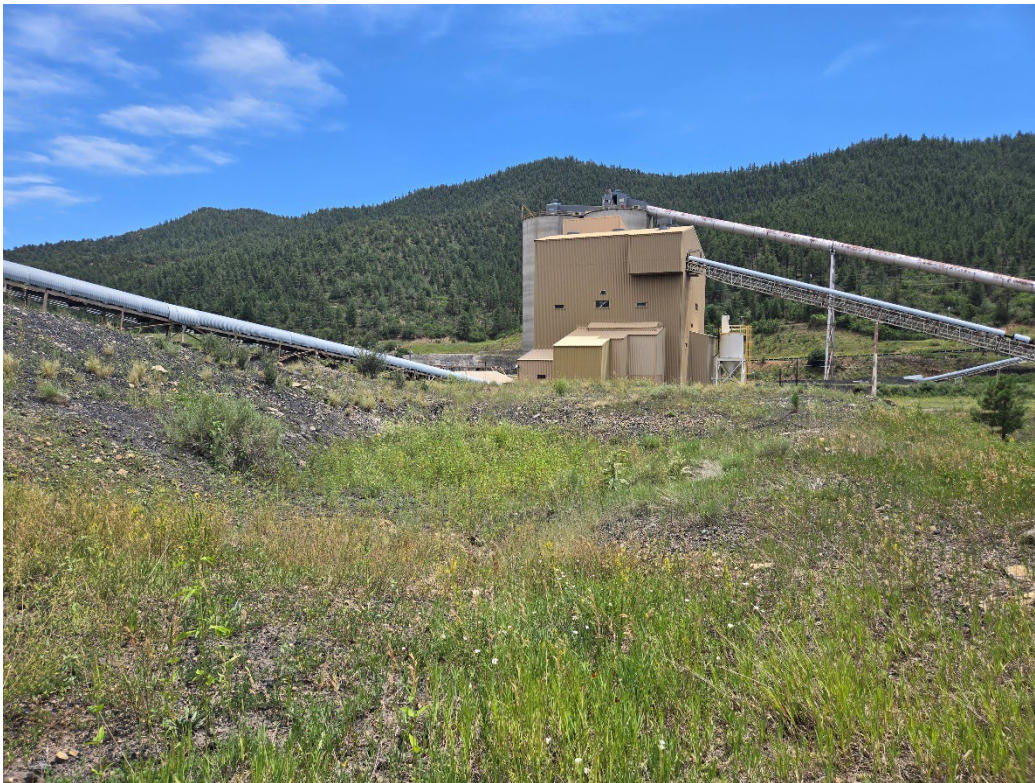
*Photo 15: Containment Area #3*

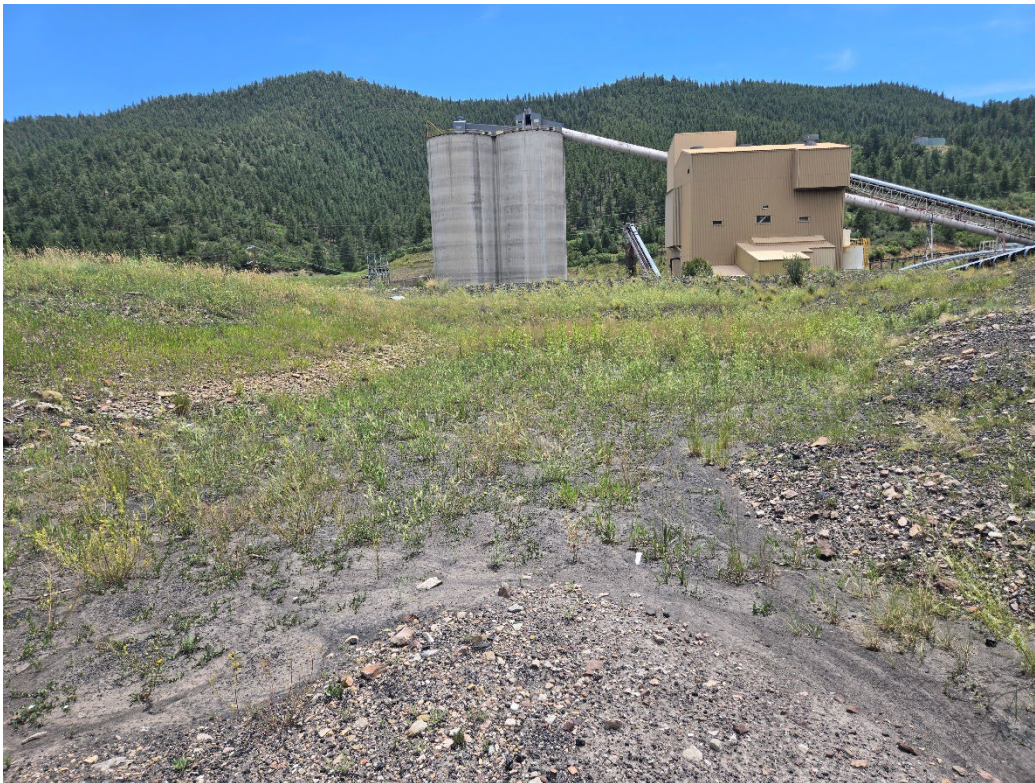
*Photo 16: Containment Area #4*

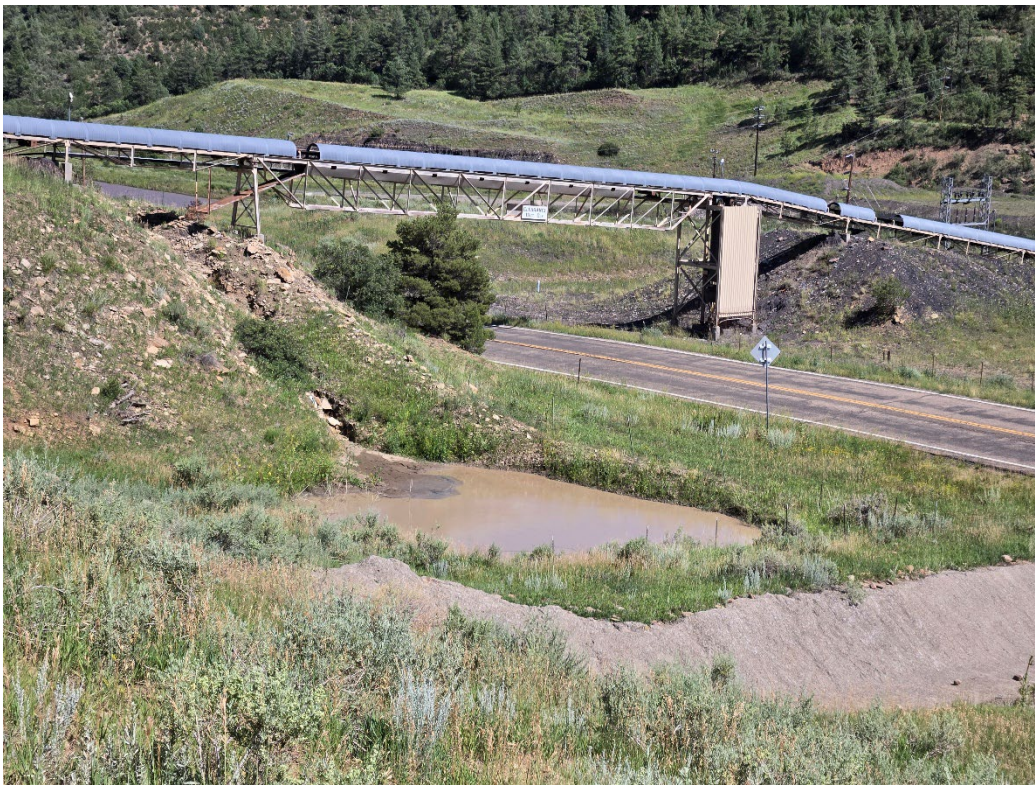
- Containment areas #1-4 were dry at the time of the inspection.
- Containment area #5 contained water at the time of the inspection. The containment area was still below capacity, but water was nearing the top of the embankment. There is a ditch that leads to the Pond 08 emergency spillway if the water in the containment were to the embankment.

*Photo 17: Containment Area #5*

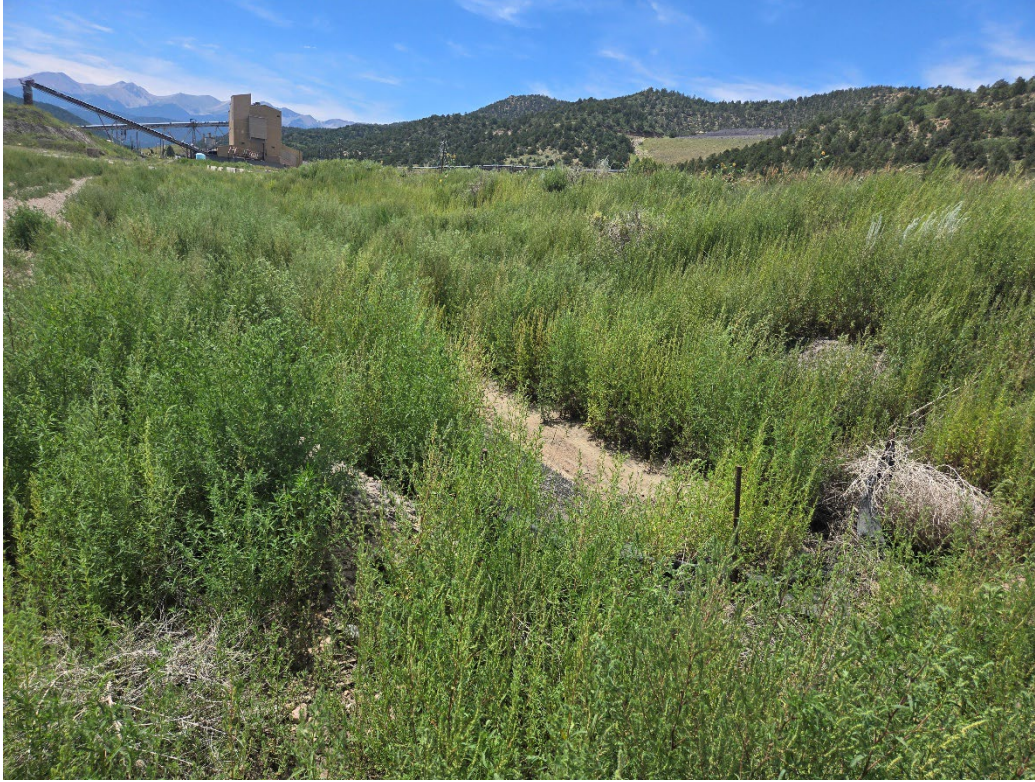
- **OMI: (January 2024 report) The silt fences along the road in the S.A.E south of Pond 007 are damaged and need to be repaired.**
- **OMI: (March 2024 report) The silt fence on the western border of the S.A.E. on the top of the hill needs to be repaired.**

*Photo 18: Looking west along the damaged silt fences on the north side of the road in the S.A.E. on the south side of Pond 007a.*

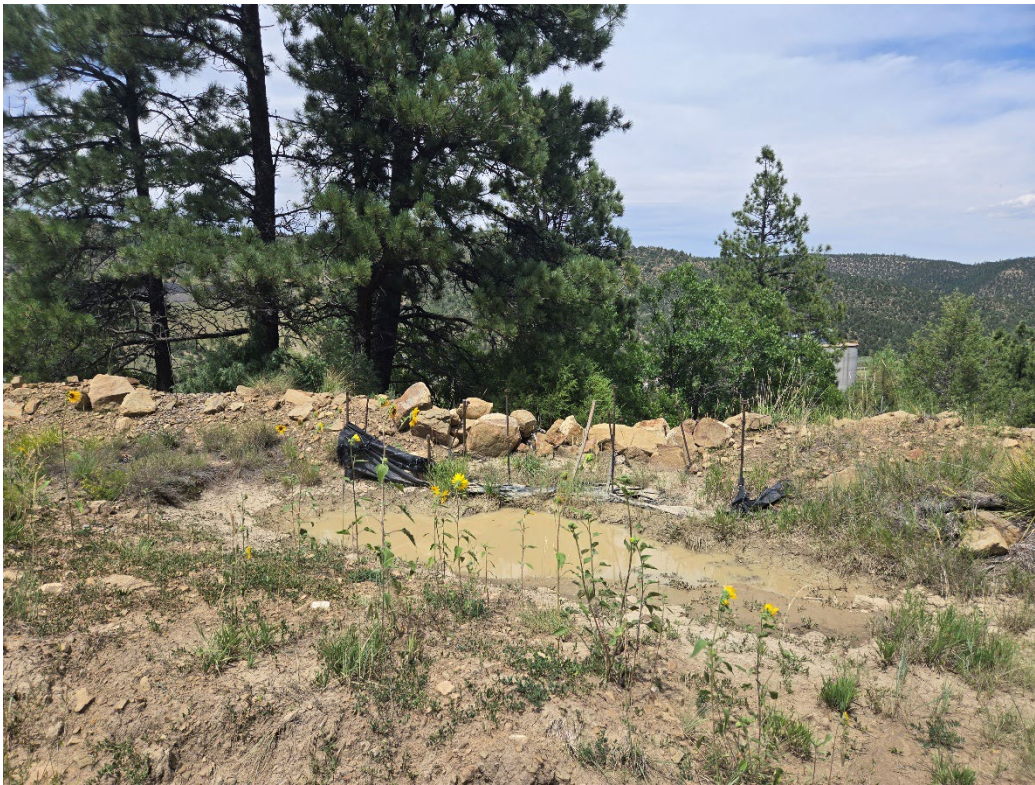
*Photo 19: Looking northeast at the damaged silt fence within the S.A.E. on the southside of the permit area, near the water tanks.*

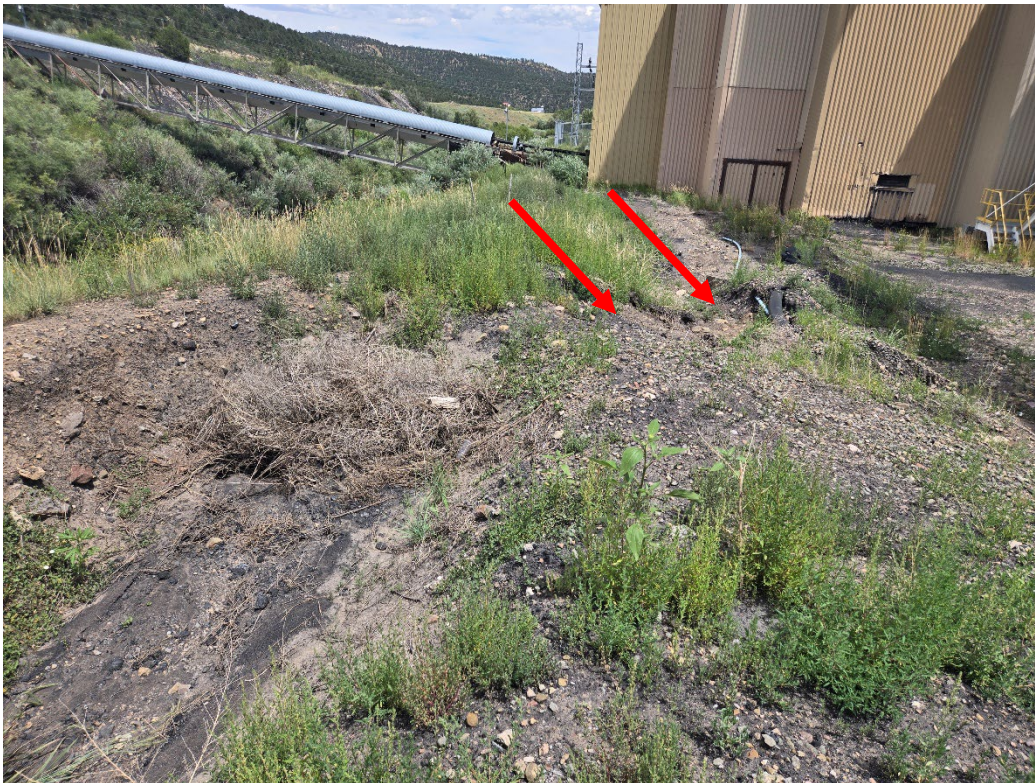
- Culvert C64, within Ditch D32, is blocked by vegetative debris. As a result, water has cut around the ditch and has deposited sediment within the raw coal storage area. No water appears to have overflowed on the north side, which leads to the river. **The Operator shall clear the debris from C64 and repair D32 to ensure that water from this ditch flows directly to Pond 007a as designed.**

*Photo 20: Tumbleweeds and other debris block the inlet for culvert C64. The arrow points to where water had overflowed in the ditch and discharged into the Raw Coal Storage area.*

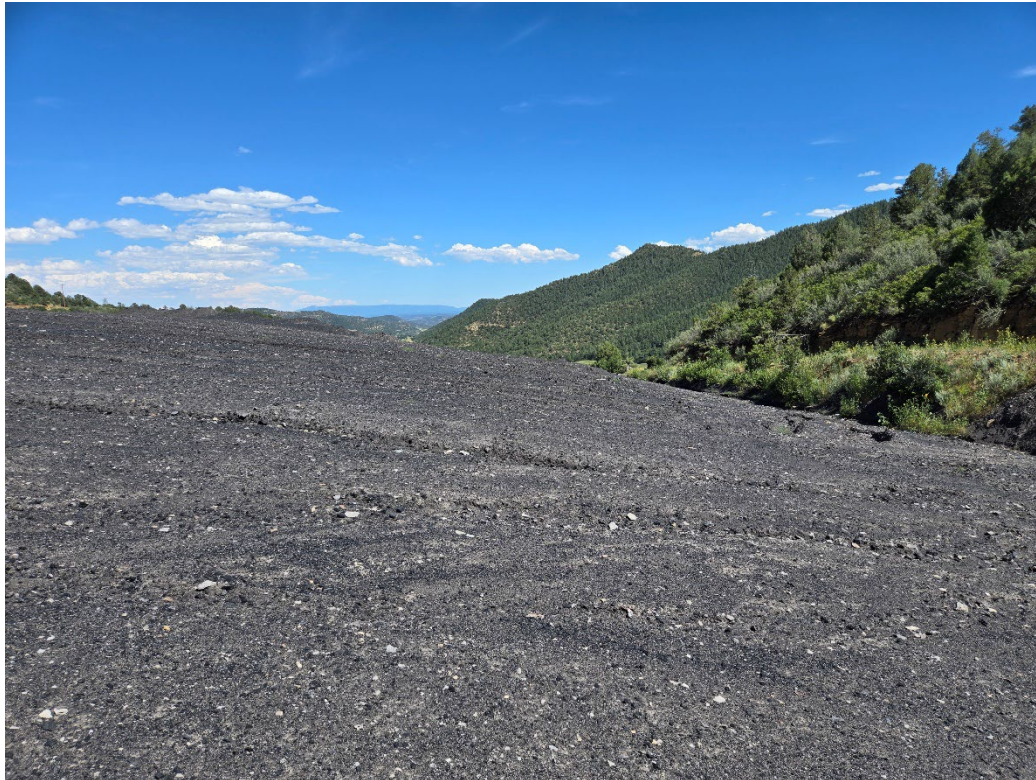
- The top of the RDA is still exhibiting positive drainage to the back and side ditches.

*Photo 21: Positive drainage on RDA.*

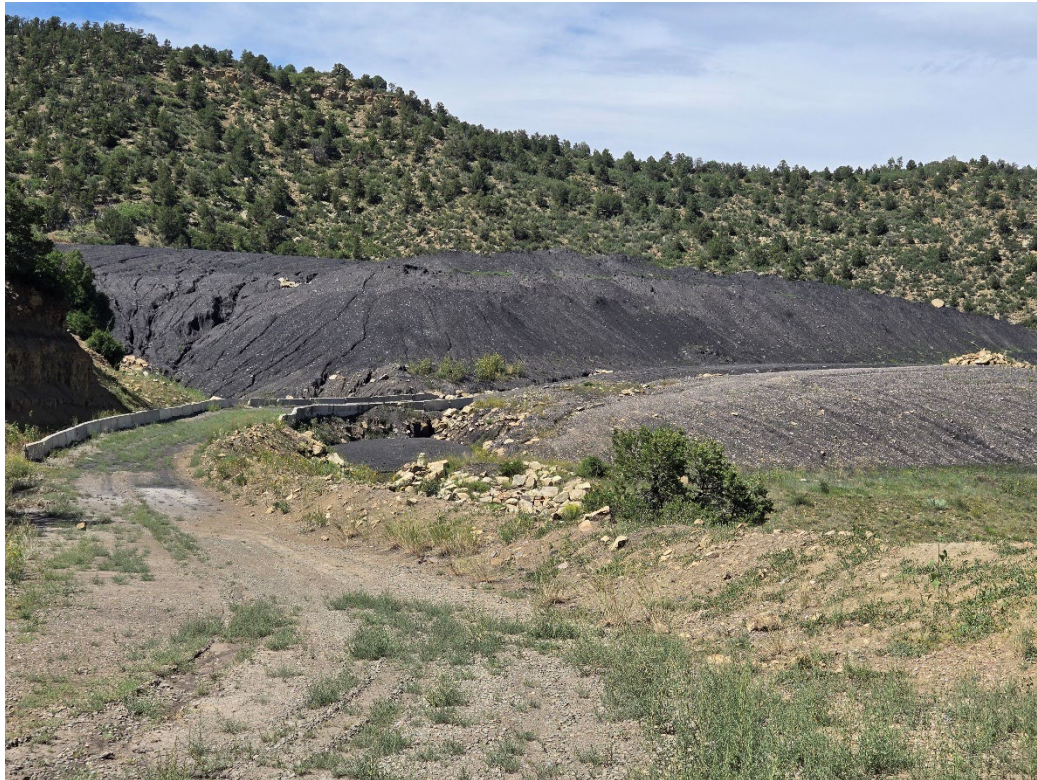
- c. There is a culvert (C81) at the end of ditch D55 and the unnamed ditch that allows runoff to flow under the road and out to the ditch leading to Pond 08. The inlet side of C81 (located on the north side) appears to be clear of obstructions at this time. **However, the Operator shall remove some of the sediment that has accumulated in the basin to the north of C81 to help minimize the sediment load deposited into Pond 08. \*As of the August 2025 inspection, the inlet side of C81 has begun to fill with sediment.**
- d. The outlet side of C81 (located on the south side) has been partially filled with sediment. **The Operator shall clean sediment out of C81 and from the area around the culvert. \*As of the August 2025 inspection, the outlet side of C81 has been completely covered by sediment.**

*Photo 22: Looking north at the significant erosion occurring on the west side of the unclaimed RDA areas that lead to C81.*

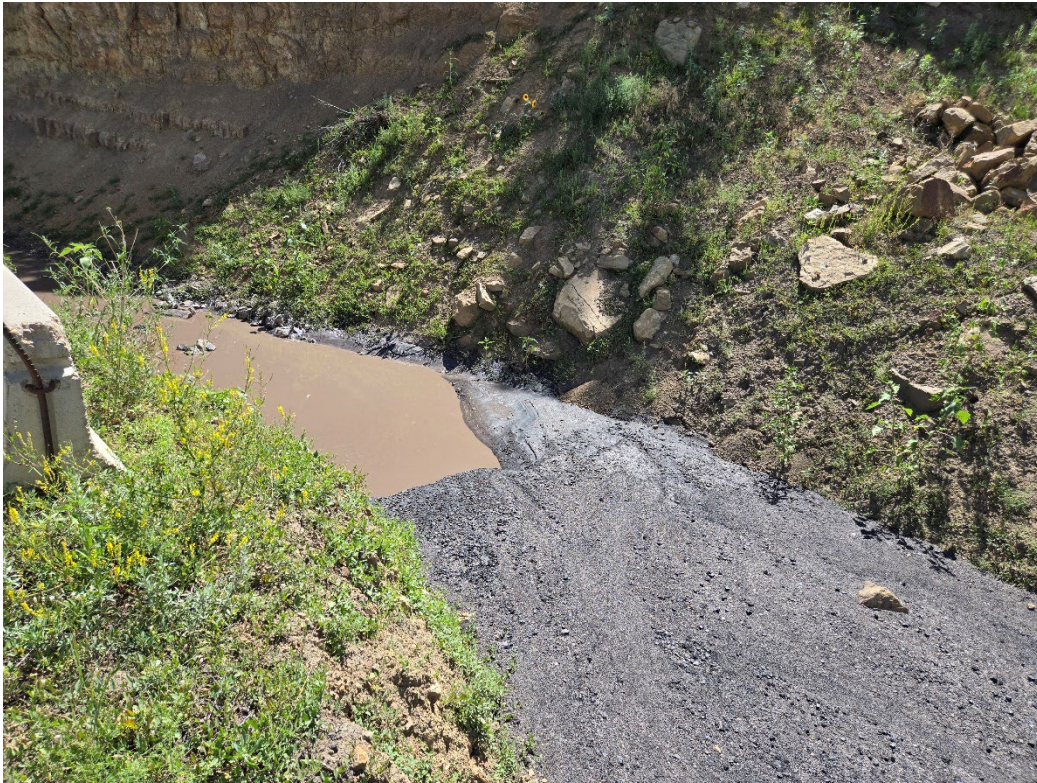
*Photo 23: Looking at sediment accumulation and water held in Ditch D56 at the time of the inspection.*

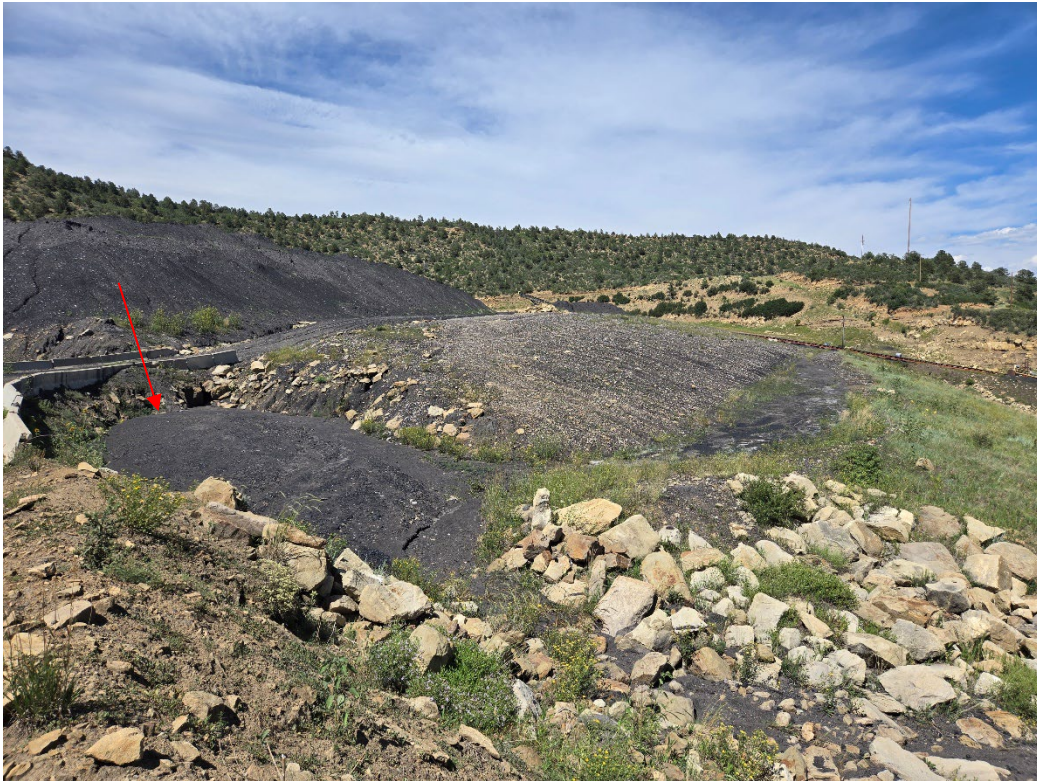
*Photo 24: Looking east across where the un-reclaimed RDA benches meet the reclaimed benches. The arrow points to the outlet for C81.*

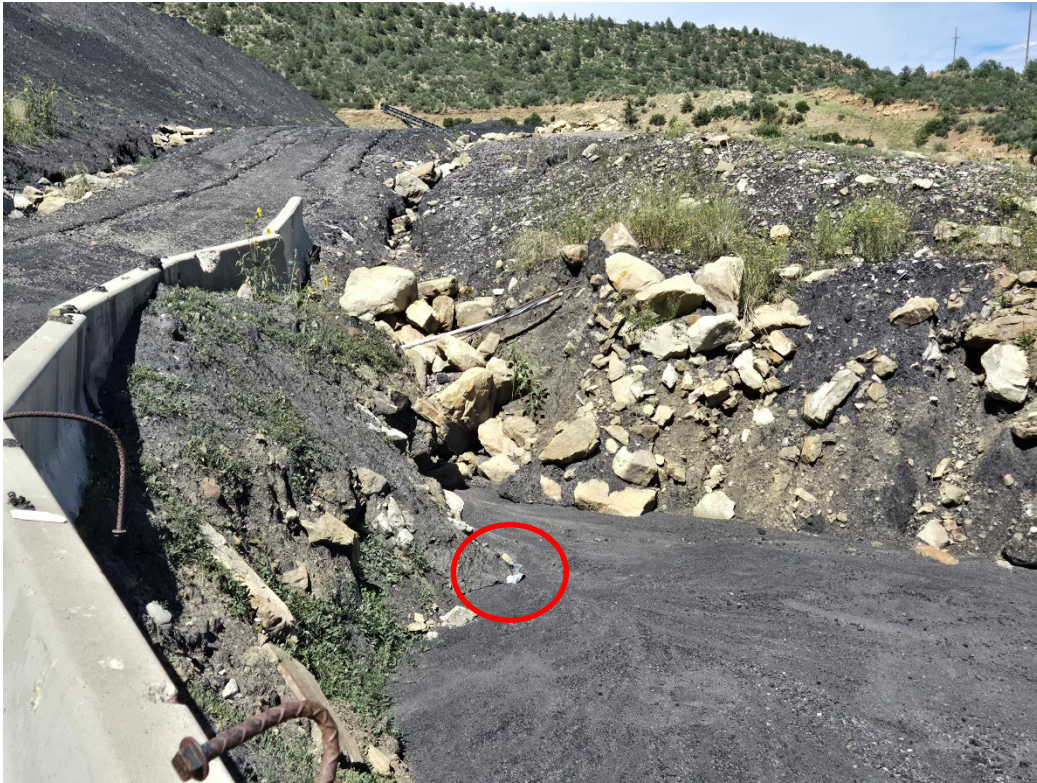
- b. The unnamed ditch east of D55, running along the west side of the RDA contains a few check dams to control run off and reduce erosion along the RDA. The southernmost check dam is damaged and is no longer functioning appropriately. It appears that water has undercut the check dam and has allowed for excess sediment to accumulate at the end of the ditch. **The Operator shall repair the check dam in the unnamed ditch leading to C81.**

*Photo 25: Looking at the damaged and eroded check dams within the ditches that lead to the outlet area for C81. The red circle shows the very top of the now buried C81.*
