**PERMIT INFORMATION**

| <b>Permit Number:</b> C-1981-012<br><b>Mine Name:</b> New Elk Mine<br><b>Operator:</b> New Elk Coal Company, LLC<br><b>Operator Address:</b><br>12250 Highway 12<br>Weston, CO 81091 | <b>County:</b> Las Animas<br><b>Operation Type:</b> Underground<br><b>Permit Status:</b> Suspended<br><b>Ownership:</b> Private |

| <b>Inspection Start Date:</b> August 5, 2025<br><b>Inspection Start Time:</b> 13:04<br><b>Inspection End Date:</b> August 5, 2025<br><b>Inspection End Time:</b> 16:36 | <b>Inspection Type:</b> Coal Complete Inspection<br><b>Inspection Reason:</b> Normal I&E Program<br><b>Weather:</b> Cloudy |

This was a complete inspection of the New Elk Mine, Colorado Division of Reclamation, Mining and Safety ("DRMS" or "Division") permit number C-1981-012, operated by New Elk Coal Company, LLC. ("NECC"). Amber Gibson, with the Division, conducted the inspection. During the inspection, I was unaccompanied by an Operator representative for the Permittee -- New Elk Coal Company, LLC (NECC). The weather was warm and the sky was cloudy.

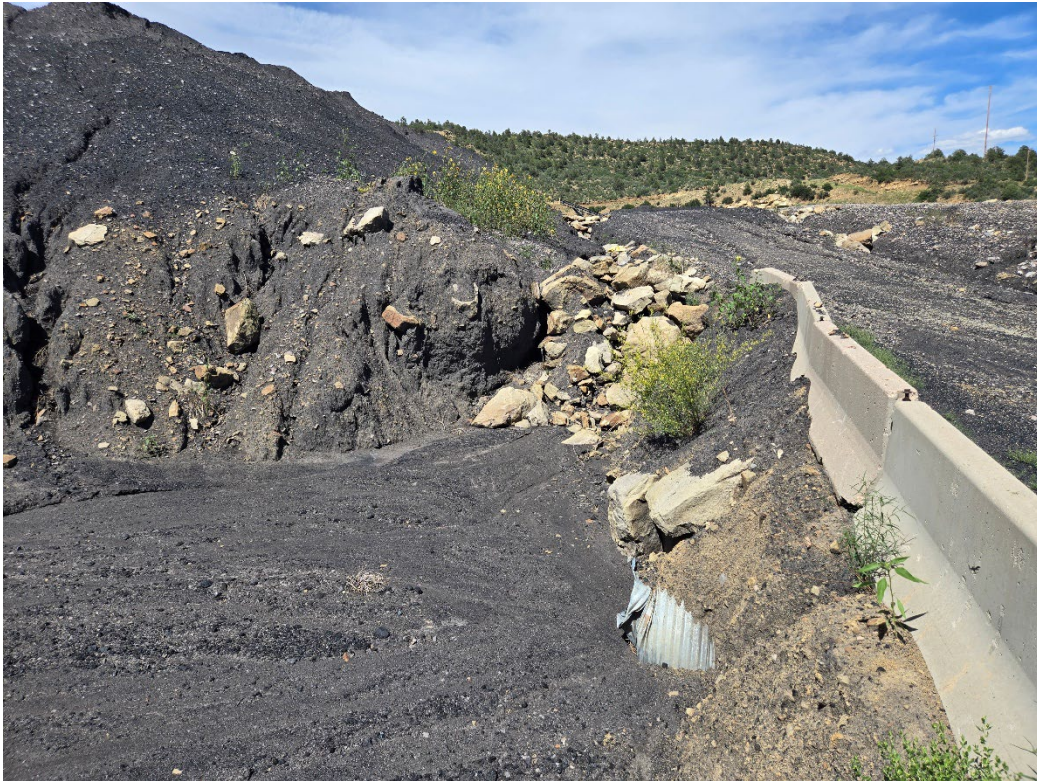
- b. The unnamed ditch east of D55, running along the west side of the RDA contains a few check dams to control run off and reduce erosion along the RDA. The southernmost check dam is damaged and is no longer functioning appropriately. It appears that water has undercut the check dam and has allowed for excess sediment to accumulate at the end of the ditch. **The Operator shall repair the check dam in the unnamed ditch leading to C81.**

*Photo 26. Looking at the damaged and eroded check dams within the ditches that lead to the inlet area for culvert C81.*

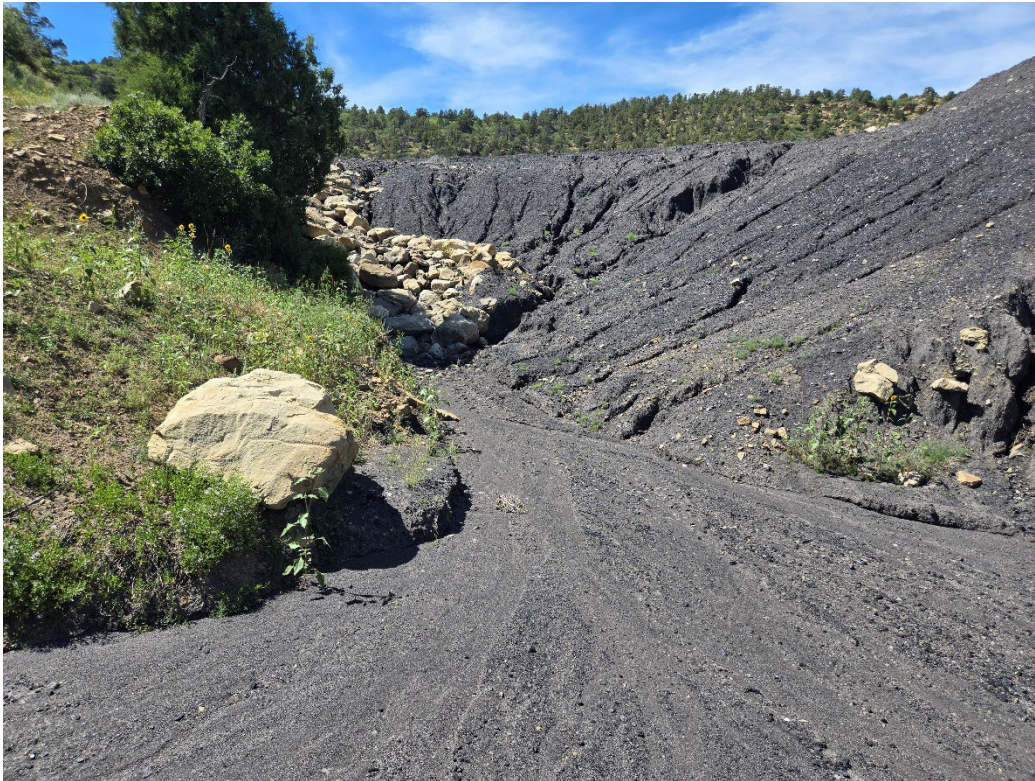
*Photo 27: Looking north at the excessive erosion on the west side of the RDA slopes.*

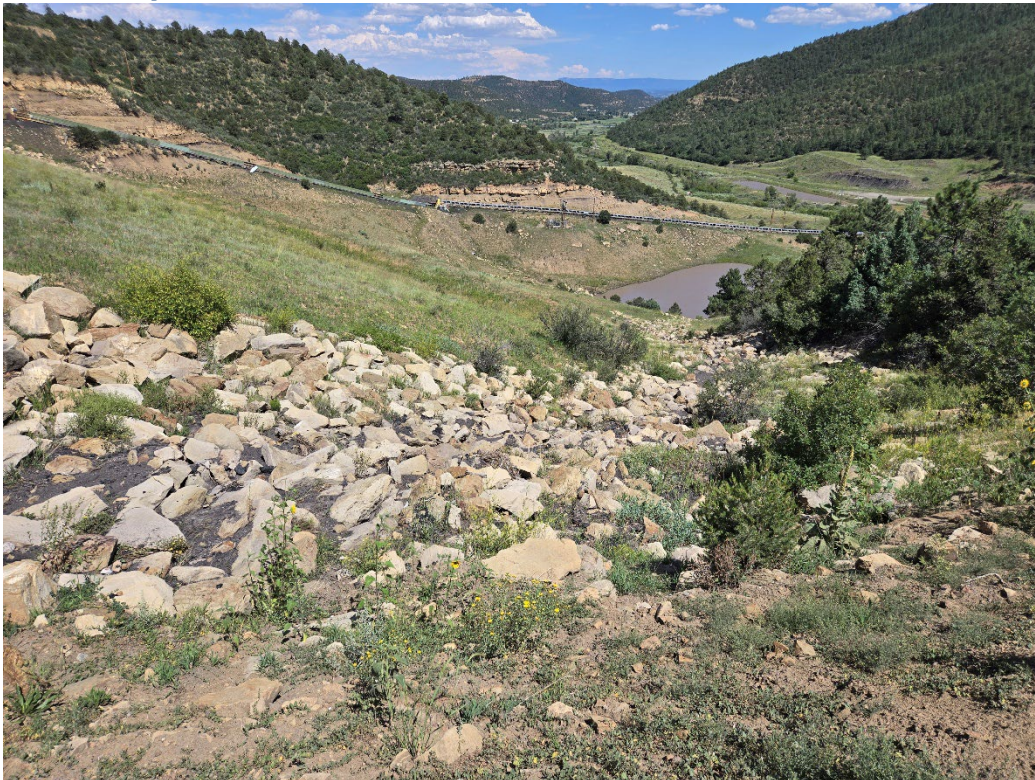
*Photo 28: Sediment accumulation within the rock lined channels around the reclaimed portions of the RDA.*

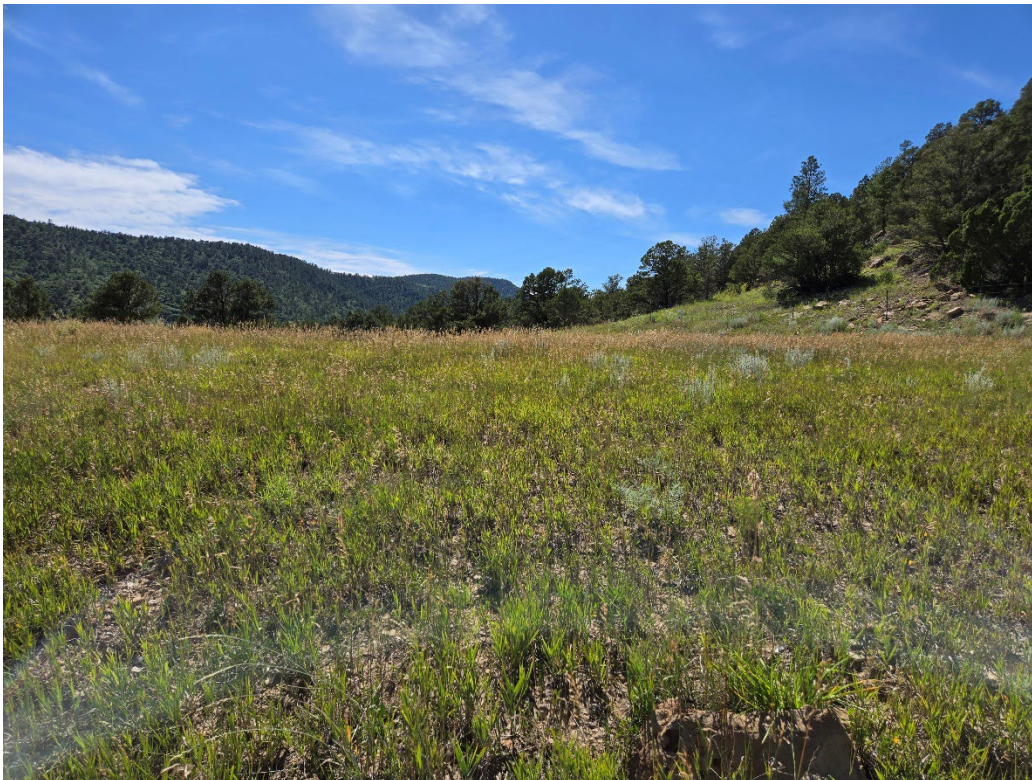
- The vegetation on the Golden Eagle Ventilation Shaft area appears to have returned and stabilized since the Division's December 2024 inspection. However, the Operator is still advised to monitor and assess this area to determine species diversity.

*Photo 29: Current revegetation on the Golden Eagle Ventilation Shaft Area.*

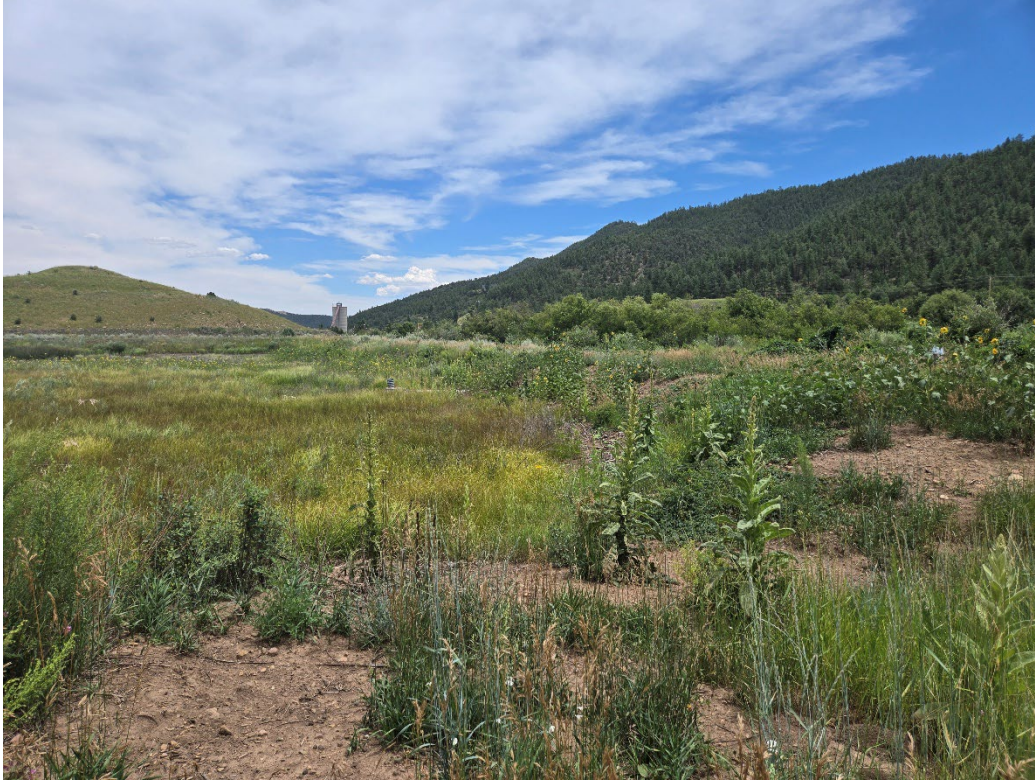
- **OMI:** (July 2024 report) The state listed noxious weed, Mullein, was observed along the light use road leading to the southwest corner of Pond 004. **The Operator shall treat and or remove the Mullein from the area around Pond 004.**
- Mullein was observed near the underdrain area in the northwest corner of the RDA. **The Operator shall treat and or remove the Mullein from the area around the underdrains.**

*Photo 30: Mullein in the southwest corner of Pond 004a.*

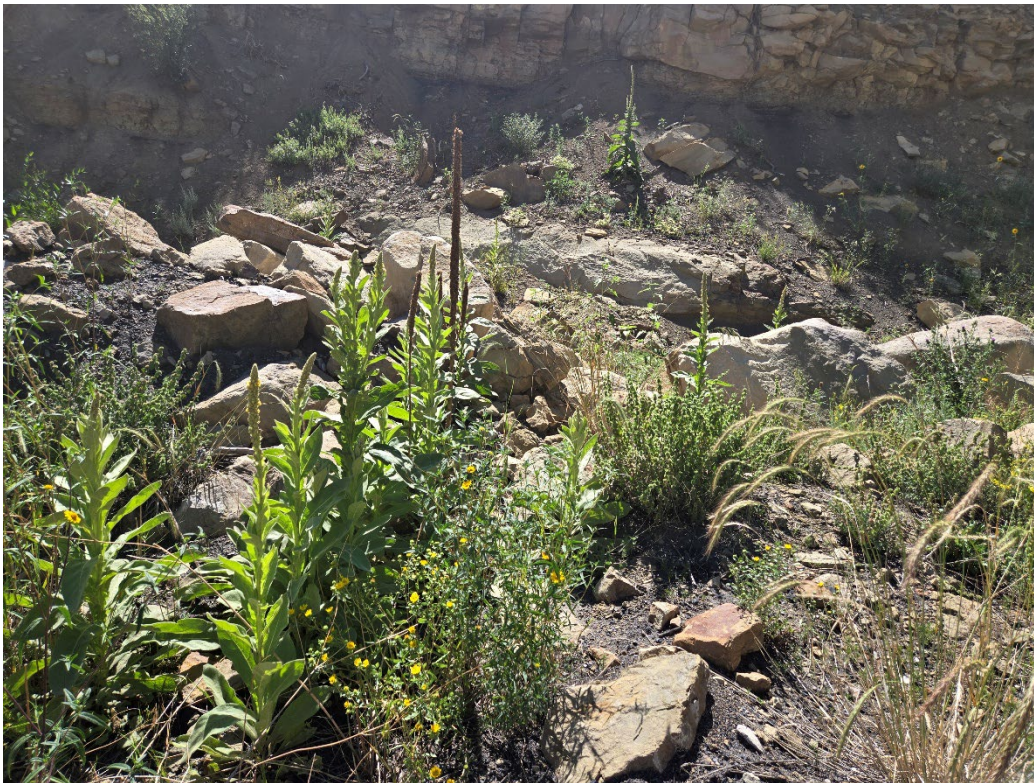
*Photo 31: Mullein established near the underdrains in the northwest corner of the RDA.*

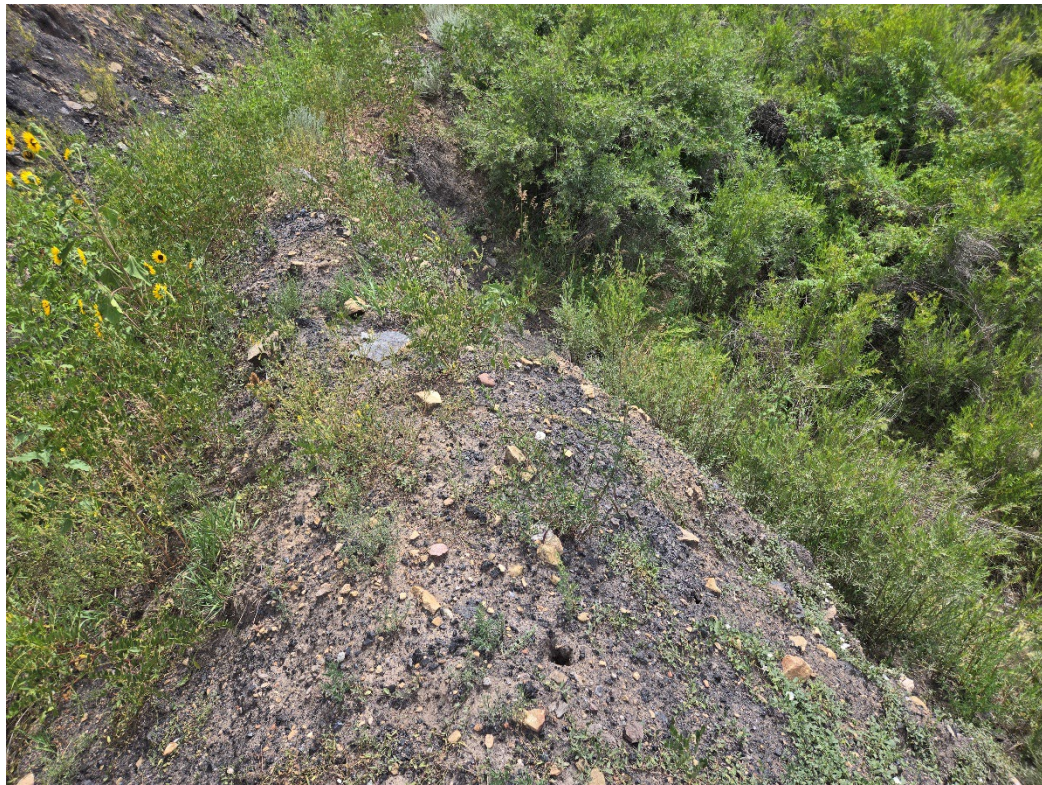
- **OMI:** (September 2023 – December 2024 reports)  
During the September 2023 inspection, it was noted that the embankment slope on the northwest side of the Soil Storage Area was eroding and sluffing into the ditch that discharges to ditch D6. NECC was instructed to repair and stabilize the area. The ditch embankment separating the affected land drainage from the adjacent clear water ditch (D7) is very thin in areas. Failure of this embankment may overwhelm the ditch and cause sediment to discharge into the clean water ditch D7 that discharges to the river. During the October 2023 inspection, the Operator stated that they had hydro-mulched the northwest side of the Soil Storage Area in an attempt to stabilize the slope. They also stated that they are unable to safely get equipment in the area to mechanically stabilize the slope and berm separating the treated water run-off from the clean water ditch. NECC had been monitoring this area. As of the December 2024 inspection, it appears that the hydro-mulching and seeding of the bench has failed, as no vegetation appears to have been established. As of \*the July 2025 inspection, the only vegetation that appears to be establishing is the C-listed noxious weed ‘bindweed’. **The Operator shall determine how to re-stabilize this bench and do so as soon as possible. (July 2025) The Operator shall also treat and remove the bindweed in this area.**

*Photo 32: Standing on the berm dividing the clean diverted surface water (D7) from the water contacting disturbed areas (ditch that discharges into D6). The right side has bindweed growth.*

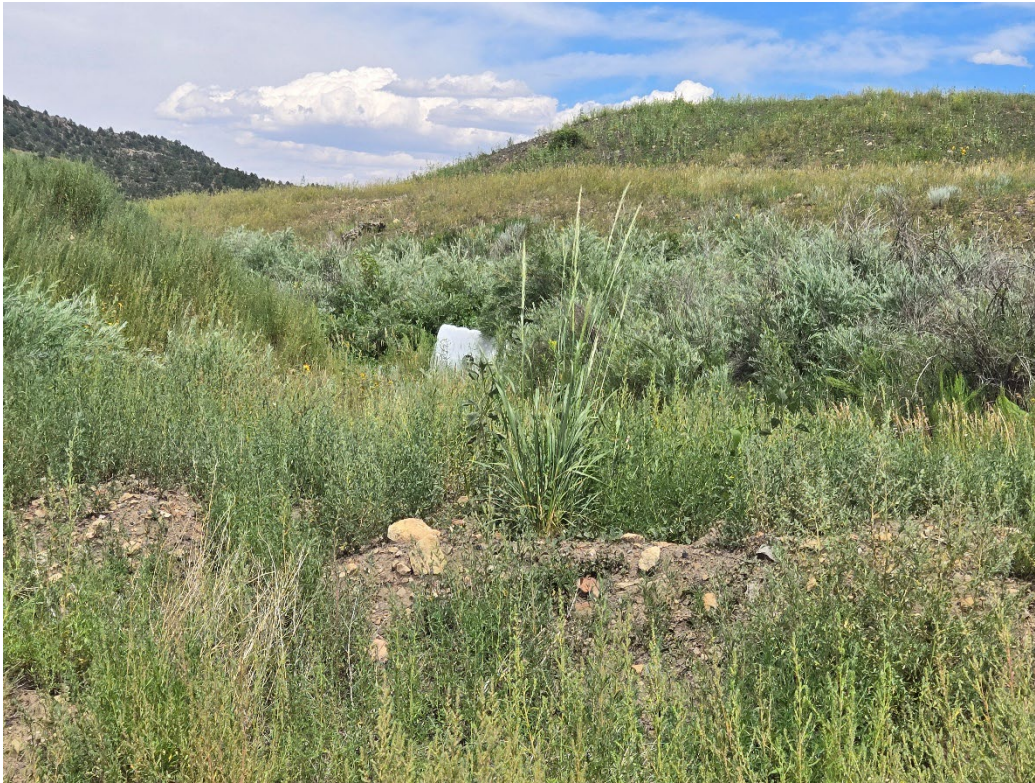
- **OMI:** (December 2024 report) The Portable Explosives and Chemical Storage area was overall stable. However, the Division observed an empty tank in the ditch to the east of the storage area. **The Operator shall remove the tank from the ditch.**

*Photo 33: Empty tank within the unnamed ditch on the east side of the Portable Explosives and Chemical Storage area.*

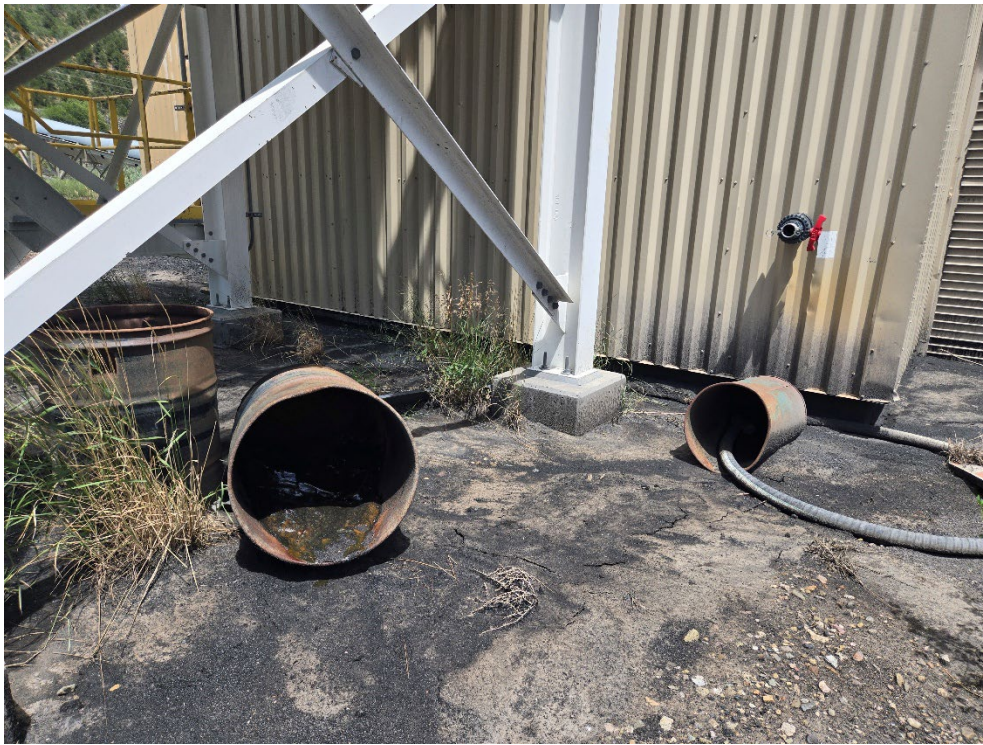
- **OMI:** (October 2024 report) During the Division's September 2024 inspection, a few barrels were observed along the west side of the wash plant building, within the raw coal storage area. One of the barrels had fallen over, and its liquid contents have spilled onto the ground next to the wash plant building. The Division believes the spilt material to be rusty stormwater. The Division observed the overturned barrel again during the October inspection and has not yet received confirmation that the spill has been cleaned. **The Operator shall provide evidence to the Division that the spill has been cleaned.**

*Photo 34: Overturned barrels with rusty material next to wash plant.*

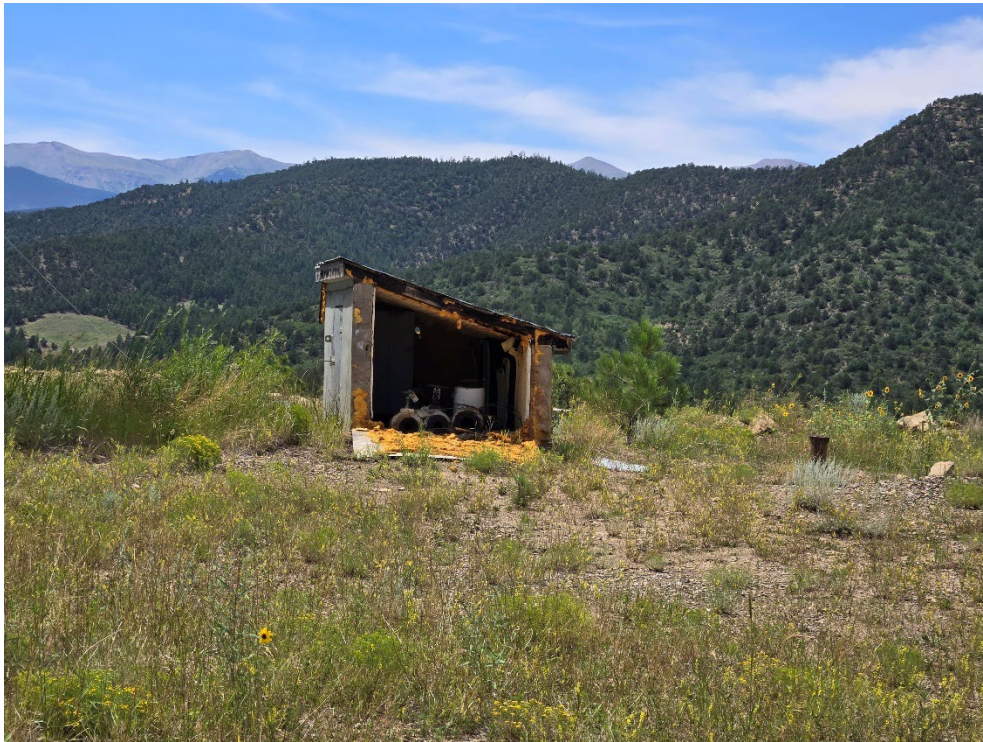
- **OMI:** (December 2024 report) The water pump/valve cover structure near the water tanks on the south side of the permit has been damaged. **The Operator shall repair, replace, or remove this structure.**

*Photo 35: Damaged water pump/valve cover structure.*

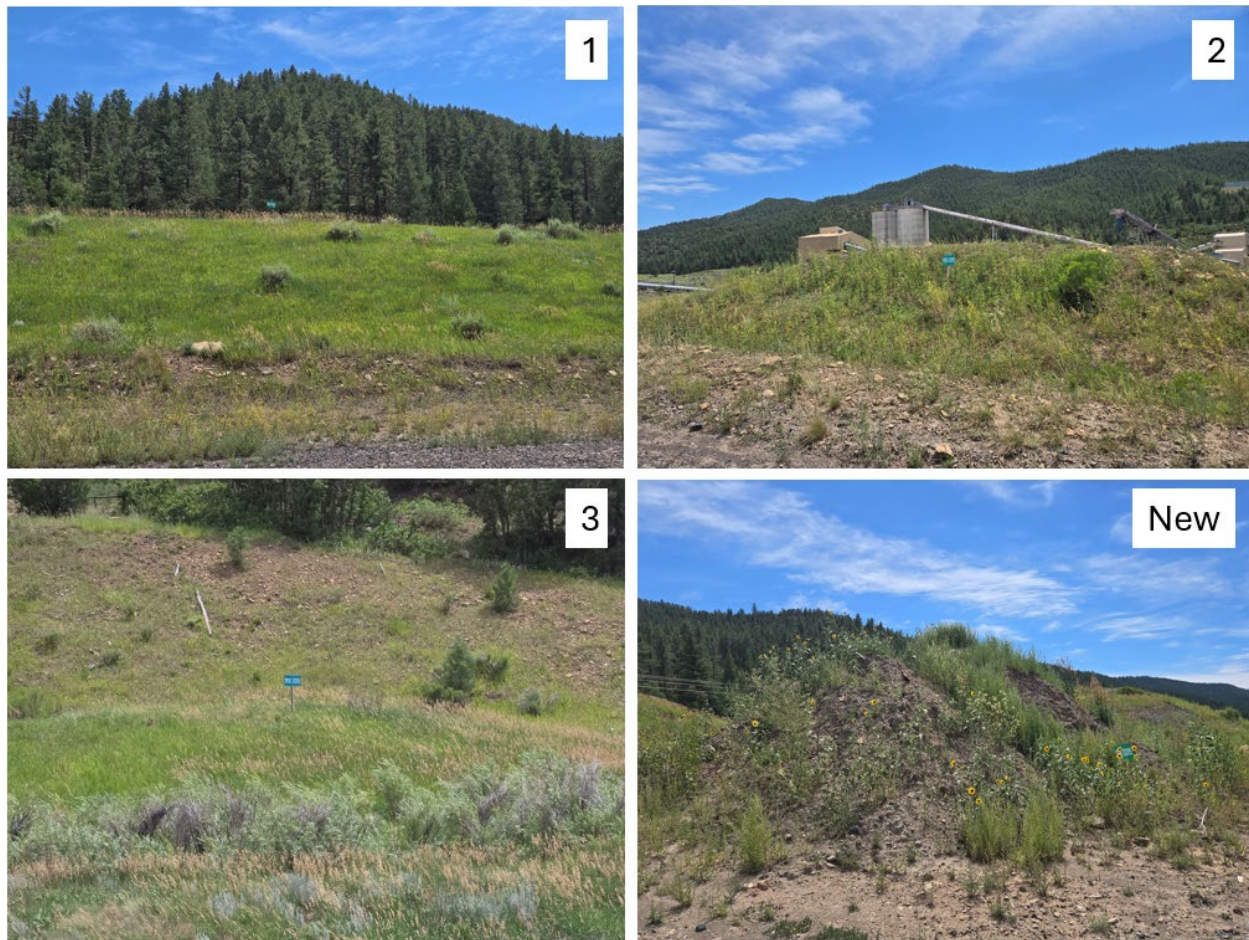
- Signs reading “Topsoil” were posted at topsoil piles #1-#3 and the new pile located near #1 in compliance with Rule 4.02.7.

*Photo 36: Topsoil piles with signs posted at the site.*

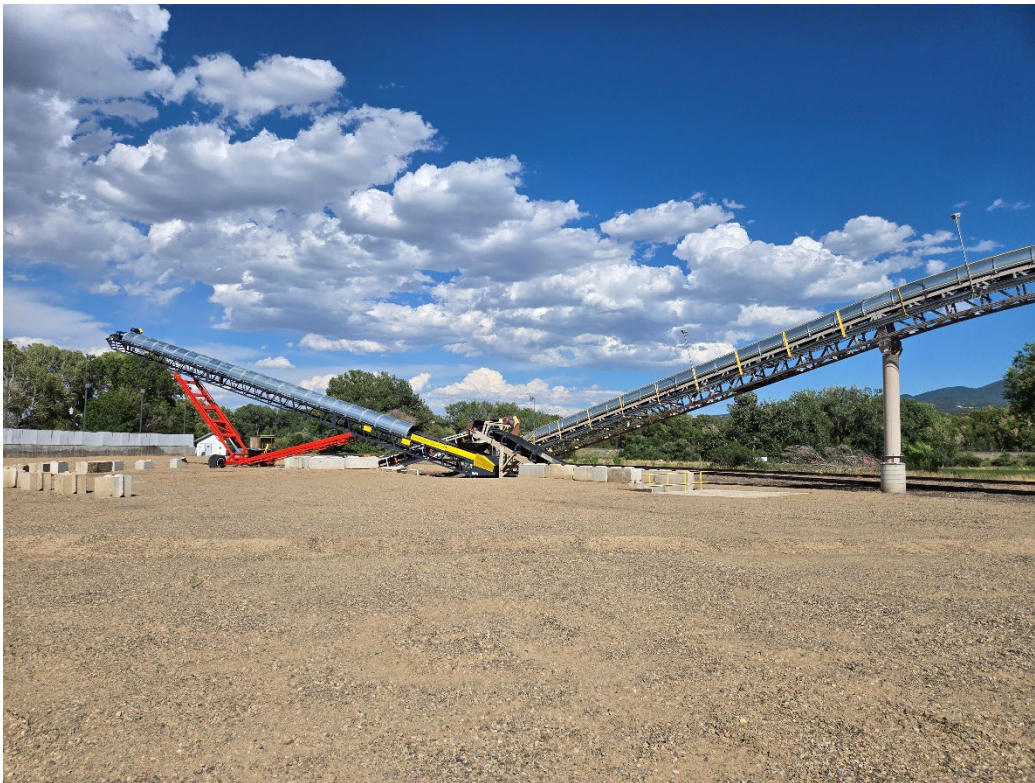
- The facilities at the Jansen Loadout were observed. All equipment on-site appears to be stable at the time of the inspection. It appeared that many portions of the conveyor system have been replaced with new parts.
- The coal in the yard area near the entrance has been removed/covered with what looks like soil and/or gravel. On the east side, near the office trailer, the yard has also been graveled.

*Photo 37: New/replaced conveyor equipment at the Jansen Loadout.*

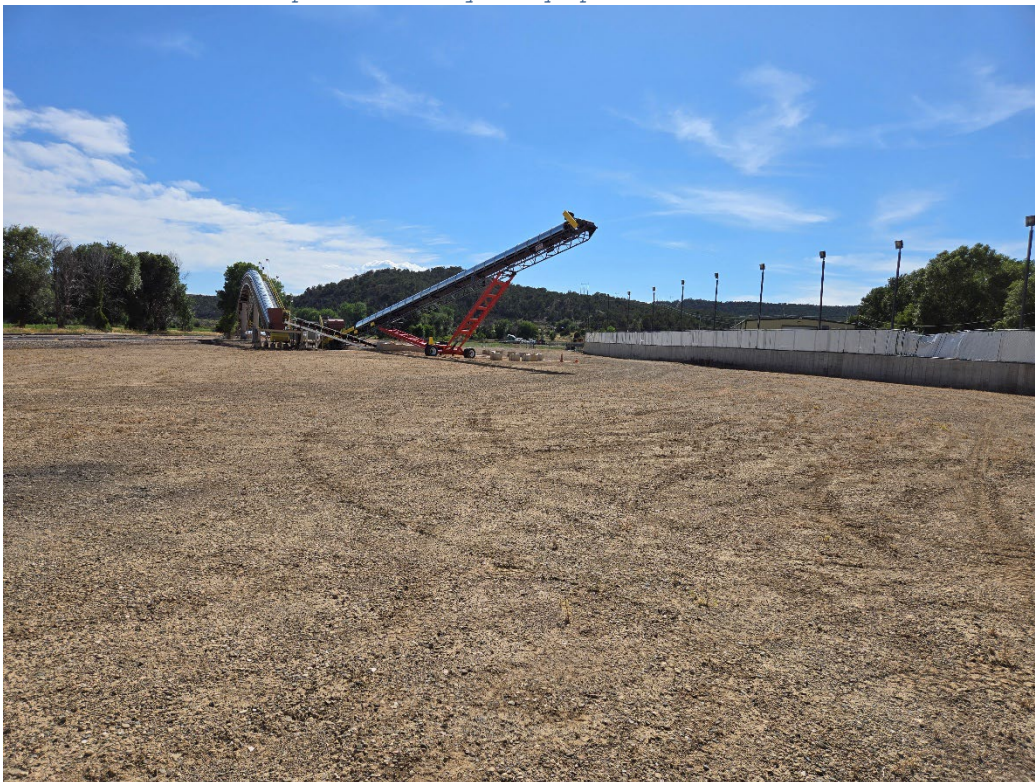
*Photo 38: Graveled area over what had previously been coal.*
