**MINERALS PROGRAM INSPECTION REPORT**  
**PHONE: (303) 866-3567**

| <b>MINE NAME:</b><br>Raymond Mine | <b>MINE/PROSPECTING ID#:</b><br>M-2020-013 | <b>MINERAL:</b><br>Gold and silver | <b>COUNTY:</b><br>Gunnison |
| <b>INSPECTION TYPE:</b><br>Monitoring | <b>WEATHER:</b><br>Clear | <b>INSP. DATE:</b><br>August 5, 2025 | <b>INSP. TIME:</b><br>10:30 |

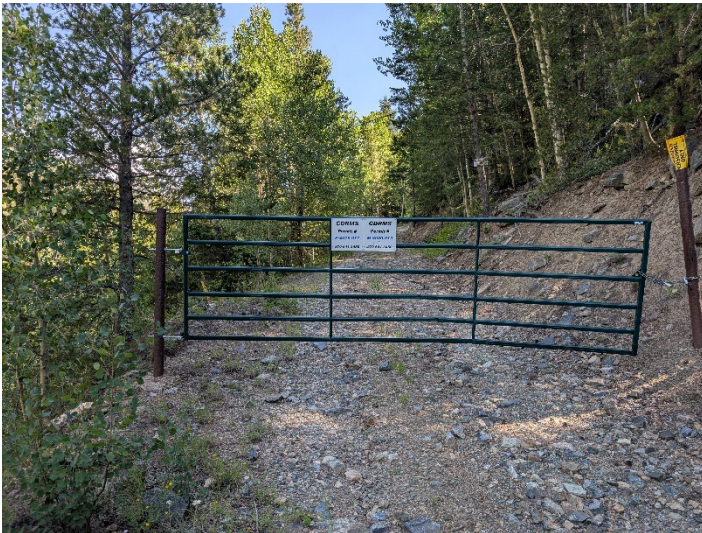
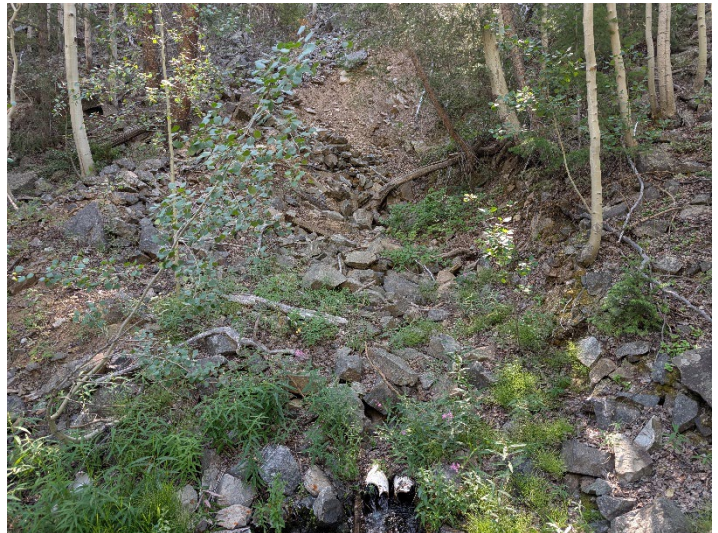
Adequate mine identification signage was noted on the gate at the entrance to the site.

The Raymond Portal is currently collapsed.
