MINERALS PROGRAM INSPECTION REPORT
PHONE: (303) 866-3567

MINE NAME: Cross Gold Mine	MINE/PROSPECTING ID#: M-1977-410	MINERAL: Gold, copper, silver,	COUNTY: Boulder
INSPECTION TYPE: Preoperation Inspection	WEATHER: Cloudy	INSP. DATE: July 30, 2025	INSP. TIME: 10:00
OPERATOR: Grand Island Resources LLC	OPERATOR REPRESENTATIVE: Richard Mittasch, Ben Langenfeld	TYPE OF OPERATION: 110(2) - Hard Rock Limited Impact	
REASON FOR INSPECTION: Preoperation Inspection	BOND CALCULATION TYPE: None	BOND AMOUNT: \$546,751.00	
DATE OF COMPLAINT: NA	POST INSP. CONTACTS: None	JOINT INSP. AGENCY: None	
INSPECTOR(S): Patrick Lennberg Lucas West Jared Ebert	INSPECTOR'S SIGNATURE:

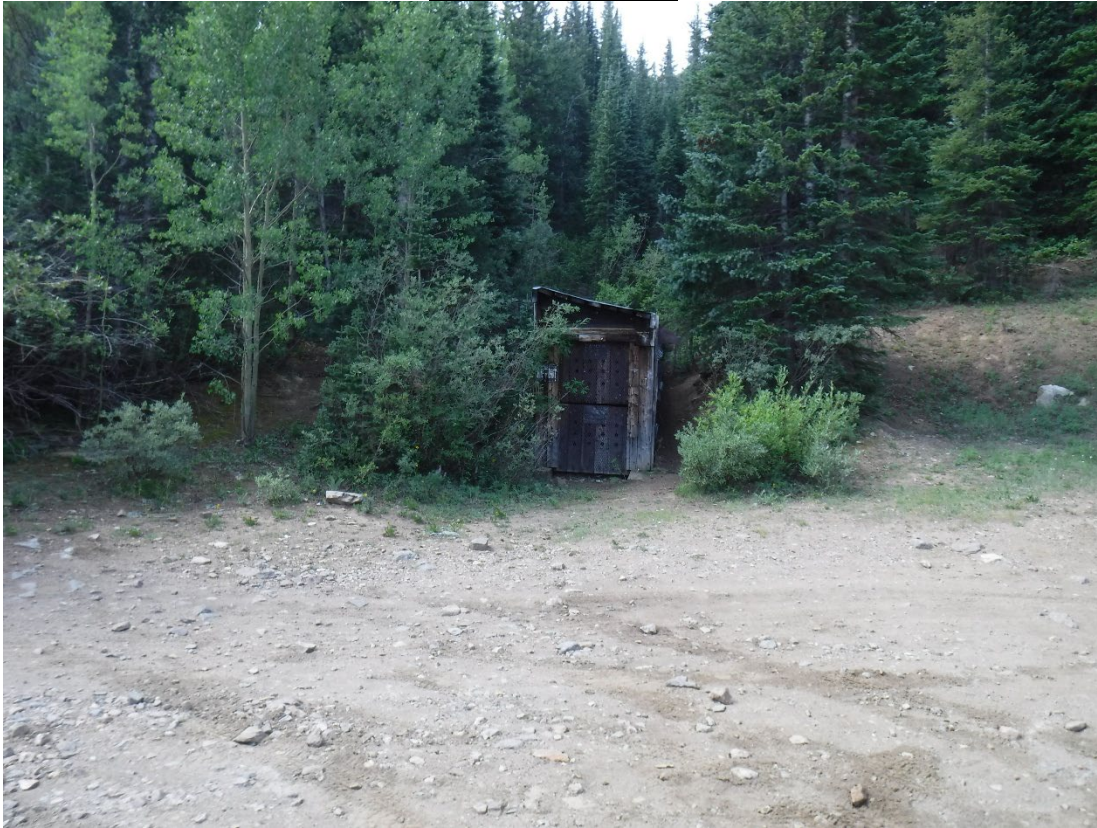
Currently the entrance of the Caribou 300 Portal consists of a snow shed with a locking gate. The portal has collapsed approximately 80 feet from the gate, towards the hillside, and access to the underground workings is not possible. If the conversion is approved the portal will be evaluated and maybe rehabilitated into a ventilation shaft and or an emergency escape way for underground operations in the area.

Photo 1: Caribou 300 Portal gated entrance

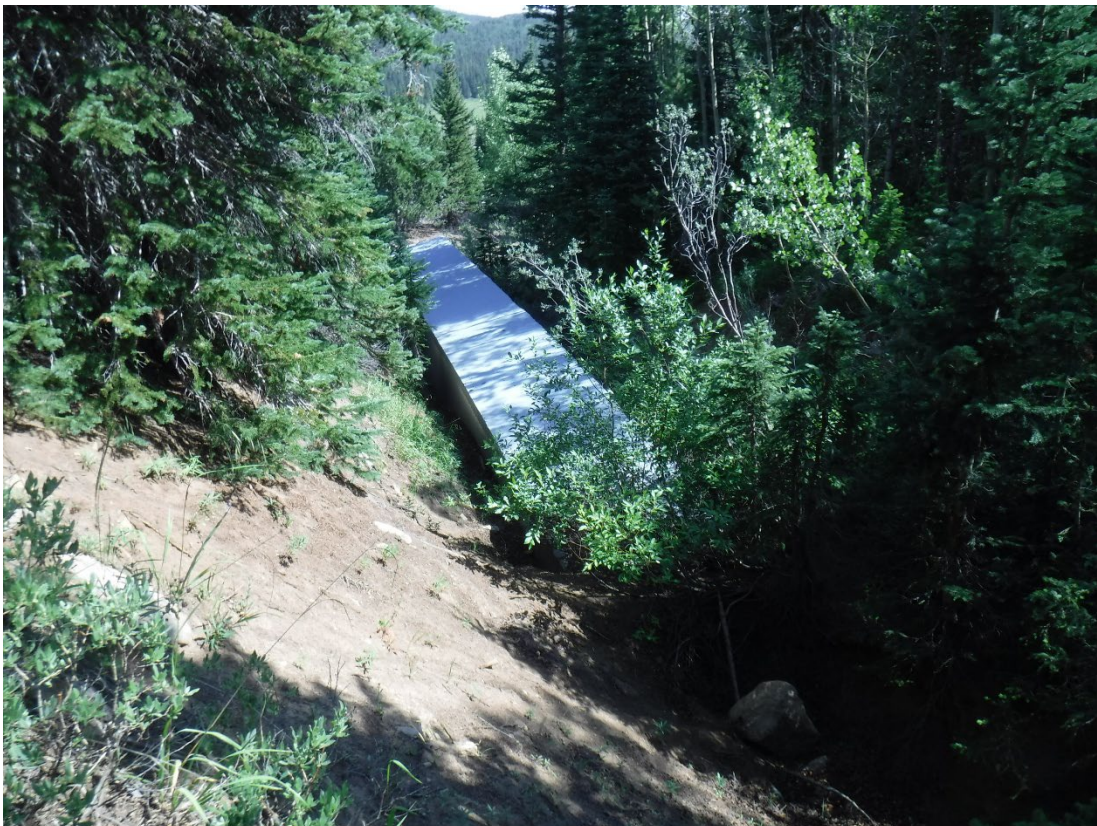
Photo 2: Caribou 300 Portal snowshed looking towards the gated entrance

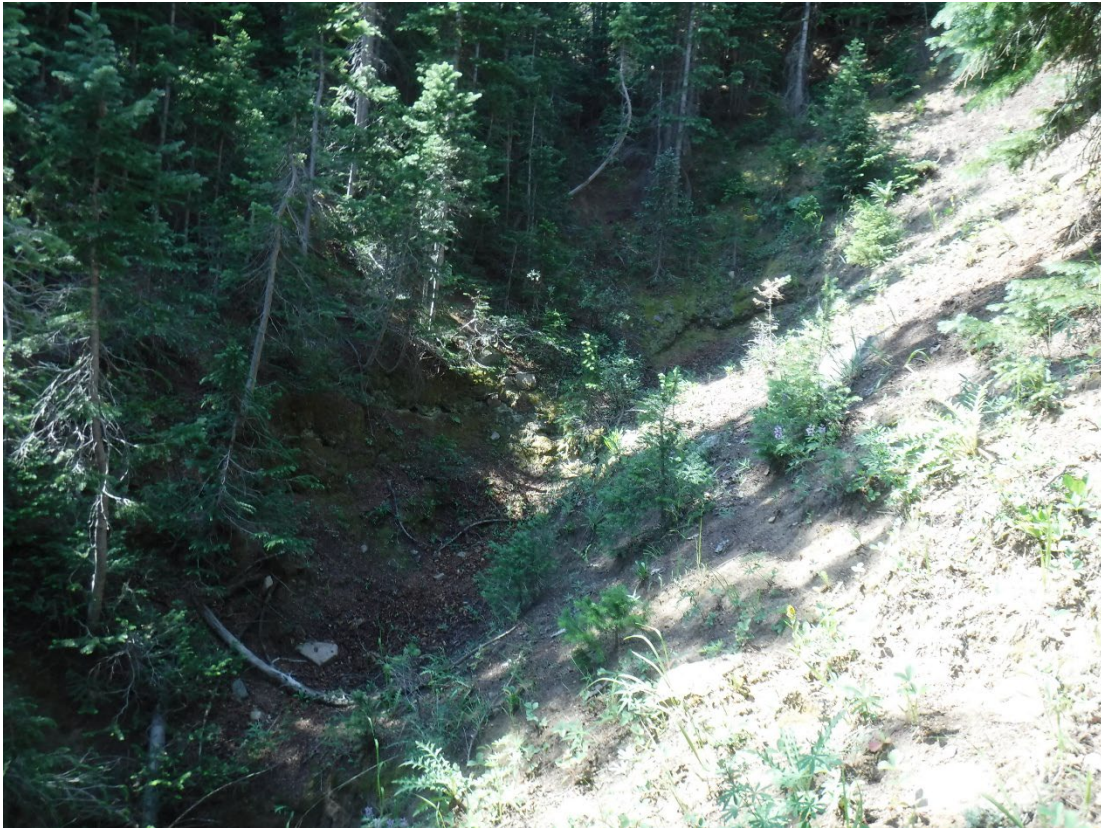
Photo 3: Caribou 300 Portal collapsed portion towards hillside

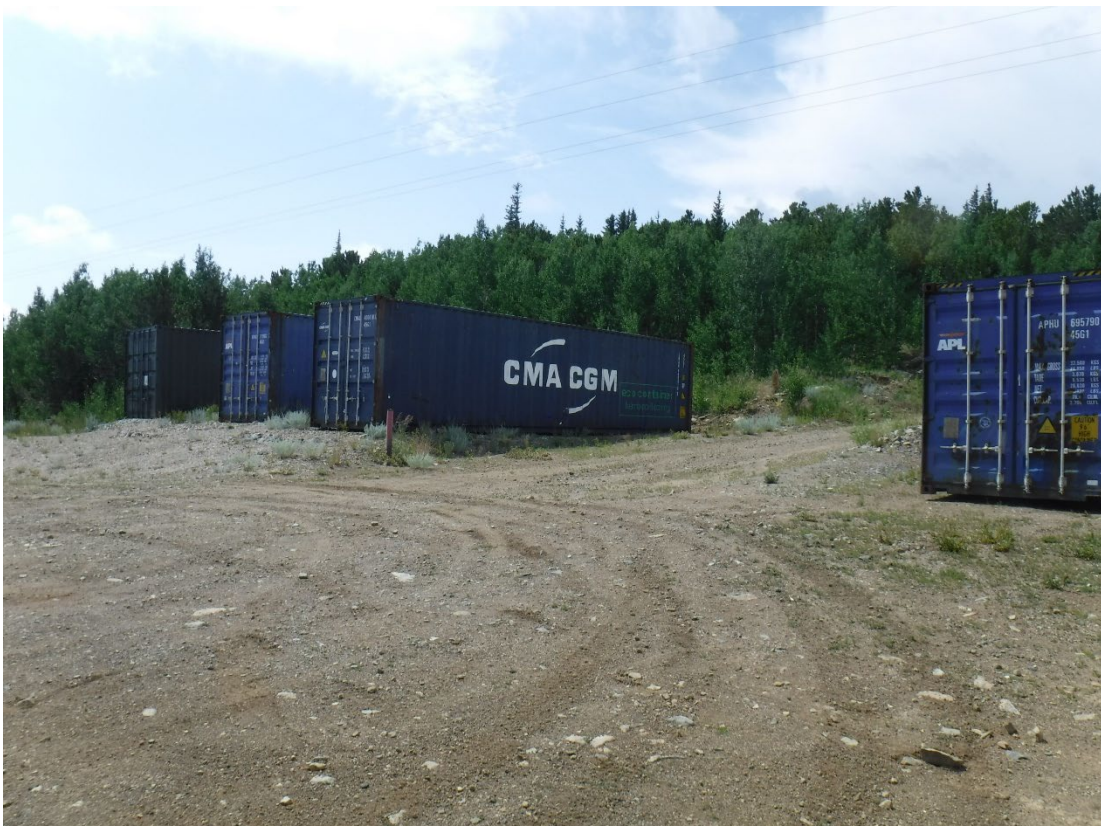
Photo 4: Conex boxes in the Comstock Area

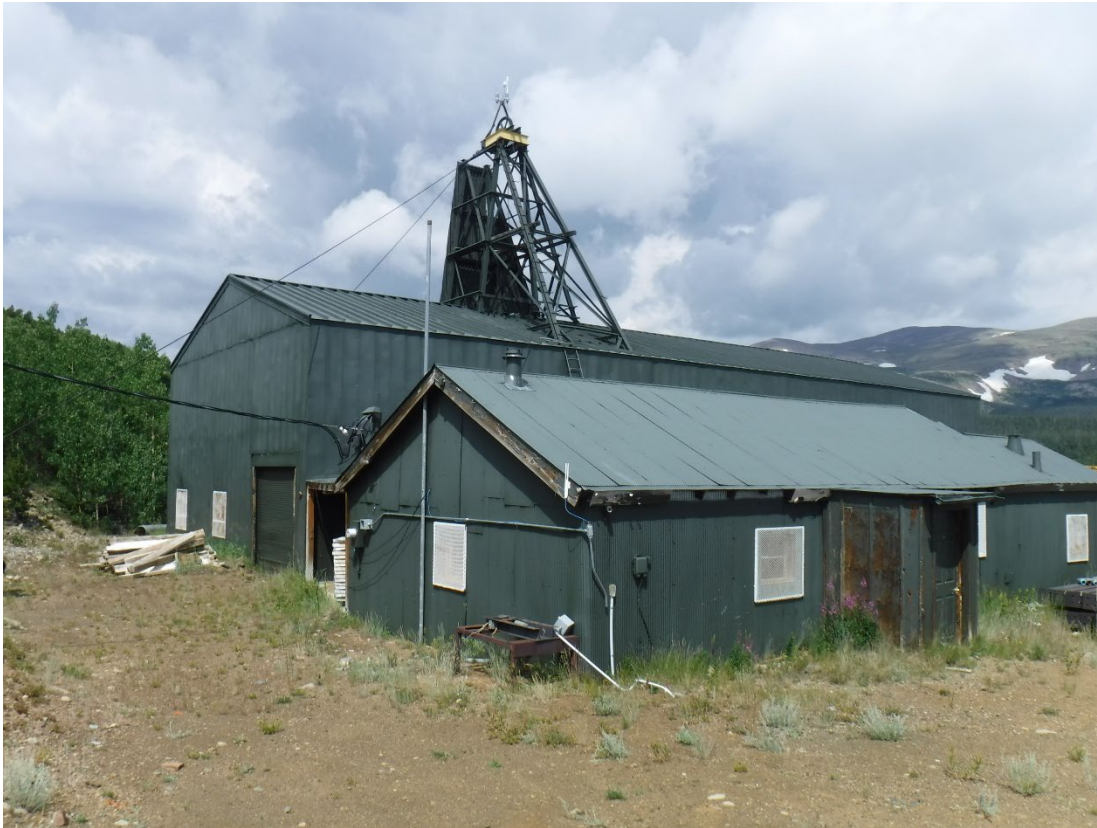
Photo 5: Weathered storage buildings in Comstock Area

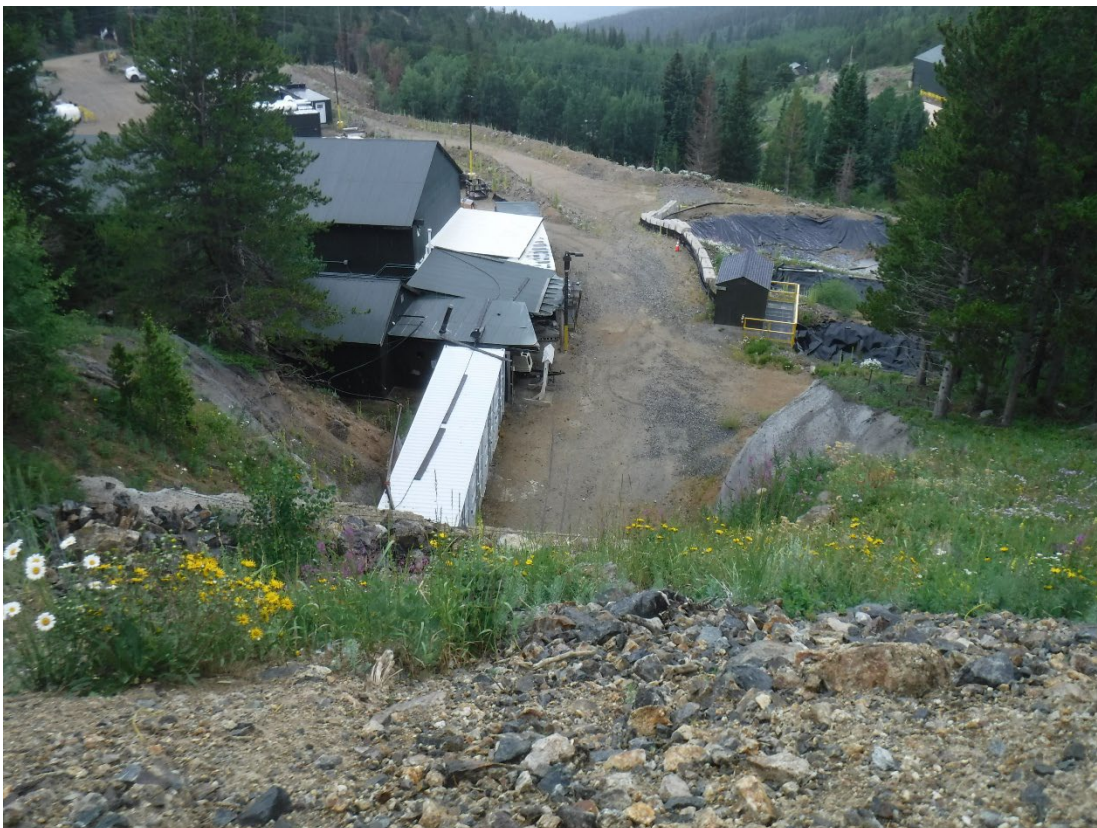
The Division did observe the Idaho Tunnel, located in the Operations Area, from Caribou Road and from the tunnel entrance. The Operator stated that recently three cores had been advanced to determine the stability and competency of the bedrock surrounding the entrance. The competency of the surrounding rock is needed to determine how the entrance will be rehabilitated for long-term stability. The results of the core drilling and a proposal for the rehabilitation are expected to be included with the conversion application preliminary adequacy review responses.

Photo 6: Looking from Caribou Road down to the Idaho Tunnel entrance

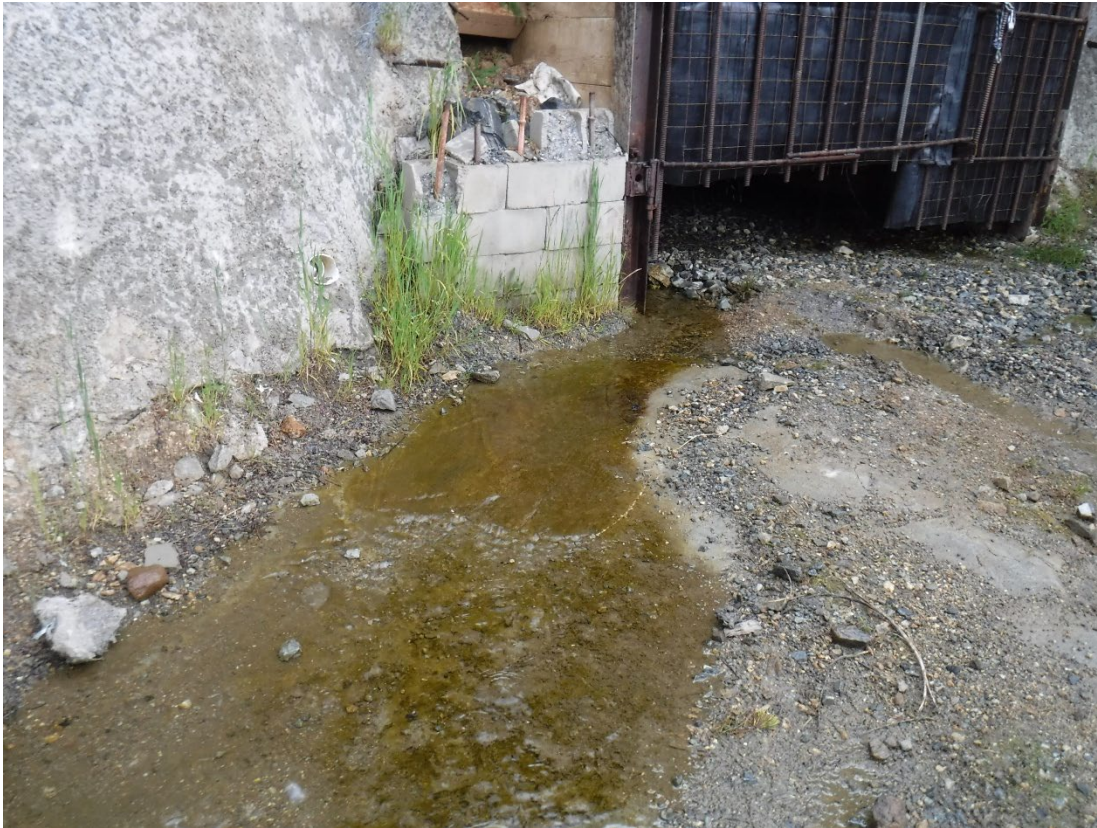
Photo 7: Idaho Tunnel effluent discharge

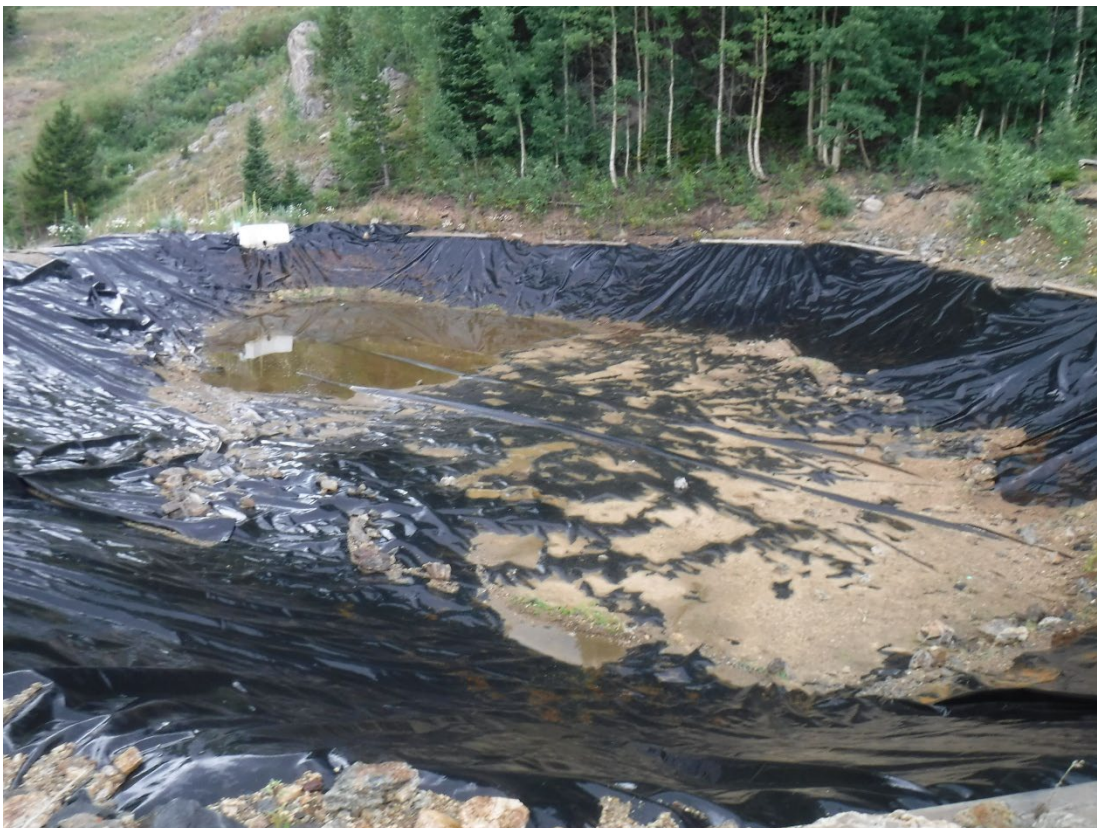
Also located at the Idaho Tunnel entrance are the 3-Series Ponds. On July 13, 2025 the Operator submitted Technical Revision 16 (TR-16) which provided the details on how the Operator plans on decommissioning and reclaiming the sediment ponds. The ponds were approved to be installed with the approval of TR-2 in 1987. They were installed as settling ponds to remove sediment to meet water quality standards at that time. Currently, mine effluent is being conveyed to Pond 1 via a pipeline that was installed two winters ago when the ponds were freezing over, and Xcel Energy was discontinuing electrical service during winter storms. Since the pipeline was installed there has been no need for the ponds. On August 11, 2025, the Division approved TR-16 to remove the 3-series ponds.

Photo 8: Pond 3C

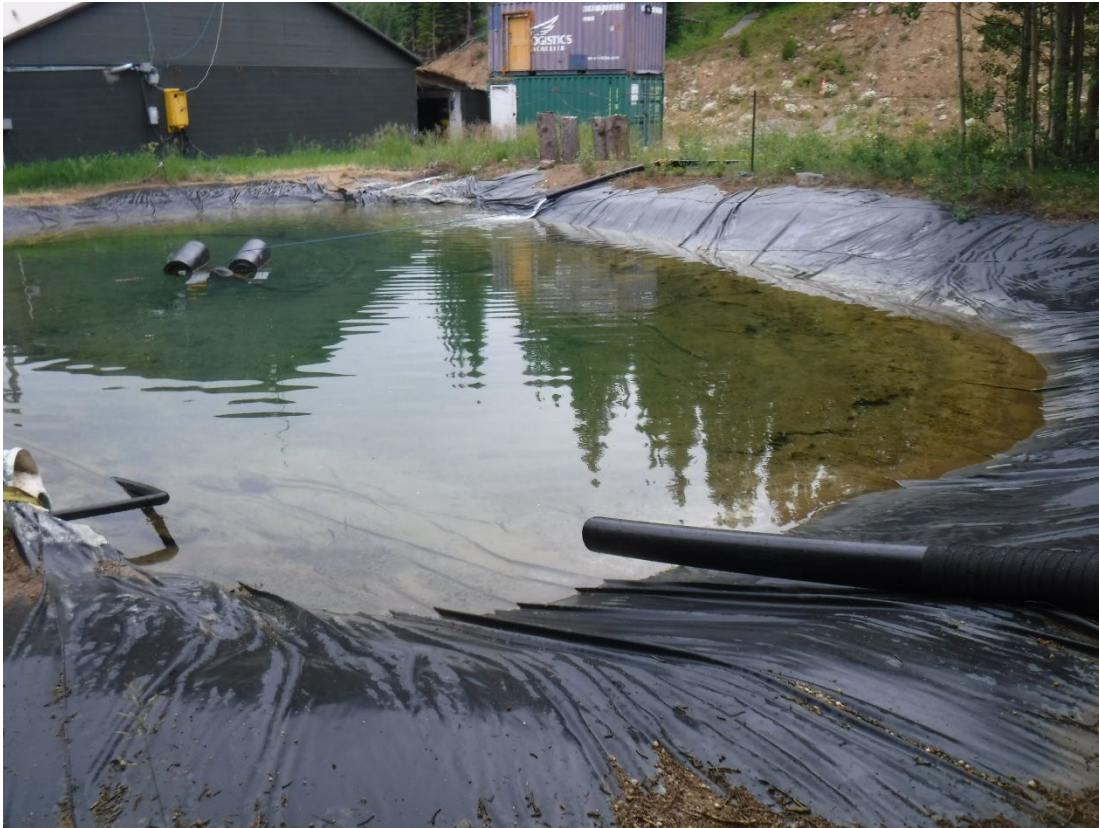
The Division observed Ponds 1 and 2. Pond 1 was receiving water from the Cross Mine while Idaho Tunnel effluent was being directed into the Cross Mine. From Pond 1, water was being directed through the water treatment system which once treated was being discharged at the permitted discharge location on Coon Track Creek. Pond 2 receives backflush water from the water treatment plant during routine maintenance of the filter media. Pond 2 has numerous Tiger Salamander larvae in it. Also observed at Pond 2 were two pipes that discharge water to the pond. A white pipe is used for the backflush water from the treatment plant. Another black pipe is an alternative discharge pipe for Idaho Tunnel effluent water. During conversations about the pipe the Operator stated that they would remove the pipe during the regrading process of the haul road as the pipeline is not useful now.

Photo 9: Pond 1, discharge in background is from the Joliet Raise and the pipe in the foreground is for Idaho Tunnel effluent direct discharge to pond

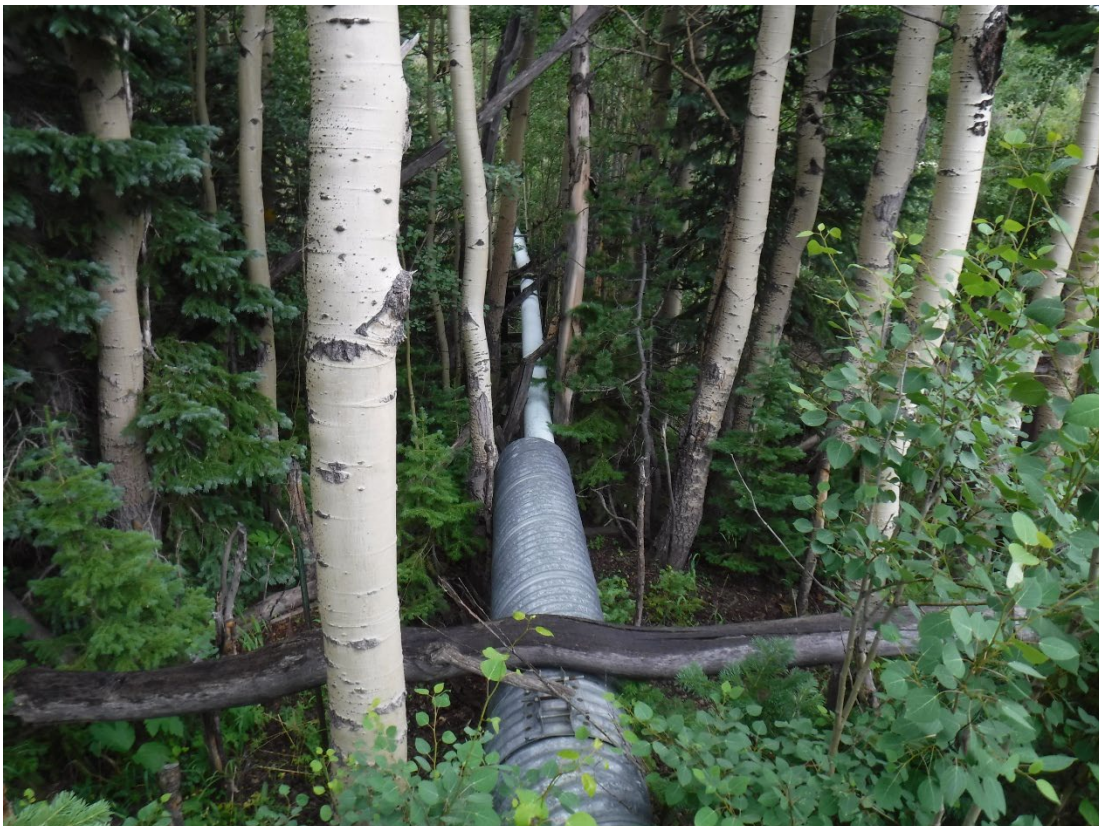
Photo 10: Back flushing discharge pipe from Pond 1 going to Pond 2

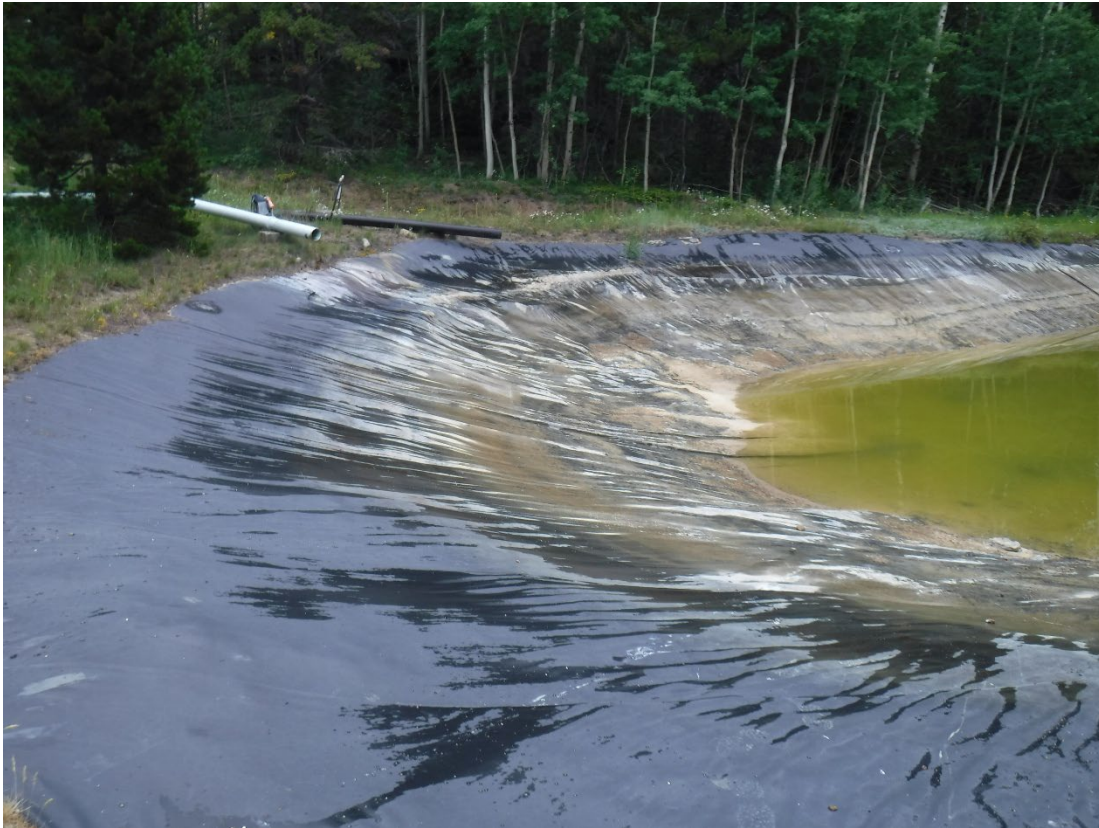
Photo 11: Back flushing discharge pipe from Pond 1 going to Pond 2, and black pipe from Idaho Tunnel

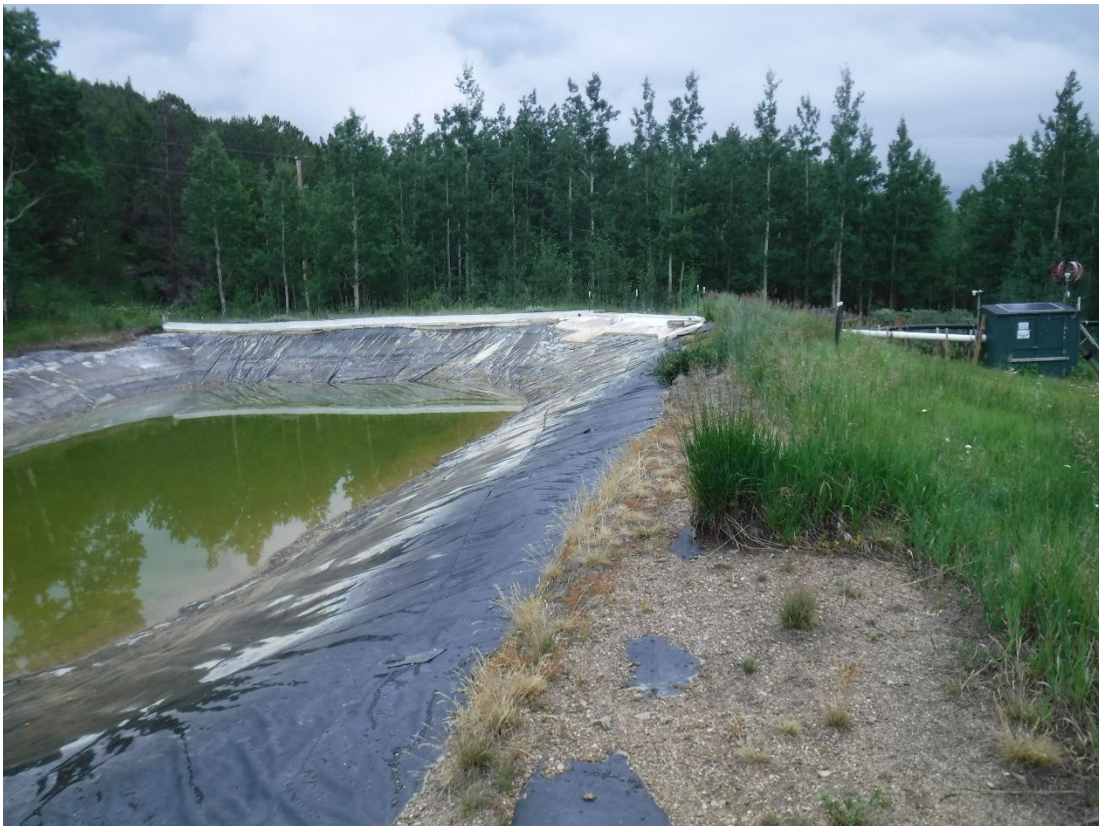
Photo 12: Pond 2

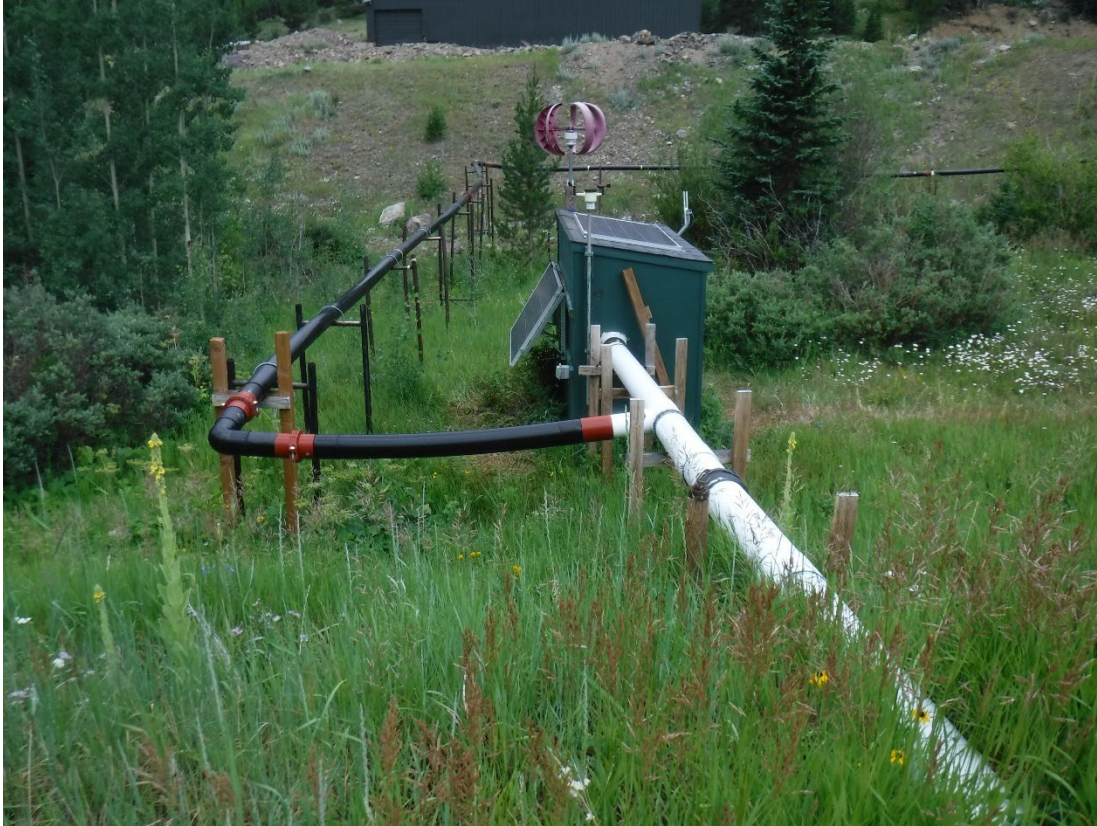
Photo 13: CDPHE approved discharge location, black pipe is from water treatment plant white pipe not used from Pond 2

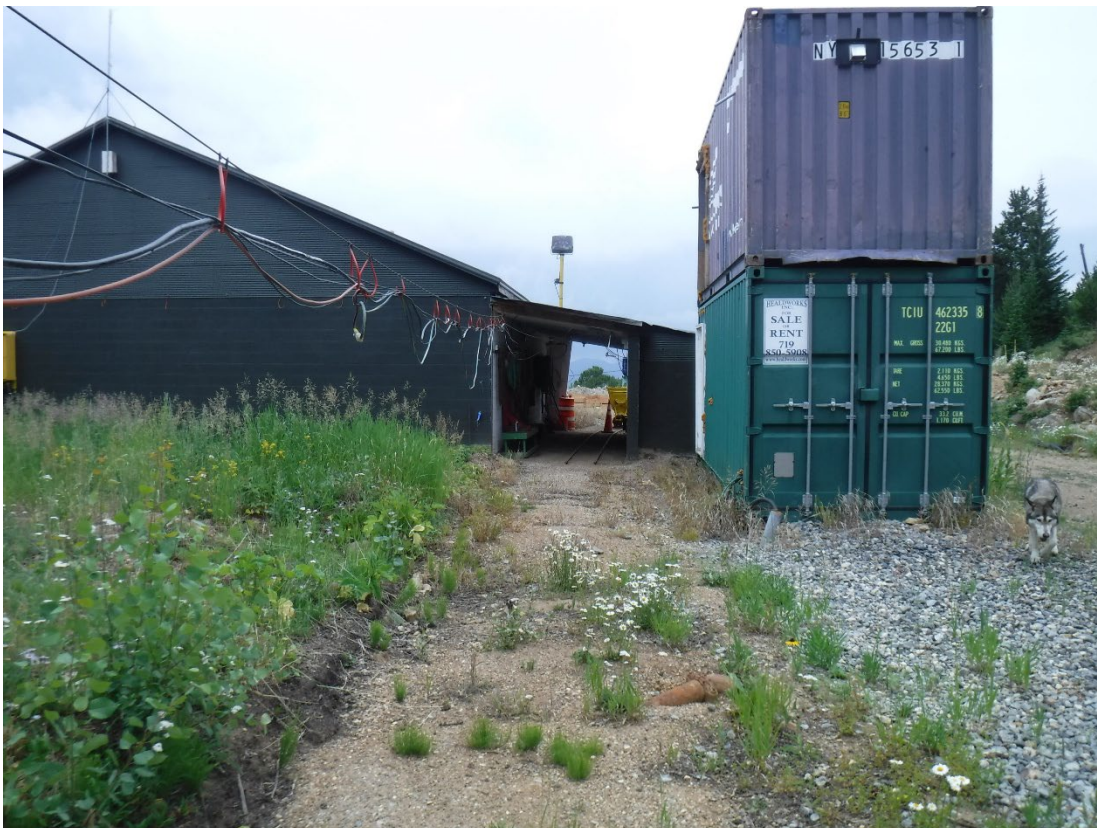
Near the Cross Mine entrance, the Division observed several large stacks of lumber. The Operator has plans to begin construction of the snowshed over the tracks and leading to the mine entrance as approved in TR-12. It is unclear if the Operator plans on relocating the water treatment plant at the same time, which was also approved in TR-12.

Photo 14: New snowshed location

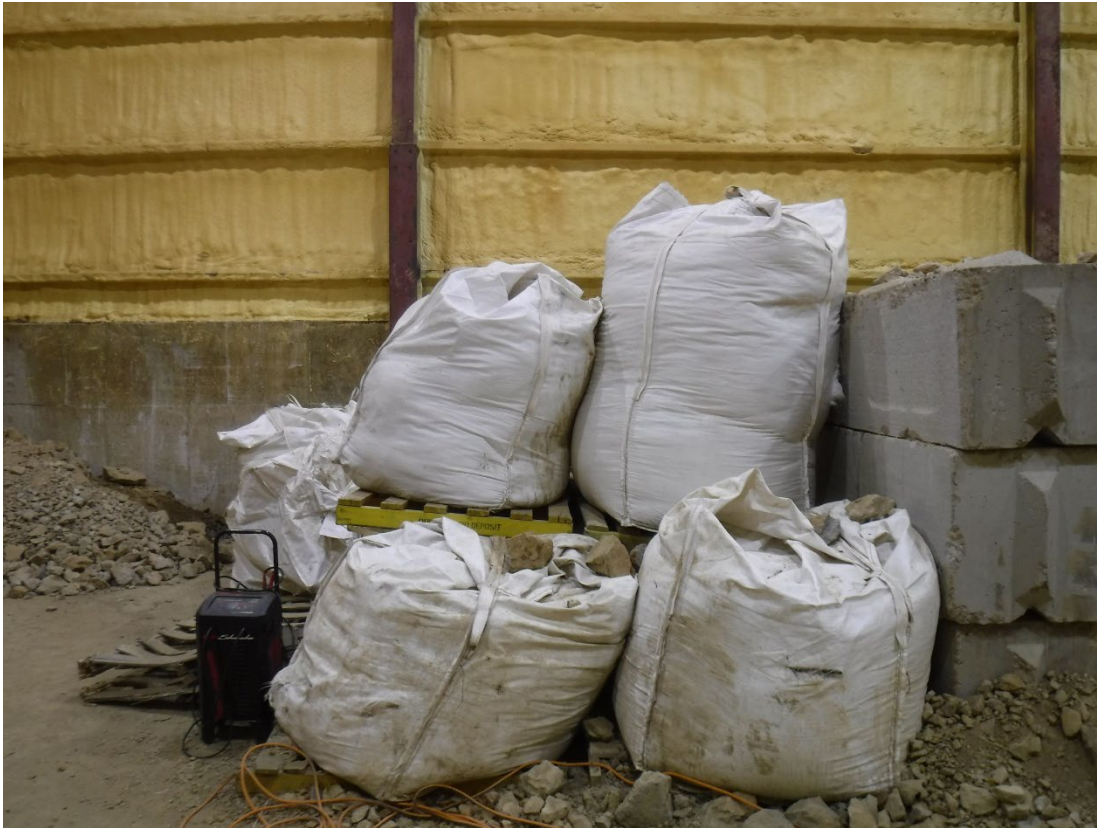
The Division observed the inside of the warehouse. In the warehouse the Division noted a SuperSacs of spent filters and approximately 10 SuperSacs of sediment from the water treatment operations, including sediment from the water treatment methods used by the previous Operator. The sediment is from the cleaning out of the ponds and backflush material from the treatment system. This material is to be disposed of in an appropriate off-site facility. The Operator is to submit to the Division prior to transporting the sediment and filters off-site, for proper disposal, a memo that provides information from analytical sample results of the materials where the materials are to be disposed and any other relevant information that shows proper disposal protocols are being followed.

Photo 15: SuperSacs in warehouse building of pond sediment and backflush sediment material

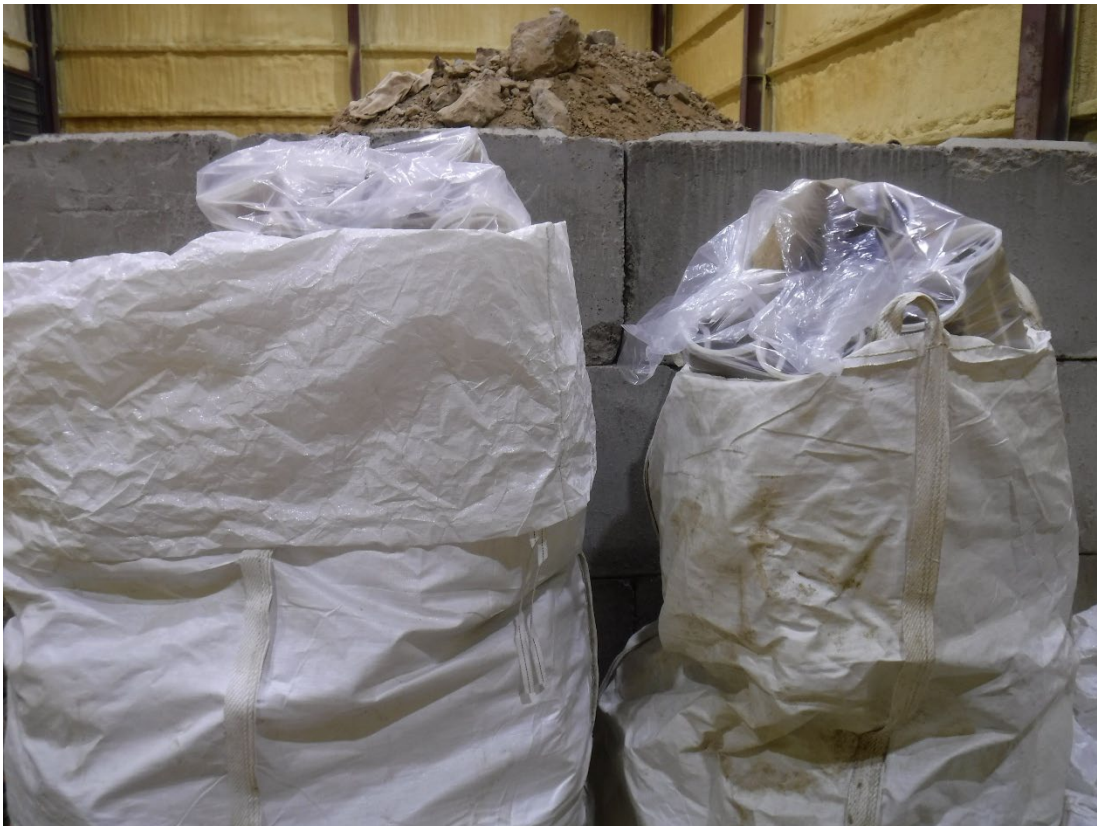
Photo 16: SuperSacs in warehouse building of spent water treatment filters

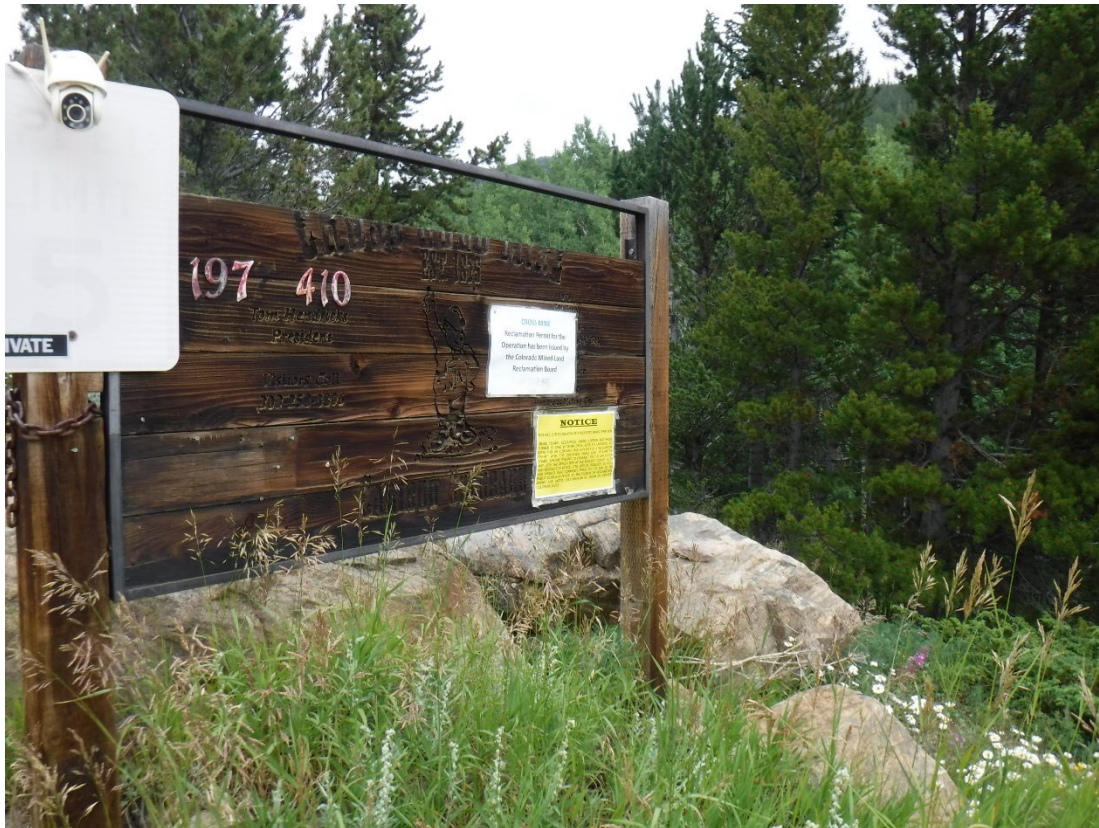
Photo 17: Typical notice sign of application

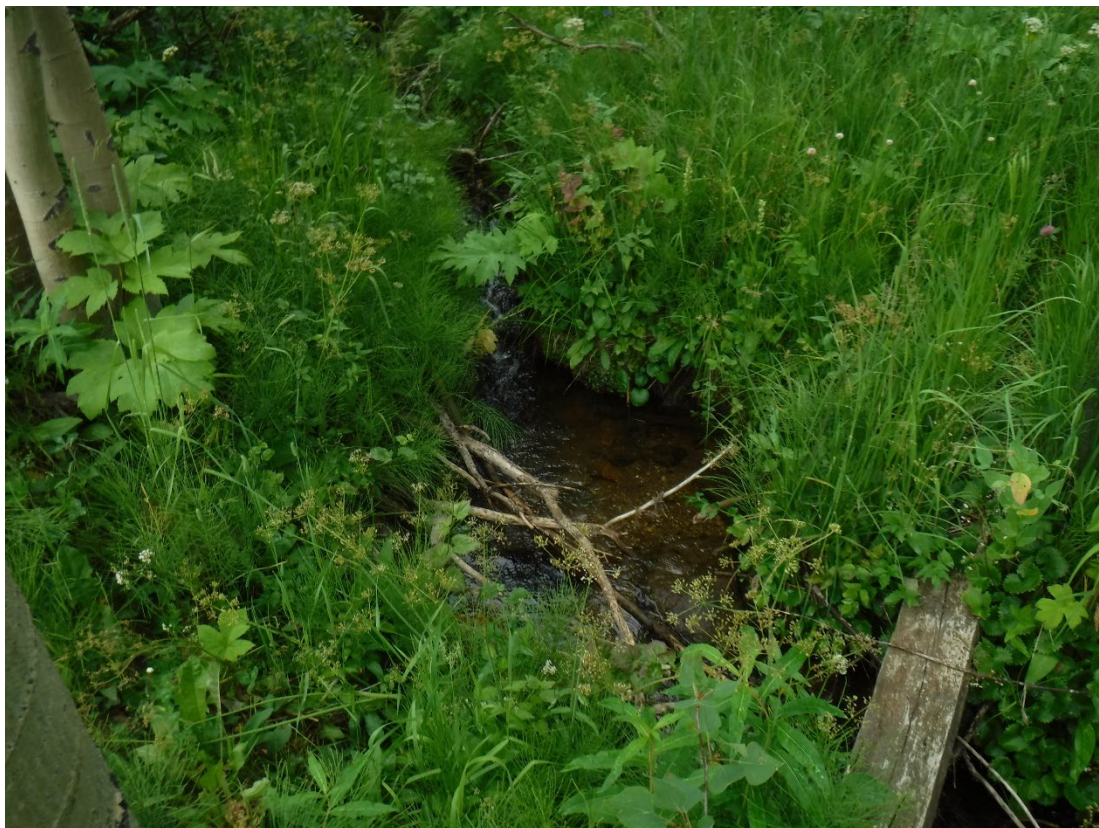
Photo 18: Surface water flow at downstream sampling location
