MINERALS PROGRAM INSPECTION REPORT
PHONE: (303) 866-3567

MINE NAME: Hukill Gulch Millsite	MINE/PROSPECTING ID#: M-2009-076	MINERAL: Silver and gold	COUNTY: Clear Creek
INSPECTION TYPE: Monitoring	WEATHER: Clear and Warm	INSP. DATE: July 18, 2025	INSP. TIME: 10:00
OPERATOR: Venture Resources, Inc.	OPERATOR REPRESENTATIVE: Mason Drake	TYPE OF OPERATION: 110d - Designated Limited Impact	
REASON FOR INSPECTION: Notice of Temporary Cessation	BOND CALCULATION TYPE: None	BOND AMOUNT: \$107,742.72	
DATE OF COMPLAINT: NA	POST INSP. CONTACTS: None	JOINT INSP. AGENCY: None	
INSPECTOR(S): Nikie Gagnon	INSPECTOR'S SIGNATURE:

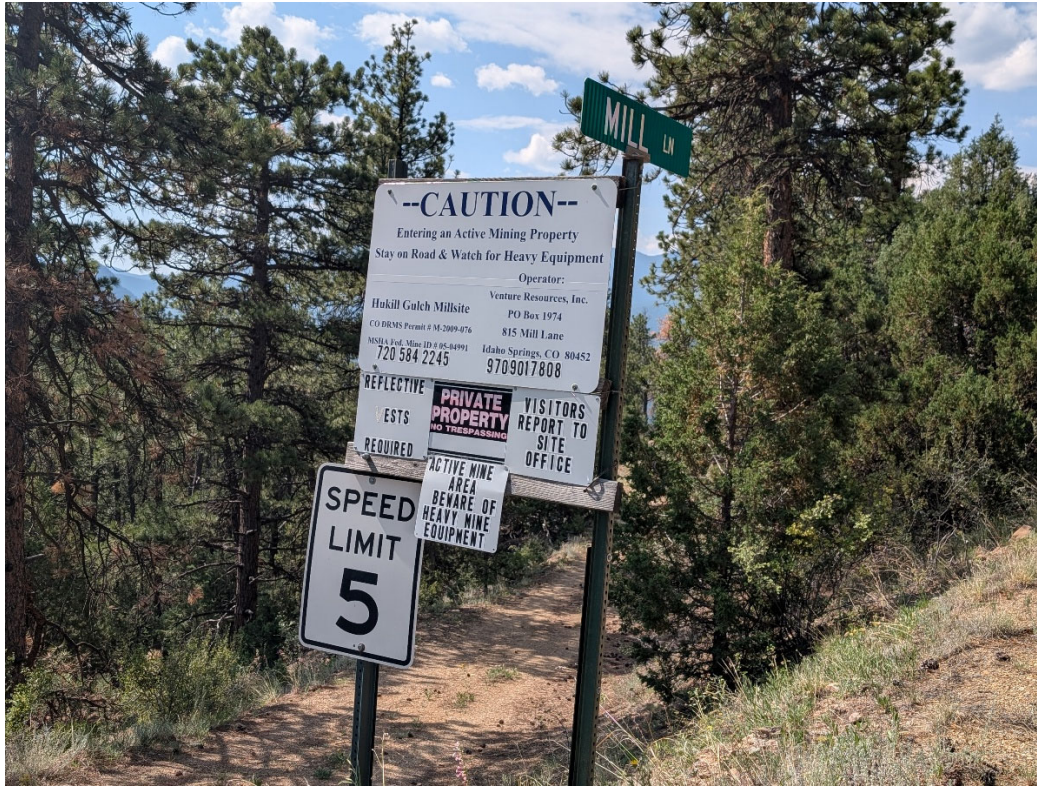
Photo 1: Mine sign posted at the entrance to the mill.

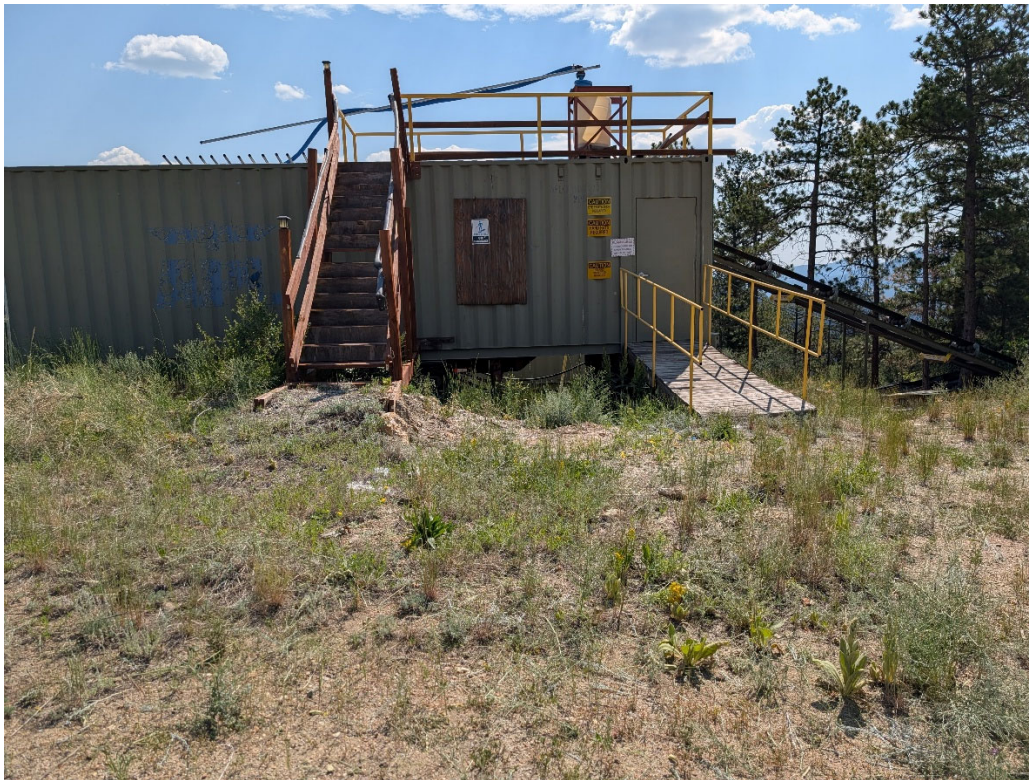
Photo 2: Looking at Ball Mill Trailer adjacent to the Mill parking area. Lime pile has been relocated to the storage shed.

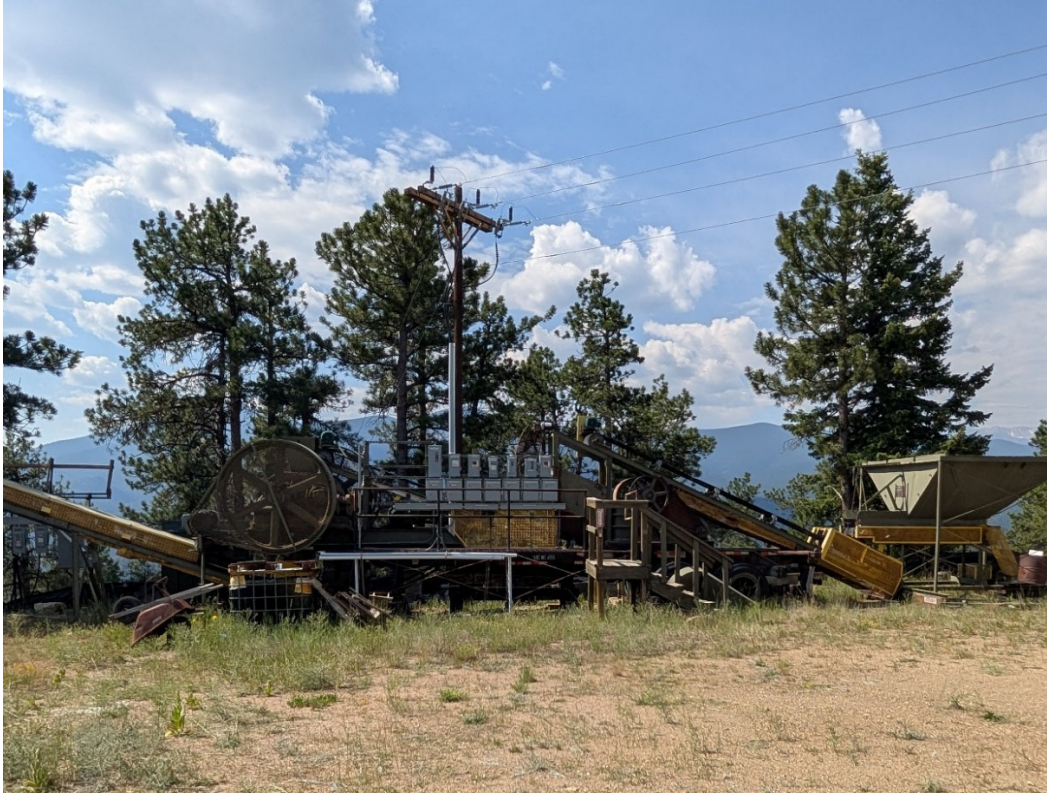
Photo 3: Looking south at the crusher feed bin, crushing plant, and conveyor.

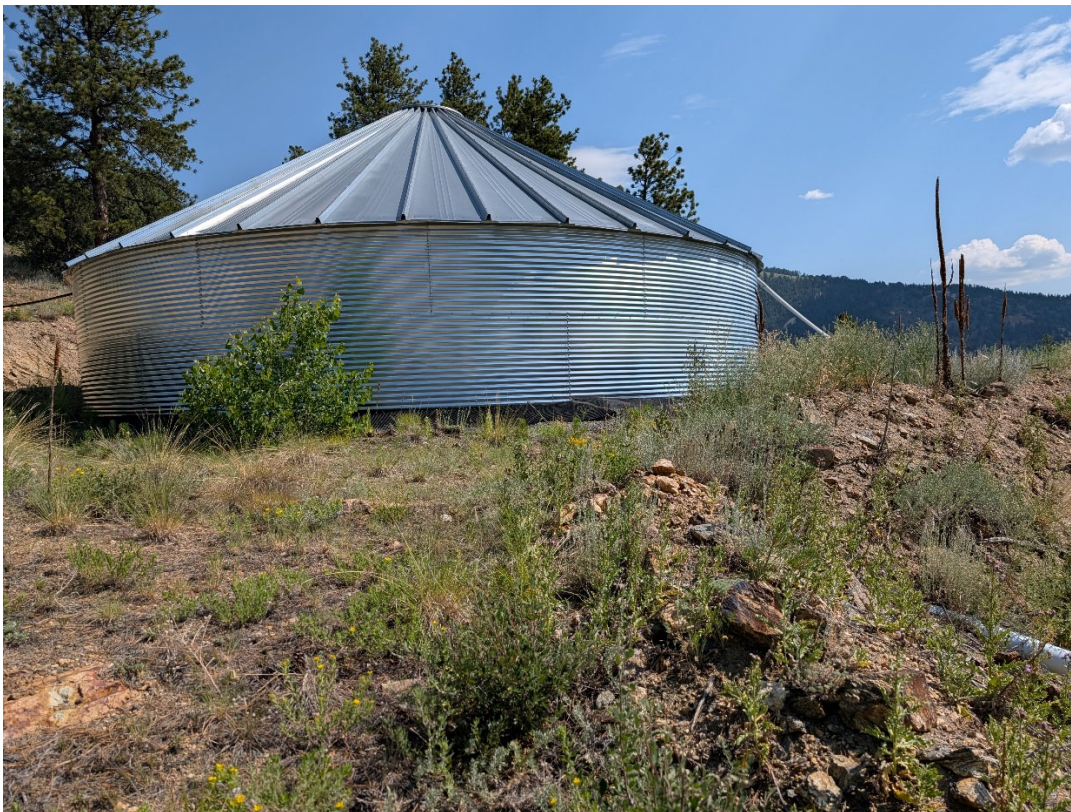
Photo 4: The 65,000 gallon water tank installed north and above of the mill.

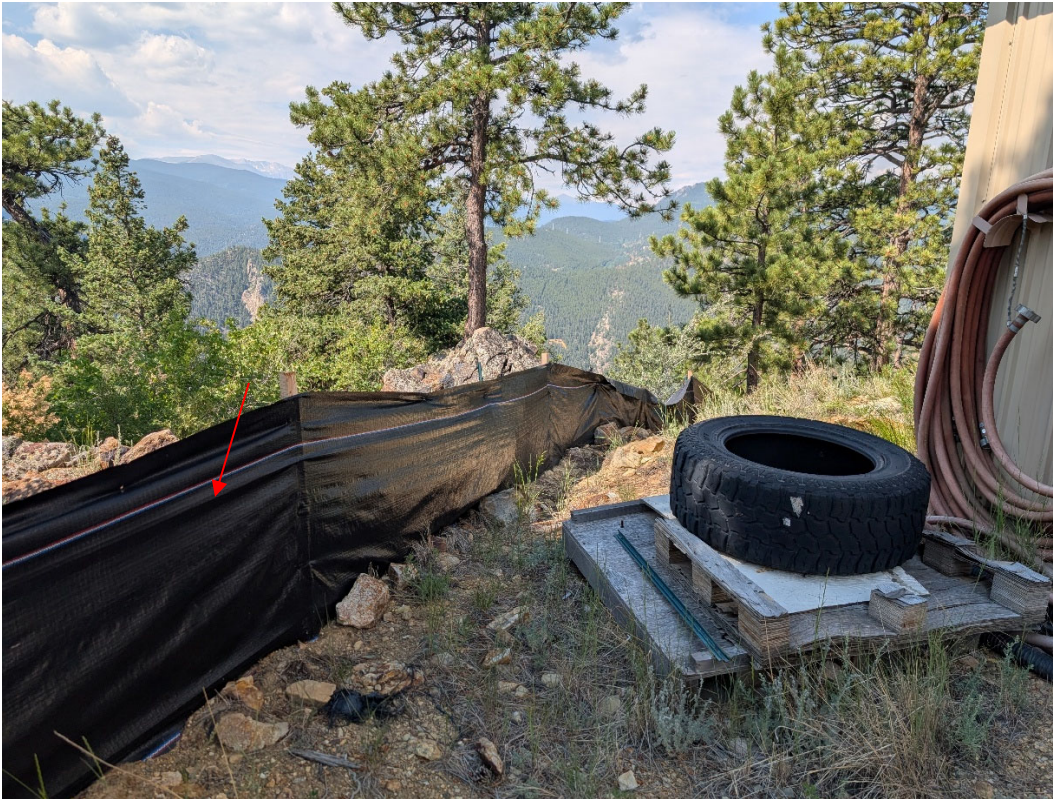
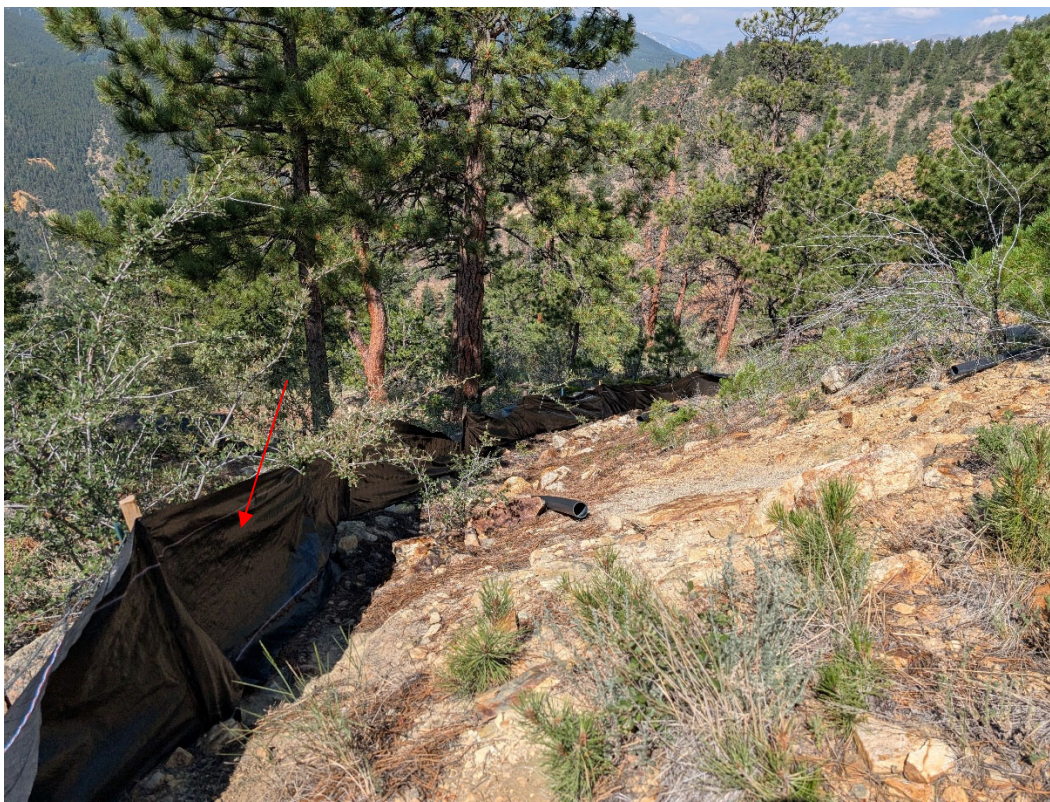
Photos 5 & 6: Silt fence reinstalled along the perimeter of the mill area.

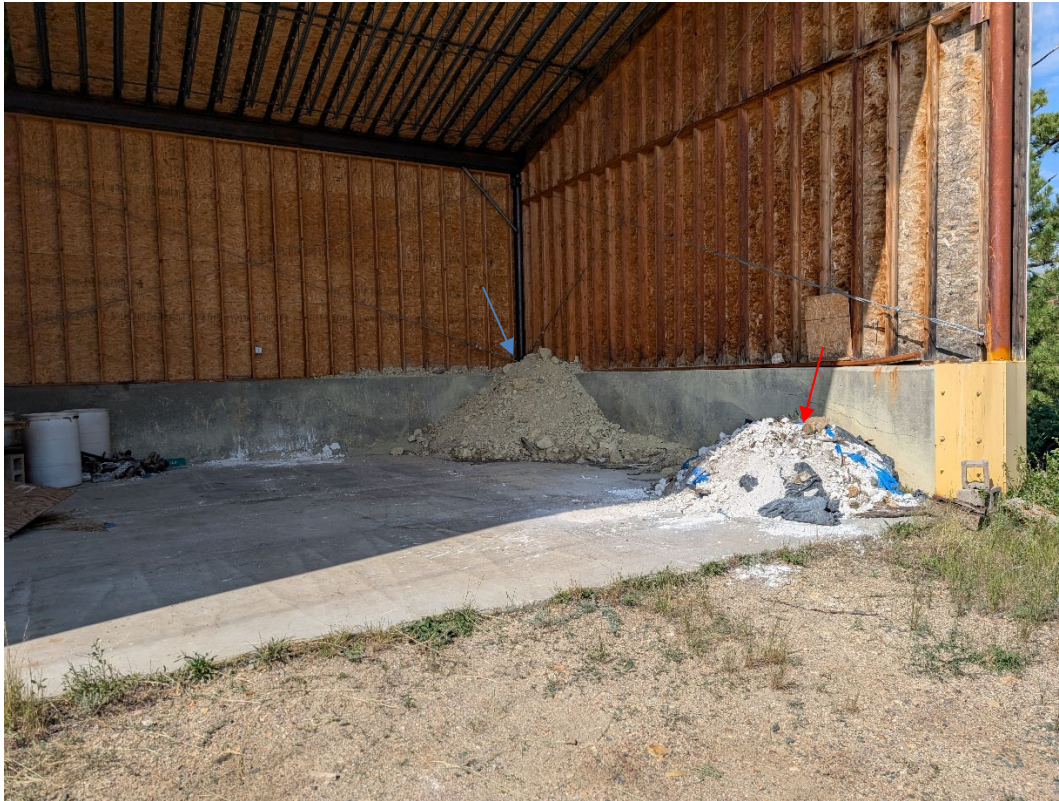
Photo 7: Feed pile shelter near the parking area. Lime pile relocated to inside the shelter (red arrow). Waste rock stored in the back corner of the shelter (blue arrow).

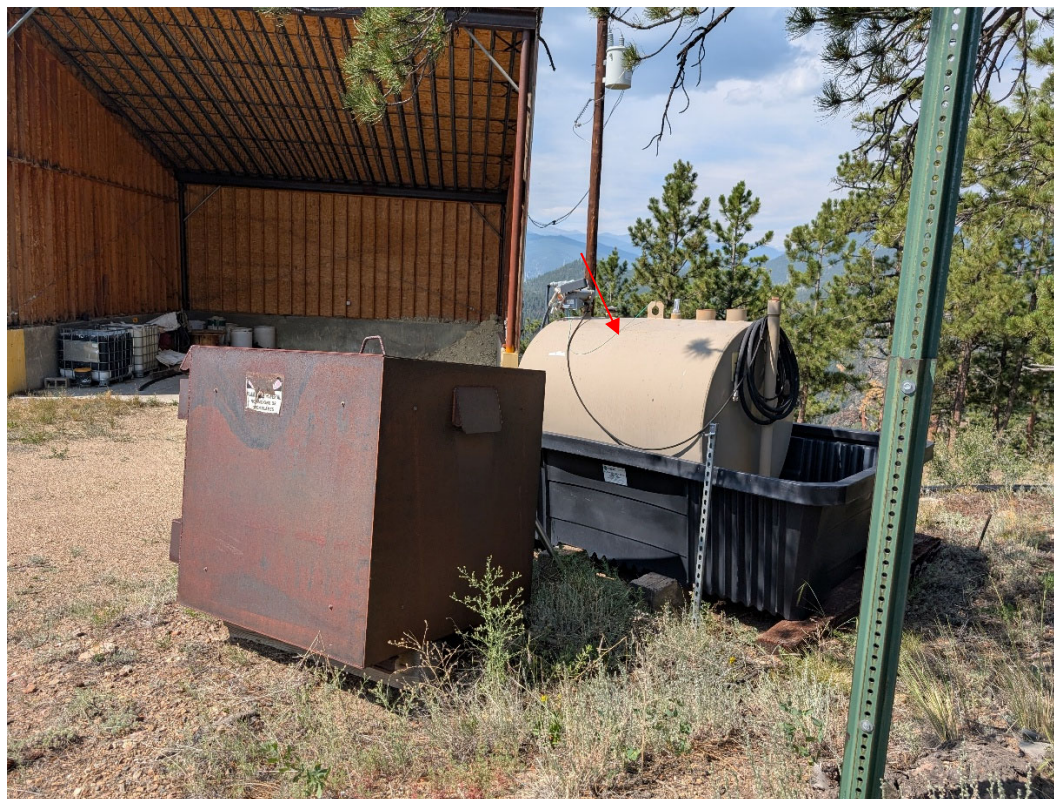
Photo 8: Fuel tank stored inside a containment vessel.

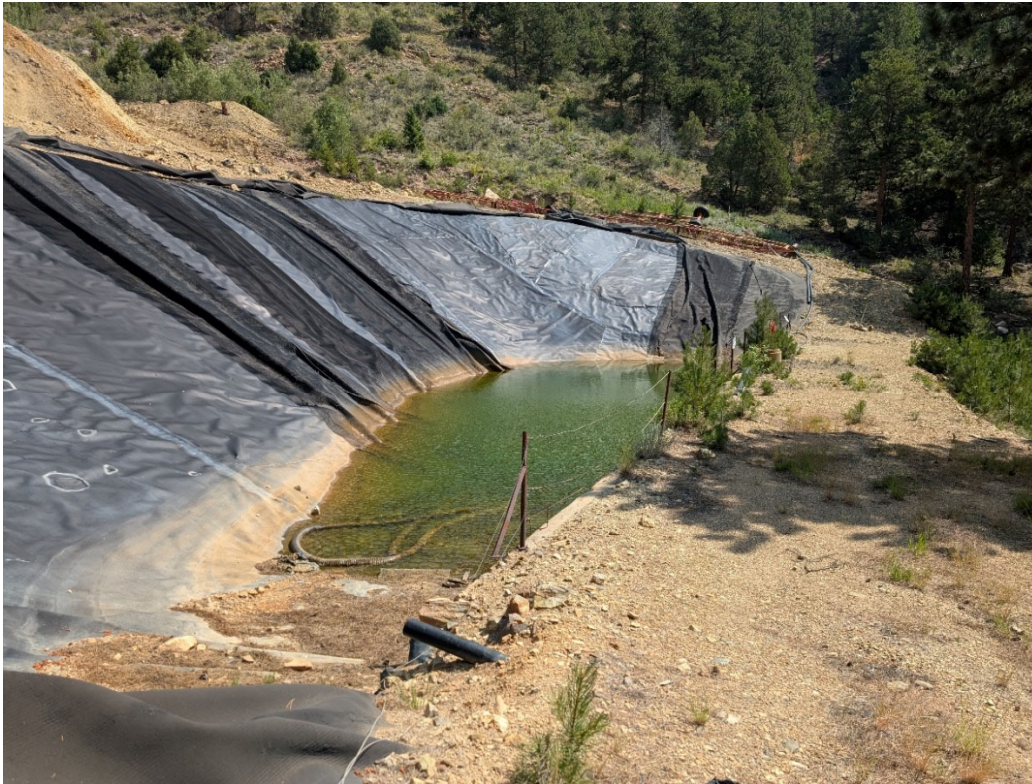
Photo 9: Looking at the out of compliance liner system in tailings storage impoundment. The liner is loose and damaged and will need to be repaired and re-certified before milling resumes.

As noted in previous correspondence, prior to re-initiating operations and in accordance with Rule 7.3.2, the permittee will be required repair and recertify the geo composite liner system in the tailings impoundment. If the facility cannot be recertified, the Operator will need to file a Technical Revision to update the Environmental Protection Plan to repair and/or modify the Environmental Protection Facility in accordance with Rule 6.4.21(7) and 7.3.

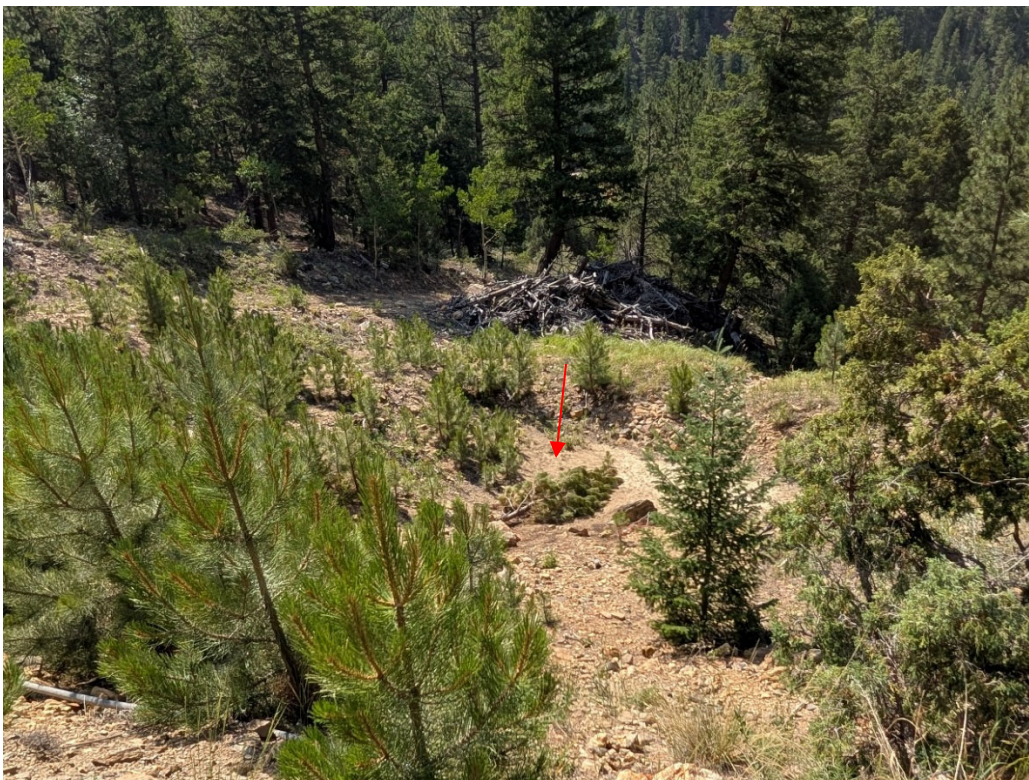
Photo 10: Sedimentation collection pond for surface runoff below the Tailings Storage Impoundment. HDPE pipes have been removed.

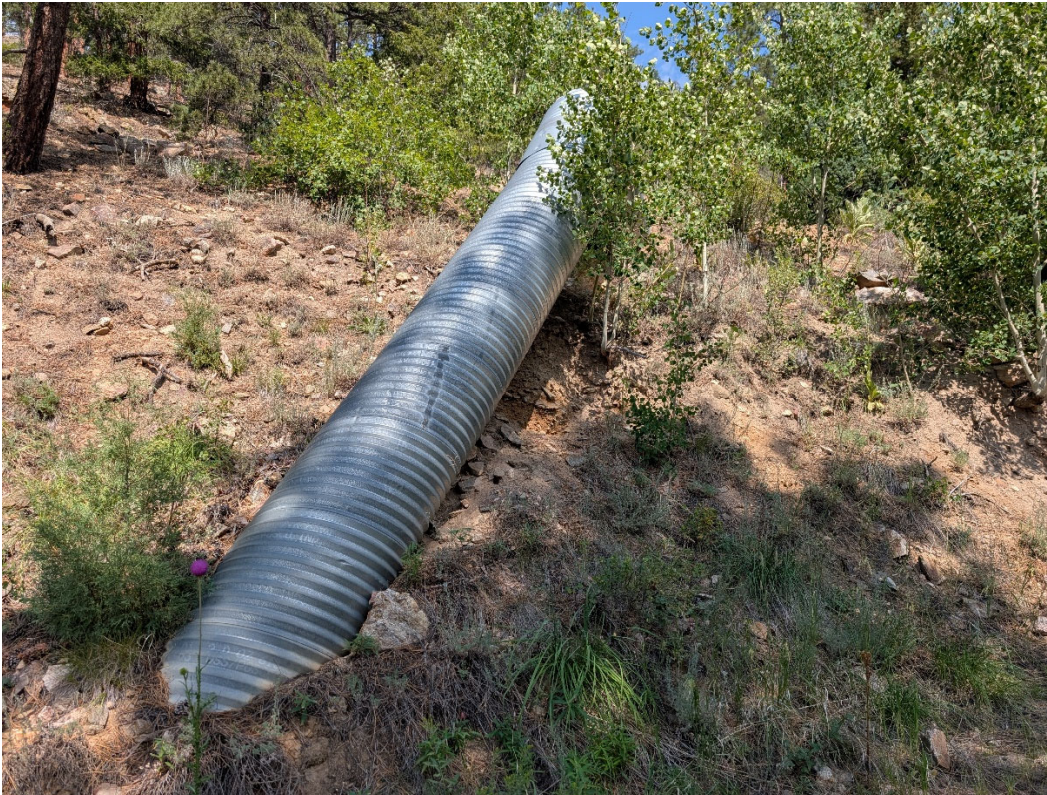
Photo 11: Looking at the stormwater diversion pipeline on the west side of the Tailings Impoundment Area.

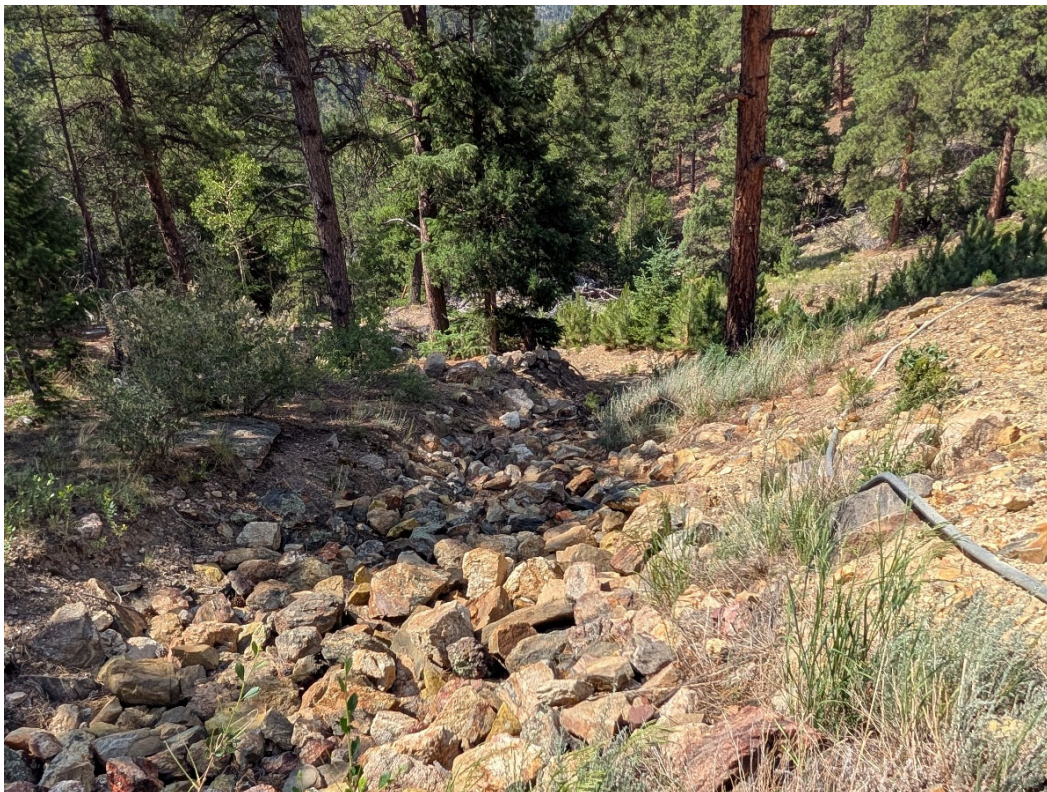
Photo 12: Looking at the stormwater diversion channel on the east side of the tailings impoundment area.

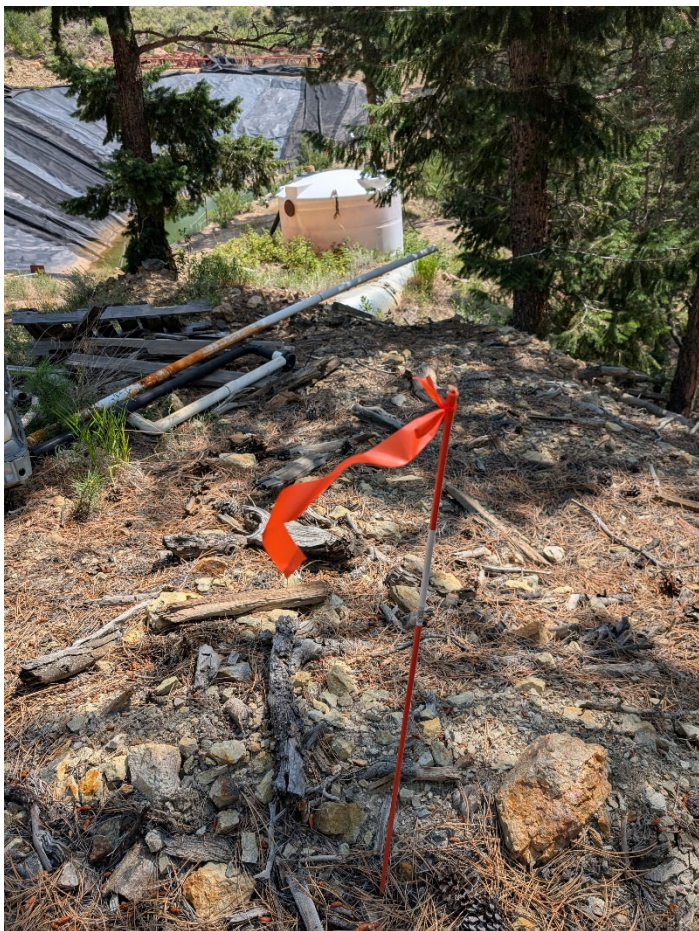
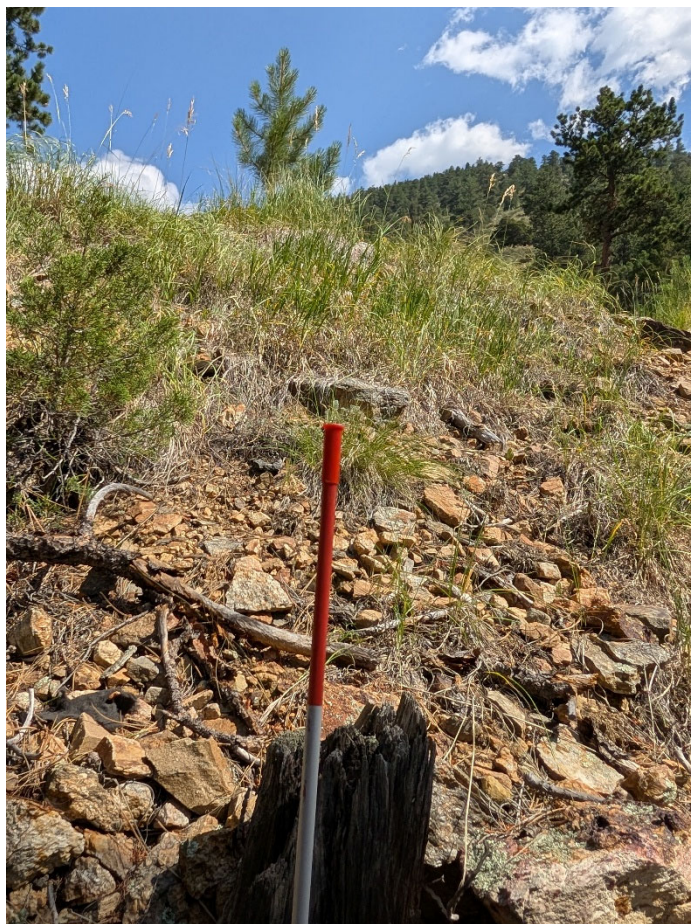
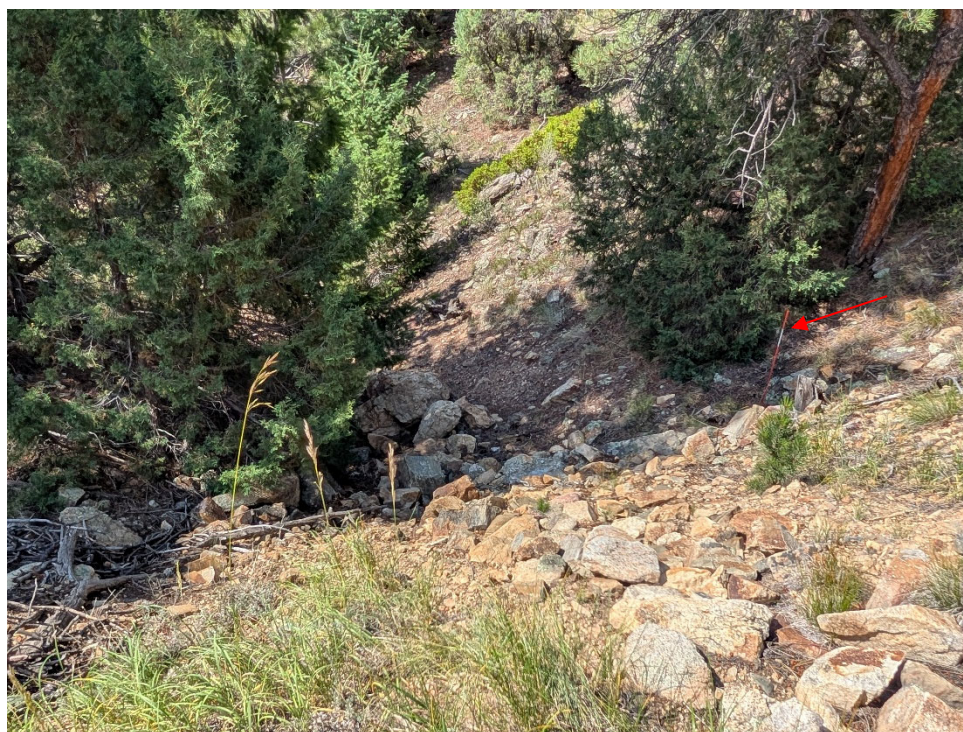
Photos 13-15: Looking at the boundary markers placed around the lower part of the mill site.

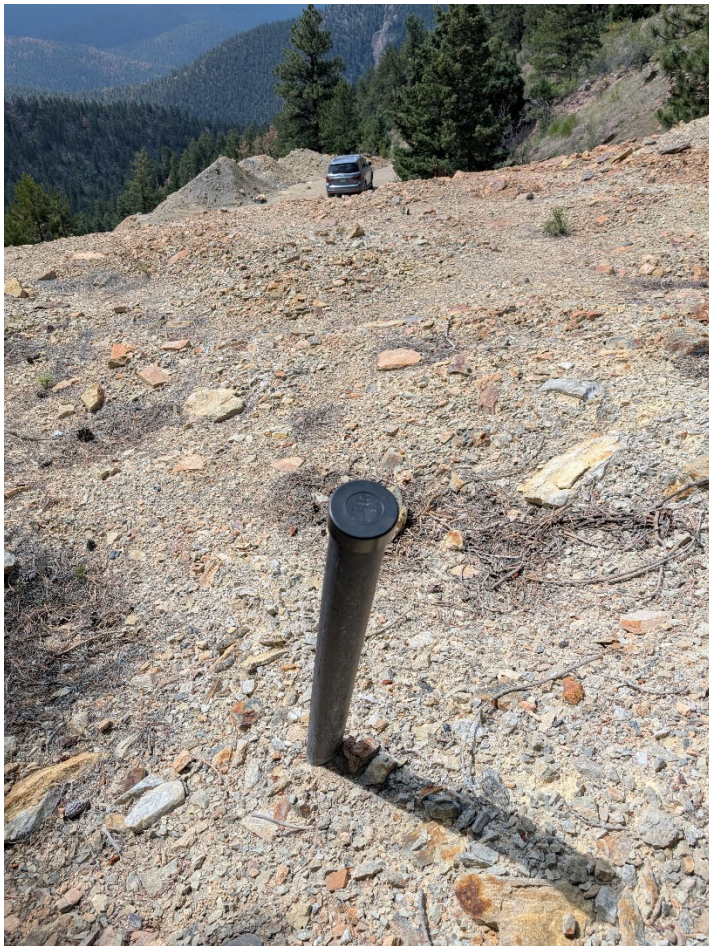
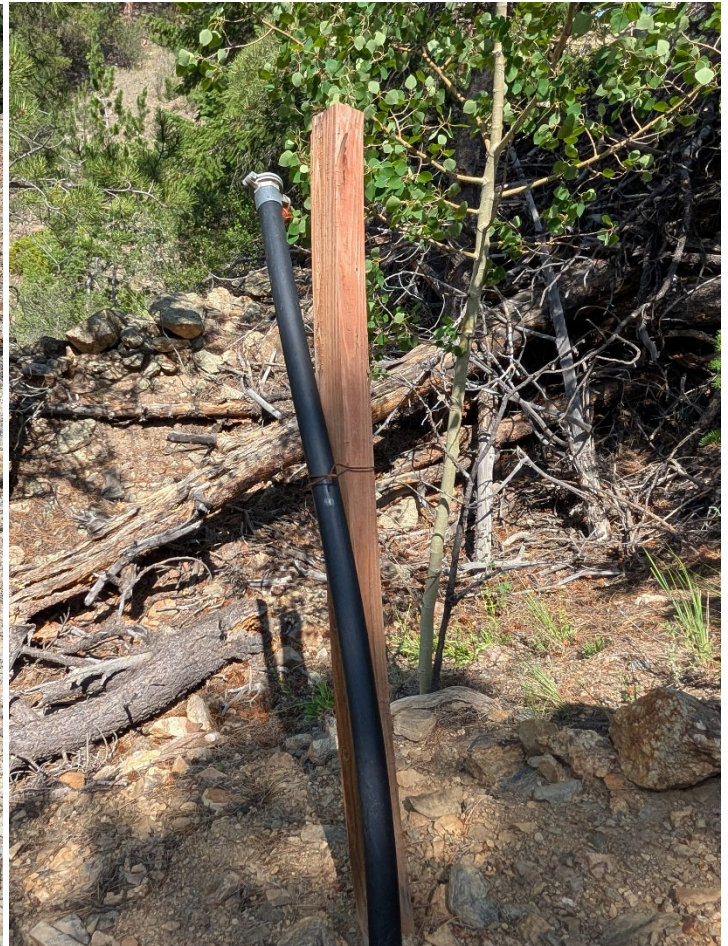
Photos 16-17: Looking at the groundwater wells above and below the tailings impoundment area.
