**MINERALS PROGRAM INSPECTION REPORT**  
**PHONE: (303) 866-3567**

| <b>MINE NAME:</b><br>Henderson Mine | <b>MINE/PROSPECTING ID#:</b><br>M-1977-342 | <b>MINERAL:</b><br>Molybdenum | <b>COUNTY:</b><br>Clear Creek |
| <b>INSPECTION TYPE:</b><br>Monitoring | <b>WEATHER:</b><br>Cloudy | <b>INSP. DATE:</b><br>July 28, 2025 | <b>INSP. TIME:</b><br>09:30 |
| <b>OPERATOR:</b><br>Climax Molybdenum Company | <b>OPERATOR REPRESENTATIVE:</b><br>Ron Hickman | <b>TYPE OF OPERATION:</b><br>112d-3 - Designated Mining Operation | |

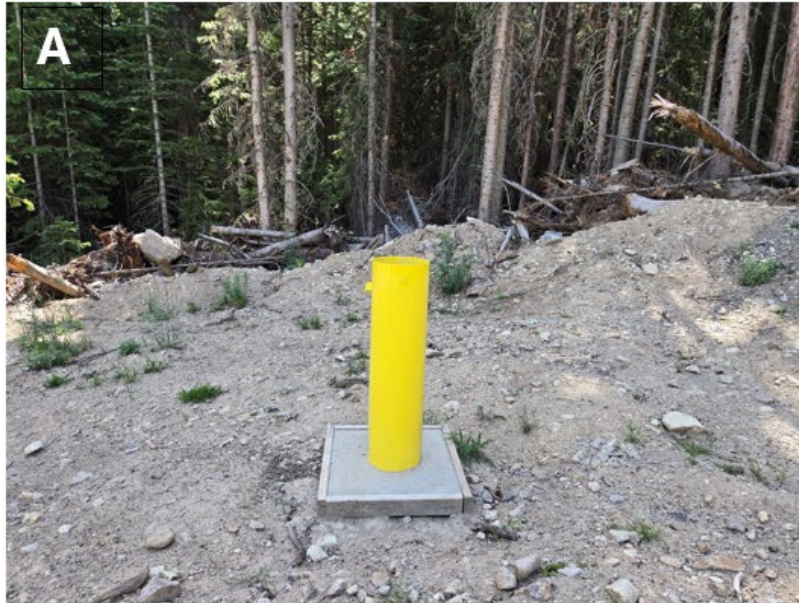
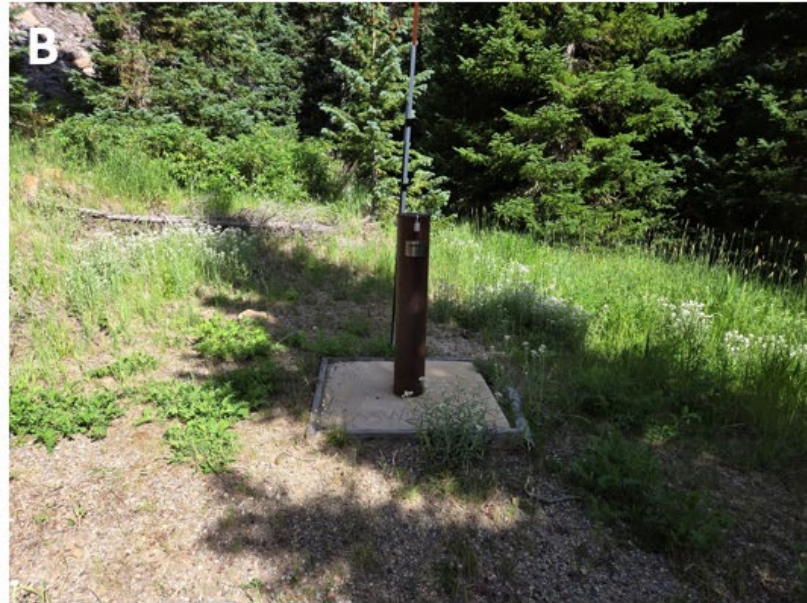
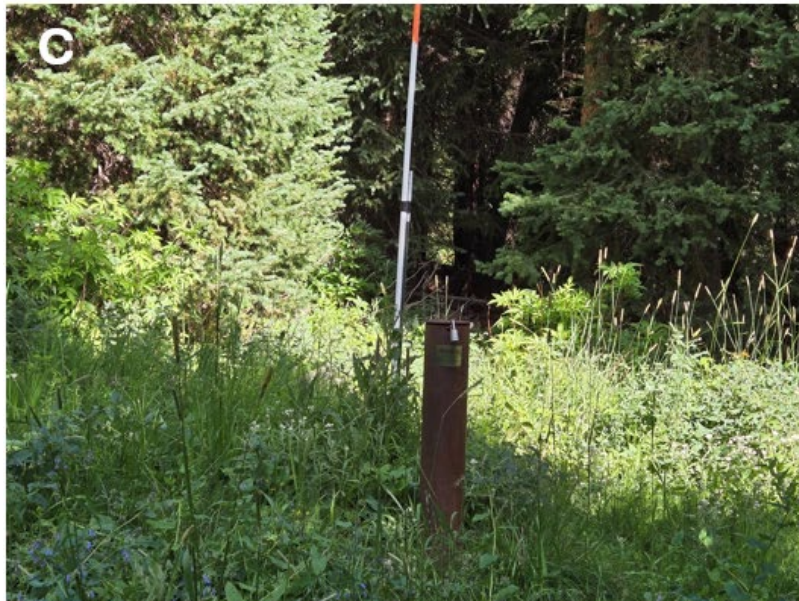
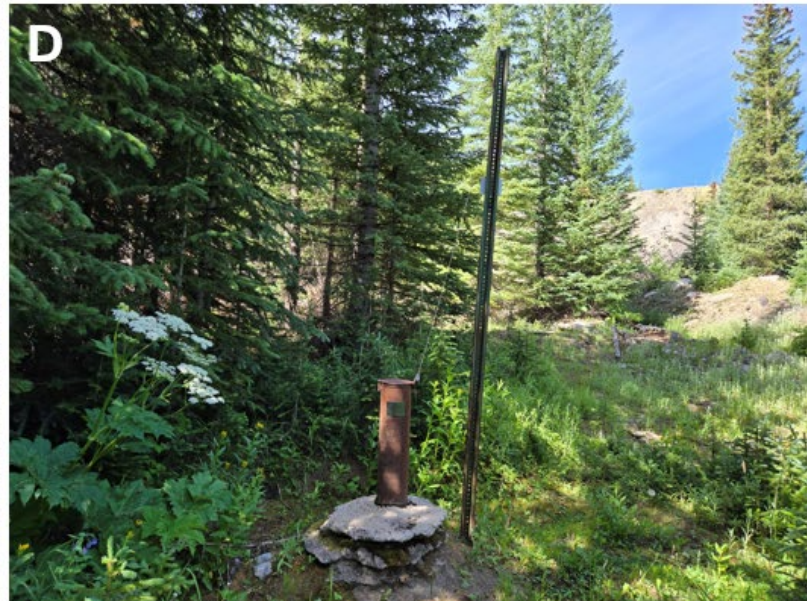
The groundwater monitoring wells, located on the east side of the mine facilities, were observed during the inspection. The Permittee wanted to ensure that samples from mine side's Point of Compliance (POC) well were as accurate and reliable as possible, and had reason to doubt the accuracy of the samples being acquired from MNGW-1 due to the well's inadequate construction. As a result, monitoring well MNGW-5 was installed in 2023, adjacent to and in the same geohydrologic setting downgradient of the mine operations as the current POC well MNGW-1. Since it's installation, the Permittee has been sampling MNGW-5 to collect two years (6 triannual sampling events) of water level and water quality data to establish baseline conditions to and determine the efficacy of the well for its replacement as the POC well. Monitoring wells MNGW-3 and MNGW-4 were also observed during the inspection. MNGW-2 was not observed, but as stated in Technical Revision 37, the well has been dry since it's construction in 1993.

**Photo 1:** Groundwater monitoring wells observed during the inspection. **A)** MNGW – 5, **B)** MNGW – 3, **C)** MNGW – 4, **D)** MNGW – 1 .

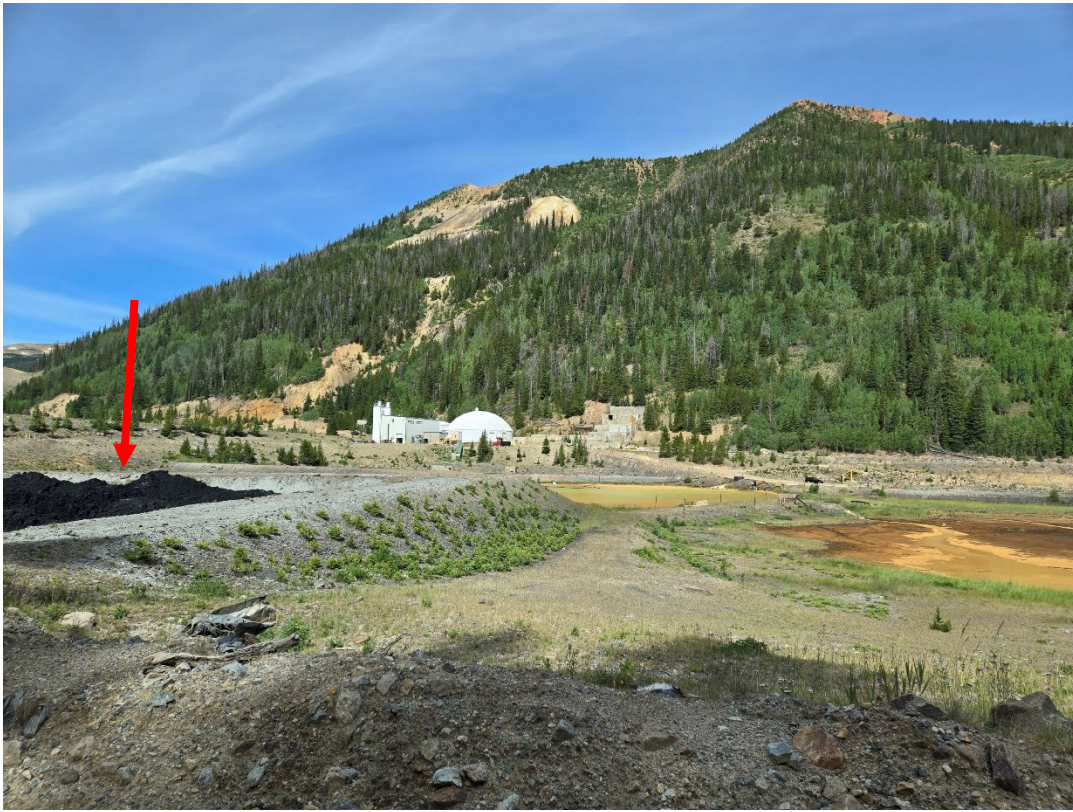
**Photo 2:** Looking west at external ponds at the URAD water treatment plant. The arrow points to Sludge Pond 2 where sludge was drying at the time of the inspection.

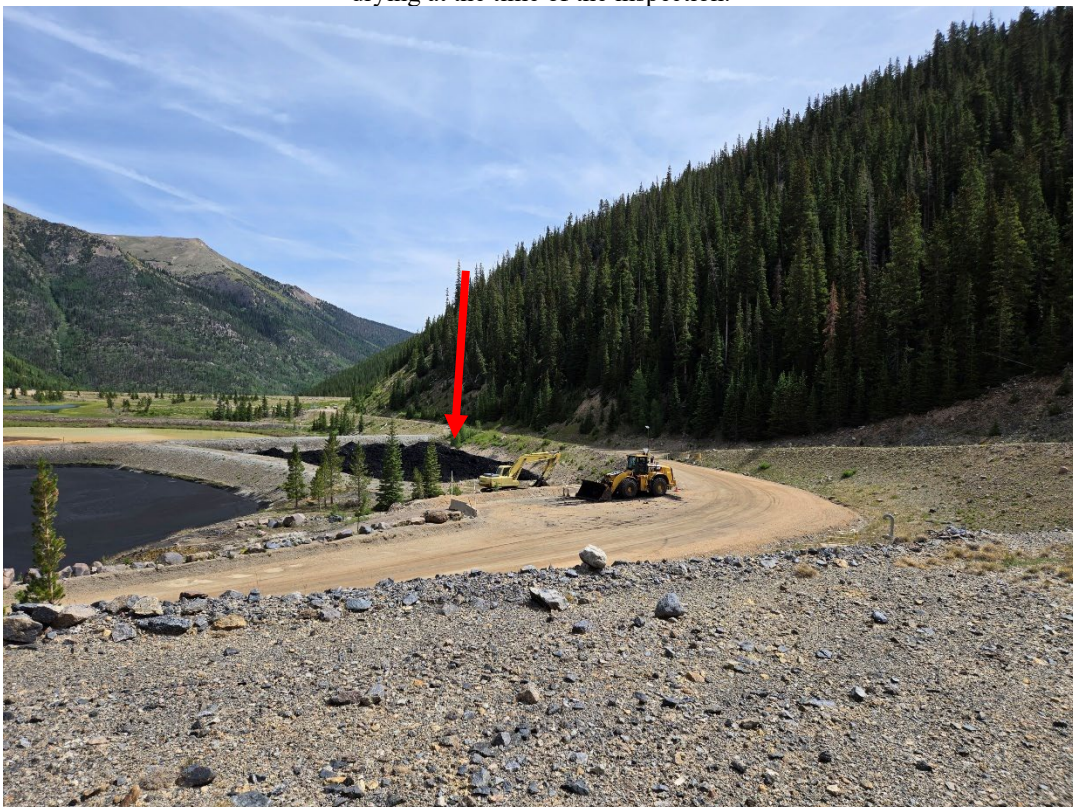
- **Sludge Pond 1 and Sludge Pond 2**  
During the inspection, the sludge generated during the treatment process was deposited into Sludge Pond 1. Sludge Pond 2 contained sludge that had recently been mixed to help aid in the drying process. The Operator stated that sludge storage is alternated between Sludge Ponds 1 and 2 ever other year. This September, the dried sludge in Sludge Pond 2 is planned to be hauled away.

**Photo 3:** The red arrow points to Sludge Pond 2 where sludge was drying during the inspection. On the west side of Sludge Pond 2 is Sludge Pond 1, where sludge was being deposited during the inspection.

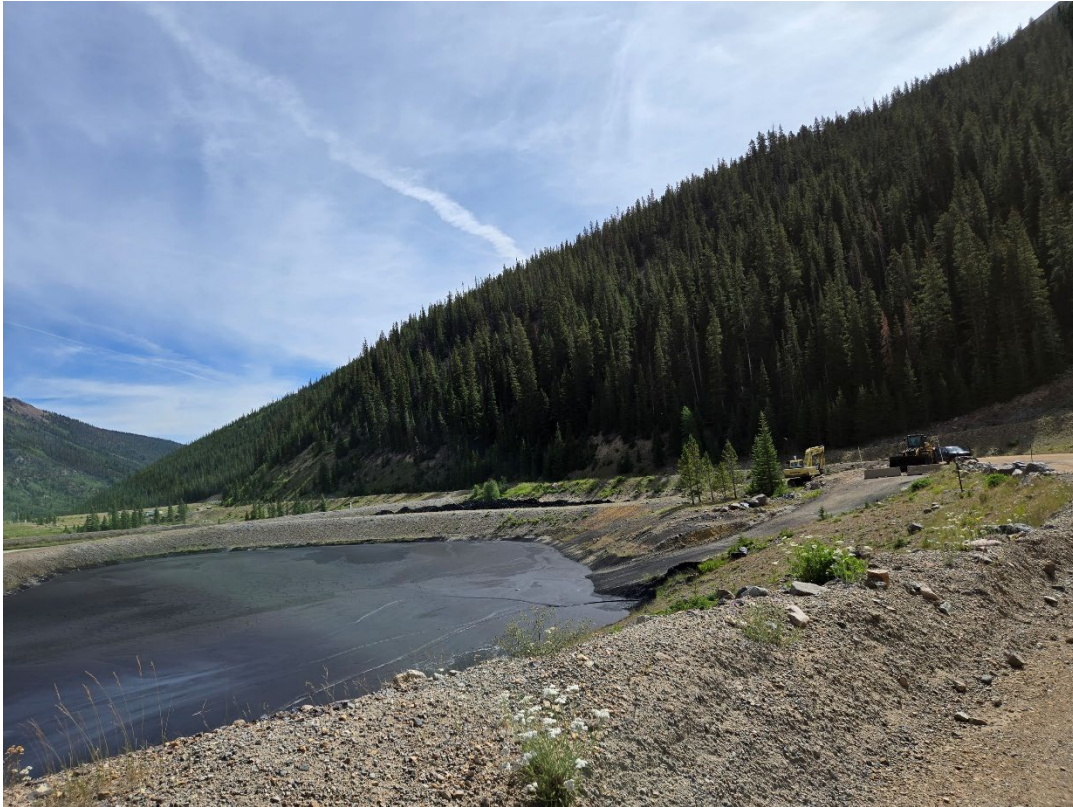
**Photo 4:** Looking east at Sludge Pond 1.

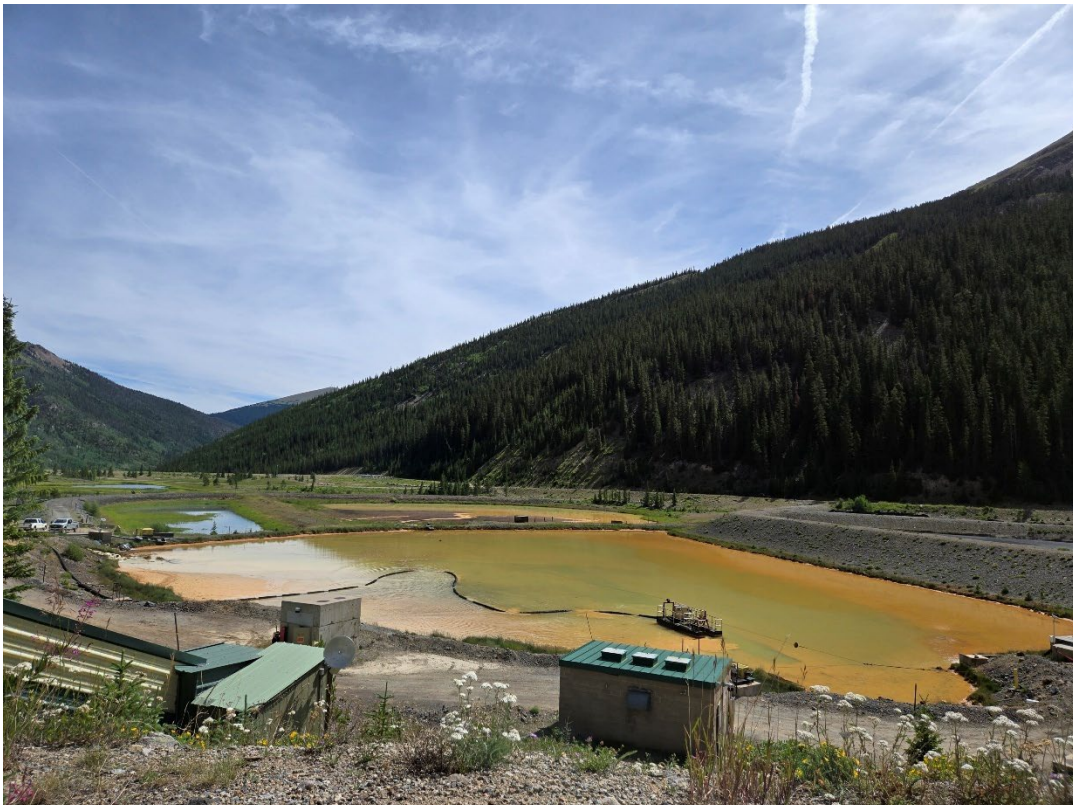
**Photo 5:** Looking east at the external Ponds at the URAD treatment plant. Treatment Pond 1 was being dredged at the time of the inspection.

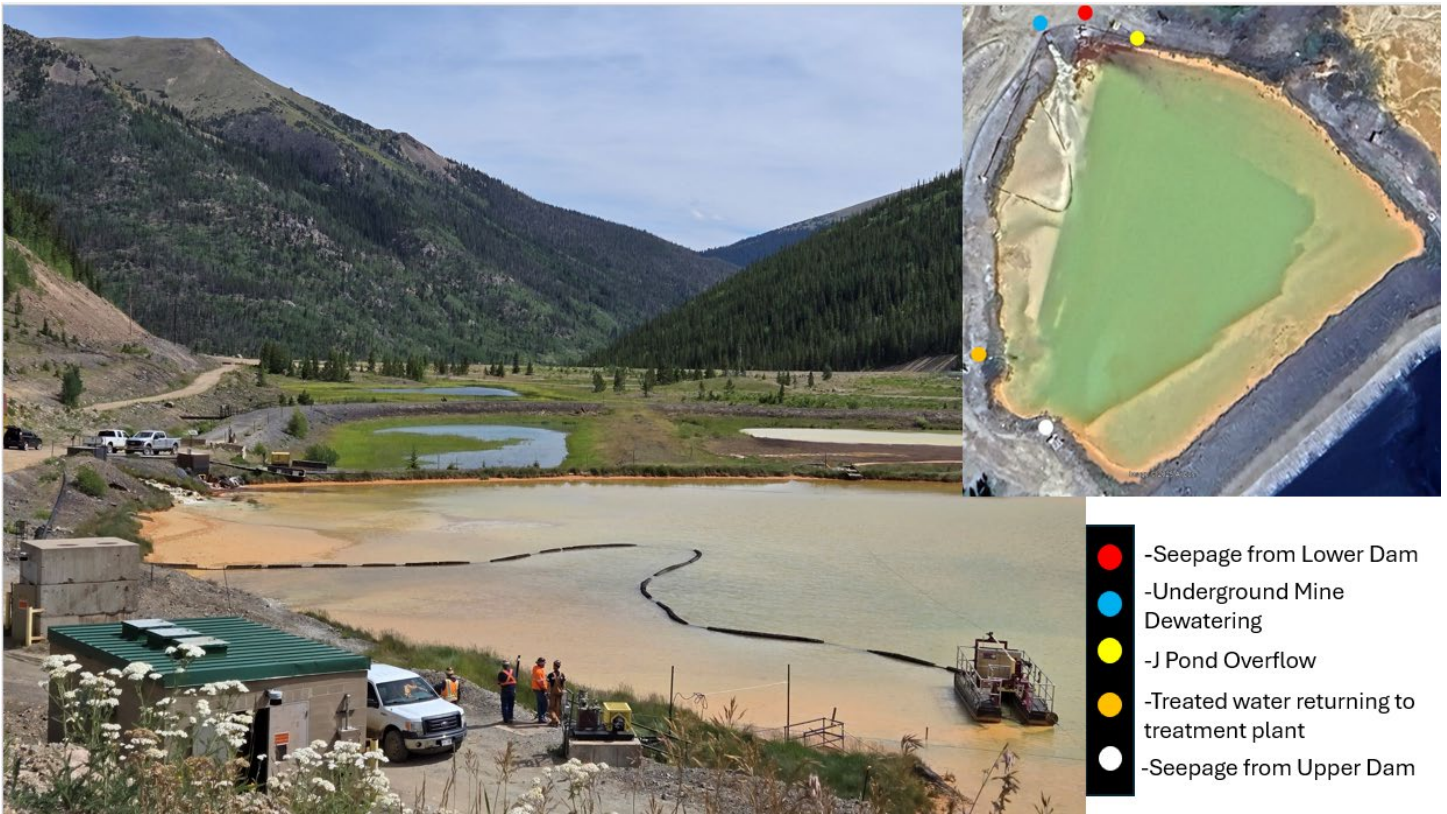
- **Treatment Pond 1**  
Treatment Pond 1 (also referred to as 1 Pond or 'Buffer' Pond) receives the dewatering water from the underground mine facilities, water from seepage areas located both below the Upper Dam and the Lower Dam, and sometimes water from J Pond to aid with capacity (see Photo 6 in this report). During the inspection, sediment from the Treatment Pond 1 was being dredged. Water contained within the Treatment Pond is pumped from the Treatment Pond into the Treatment Facility to be treated. Once the water is treated, it discharges into a culvert that runs underground along the south side of the URAD ponds, and discharges north of the ponds into Woods Creek (see red dashed line on the Figure 2: URAD Water Treatment Plant Stormwater Management Map enclosed with this report).

**Photo 6:** The color-coded circles, located on the image on the right, indicate inlet and outlet sources around Treatment Pond 1.

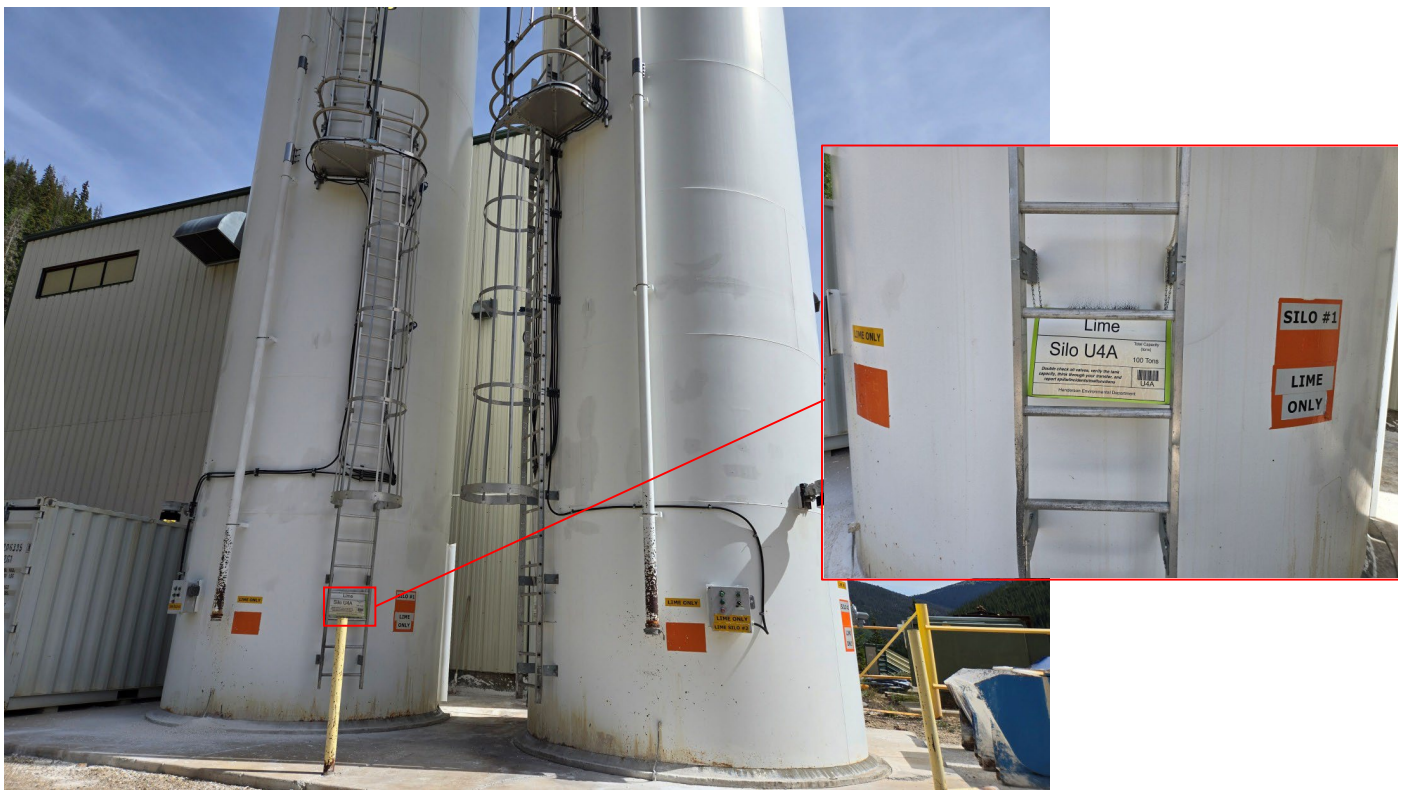
**Photo 7:** Lime silos located on the south side of the URAD water treatment plant.

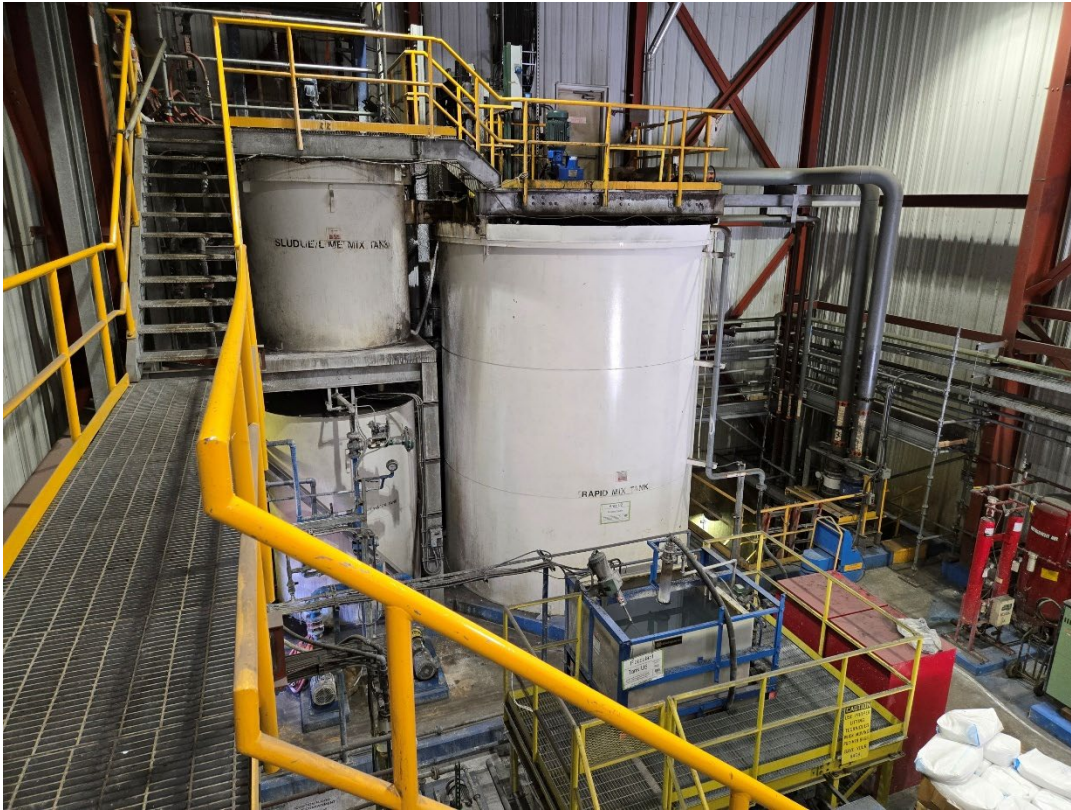
**Photo 8:** Floculant storage tank located within the URAD water treatment plant.

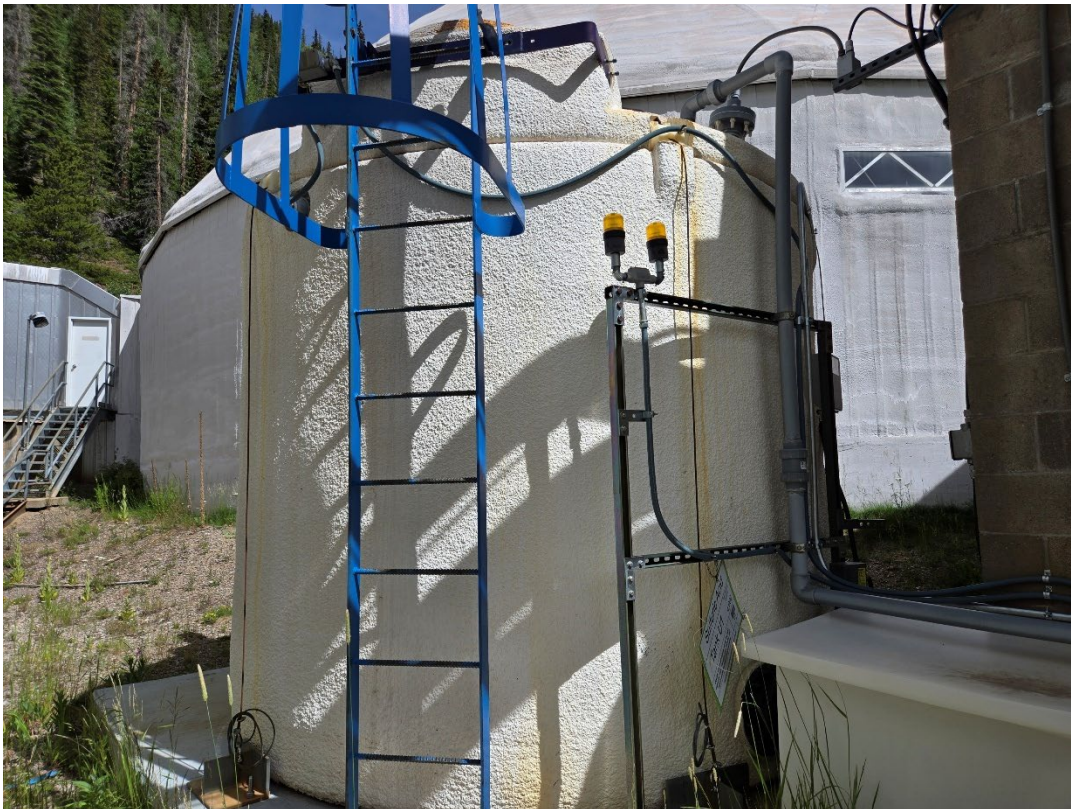
**Photo 9:** Insulated Sulfuric Acid tank located outside of the URAD water treatment plant.

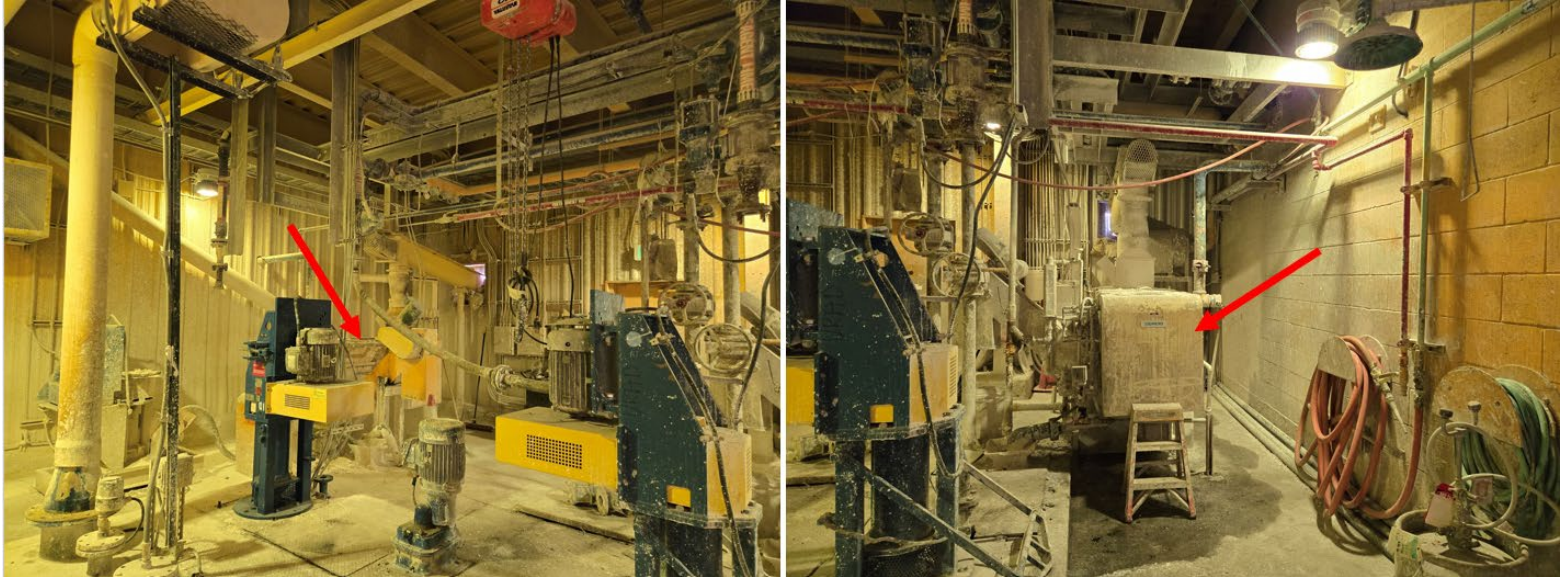
Two ‘slakers’ (equipment used to mix water with quicklime – producing slaked lime) are located inside the treatment facility on the other side of the lime silos. The Operator stated that both pieces of equipment are scheduled to be replaced with newer models in the near future.

**Photo 10:** The arrows point to the two 'slakes' that will soon be replaced with updated equipment.

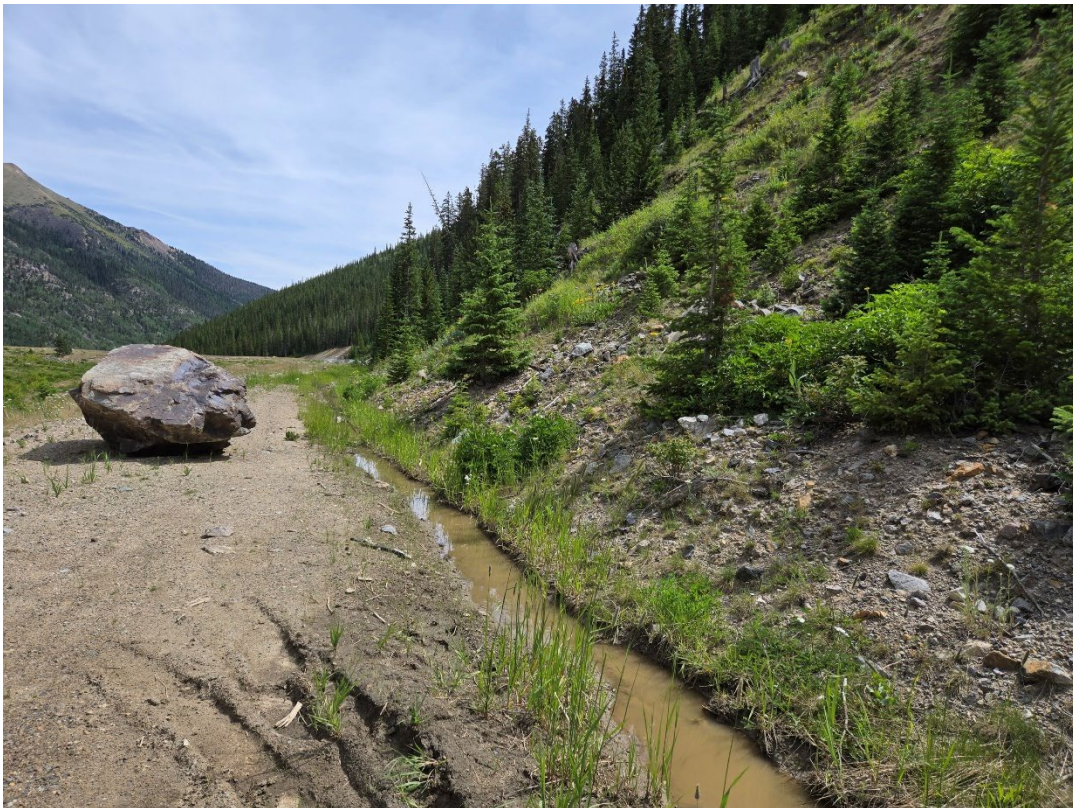
**Photo 11:** Looking north along the diversion ditch on the west side of the road leading to the URAD facilities.

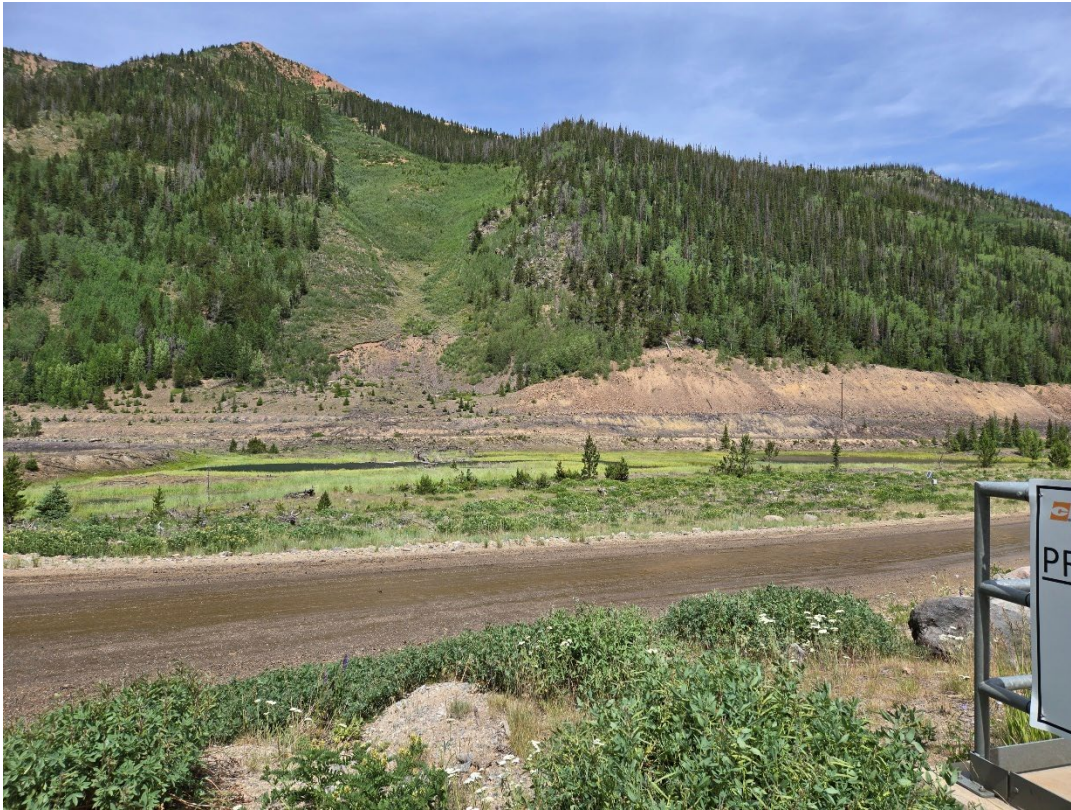
Beyond the main five ponds, on the north side of the treatment area, is what is referred to as the “Toad Pond” (colloquially named after the endangered boreal toads that reside within the area). This pond does not discharge and instead is allowed to seep within the lower tailings dam above the Lower URAD Reservoir. Again, the seepage from the lower dam is pumped back to the treatment ponds to be treated before discharging into the Woods Creek. Also, if the pond levels are elevated, the Operator will pump the water into Treatment Pond 1.

**Photo 12:** Looking west at the “Toad Pond”.

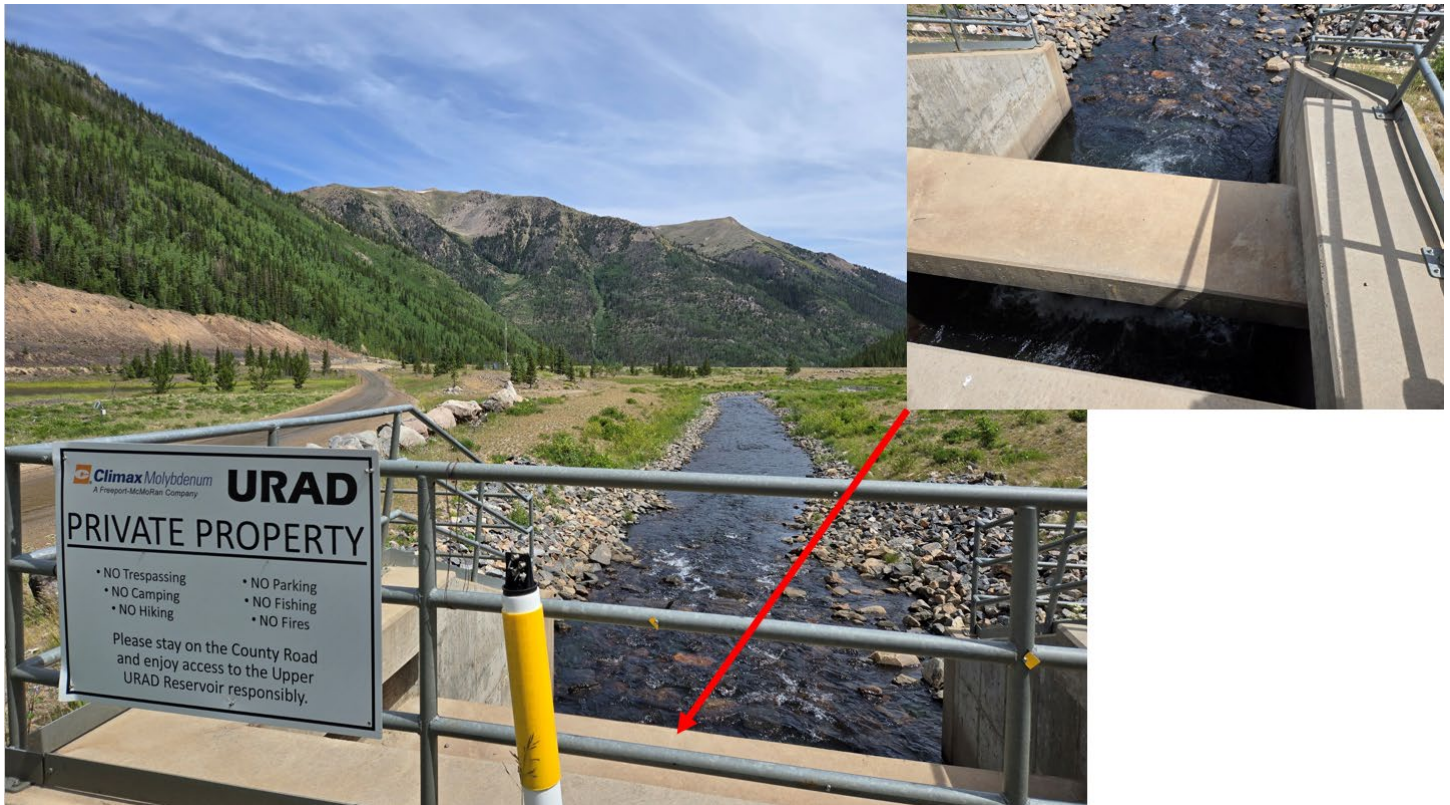
**Photo 13:** Point where the treated water from the URAD facility discharges into Woods Creek.

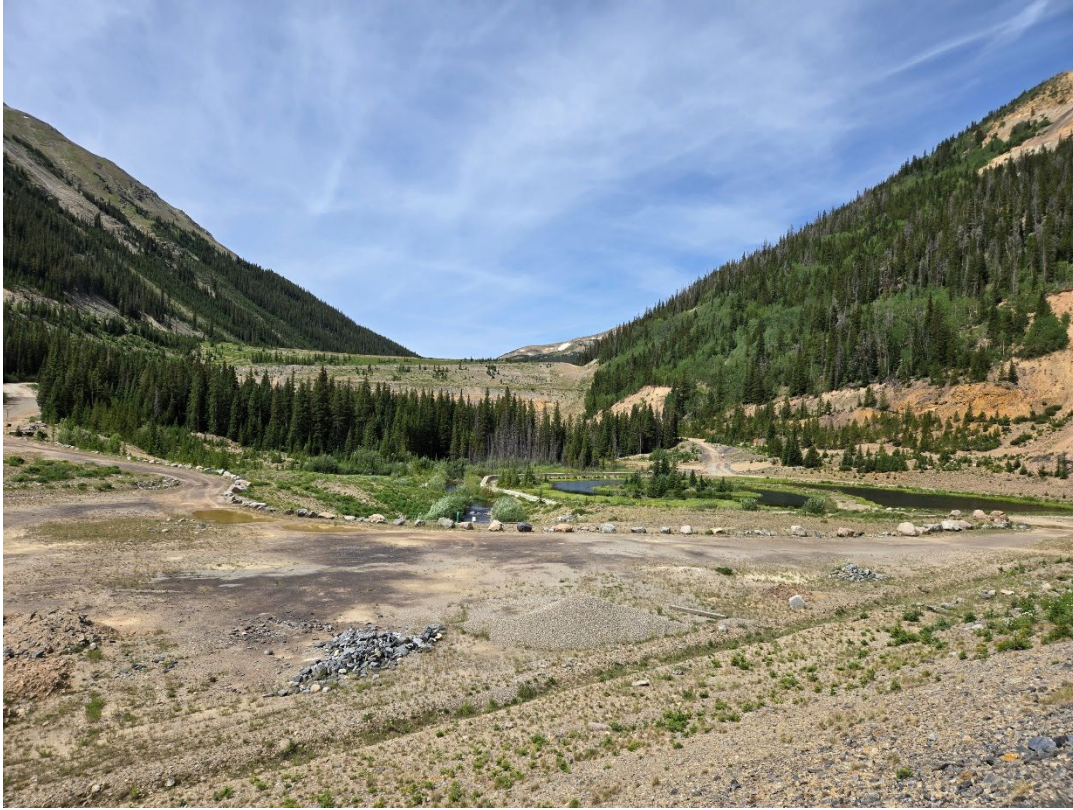
**Photo 14:** Standing along the berm that separates the URAD facilities from the inactive facilities to the south. In the photo are the wetlands and the upper tailings dam.

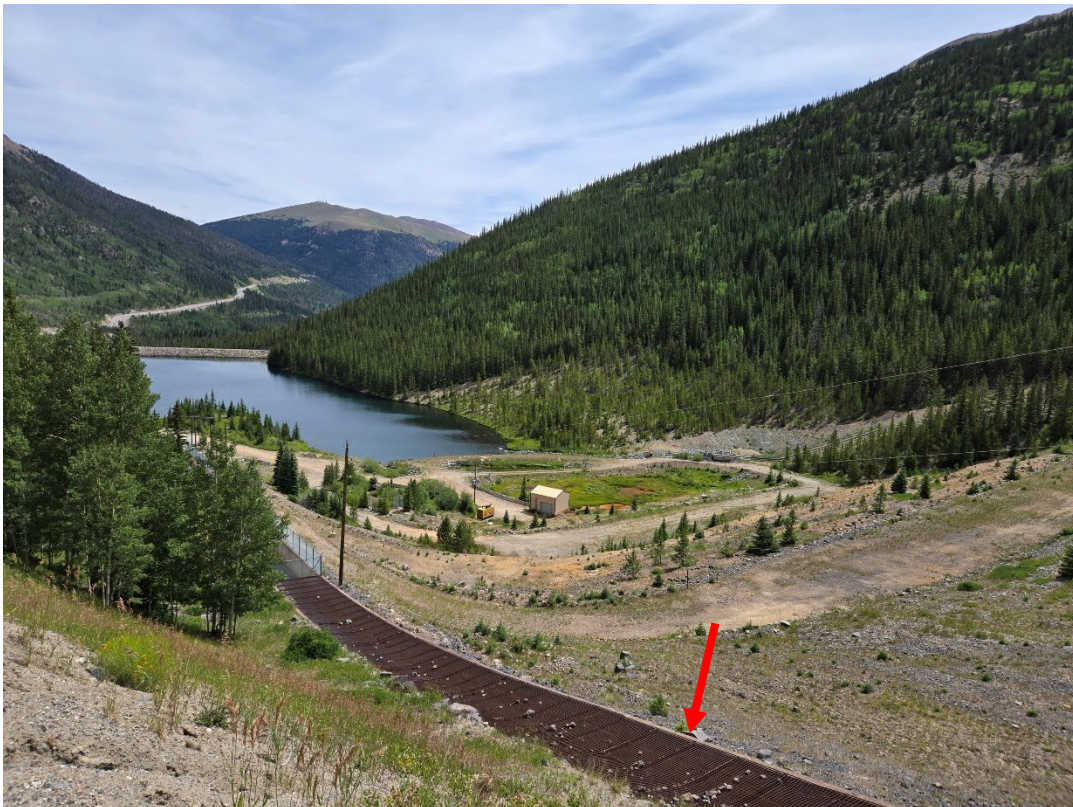
**Photo 15:** Looking north at the lower tailings dam and the Lower URAD Reservoir located on the north side of the URAD treatment facility. The arrow points to the channel connected to the box culvert within the berm on the southside of the URAD facilities, installed to divert emergency overflow.
