**MINERALS PROGRAM INSPECTION REPORT**  
**PHONE: (303) 866-3567**

<b>MINE NAME:</b> Eureka Gravel Pit	<b>MINE/PROSPECTING ID#:</b> M-1990-070	<b>MINERAL:</b> Gravel	<b>COUNTY:</b> San Juan
<b>INSPECTION TYPE:</b> Monitoring	<b>WEATHER:</b> Clear	<b>INSP. DATE:</b> June 30, 2025	<b>INSP. TIME:</b> 10:22
<b>OPERATOR:</b> San Juan County	<b>OPERATOR REPRESENTATIVE:</b> None	<b>TYPE OF OPERATION:</b> 110c - Construction Limited Impact	
<b>REASON FOR INSPECTION:</b> Normal I&E Program	<b>BOND CALCULATION TYPE:</b>	<b>BOND AMOUNT:</b> \$0.00	
<b>DATE OF COMPLAINT:</b> NA	<b>POST INSP. CONTACTS:</b> None	<b>JOINT INSP. AGENCY:</b> None	
<b>INSPECTOR(S):</b> Lucas West	<b>INSPECTOR'S SIGNATURE:</b>

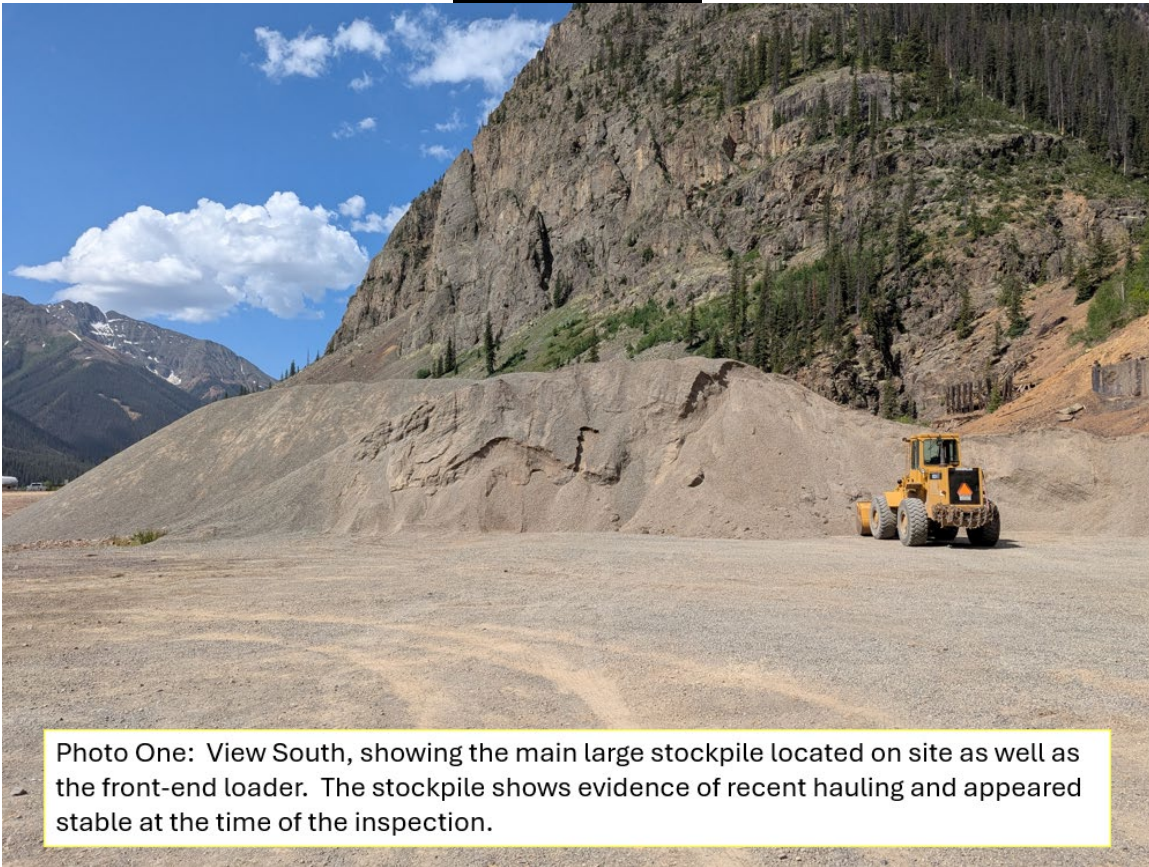
Photo One: View South, showing the main large stockpile located on site as well as the front-end loader. The stockpile shows evidence of recent hauling and appeared stable at the time of the inspection.

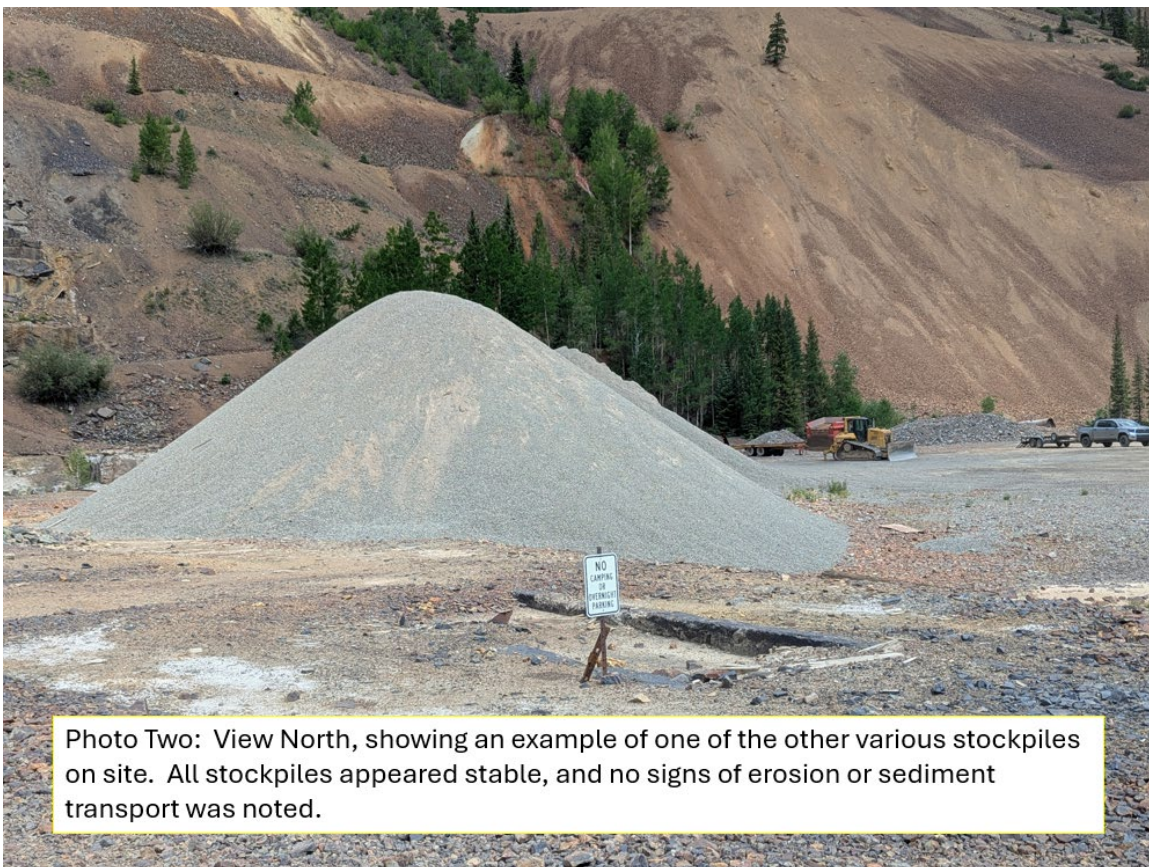
Photo Two: View North, showing an example of one of the other various stockpiles on site. All stockpiles appeared stable, and no signs of erosion or sediment transport was noted.

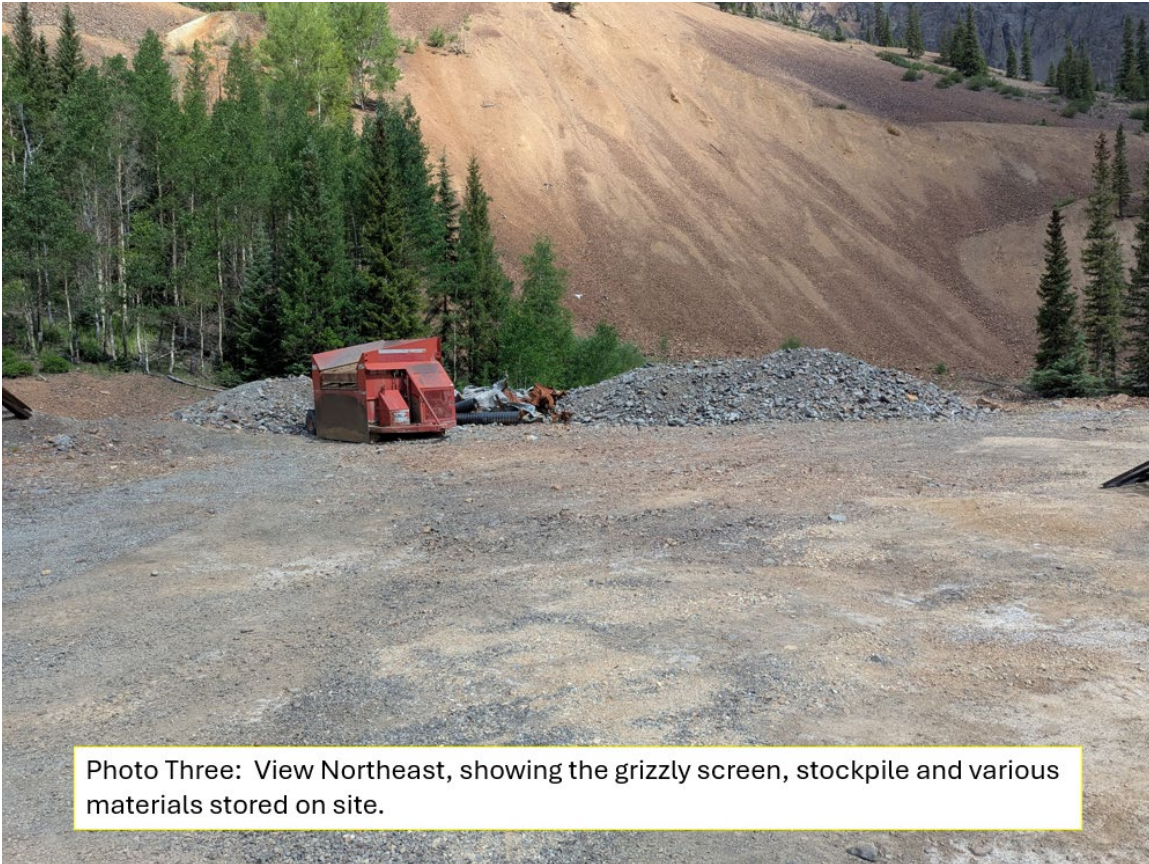
Photo Three: View Northeast, showing the grizzly screen, stockpile and various materials stored on site.
