## P1992020, Compromise Mine, May 2025 Inspection Report

**MINERALS PROGRAM INSPECTION REPORT**  
**PHONE: (303) 866-3567**

| <b>MINE NAME:</b><br>Compromise Mine | <b>MINE/PROSPECTING ID#:</b><br>P-1992-020 | <b>MINERAL:</b><br>Silver and lead | <b>COUNTY:</b><br>Pitkin |

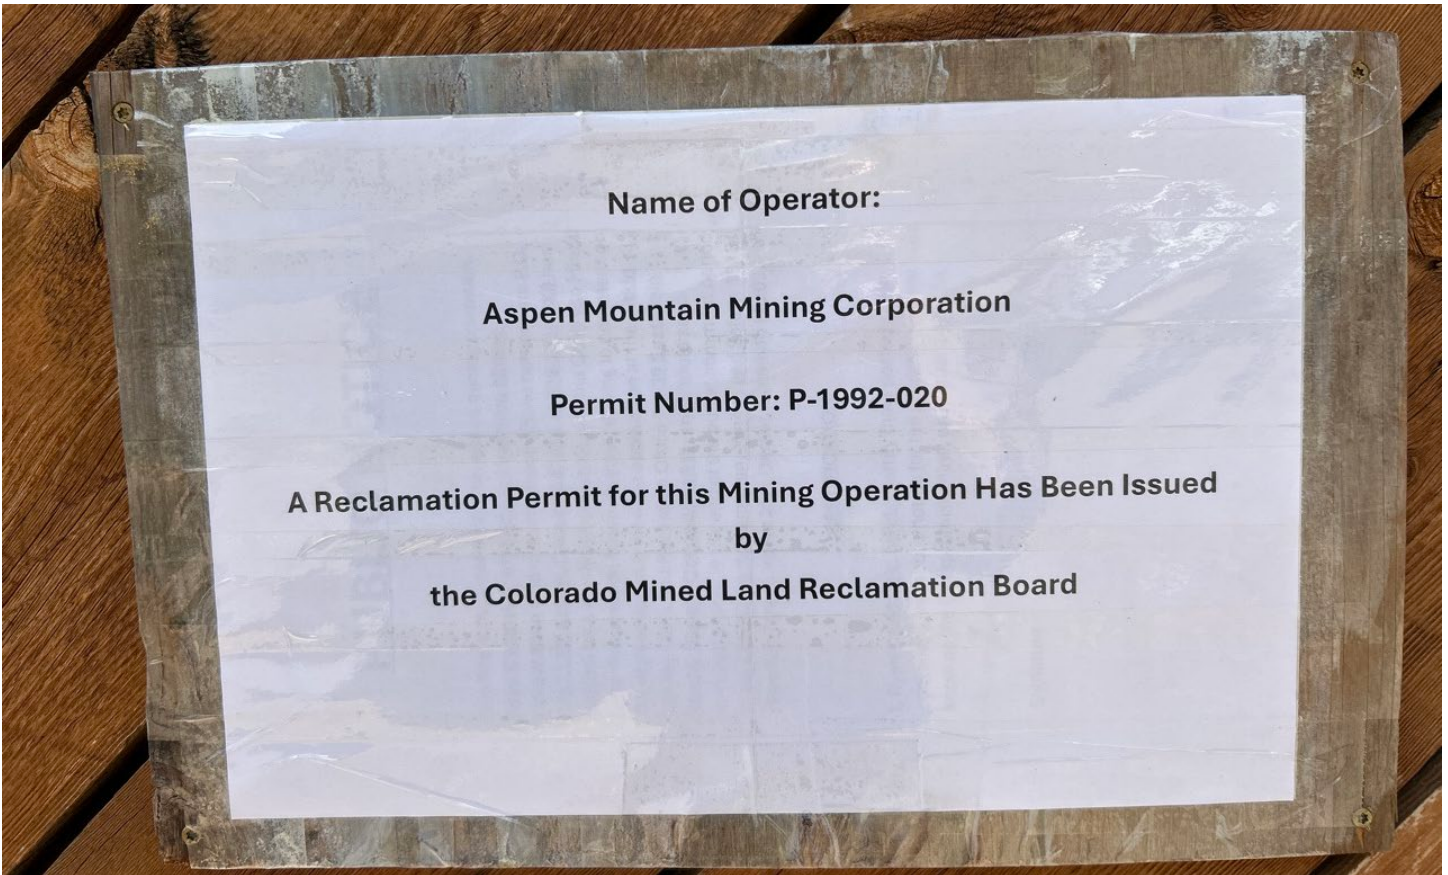
Figure 2: Mine ID sign

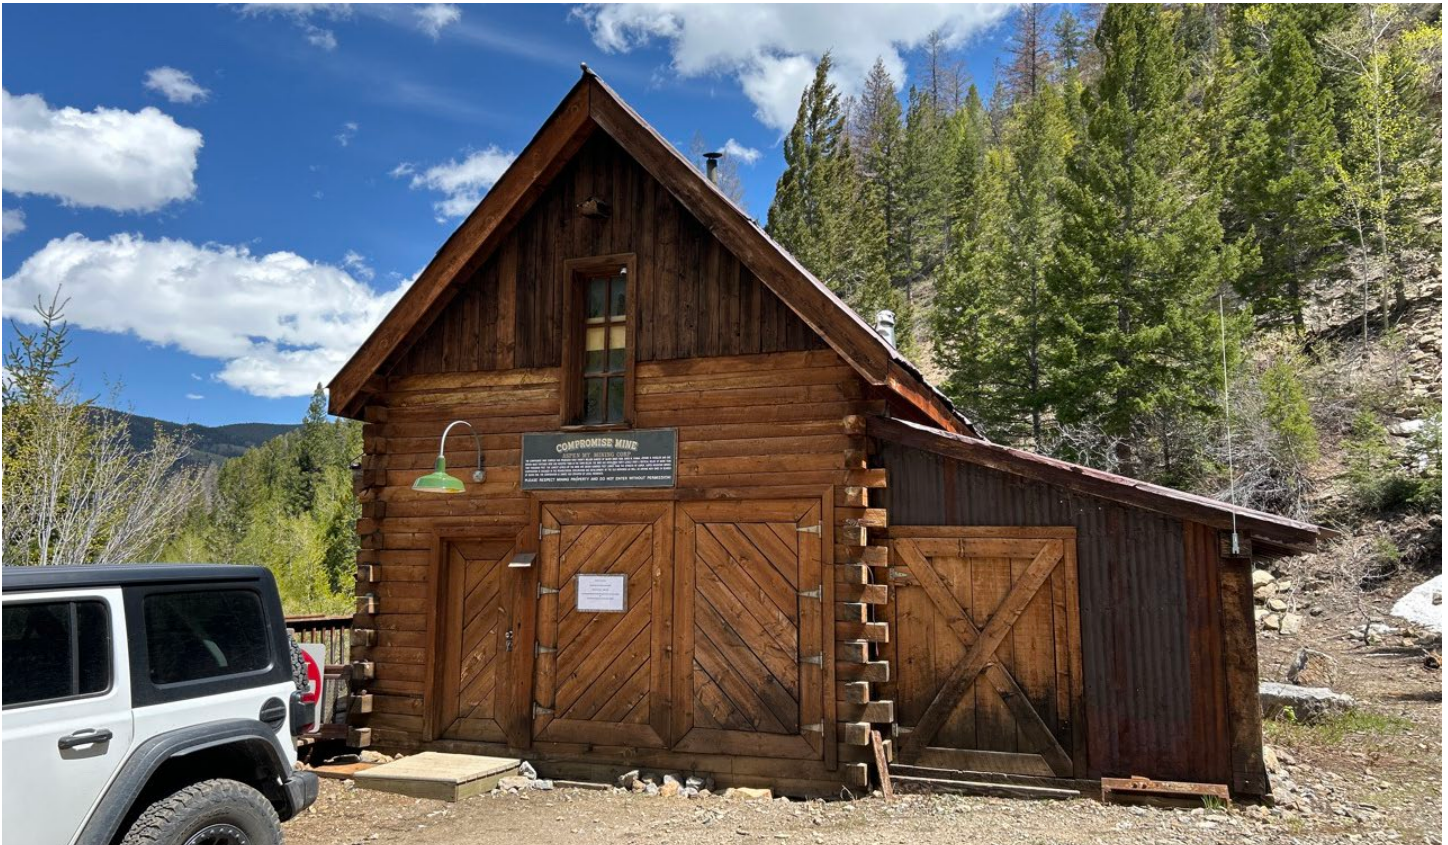
There was no evidence of any recent mining at the site, and no activity besides maintenance and upkeep of the structures. The wooden cabin was locked. The mine portal was secured behind a locked steel door. The roof of the covered rail track leading to the portal had been repaired since the last inspection.

Figure 3: Locked cabin, front (west side)

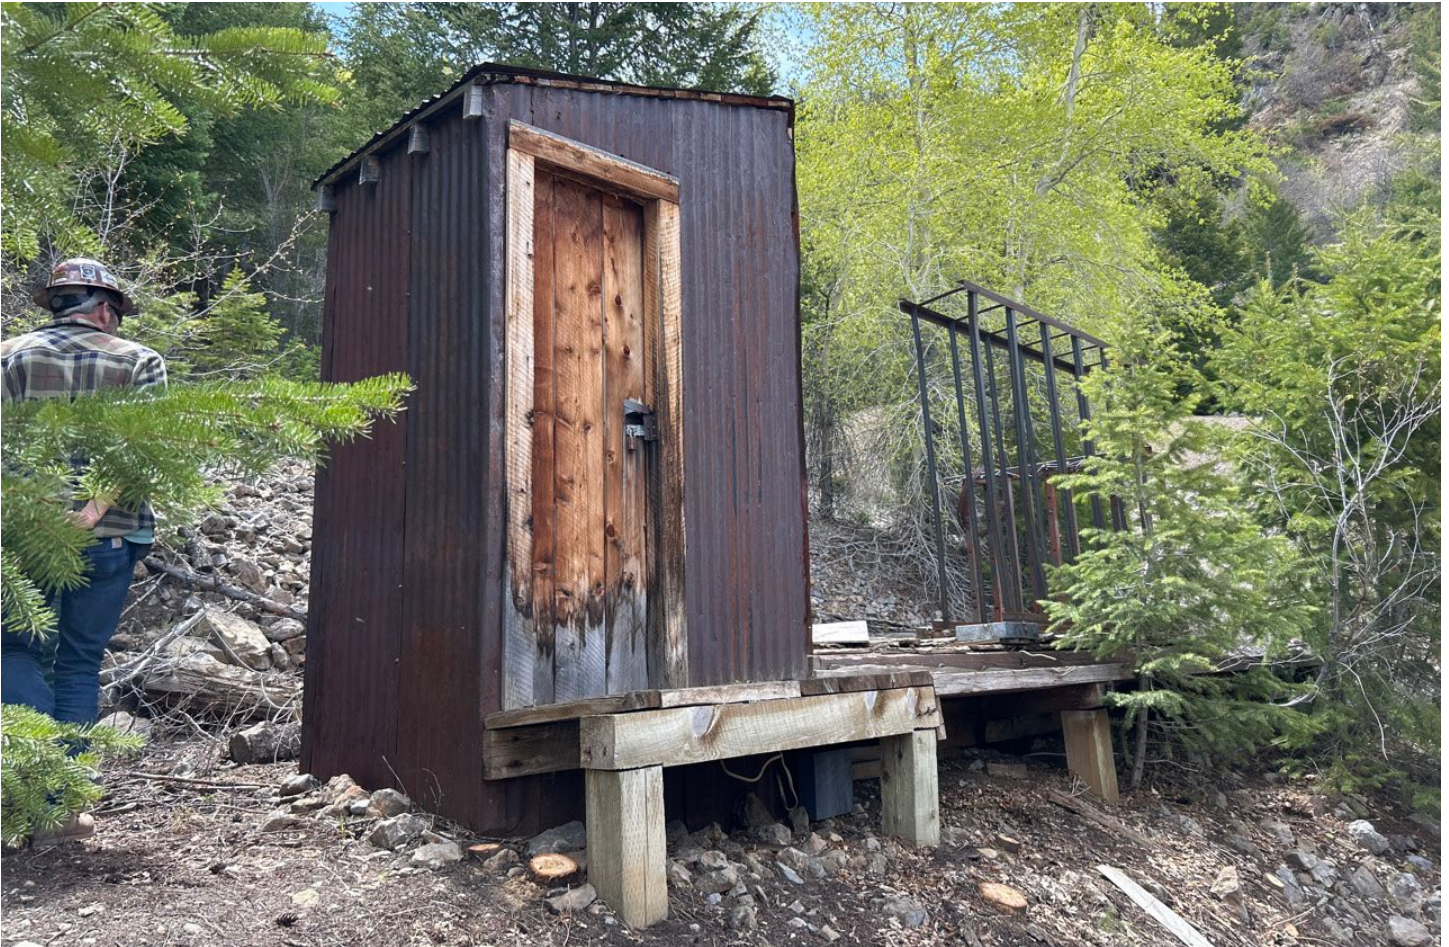
Figure 4: Outhouse

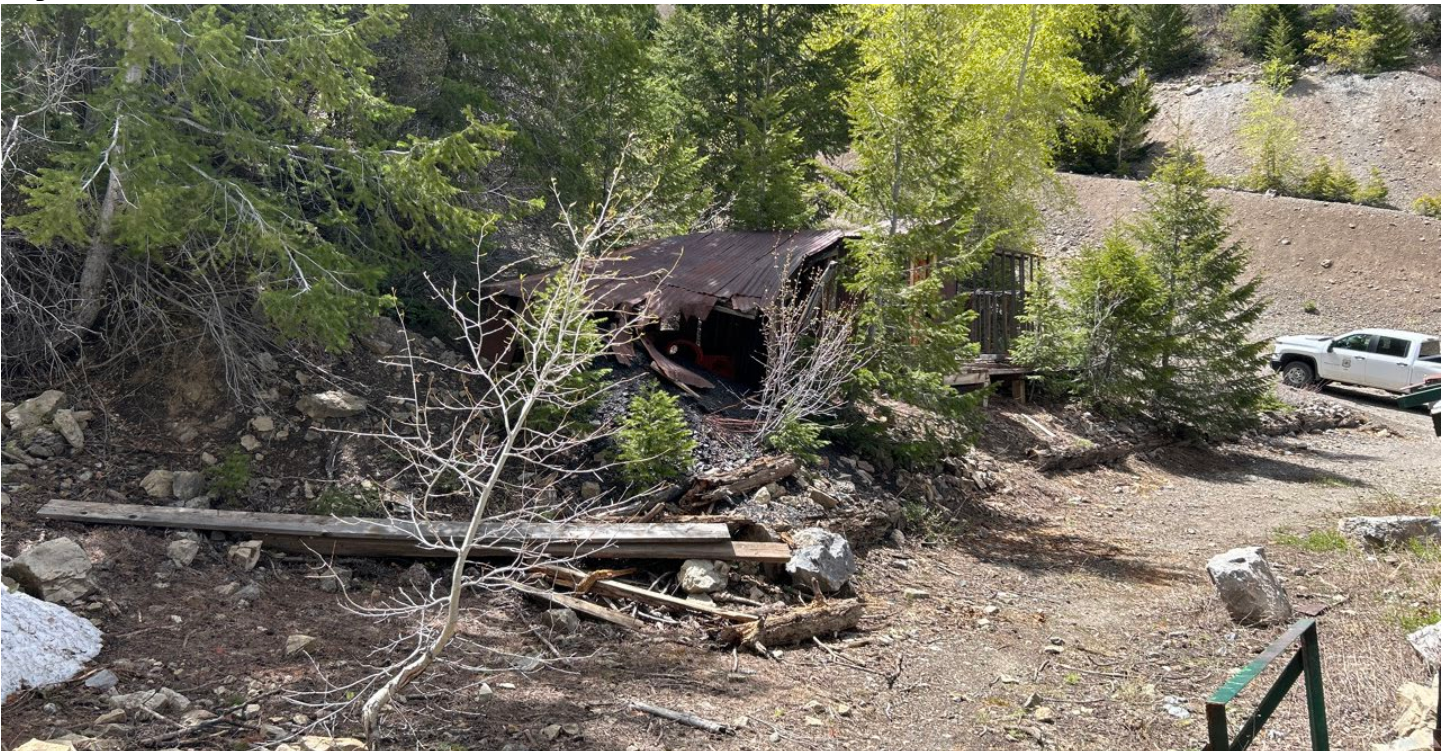
Figure 5: Outhouse area, maintenance work in progress

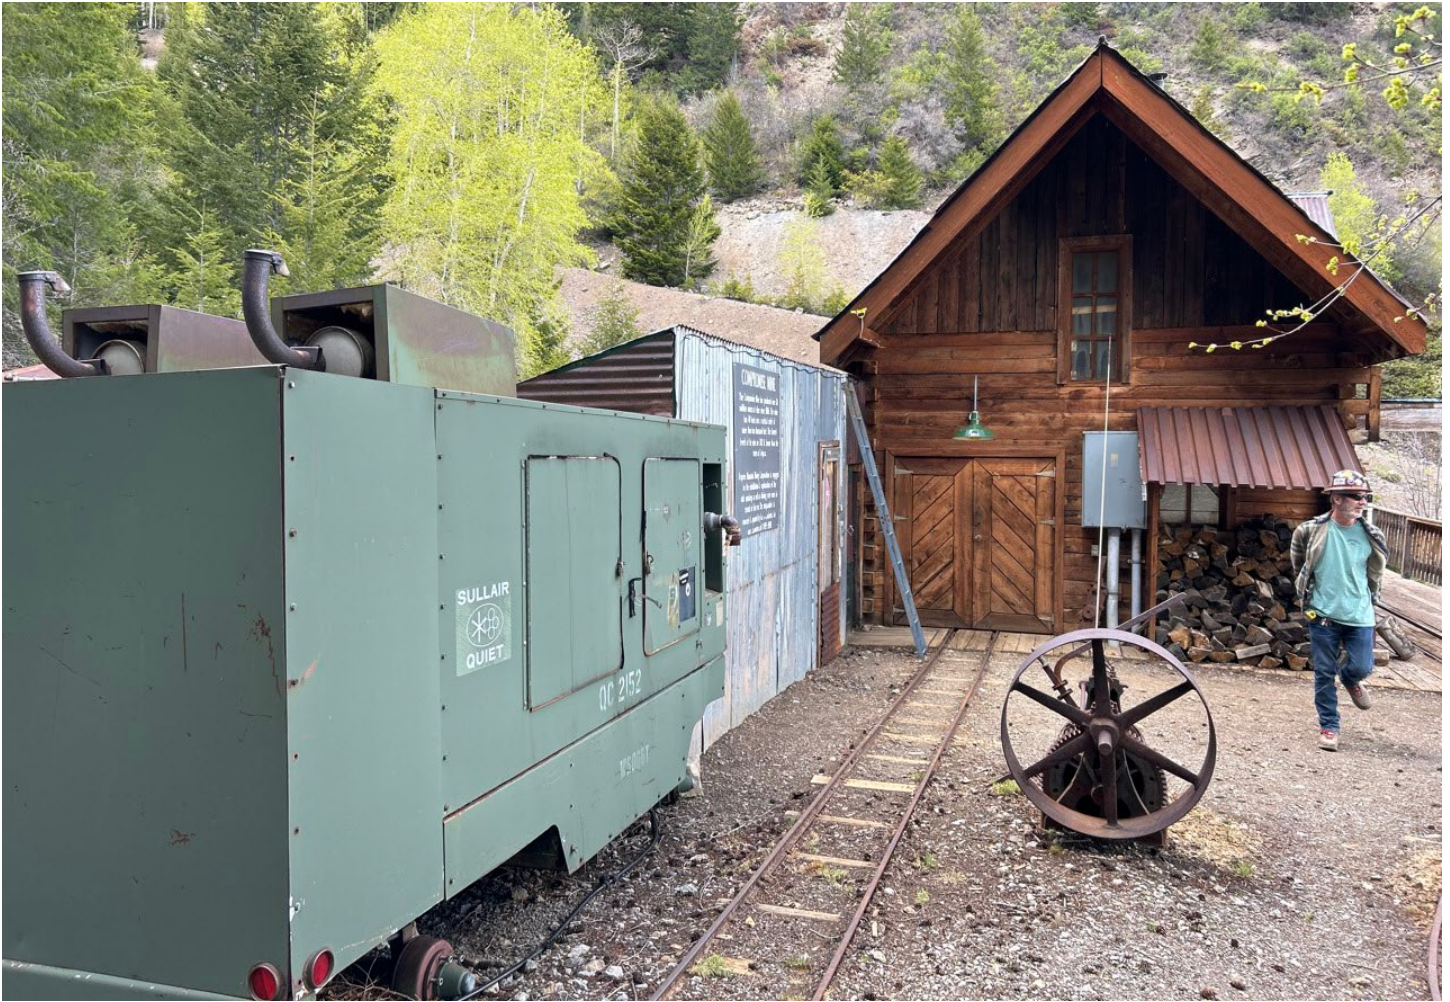
Figure 6: Compressor, tool shed and cabin, back (east side)

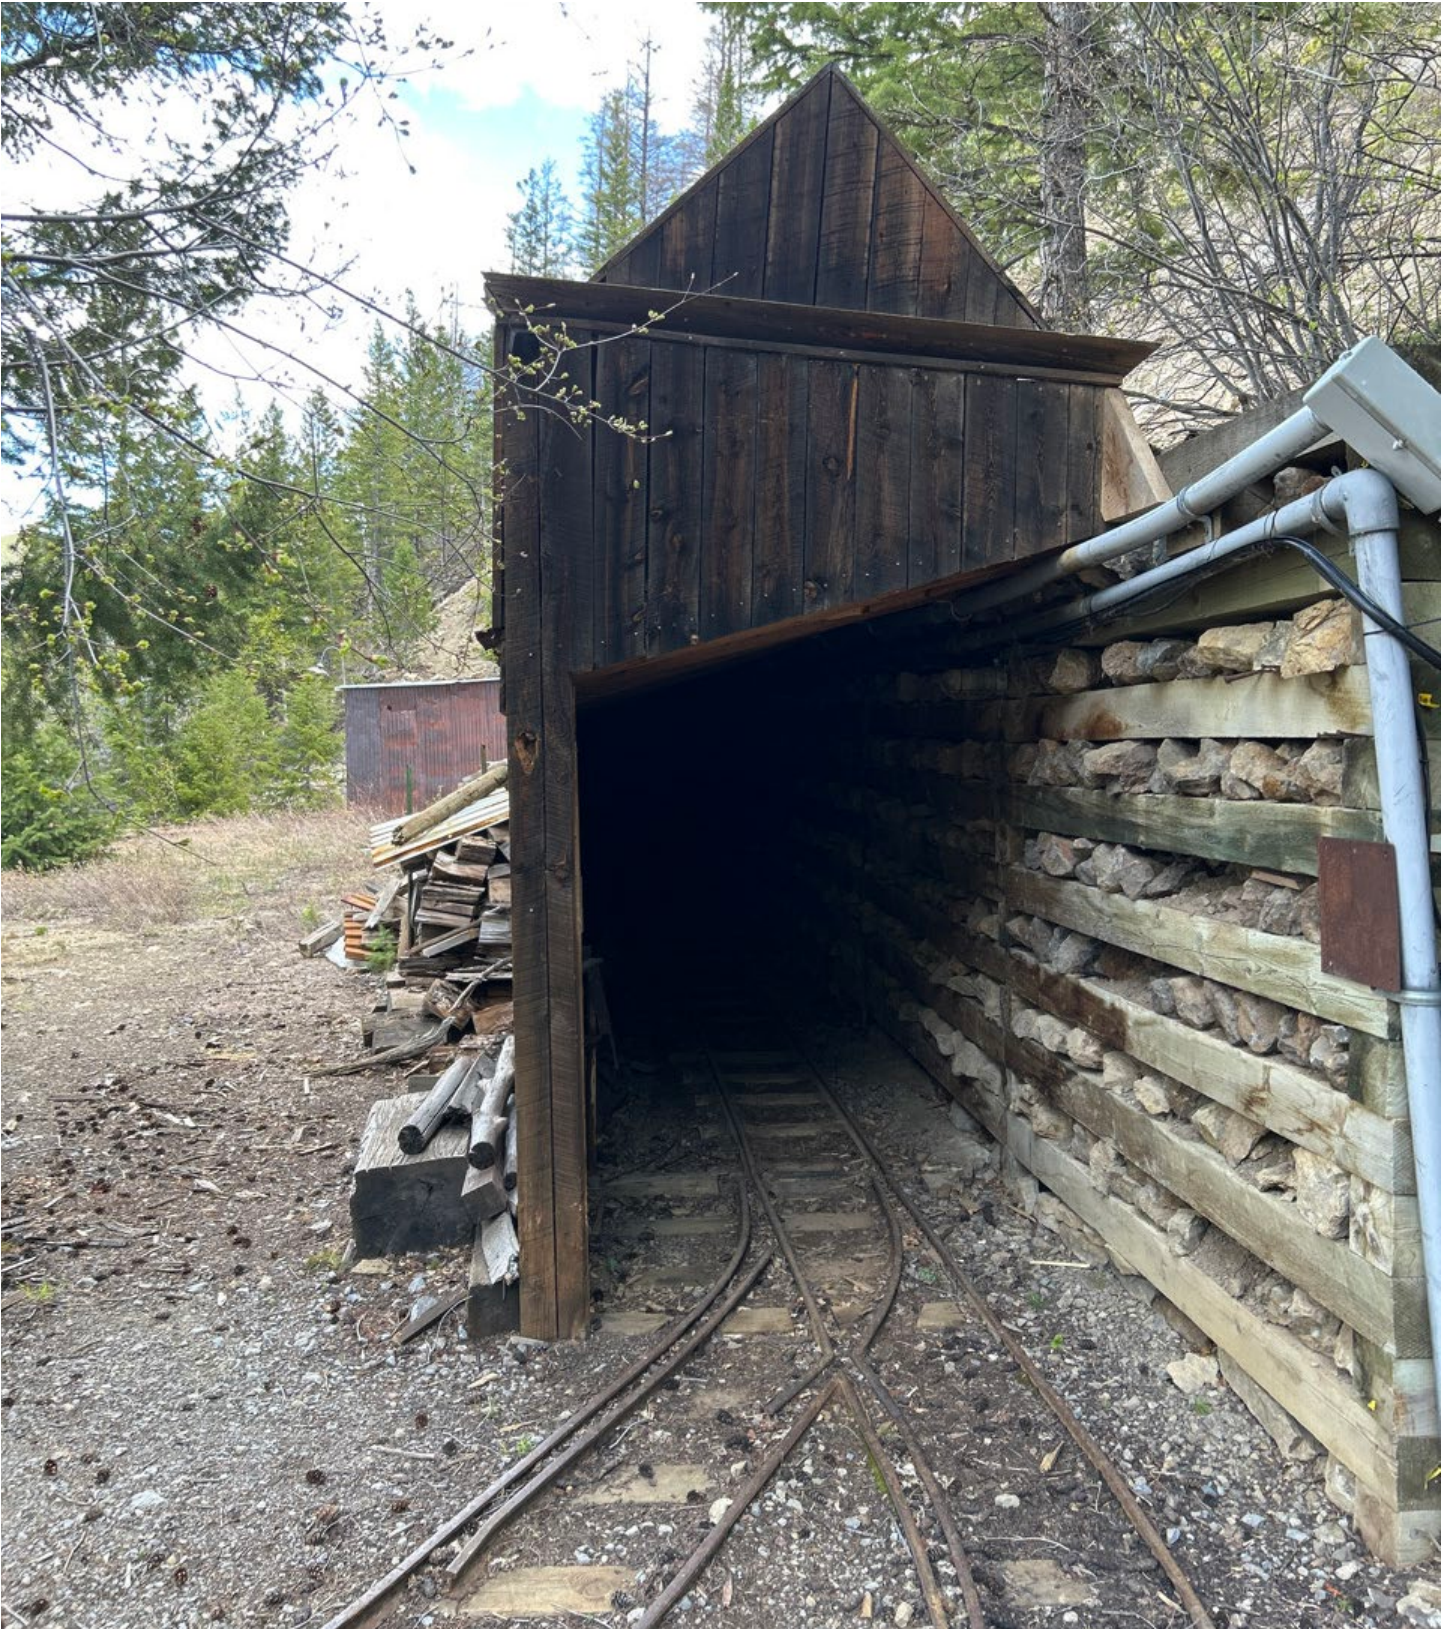
Figure 7: Covered rail between cabin and portal

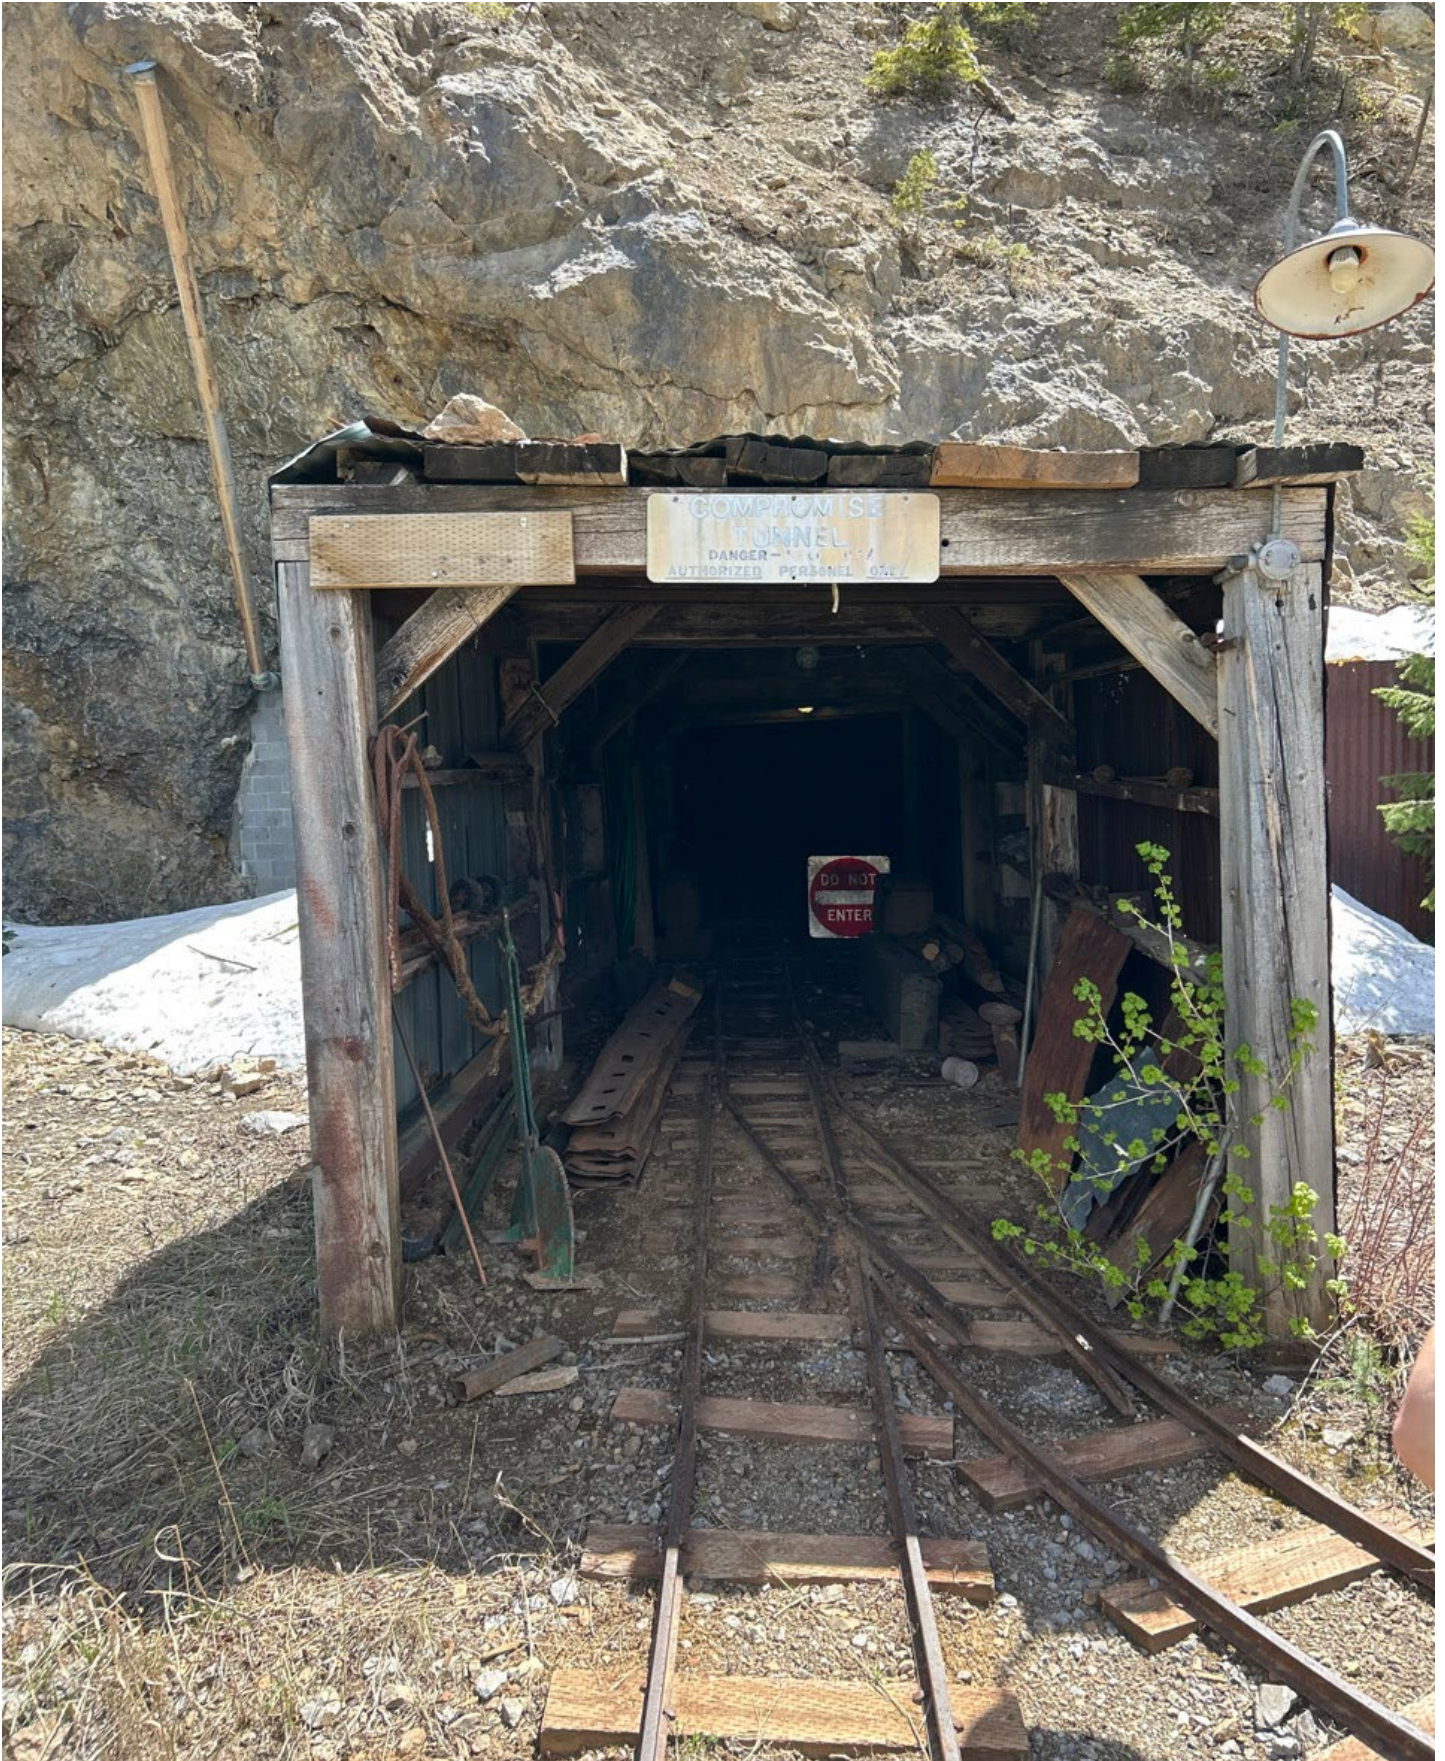
Figure 8: Tunnel entrance

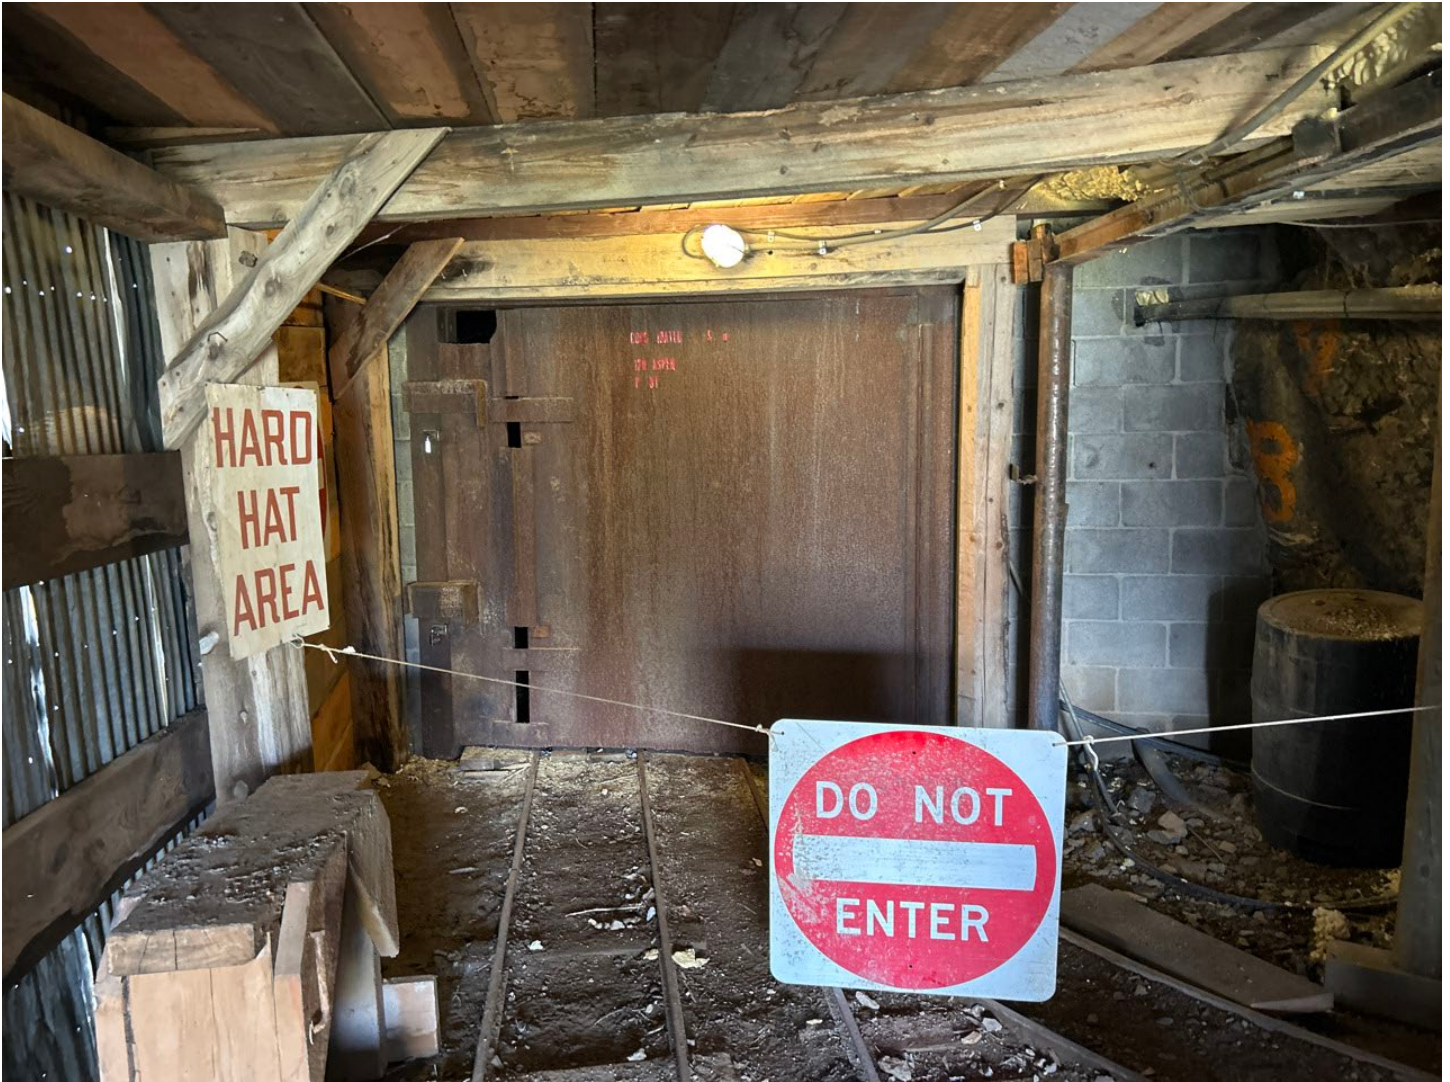
Figure 9: Portal entrance, secure.

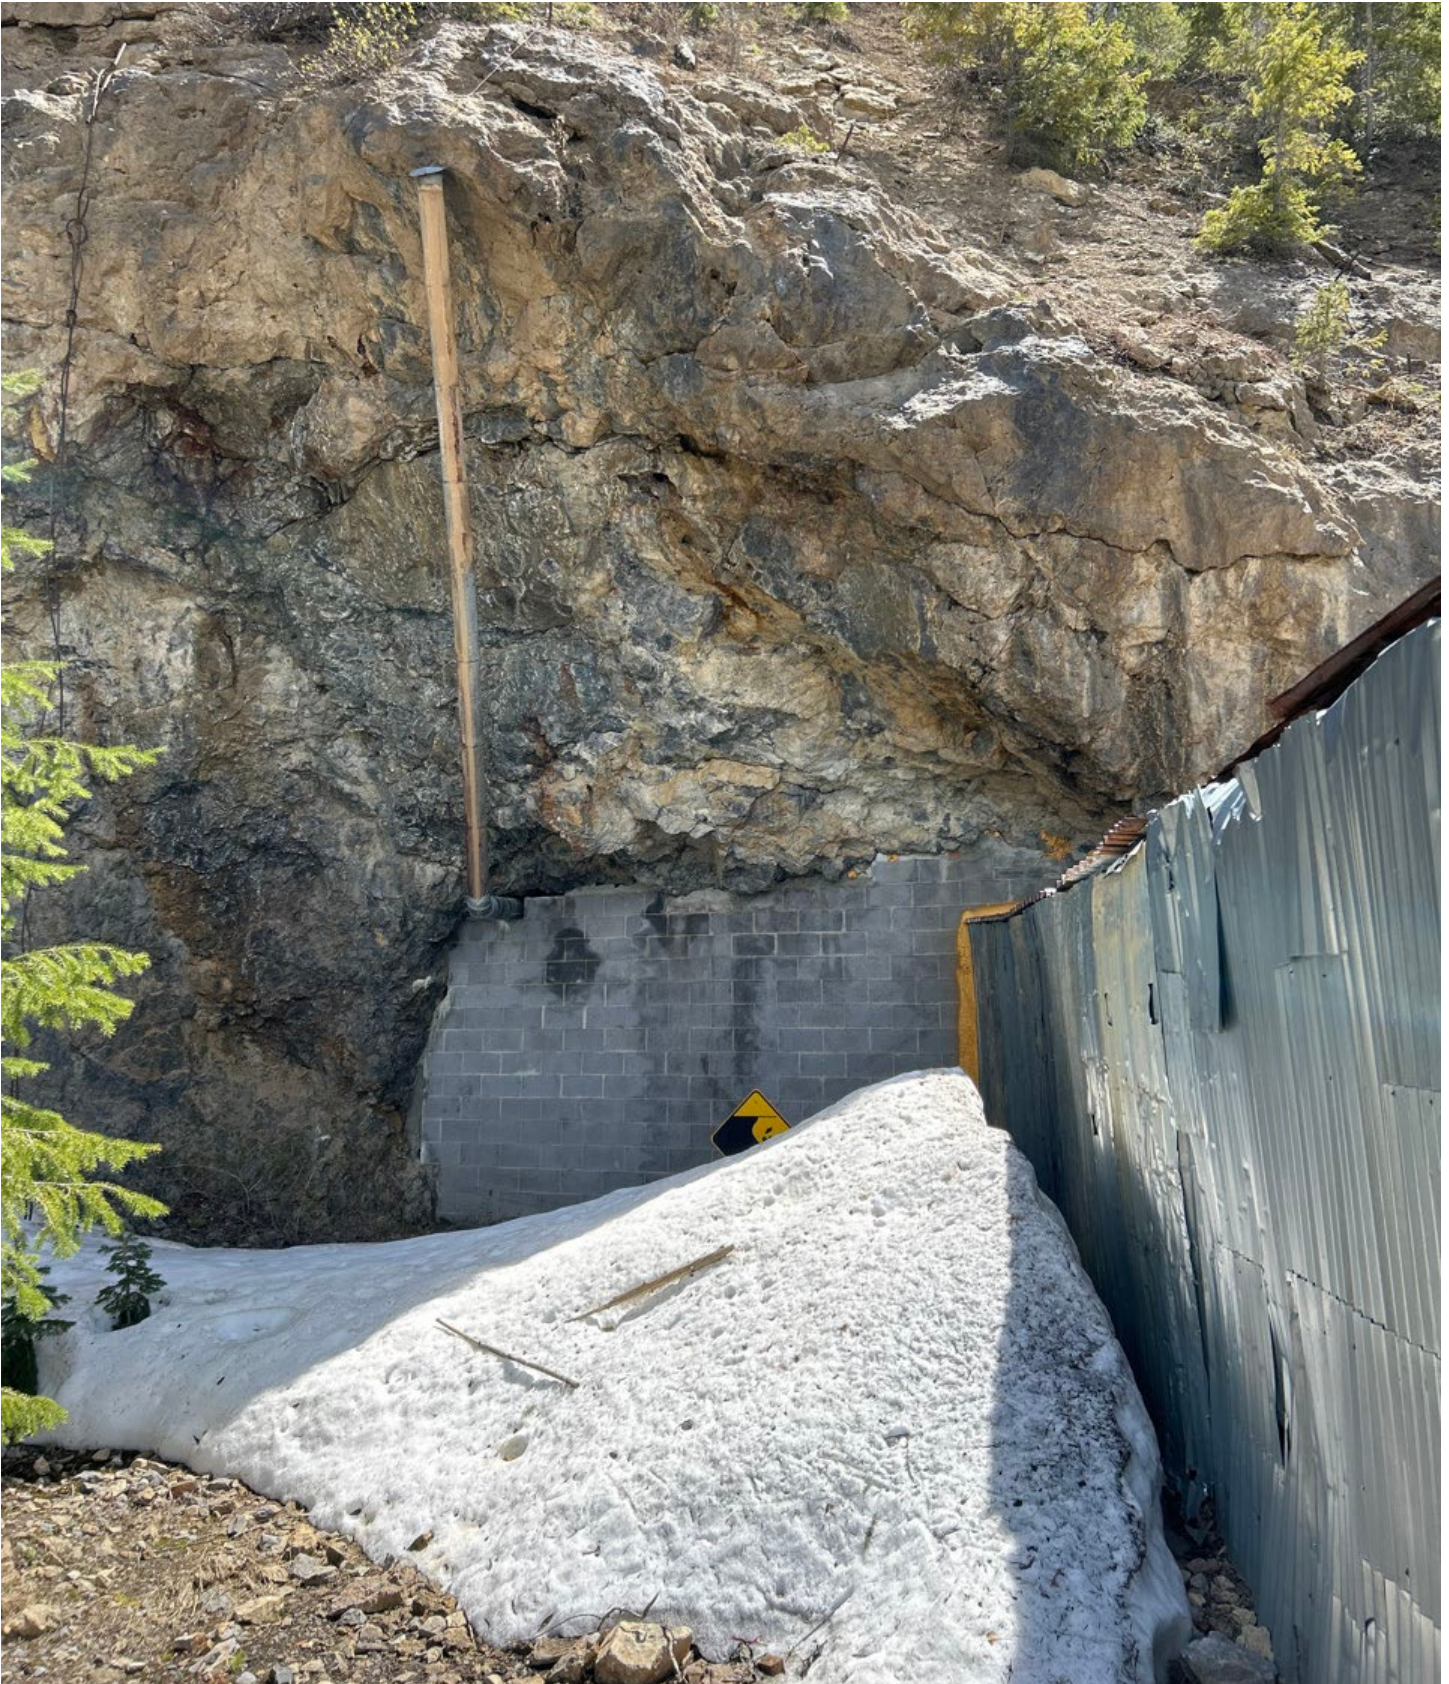
Figure 10: Blocked portion of portal entrance, adjacent to tunnel

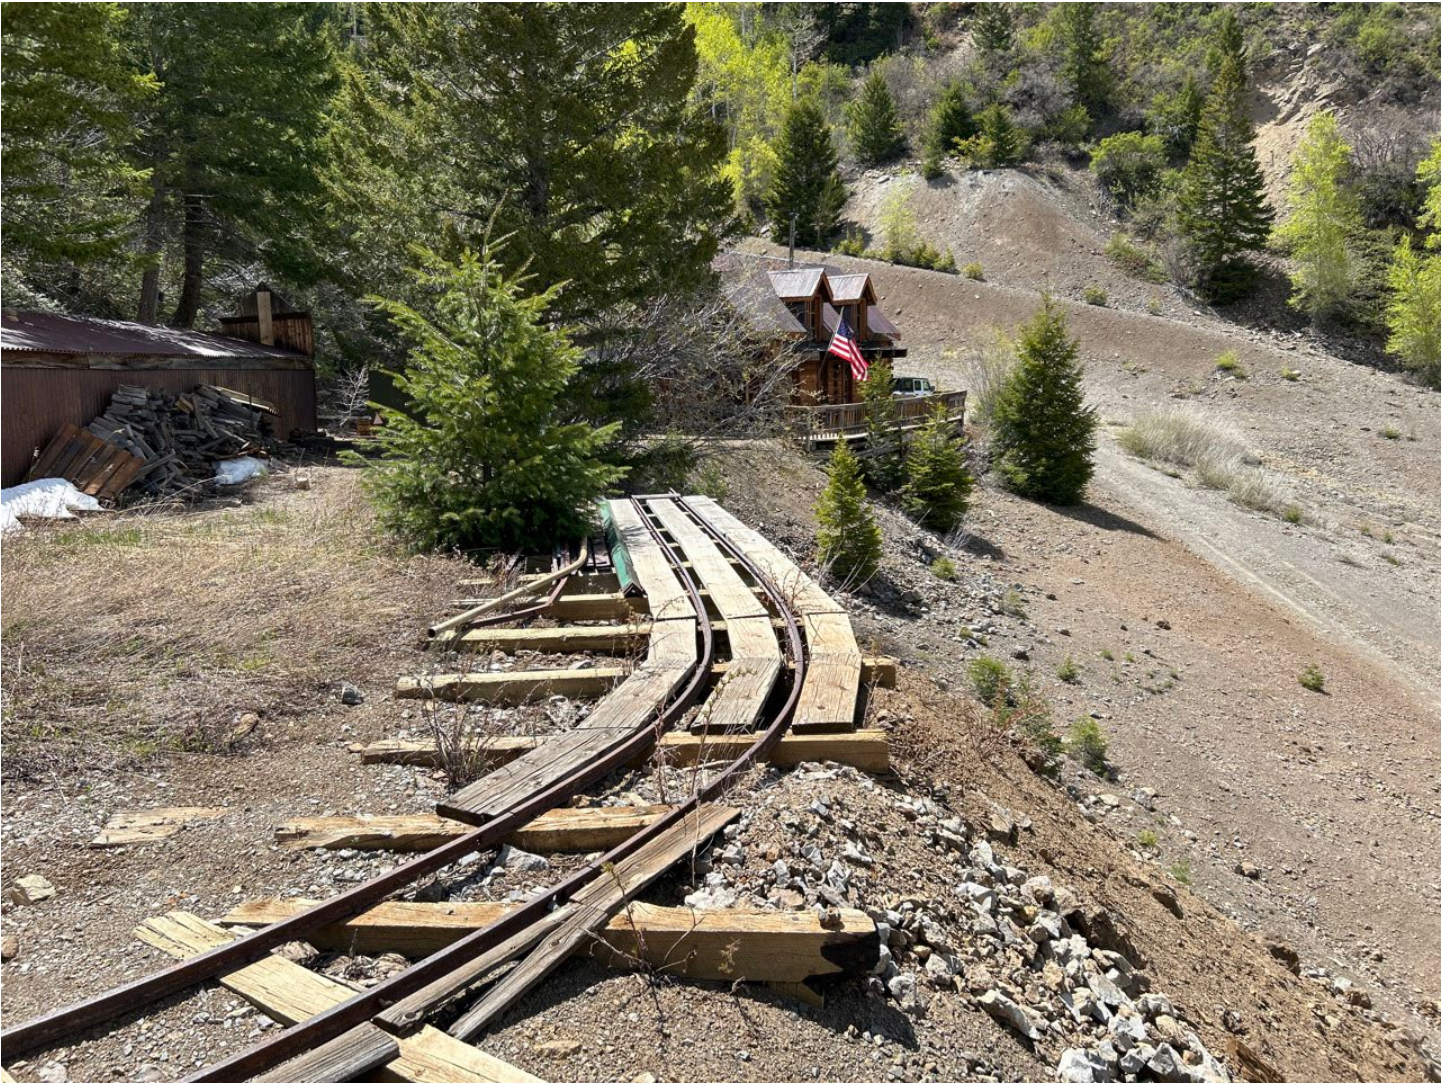
Figure 11: Rail spur

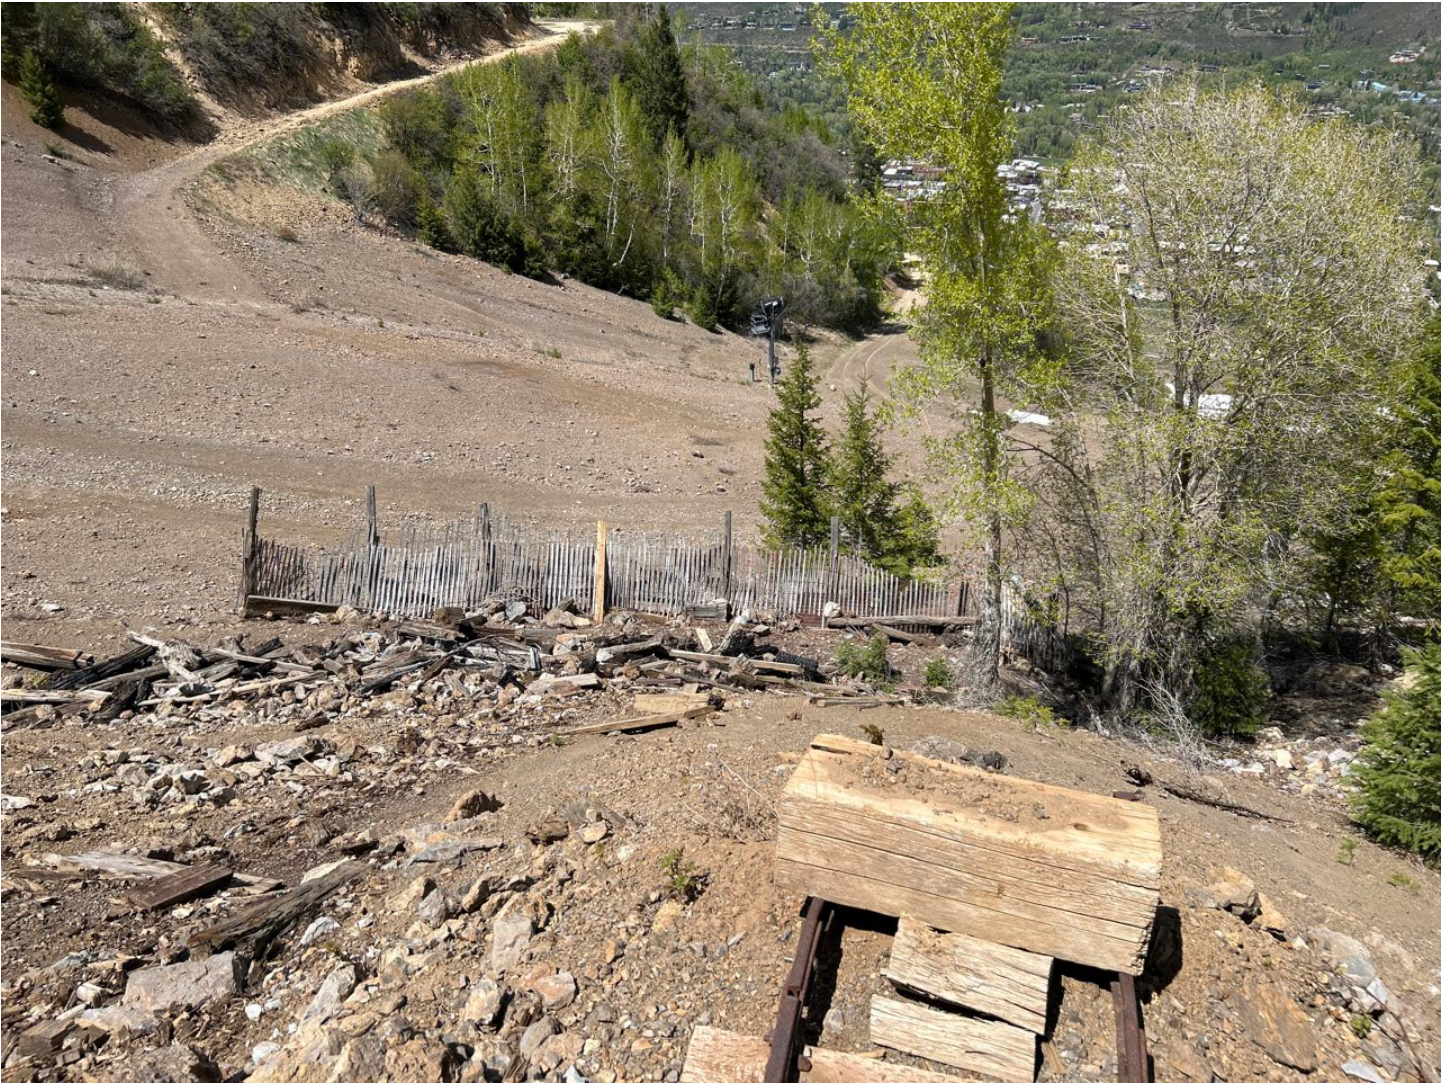
**Figure 12: Waste dump**
