**MINERALS PROGRAM INSPECTION REPORT**  
**PHONE: (303) 866-3567**

| <b>MINE NAME:</b><br>Tallahassee Resources Exploration | <b>MINE/PROSPECTING ID#:</b><br>P-2023-015 | <b>MINERAL:</b><br>Uranium | <b>COUNTY:</b><br>Fremont |
| <b>INSPECTION TYPE:</b><br>Monitoring | <b>WEATHER:</b> Clear | <b>INSP. DATE:</b><br>May 3, 2024 | <b>INSP. TIME:</b><br>9:30 |

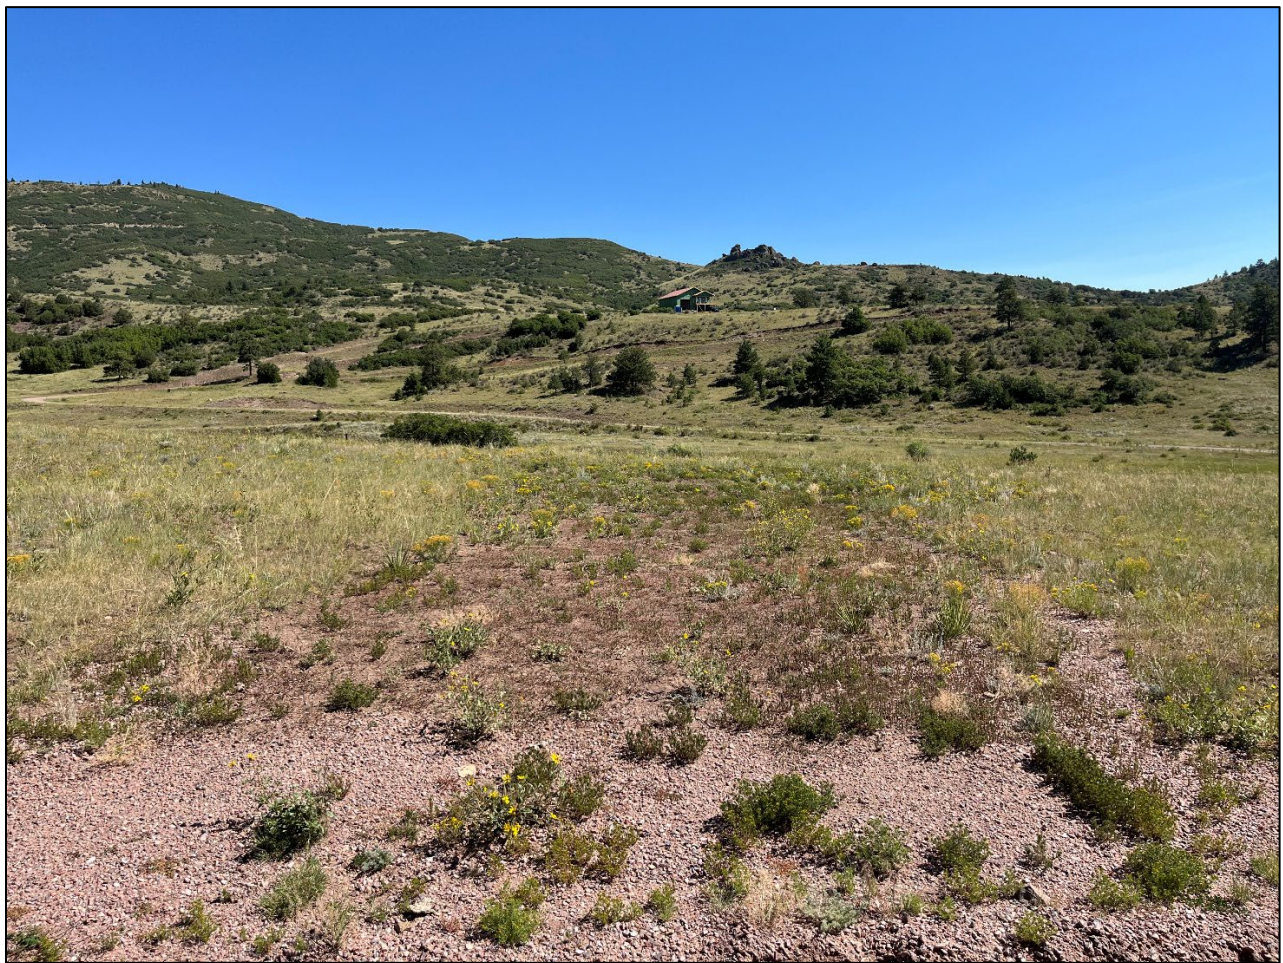
**Revegetation and Reclamation Success:** All access routes, crossings and drill pads were observed to be in final reclamation, with a mix of native vegetation growing in these areas (Photos 1,5, 6, and 8). Topsoil had been replaced at all sites. Reclamation areas were seeded in 2024. No noxious weeds were observed on site and the site representative, Dr. Angela Bellantoni, noted that she had been out to the site with weed crews recently to control any noxious or weedy vegetation.

**Photo 1: View north of the reclaimed access road and crossing for TC2023-015.**

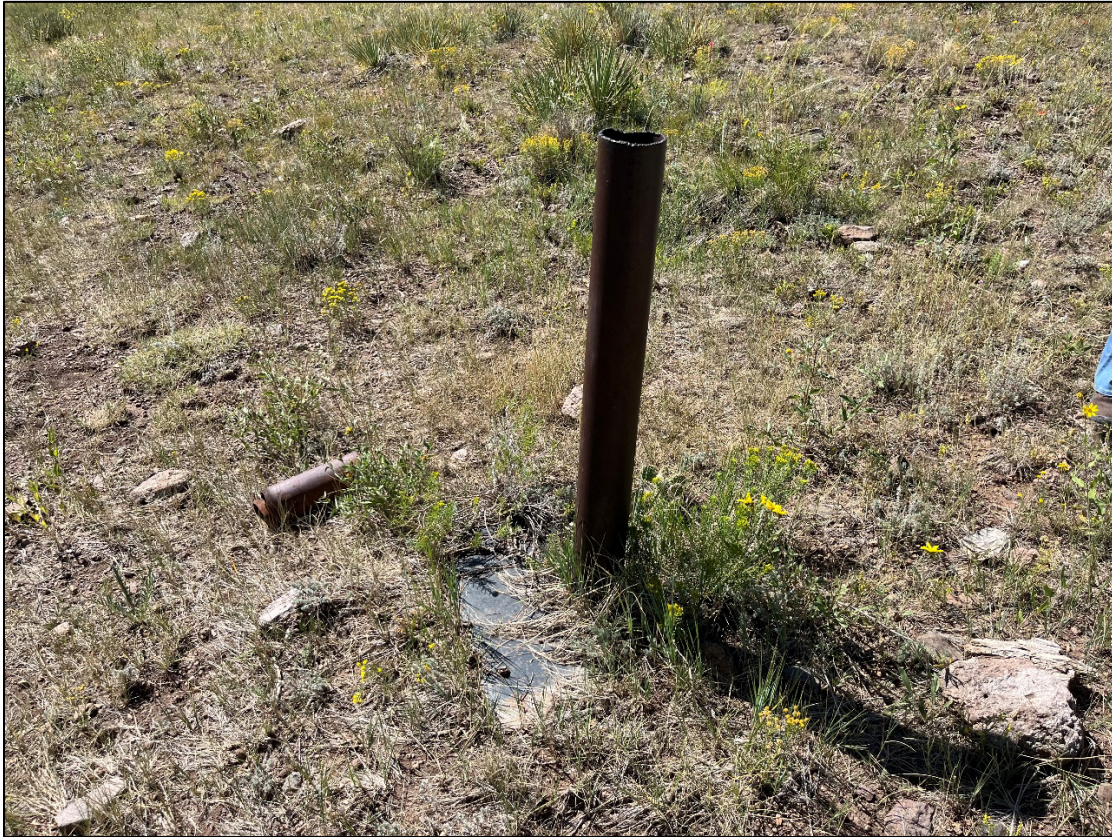
**Backfilling and Grading:** Twenty boreholes have been approved to be drilled for the project. Only eight holes have been drilled and abandoned as of the date of inspection. The Division visited each of these drilled, abandoned and reclaimed sites and attempted to locate markers for each drillhole. Four of eight markers were visually observed (Photos 2,3, 4, and 7, drillholes TC24-015, TC24-02, TC24-04, and TC24-05), although all eight drill pads and access roads were inspected and found to be fully backfilled and graded.

**Photo 2: Abandonment marker for TC24-015.**

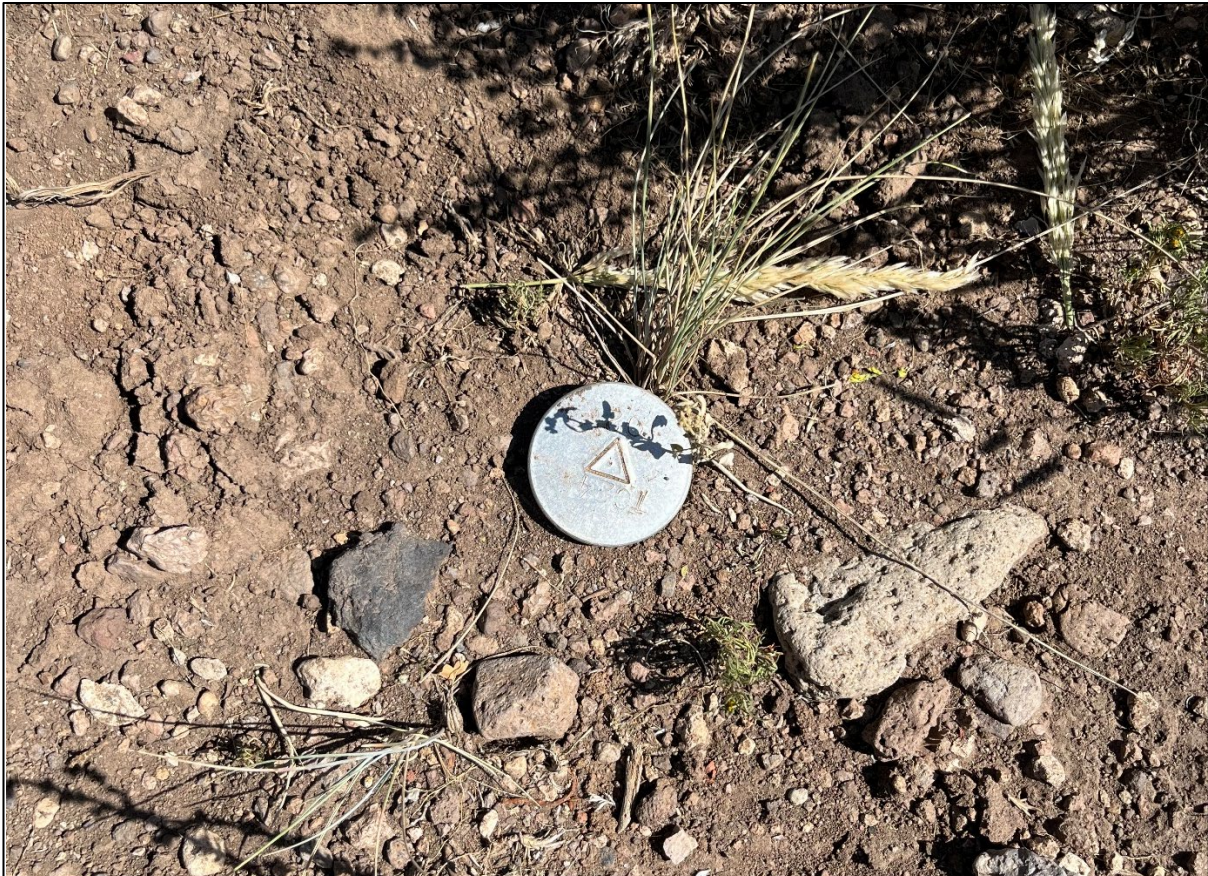
**Photo 3: Abandonment marker for drill hole TC24-02.**

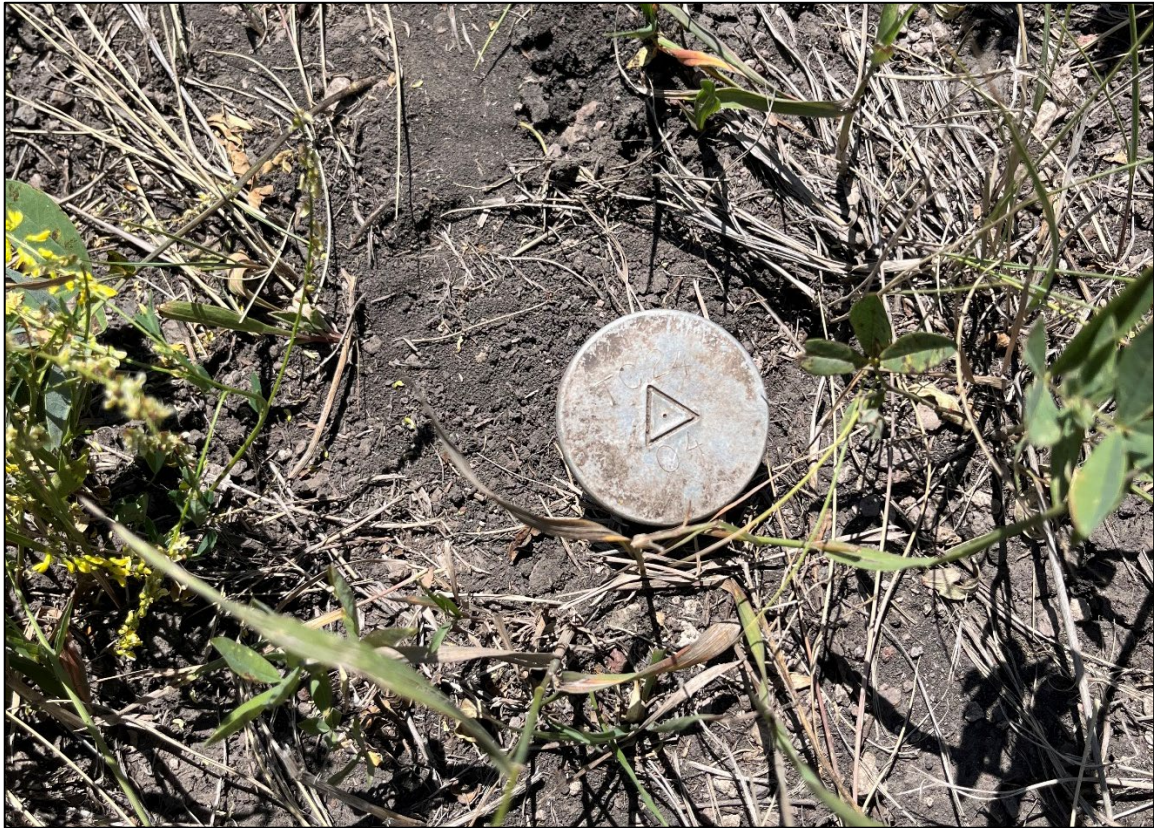
**Photo 4: Abandonment marker for drillhole TC24-04.**

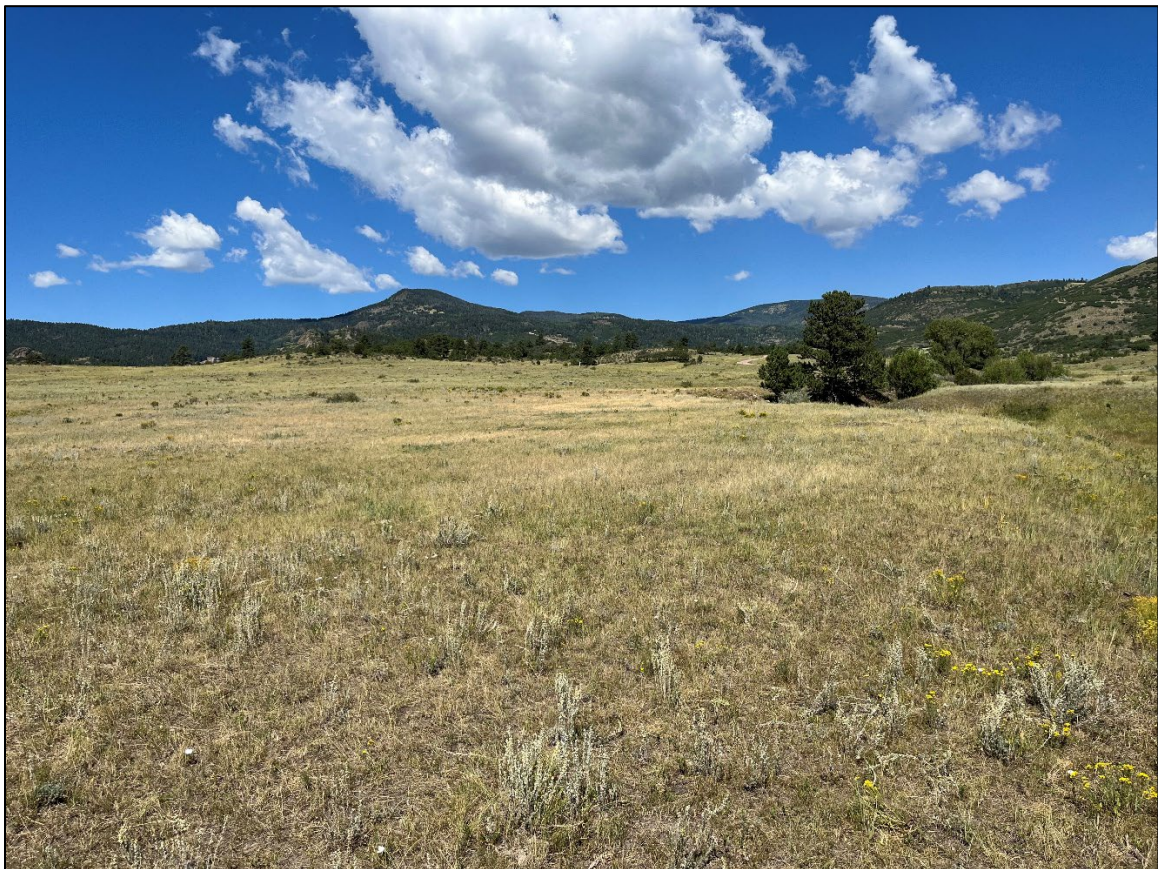
**Photo 5: View of reclaimed access area for TC24-014.**

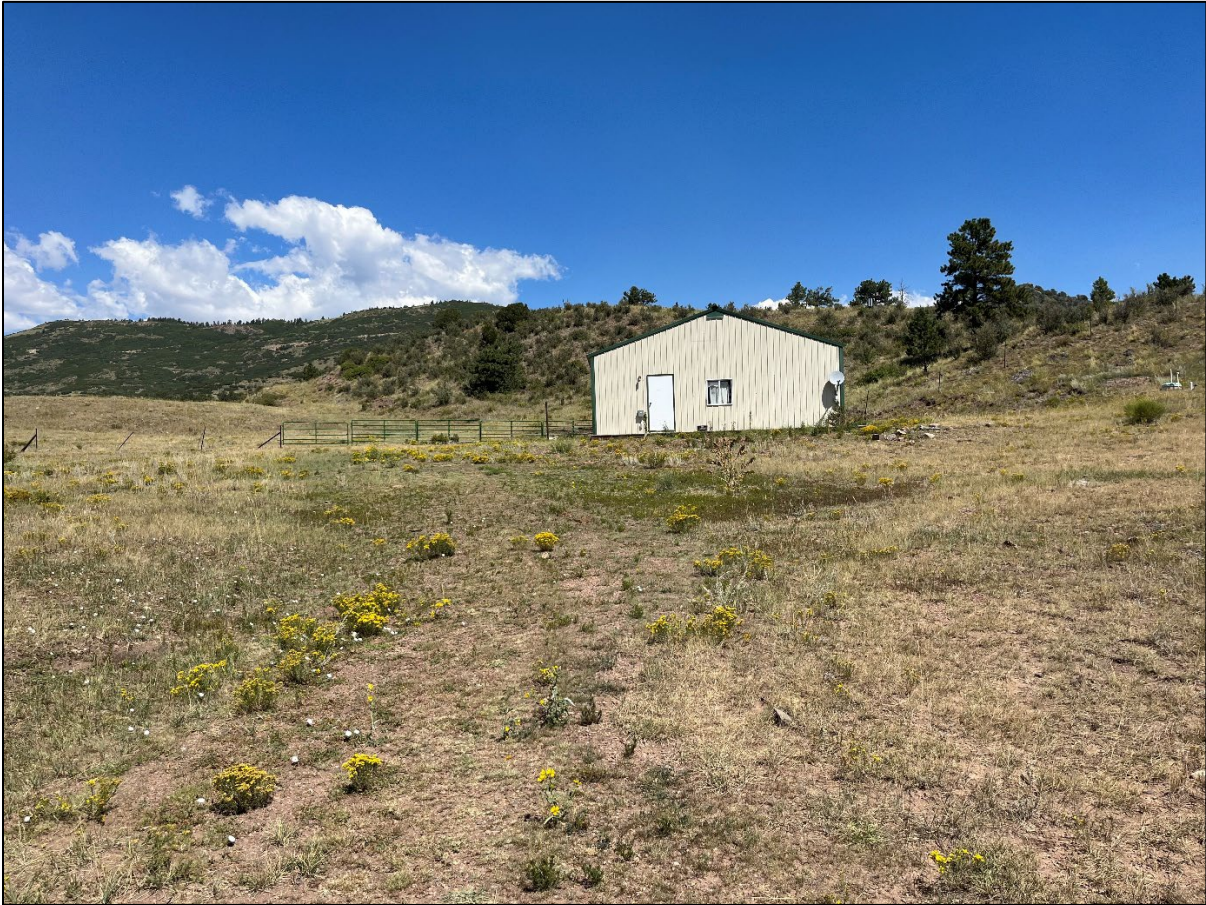
**Photo 6: View of reclaimed access area for drillhole TC24-06.**

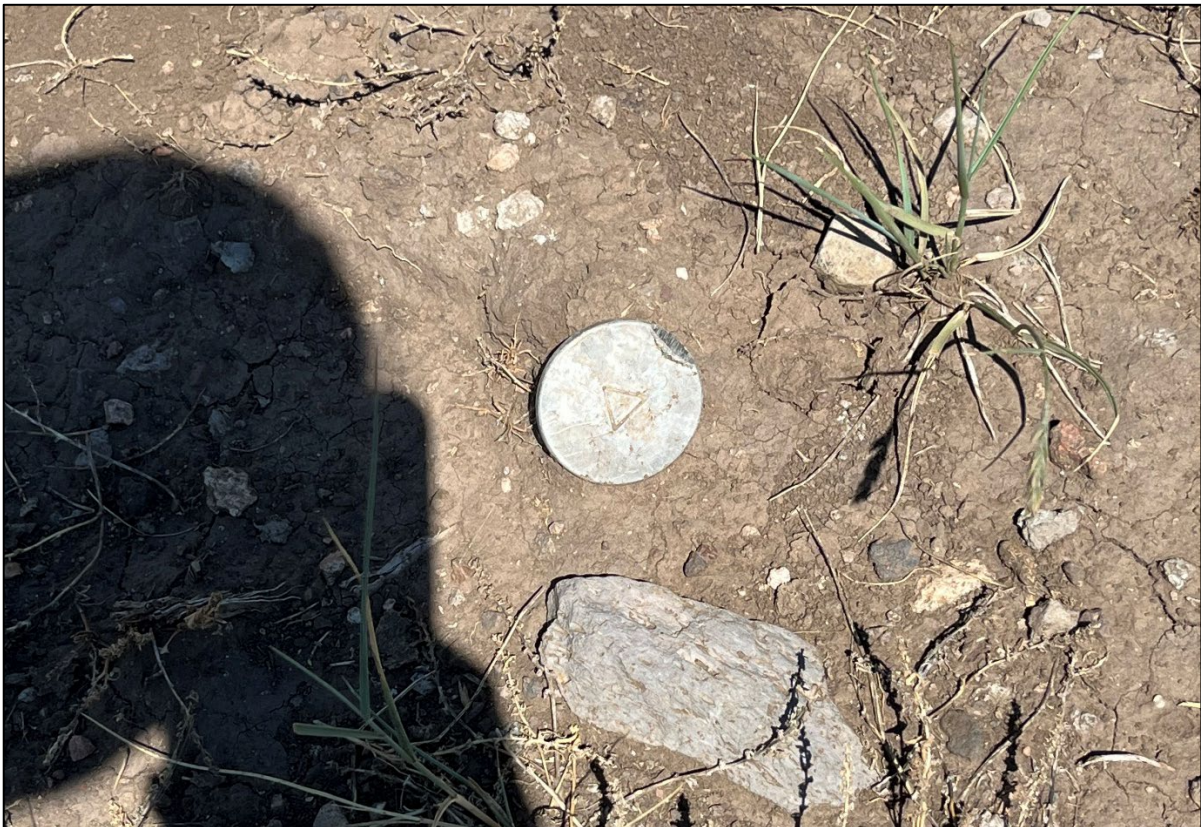
Abandonment Reports, received on November 20, 2024, documented eight drillhole abandonments. These holes are labeled as TC-2401, 2402, 2403, 2404, 2405, 2406, 2407, and 2408. However, the permit's approved site map shows some of these same drillhole locations with different labels. Based on the site map (Figure 1, below), the eight abandoned and reclaimed drillhole locations are: 2023-002, -004, -06, -07, -014, -015, -017, and -019.

**Photo 7: Abandonment marker for drillhole TC24-019 (labeled TC24-05).**

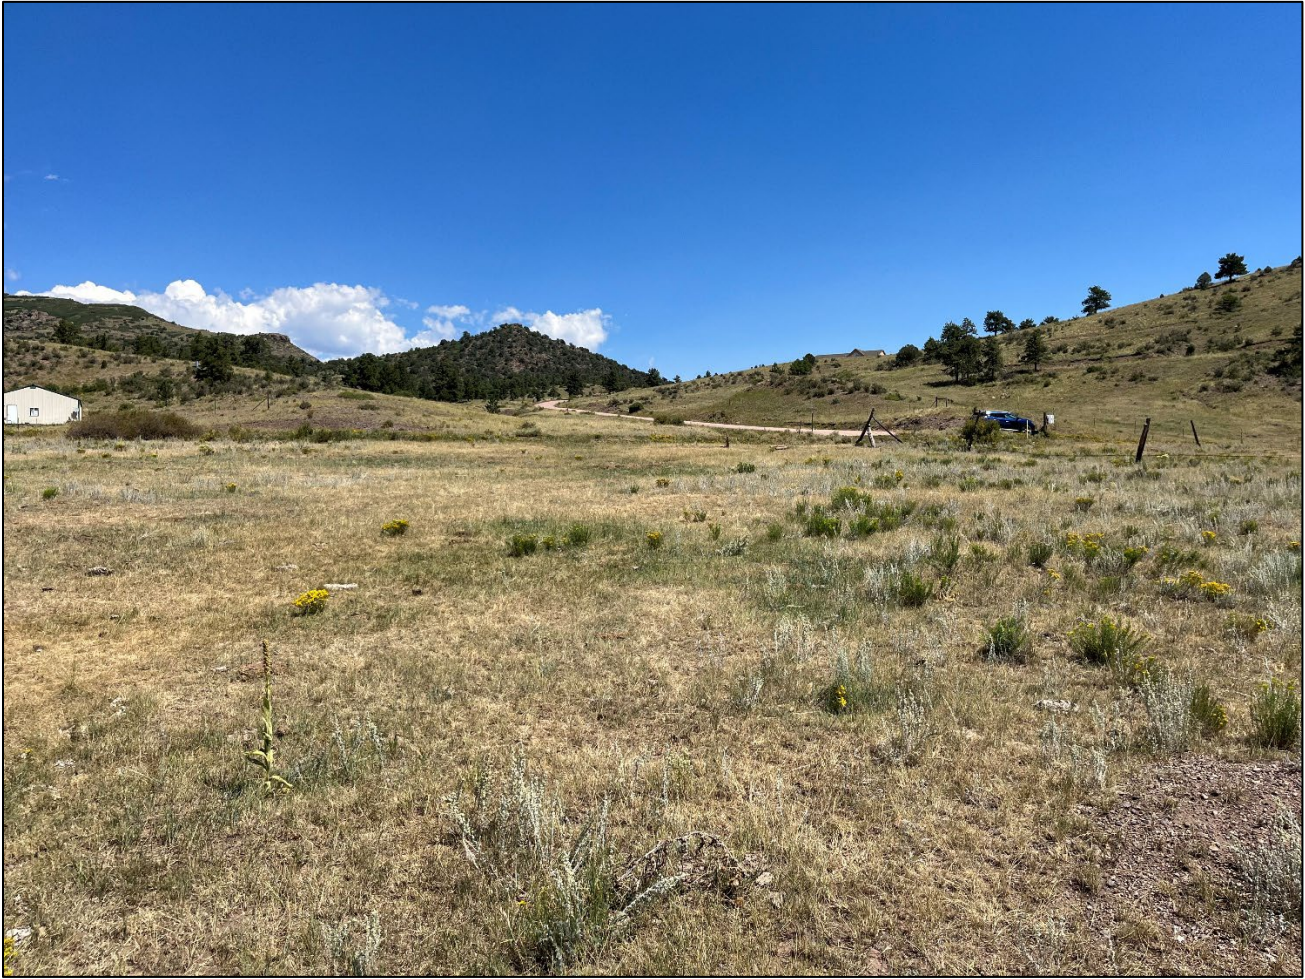
**Photo 8: View of reclaimed access area for drillhole TC24-019.**
