IMP Site Visit Memo

Date: August 15, 2025 **Project:** Brighton Pit

DRMS File No.: M-1982-160

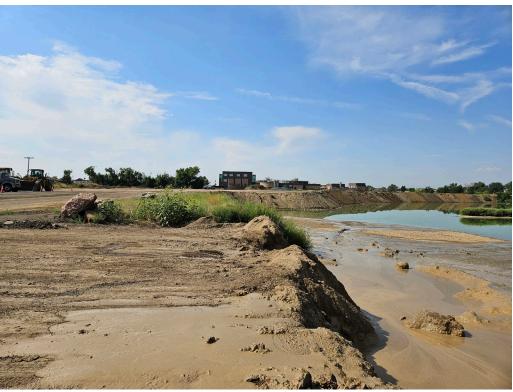
View of the eastern shoreline from the northeast corner looking south

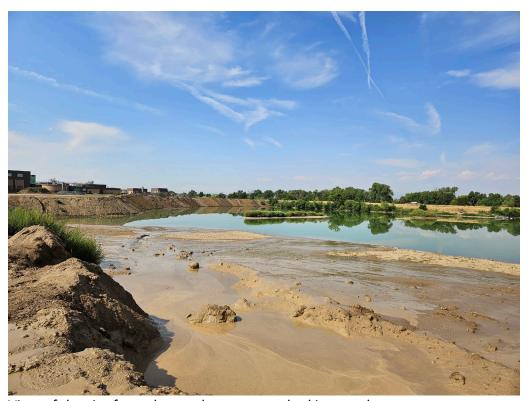
View of the site from the northeast corner looking south

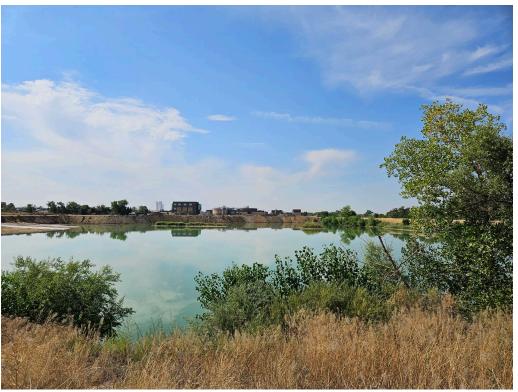
View of the site from the north shoreline looking south

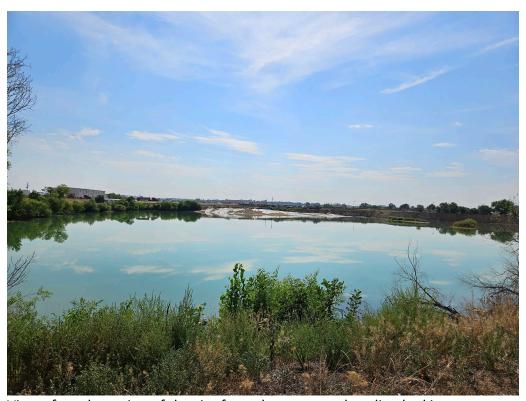
View of north portion of the site from the western shoreline looking east

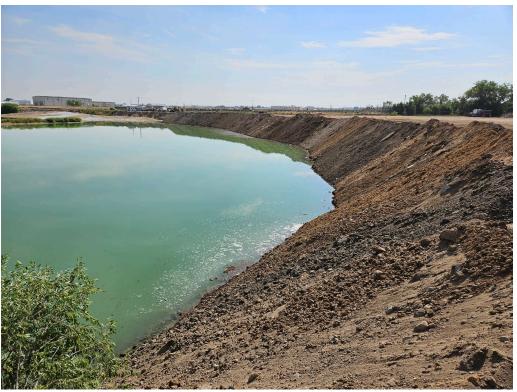
View of the backfilled southern shoreline from the southwest corner looking east

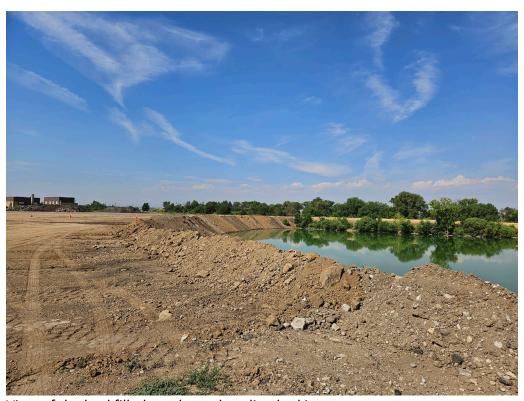
View of the backfilled southern shoreline looking west

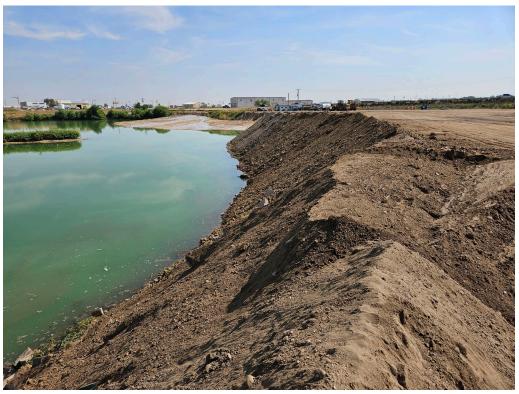
View of the backfilled southern shoreline looking northeast

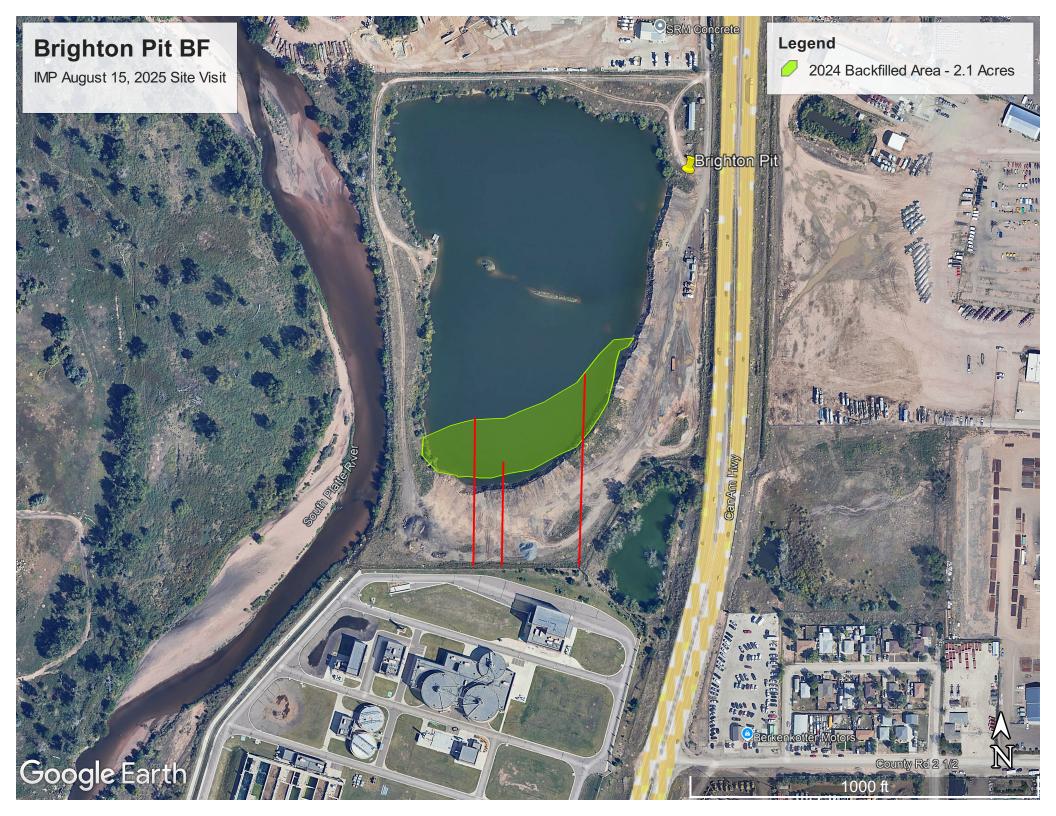
In 2023, the Division estimated the southern shoreline backfill distance at 132 feet from the southern mining extent and 177 feet along the eastern shoreline from the eastern mining extent during the site visit. In 2024, the southern and eastern shorelines backfill distances were estimated at 300 feet each. During today's visit, the southern shoreline backfill distances were estimated at 425 feet in the southwestern corner and 550 feet at the middle of the shoreline. The eastern shoreline was unchanged from the 2024 measurement. The Division estimates 2.1 acres were backfilled along the southern shoreline since the 2024 visit. A map of the estimated area is attached.
