MINERALS PROGRAM INSPECTION REPORT

MINE NAME: Upper Animas Sand and Gravel Pit	MINE/PROSPECTING ID#: M-2005-065	MINERAL: Sand and gravel	COUNTY: San Juan
INSPECTION TYPE: Monitoring	WEATHER: Clear	INSP. DATE: July 16, 2025	INSP. TIME: 09:53
OPERATOR: Jack Clark, Jr.	OPERATOR REPRESENTATIVE: Jack Clark Jr.	TYPE OF OPERATION: 112c - Construction Regular Operation

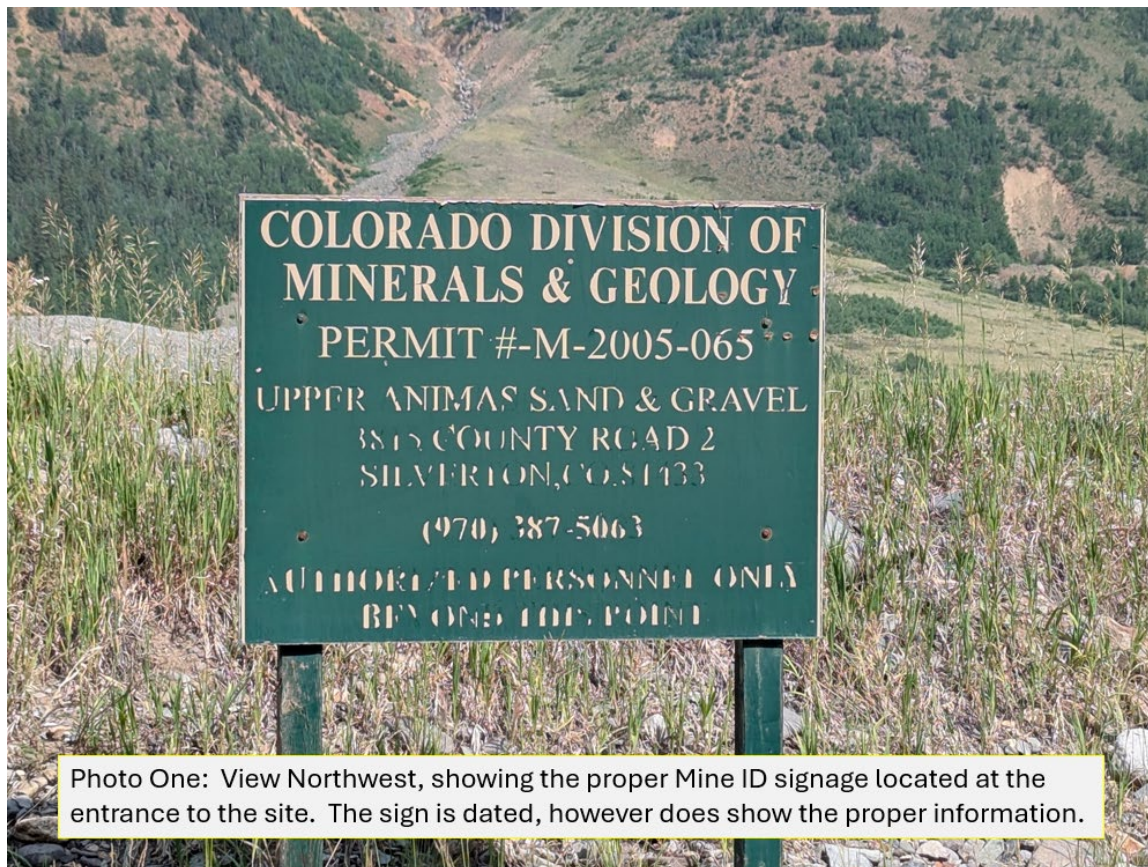
The proper mine identification signage is posted at the entrance to the site and can be seen in Photo One. The permit boundaries are also clearly marked with a combination of T-posts and earthen berms. The active mining area is focused in the northern end of Pit 1 and all of Pit 2. Pit one lies within the active floodplain of the Animas River and will be reclaimed to a developed water resource. The side slopes of the pit appear to be stable, in good condition and are in their final reclamation configuration of 3H: 1V. The Pit 1 Area can be seen in Photos Two and Three. Adequate slope below the ponds water surface was visible and in good condition. The pond currently has a peninsula extending into the pond. The Mining and Reclamation Plans do not show a peninsula in the pond, but it is unclear if Pit 1 is in its final configuration. If the peninsula is desired to remain, it should be addressed through the Division's Technical Revision process. If not, the peninsula should be removed. Pit 2 is the focus of the mining operations at this time. The pit is being mined via highwall mining. Almost the entire perimeter of pit 2 consists of 12-15 foot highwalls. The highwalls appeared to be stable at the time of the inspection and no evidence of sloughing was noted. The pit has not exposed groundwater, minimal amounts of standing water was noted in response to recent precipitation events. The continued mining of the Pit 2 area appears to be consistent with the approved Mining Plan. The Pit 2 area can be seen in Photos Four and Five.

Photo One: View Northwest, showing the proper Mine ID signage located at the entrance to the site. The sign is dated, however does show the proper information.

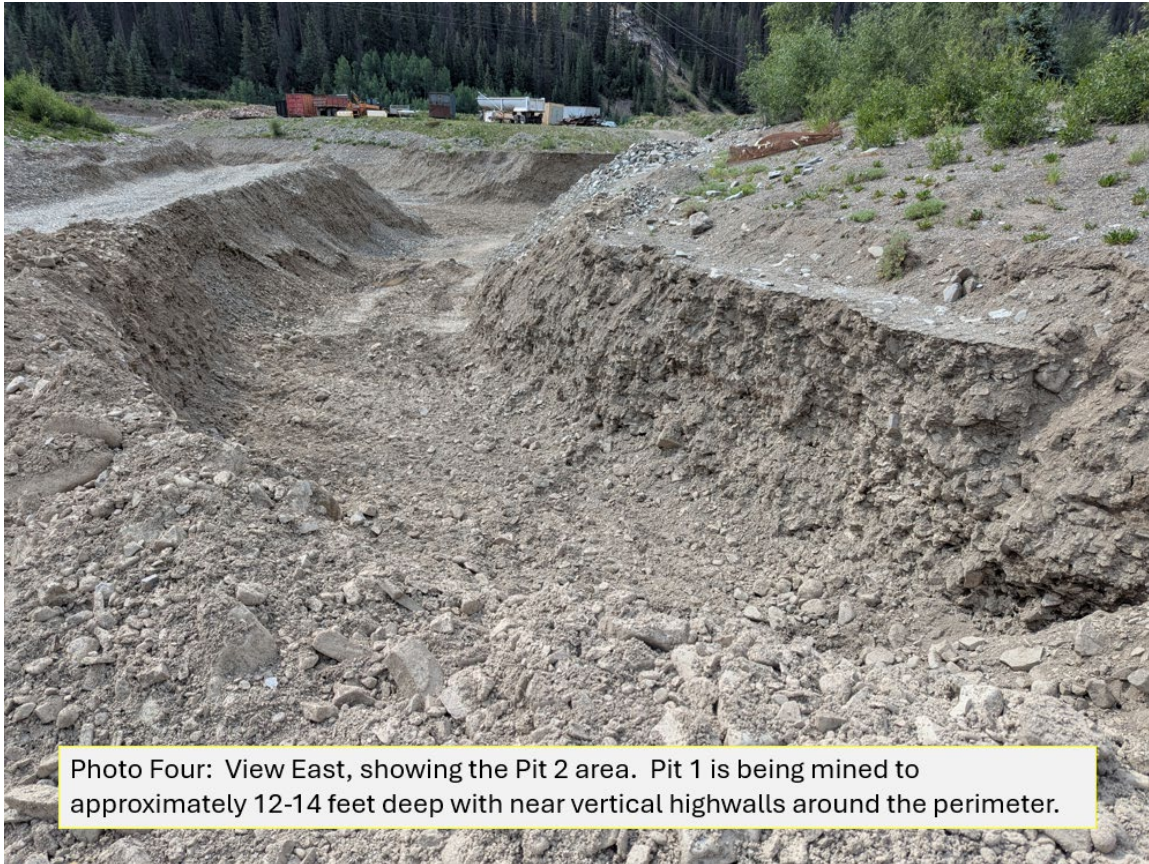
Photo Four: View East, showing the Pit 2 area. Pit 1 is being mined to approximately 12-14 feet deep with near vertical highwalls around the perimeter.

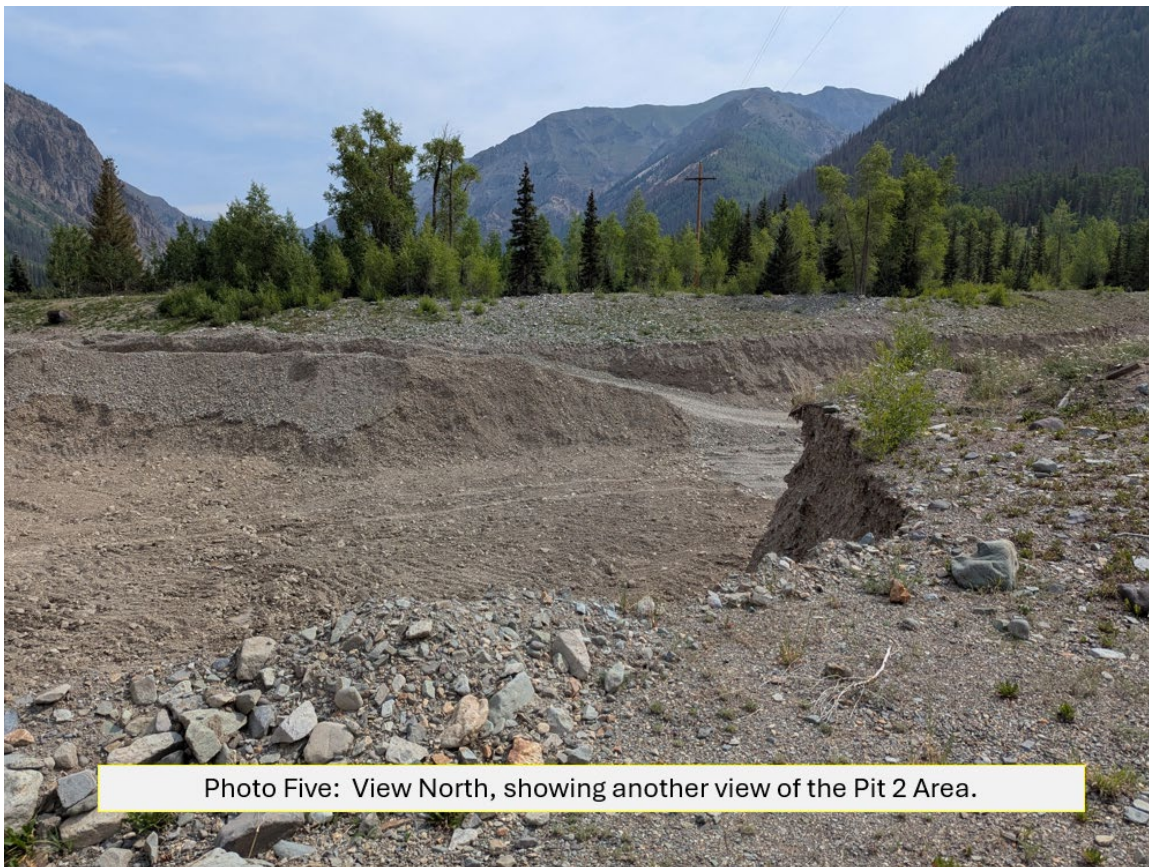
Photo Five: View North, showing another view of the Pit 2 Area.

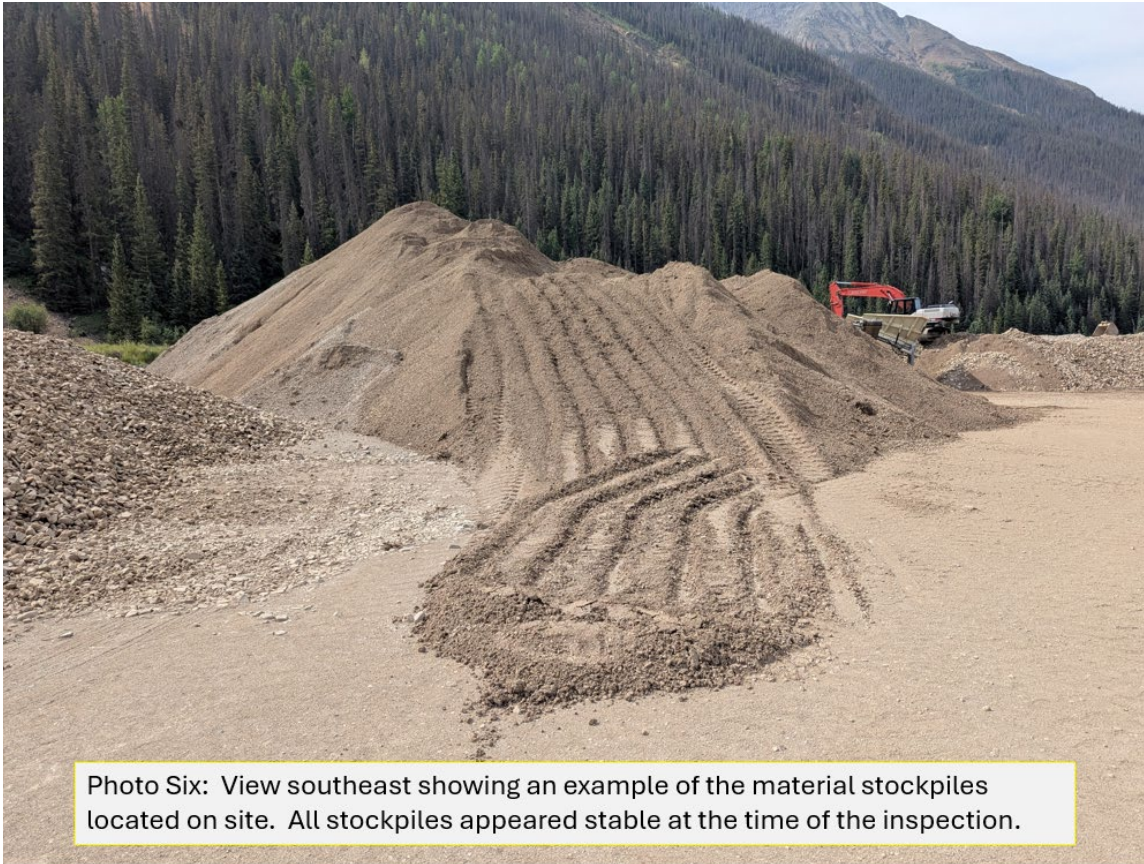
Photo Six: View southeast showing an example of the material stockpiles located on site. All stockpiles appeared stable at the time of the inspection.

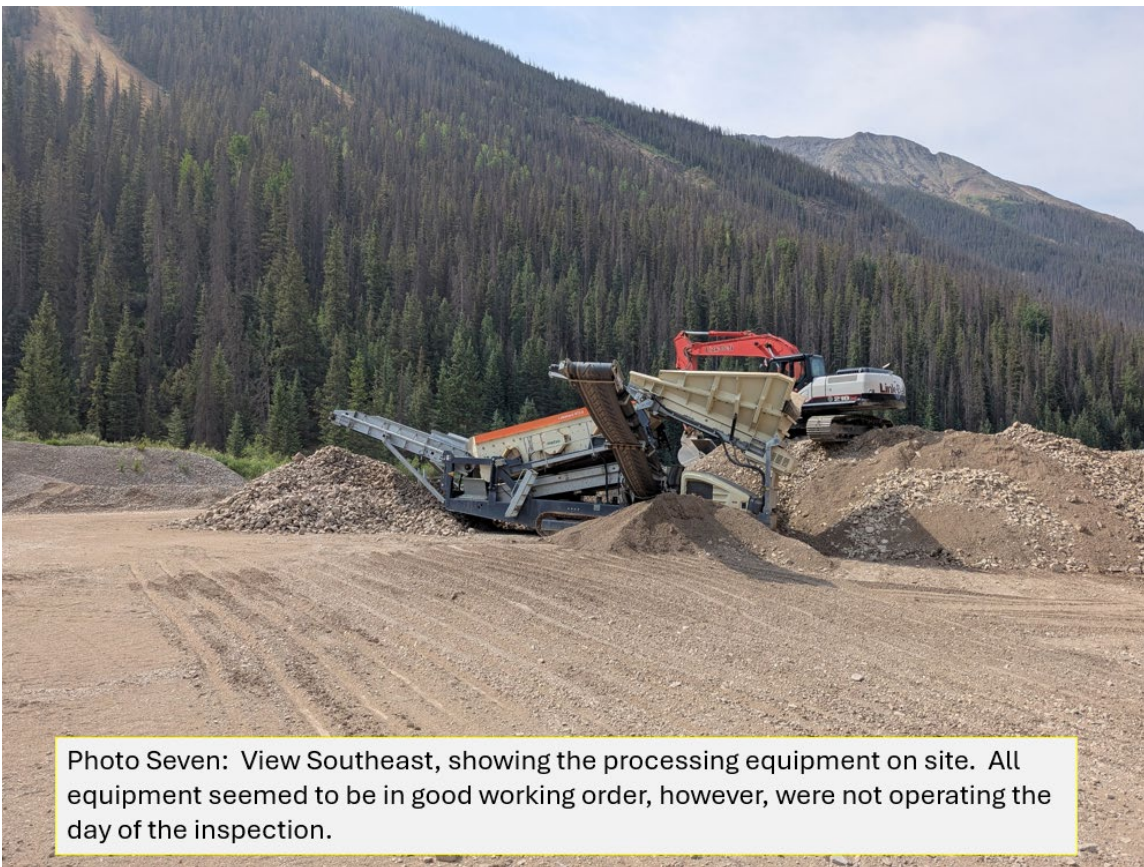
Photo Seven: View Southeast, showing the processing equipment on site. All equipment seemed to be in good working order, however, were not operating the day of the inspection.

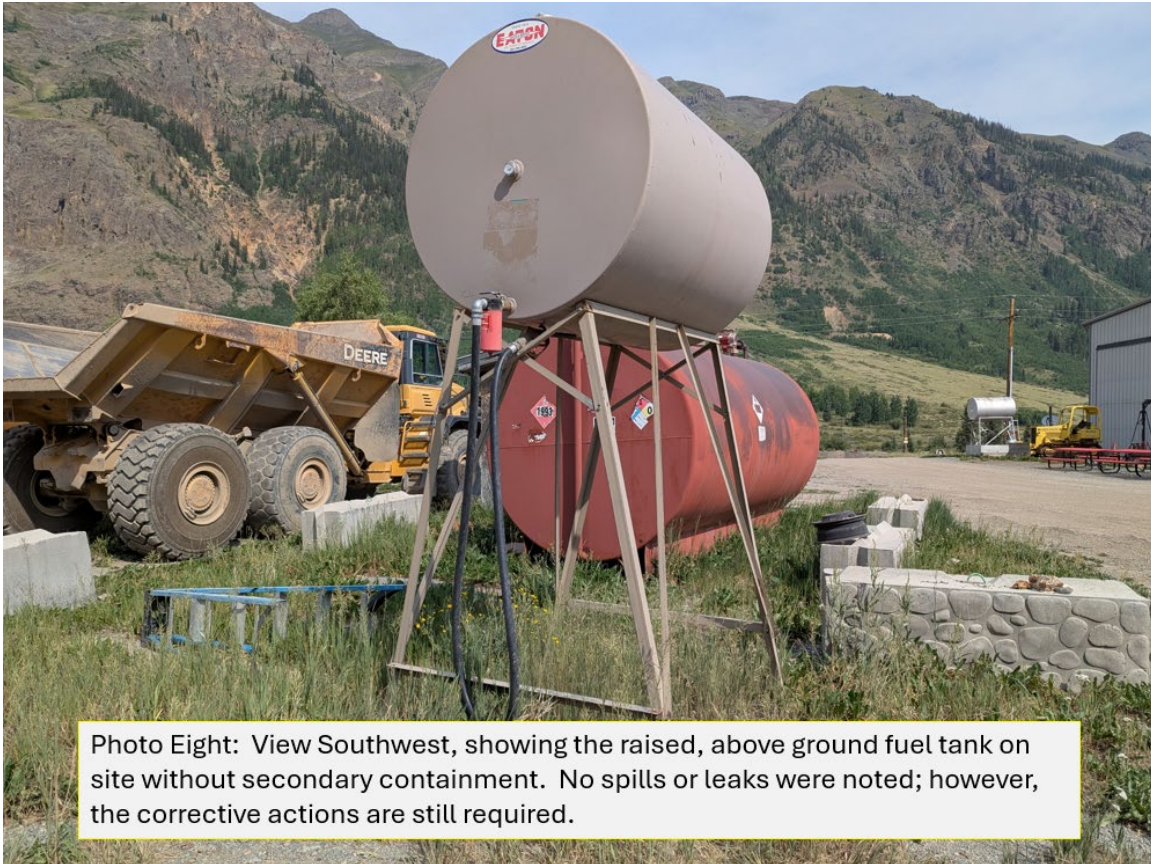
PROBLEM/POSSIBLE VIOLATION: Problem: Improper storage and containment of fuels and/or other hazardous materials was present on site. During the inspection an above ground fuel tank was observed with no secondary containment, and four super sacks of Hydrated Lime were also observed with no secondary containment.

In the pit 4 area, two problems were identified. On the West side of the unexcavated Pit 4 area is a fueling station consisting of two above ground fuel tanks. The large red tank was confirmed to be double walled for containment, however the elevated gray tank has no secondary containment structure of any kind. Photo Eight shows the fuel tank in need of containment. A secondary containment structure needs to be installed to catch any spills from the tank. The Operator or the contractor shall either empty the tank, or install some form of secondary containment with 110% of the capacity of the tank. Photo documentation of the corrective

CORRECTIVE ACTIONS: All storage tanks, petroleum and any hazardous materials on site for any period of time shall have appropriate secondary containment. The site will also have to comply with all applicable SPCC requirements. Please supply photo documentation that any fuel or hazardous materials containers are stored properly - including applicable secondary containment structures by the corrective action date. Note that secondary containment structures shall consist of an impermeable containment which could contain all contents of the tanks and various containers (when full) plus 10% of the total capacity. The operator may also provide photo documentation that all containers have been removed from the site on or before October 31, 2025.

CORRECTIVE ACTION DUE DATE: 10/31/25

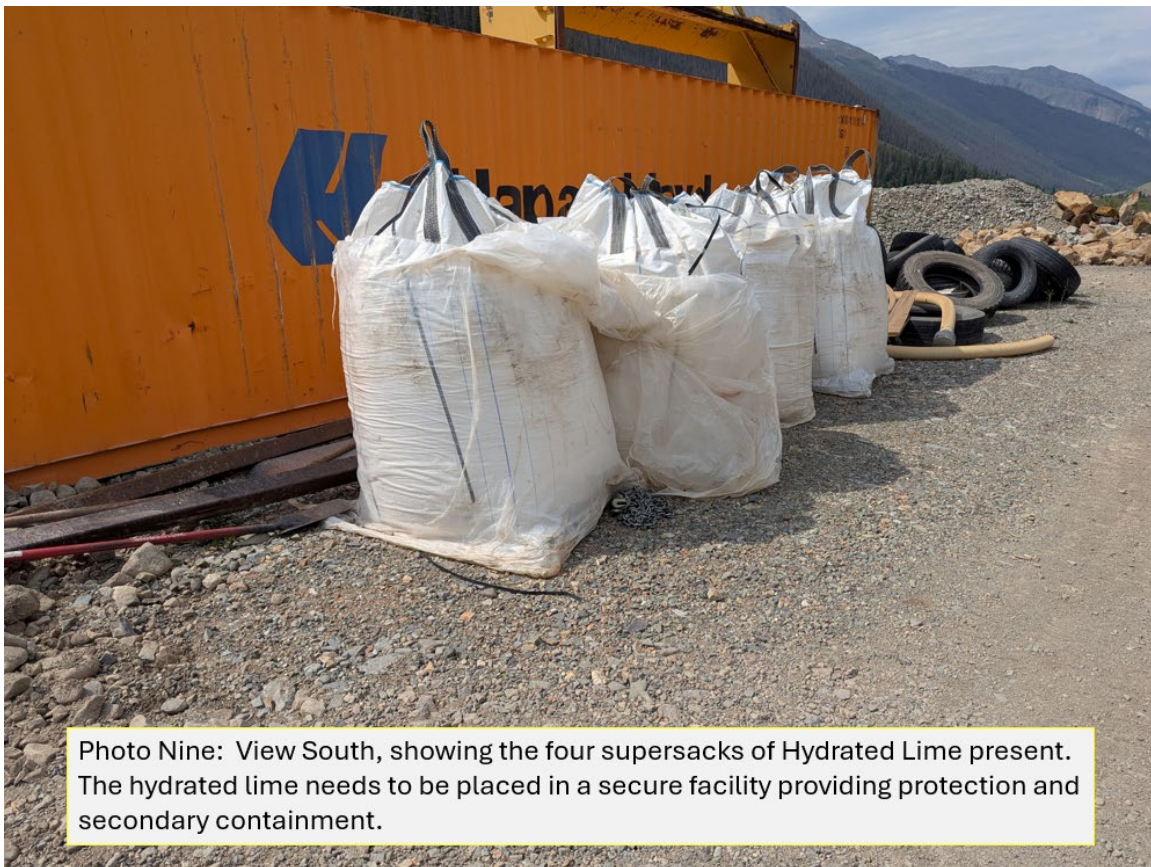
actions must be provided to the Division no later than October 31, 2025. Additionally, and in the same area, Four super sacks of Hydrated Lime, shown in Photo Nine. were observed to be outside and not on any containment structure. Hydrated Lime in large quantities is considered a hazardous substance and needs to be stored properly. The Operator or the contractor shall place the supersacks within some form of structure that protects it from the elements as well as provides secondary containment. Photo documentation of the corrective action must be provided to the Division no later than October 31, 2025.
