### MINERALS PROGRAM INSPECTION REPORT

| <b>MINE NAME:</b><br>Cottonwood Pit | <b>MINE/PROSPECTING ID#:</b><br>M-1986-010 | <b>MINERAL:</b><br>Sand and gravel | <b>COUNTY:</b><br>Fremont |
| <b>INSPECTION TYPE:</b><br>Monitoring | <b>WEATHER:</b><br>Raining | <b>INSP. DATE:</b><br>July 17, 2025 | <b>INSP. TIME:</b><br>13:28 |

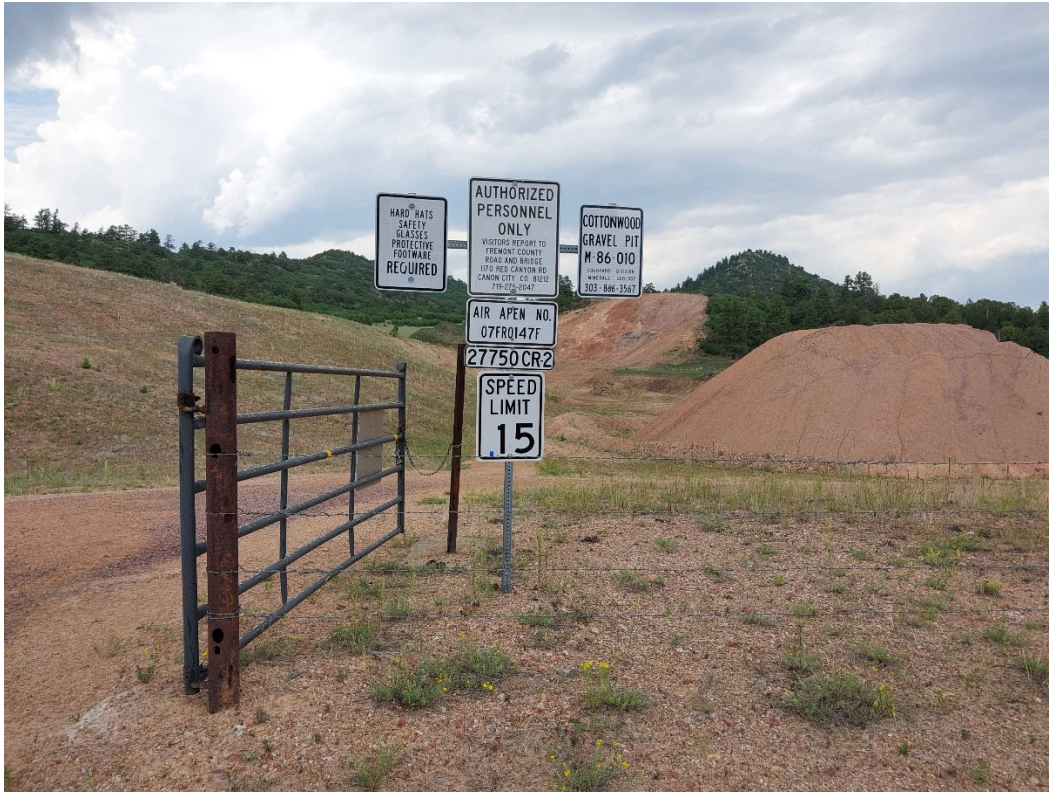
The required mine sign is posted at the entrance of the permitted area and is accurate according to the requirements of Rule 3.1.12(1), see Photo #1. Boundary markers are placed at the corners of the permit, marked with white PVC tubing, see Photo #2.

Photo #1: Mine sign posted at the pit entrance.

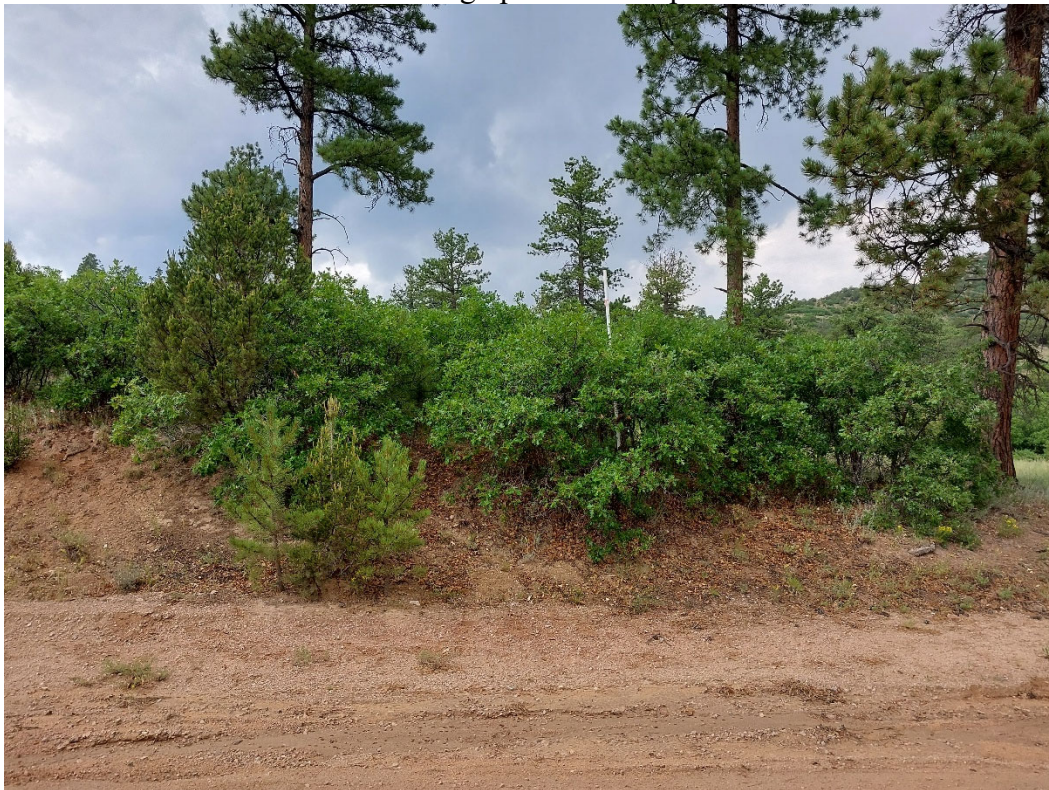
Photo #2: Example of a permit boundary marker, the white PVC pipe in the bushes.

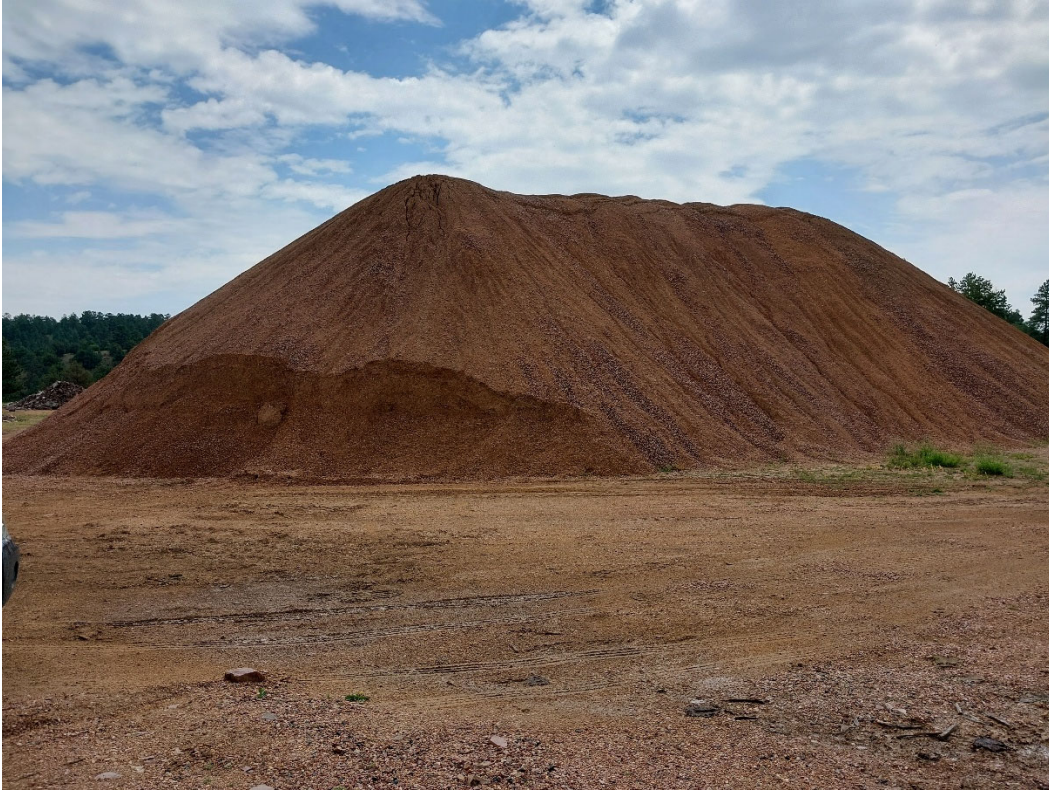
At the time of the inspection, mining activities were not occurring. A large stockpile of material was positioned in the southcentral portion of the permitted area, see Photo #3. To the east of the stockpile equipment was stored, the equipment on site included a wheel loader, a compaction roller, and a grizzly screen, see photo #4. Extraction has progressed moving northward, up a hill, with the topsoil pushed to the west side of the hill base. There does appear to be an area that has been backfilled, graded and seeded along the west side of the affected area.

Photo #3: Stockpile of material ready for use.

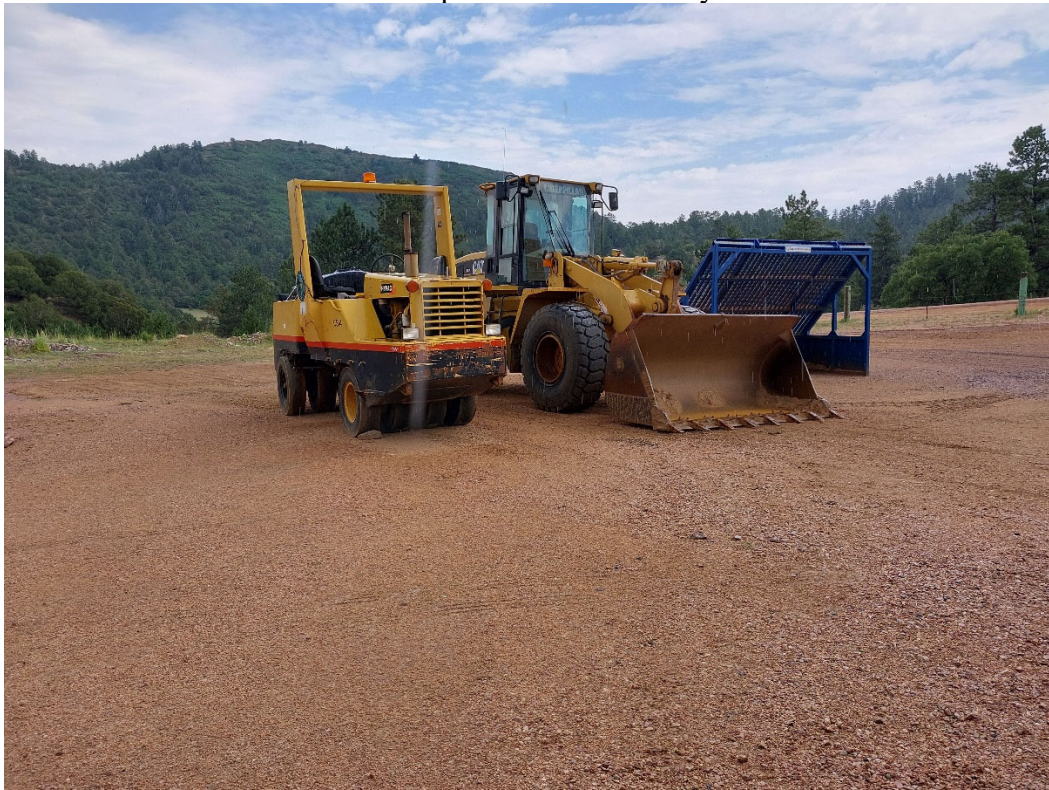
Photo #4: Stored equipment on site.

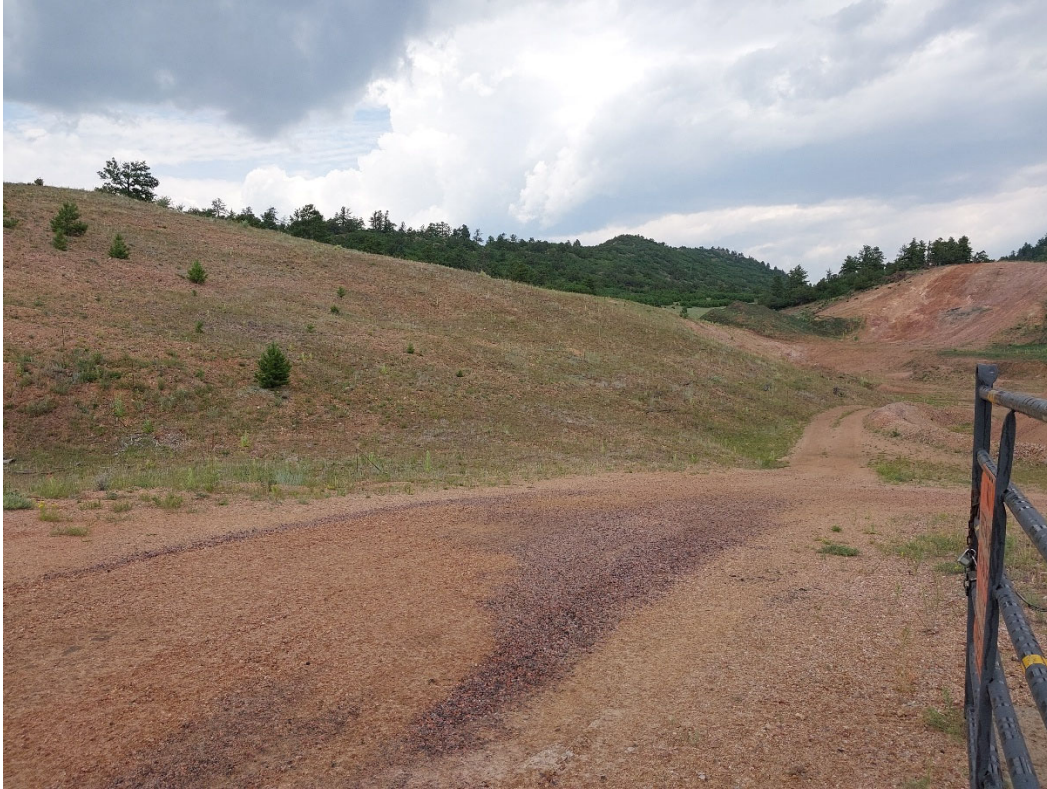
Areas that have been backfilled and graded appear to be sloped to the appropriate reclaimed slope of approximately 3H:1V. The slopes are stable with vegetation becoming established and there did not appear to be erosion occurring, see Photo #5.

Photo #5: Area observed to be backfilled, graded, and seeded on the west side of the pit area. The extraction area can be seen in the background on the right side of the picture.

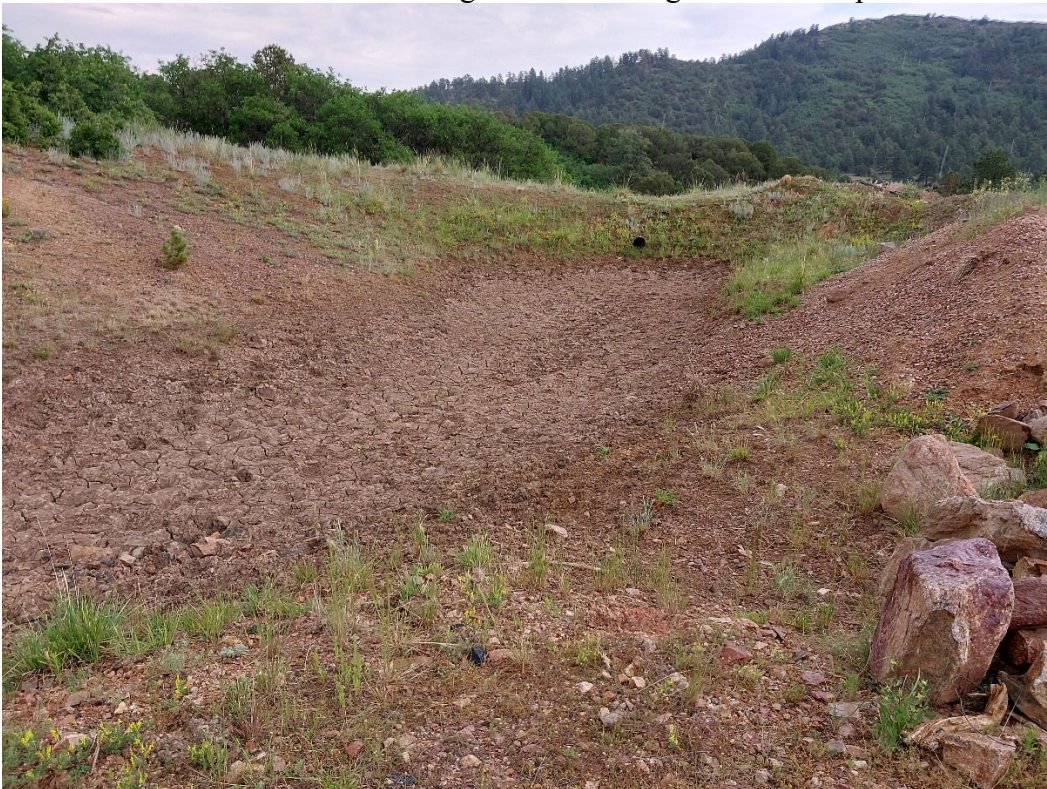
There is a stormwater impoundment located at the low area of the permit area in the southeast. There is a sediment settlement pond and a 36" culvert situated in a berm that directs runoff to a natural drainage channel. The settlement pond and culvert were clean and in good order, see Photo #6.

Photo #6: View of the settling pond and the culvert directing storm runoff to the natural drainage.

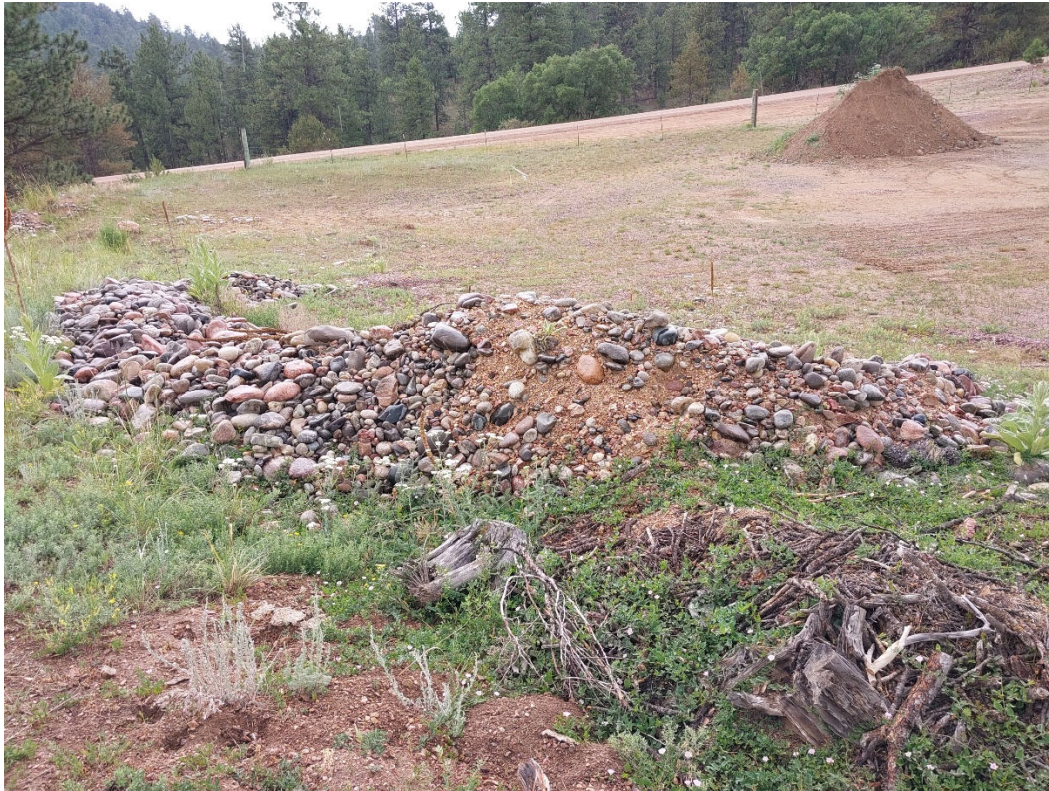
**PROBLEM:** The current mine plan needs to be updated and clarified pursuant to C.R.S. 34-32.5-112 (1)(c)(VI). The operator must provide sufficient information to describe or identify how the operator intends to conduct the operation.

There are small stockpiles of imported materials sourced from ditch cleaning activities observed to be located to the east of the stored equipment, see Photo #7. The material is resorted and repurposed for road maintenance by Fremont County. There appear to be a small amount of organic materials included with this material. This activity of importing material from cleaning sediment from ditches, resorting it, and using it for road maintenance is not documented in the approved permit file. A problem is being cited for this issue, see the problem above for details of the required corrective action and due date.

Photo #7: View of several stockpiles of imported materials.

**CORRECTIVE ACTIONS:** The operator shall submit a Technical Revision, with the required \$216 revision fee, to update and clarify the current approved mine plan to reflect existing activities of importing materials and information about if or how they will be used for reclamation. Provide a signed affidavit certifying that the materials are clean and inert.

**CORRECTIVE ACTION DUE DATE:** September 26, 2025

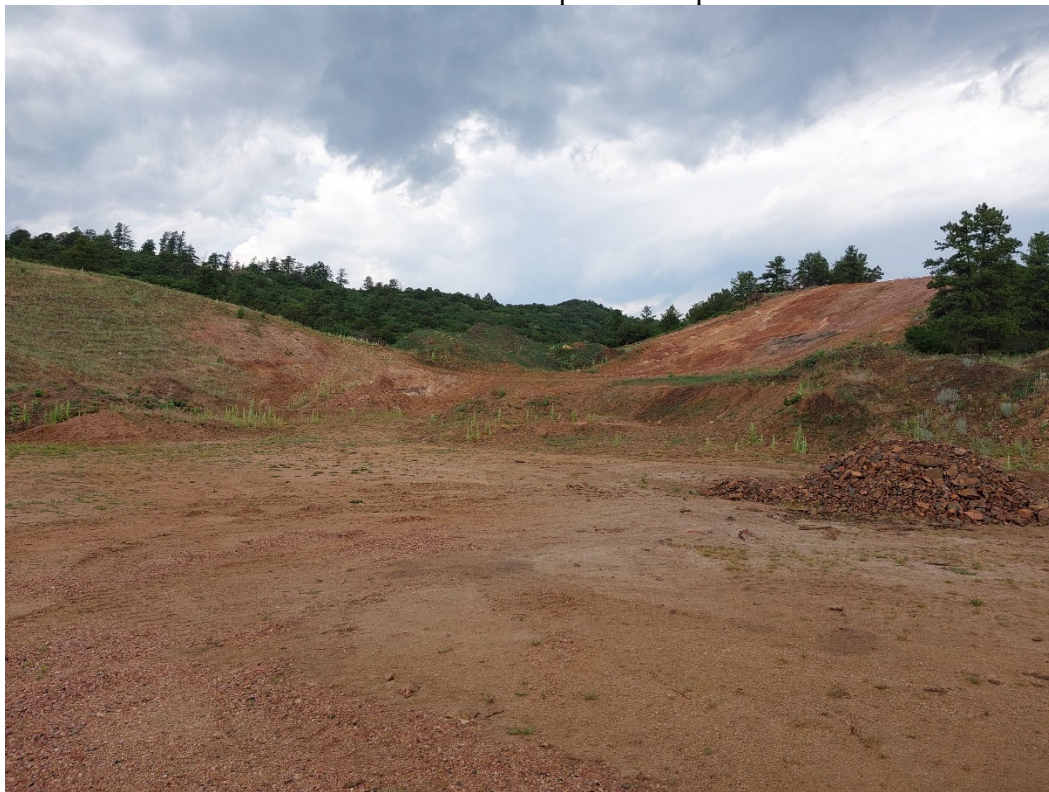
Common mullein, a List C noxious weed, was observed in some areas of the permitted area, see Photo #8. Mr. Hileman stated that he would be removing the common mullein within two weeks from the date of the inspection.

Photo #8: View of the northern expansion of the extraction area with the occurrences of common mullein in areas.
