MINERALS PROGRAM INSPECTION REPORT
PHONE: (303) 866-3567

MINE NAME: Jackrabbit Gravel Quarry	MINE/PROSPECTING ID#: M-2025-028	MINERAL: Aggregate	COUNTY: Garfield
INSPECTION TYPE: Preoperation Inspection	WEATHER: Clear	INSP. DATE: August 28, 2025	INSP. TIME: 11:00
OPERATOR: QB Energy Operating, LLC	OPERATOR REPRESENTATIVE: Ed Seymour	TYPE OF OPERATION: 112c - Construction Regular Operation	
REASON FOR INSPECTION: Preoperation Inspection	BOND CALCULATION TYPE: Complete Bond	BOND AMOUNT: PF.Actual Surety	
DATE OF COMPLAINT: NA	POST INSP. CONTACTS: None	JOINT INSP. AGENCY: None	
INSPECTOR(S): Todd Jesse	INSPECTOR'S SIGNATURE:

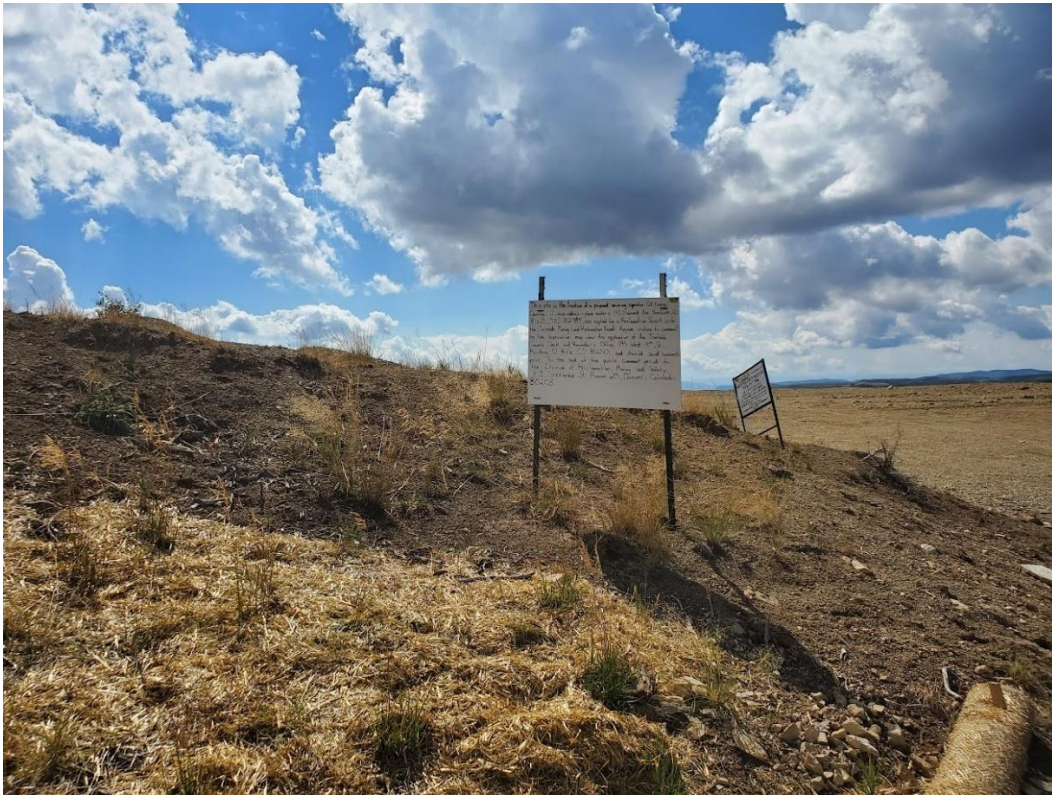
As required by Rule 1.6.2(1)(b) a sign with public notice was posted at the gate to the property.

Photo 1: View to the south of public notice sign at entrance to the pit.

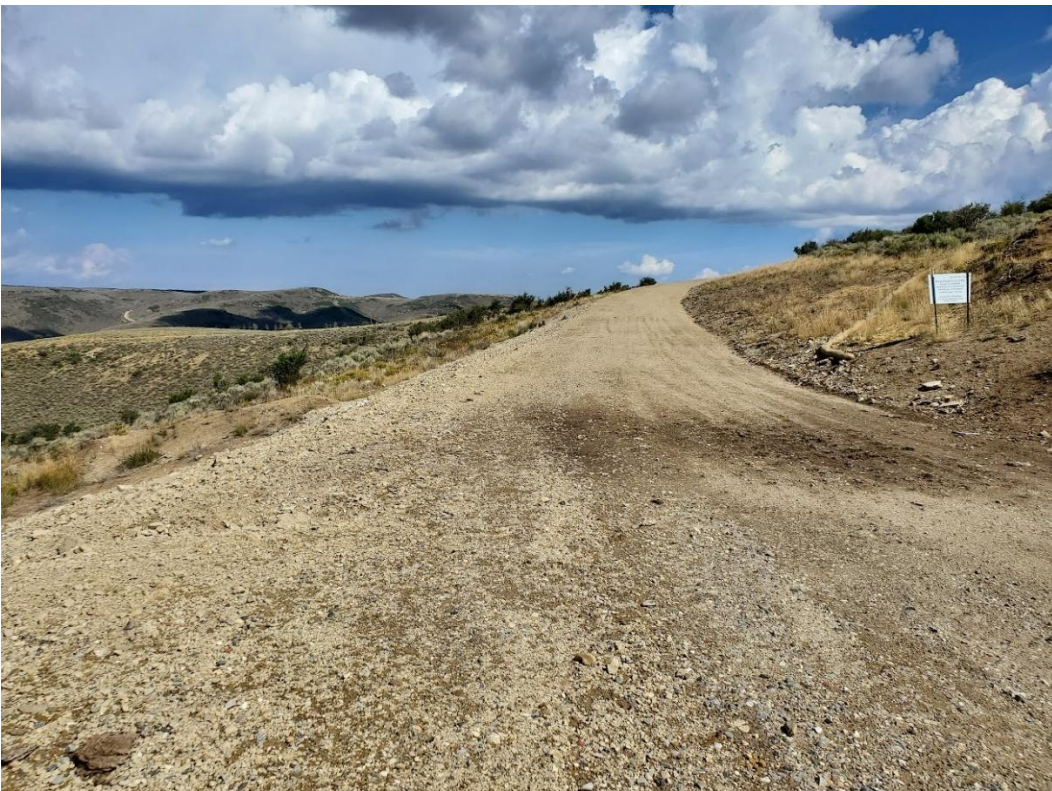
The access road to reach the site is in good condition. A water truck was observed on the roads approaching the pad. No displacement or excessive erosion was observed.

Photo 2: View to the north of access road into the quarry.

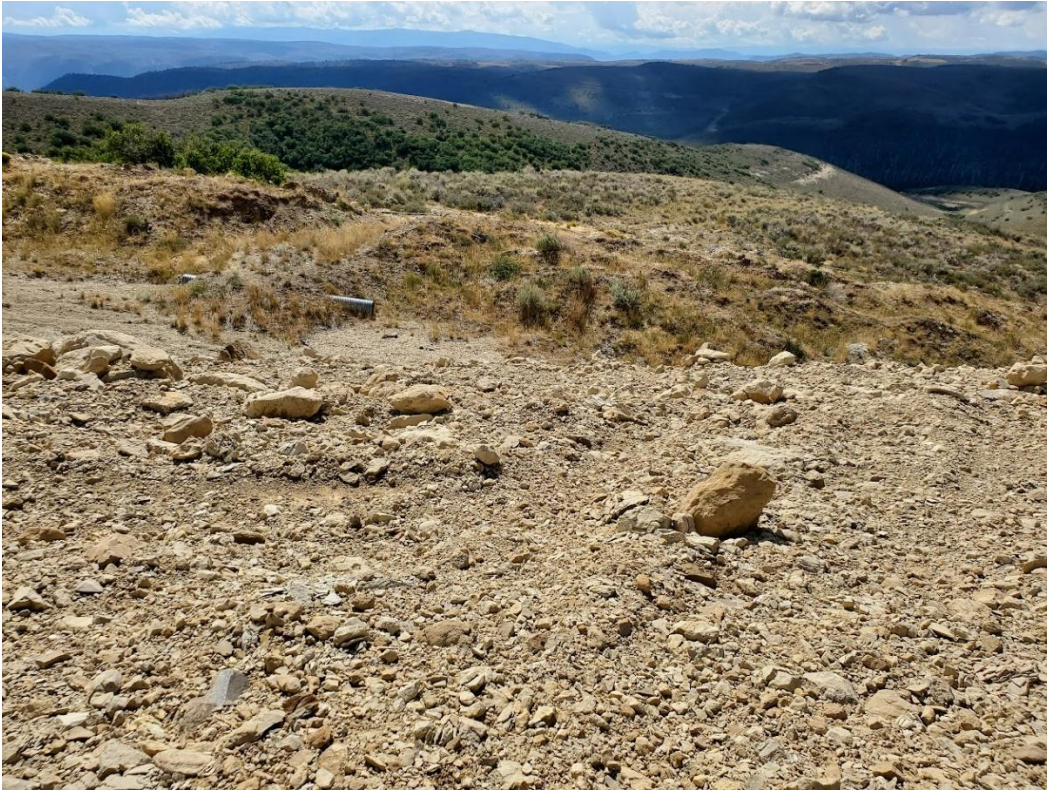
Topsoil is stockpiled on the southern end of the pad area and is protected by vegetation.

Photo 3: View to the south of topsoil stockpiles protected with vegetation.

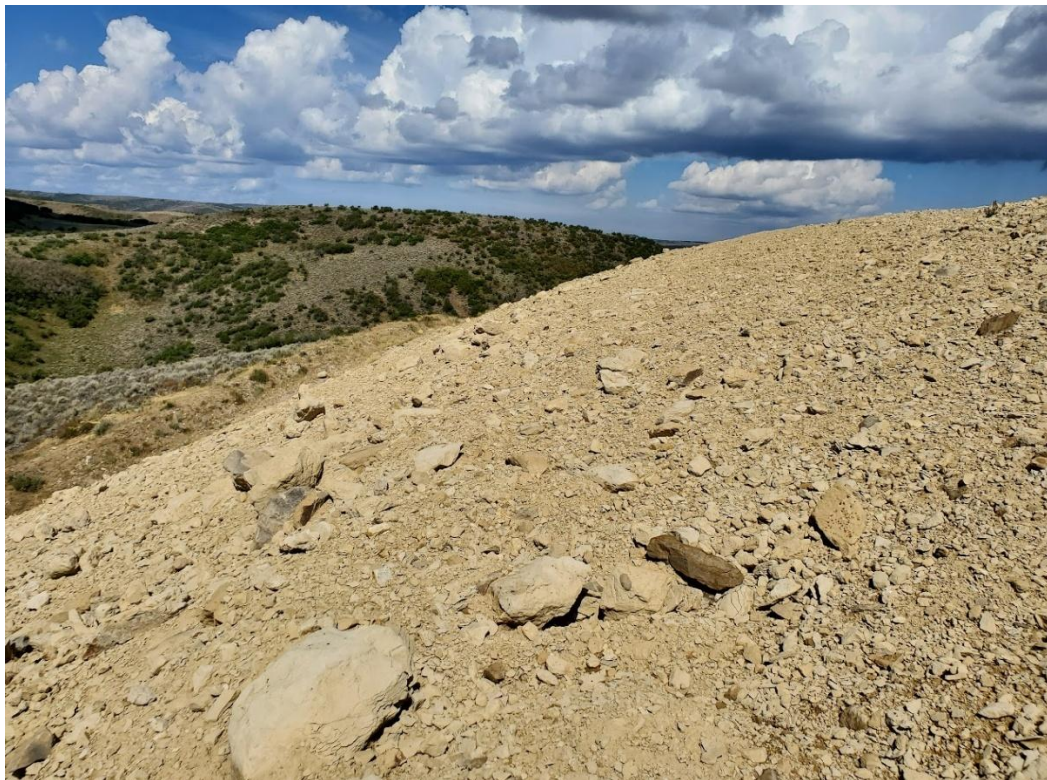
No groundwater has been exposed. It is not anticipated that the operation will impact groundwater. Meteoric water is controlled around the pad using berms and wattles. No hydrocarbons are present and no evidence of spills were noted.

Photo 4: View to the northwest of slopes below pad and stormwater berms.

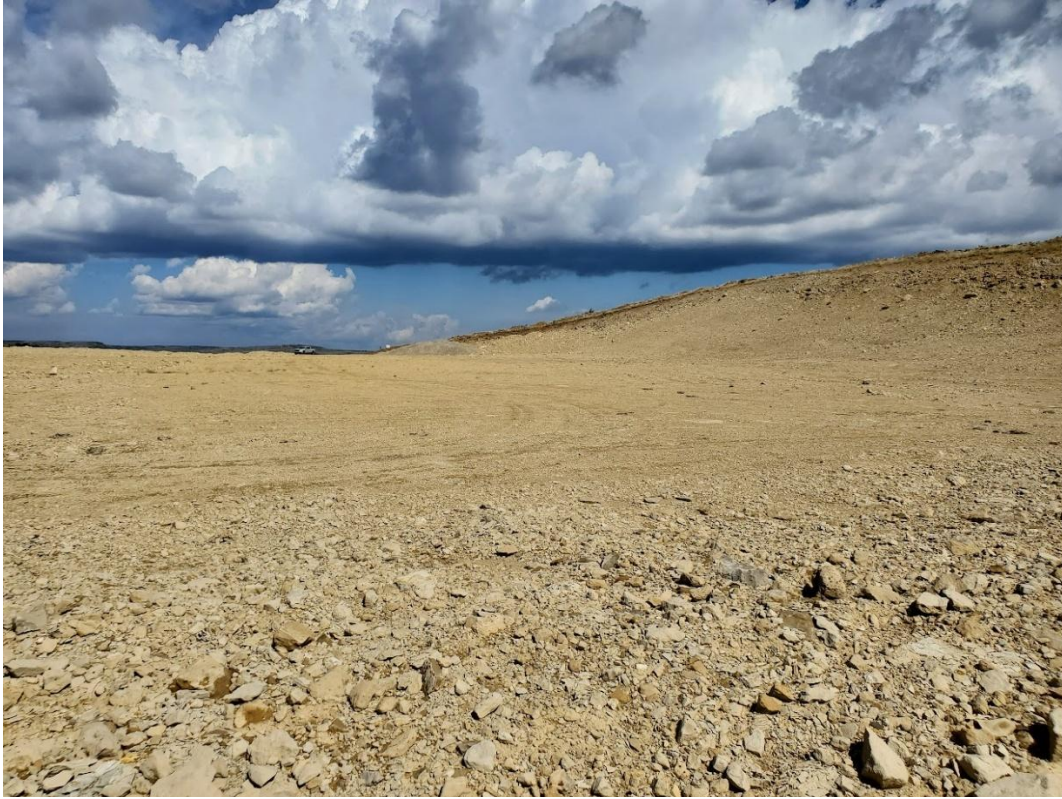
The area has been graded to a flat pad. The original intent was to create a well pad. The slopes above the pad area graded and appear stable with no erosion observed.

Photo 5: View to the north of the pad and the graded slope above it.
