**MINERALS PROGRAM INSPECTION REPORT**  
**PHONE: (303) 866-3567**

| <b>MINE NAME:</b><br>Little Tommy Mine | <b>MINE/PROSPECTING ID#:</b><br>P-2007-007 | <b>MINERAL:</b><br>Gold, silver, lead and | <b>COUNTY:</b><br>Summit |
| <b>INSPECTION TYPE:</b><br>Monitoring | <b>WEATHER:</b> Clear | <b>INSP. DATE:</b><br>August 13, 2025 | <b>INSP. TIME:</b><br>11:00 |

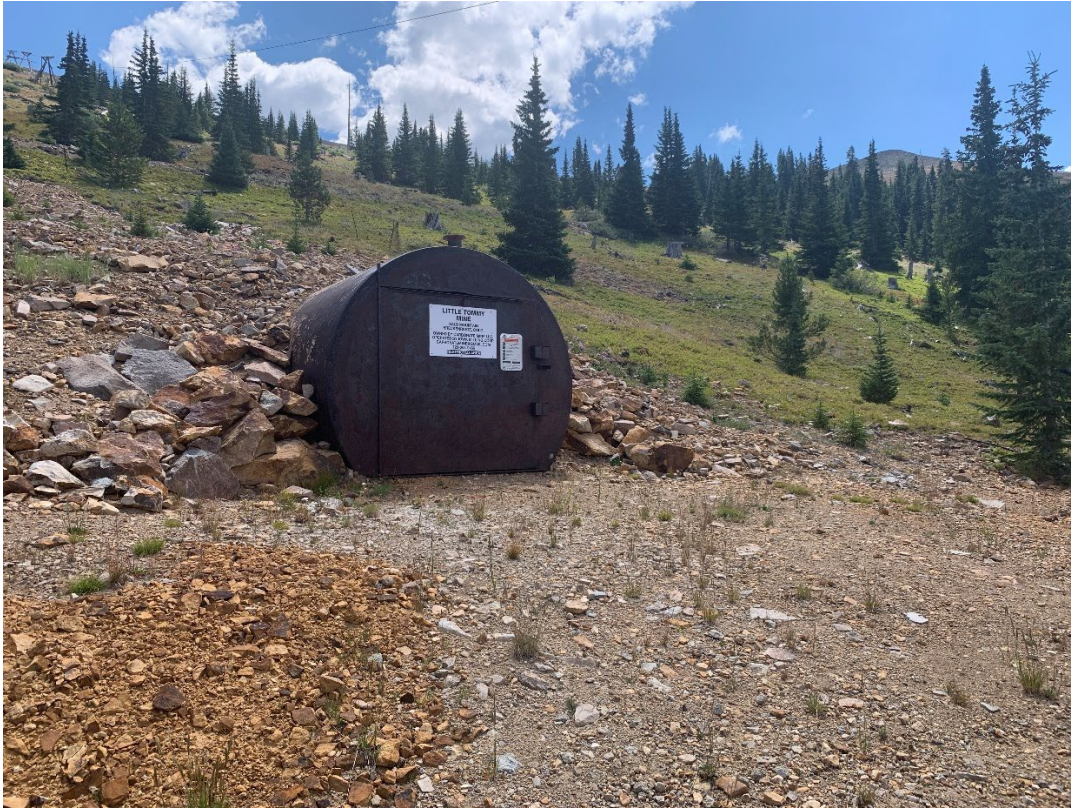
There were no signs of water draining from the portal. The hillside around the portal appeared to be stable (photo 1). The pad area around the portal appeared to be stable as there were no signs of erosion.

Photo 1- Portal entrance is well secured with no signs of water discharge.

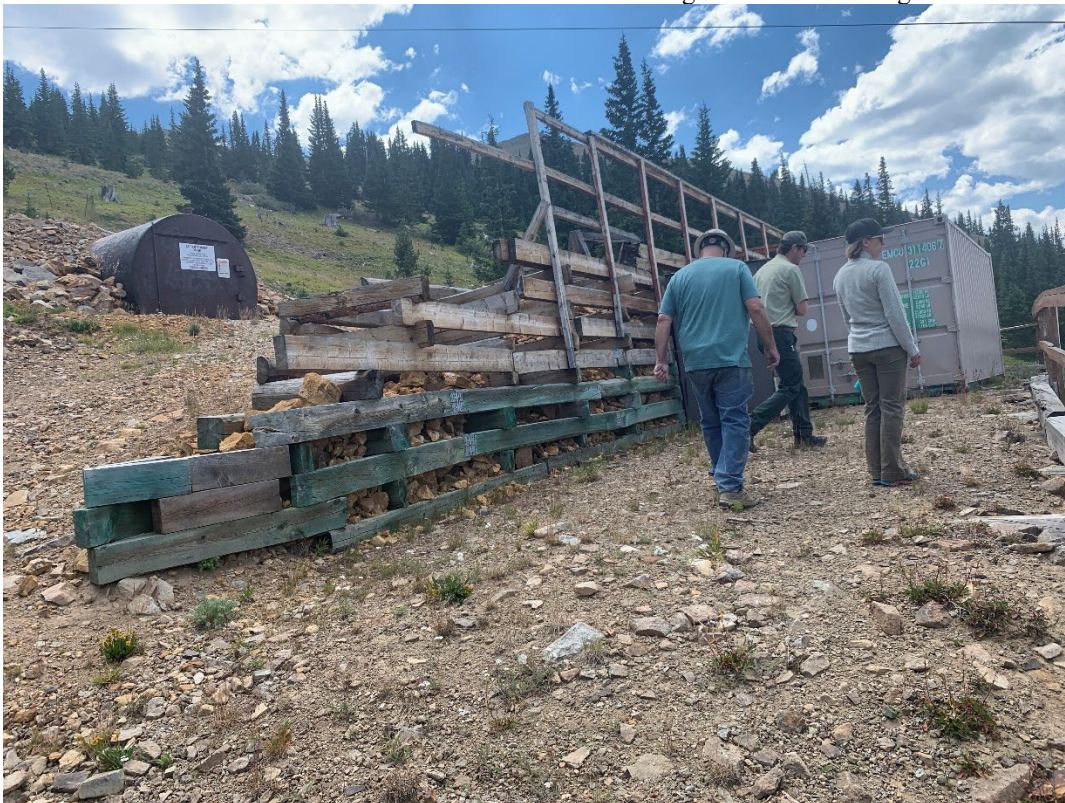
The mine pad area contained a Conex box, a cribbing structure that holds back waste rock, wooden storage shed and a secured steel portal (photo 2). The site was well maintained, and the portal was locked upon arrival.

Mining was not taking place during this inspection. The waste pile that is being held up by the cribbing appears to contain more material than in previous inspections. The cribbing structure appeared to be stable. A couple of historic tram towers with a cable suspended between them cross the site (photo 3).

Photo 2- Cribbing structure below mine portal and Conex box.

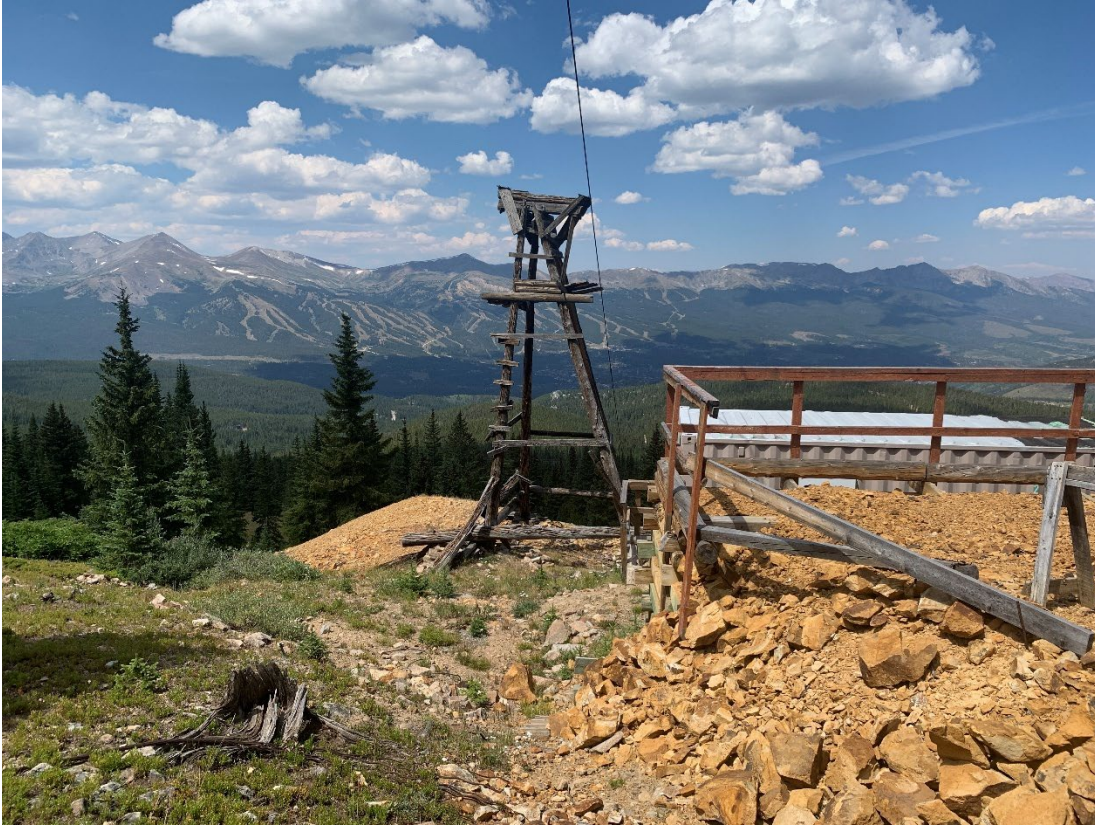
Photo 3- Historic tram tower with cable on south side of waste pile.
