**MINERALS PROGRAM INSPECTION REPORT**  
**PHONE: (303) 866-3567**

| <b>MINE NAME:</b><br>Iowa Mill Site | <b>MINE/PROSPECTING ID#:</b><br>P-1995-013 | <b>MINERAL:</b><br>Gold | <b>COUNTY:</b><br>Summit |
| <b>INSPECTION TYPE:</b><br>Monitoring | <b>WEATHER:</b> Clear | <b>INSP. DATE:</b><br>August 13, 2025 | <b>INSP. TIME:</b><br>11:00 |

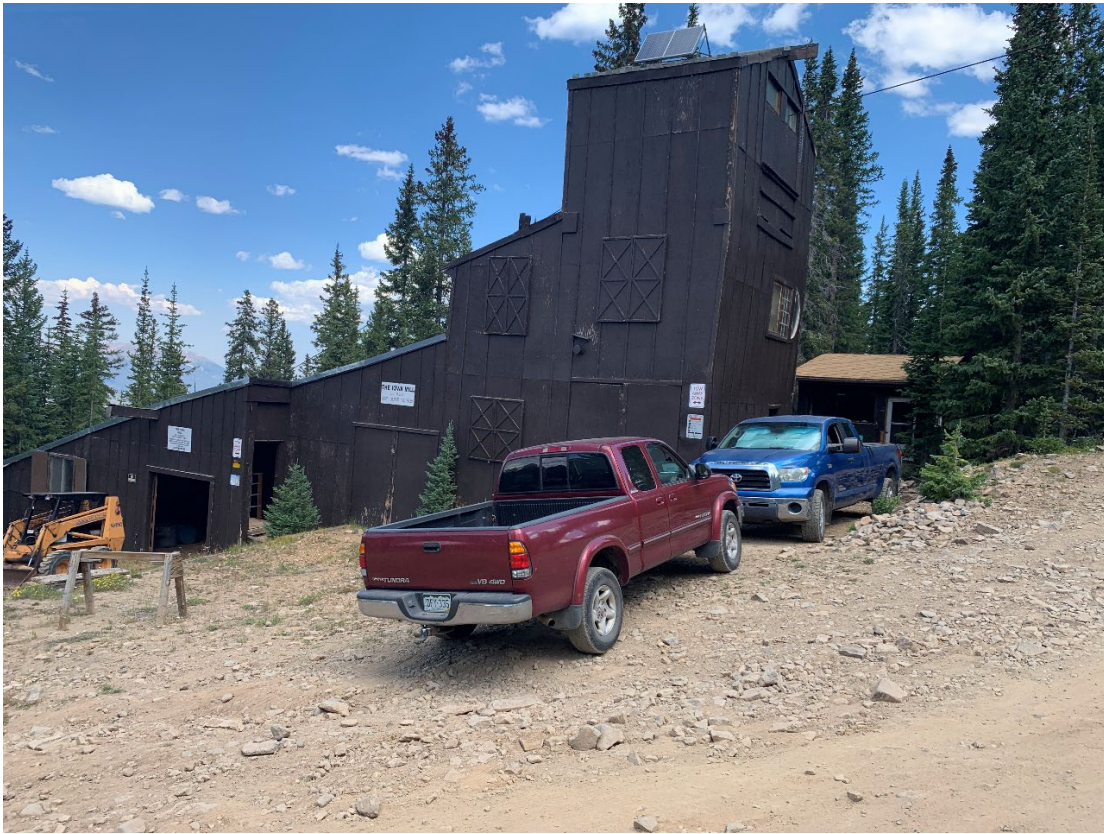
The soil around the mill building was stable and no erosion features were noted (photo 1).

Photo 1 – Mill building adjacent to forest service road.

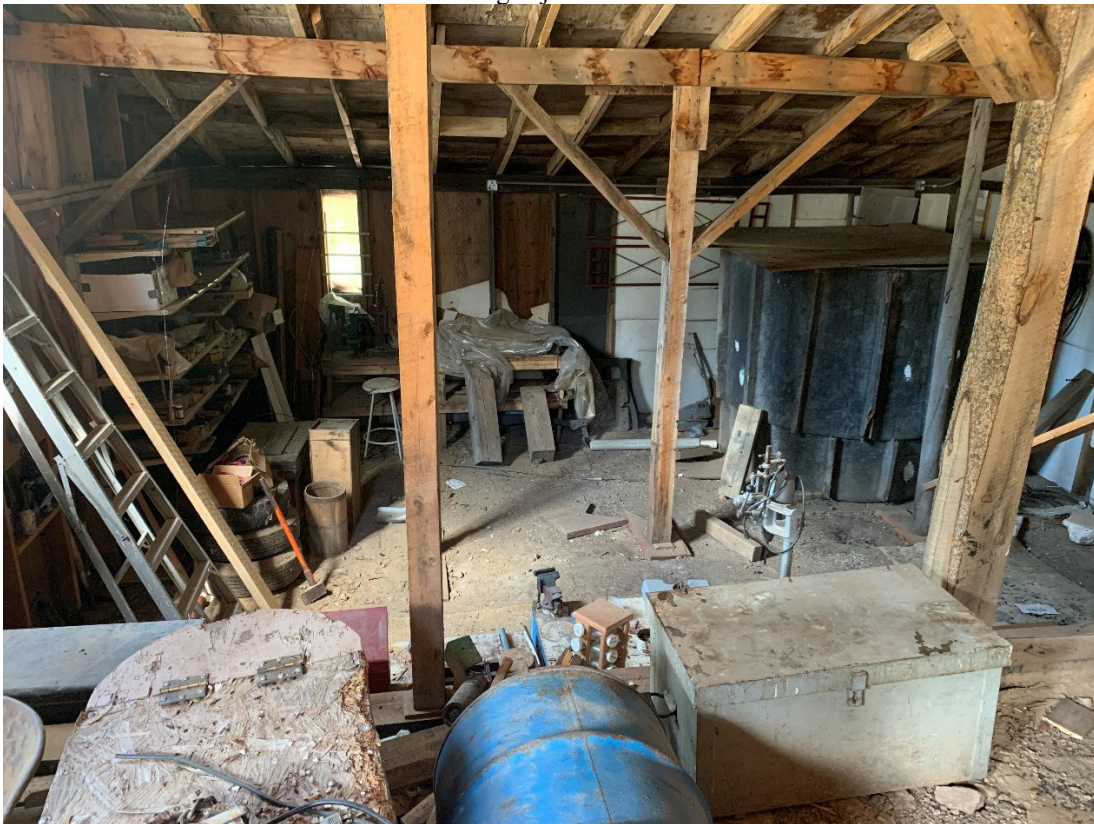
At the time of this inspection, maintenance was being performed on the Mill building. No tailings or ore were being processed or stored at the mill site (photo 2). The mill building is located very close to the USFS road which had a surprising amount of vehicle and hiker activity.

Photo 2 – Shop area inside Mill building.

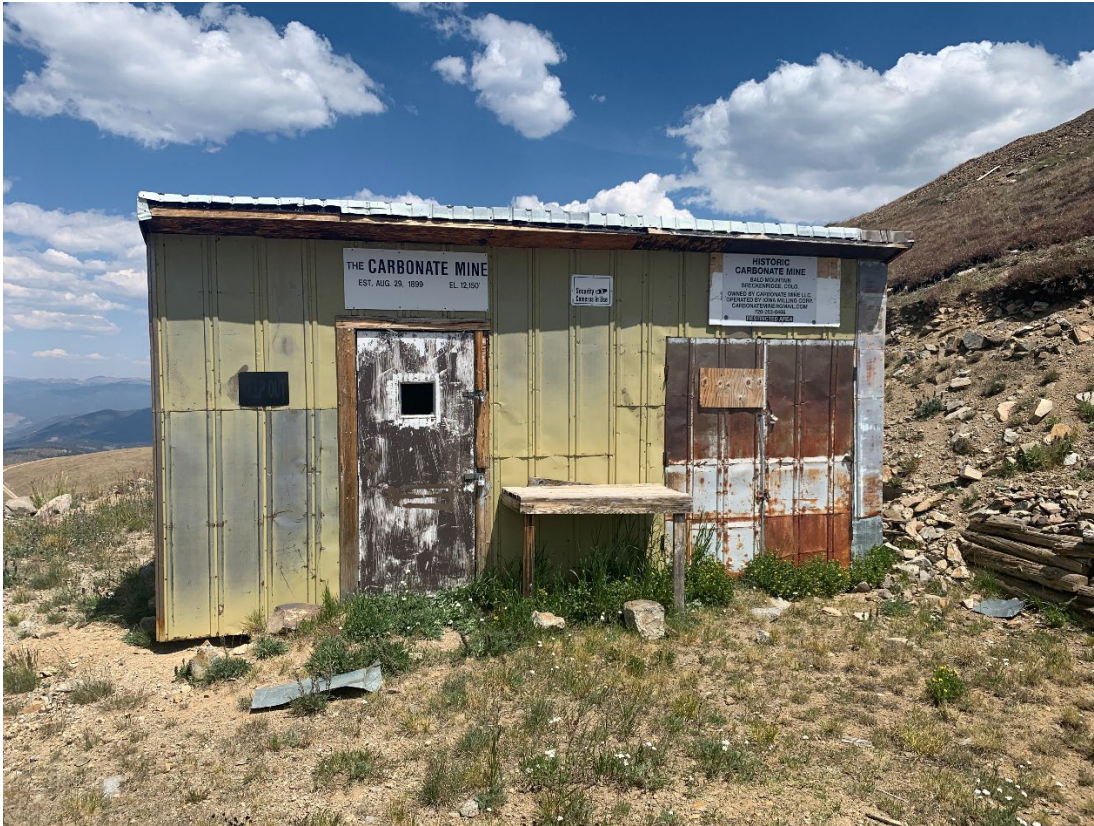
The Carbonate Mine site consists of a metal shed (photo 3), a secured steel portal and an old wooden loadout chute. The loadout chute is not operational but is being considered for historical preservation.

Photo 3 – Steel building and pad area at the Carbonate Mine.
