MINERALS PROGRAM INSPECTION REPORT
PHONE: (303) 866-3567

MINE NAME: Pioneer Farm	MINE/PROSPECTING ID#: M-2000-080	MINERAL: Sand	COUNTY: Arapahoe
INSPECTION TYPE: Monitoring	WEATHER: Clear	INSP. DATE: August 21, 2025	INSP. TIME: 10:00
OPERATOR: Holcim - WCR, Inc.	OPERATOR REPRESENTATIVE: Wyatt Webster	TYPE OF OPERATION: 112c - Construction Regular Operation	
REASON FOR INSPECTION: Normal I&E Program	BOND CALCULATION TYPE: Complete Bond	BOND AMOUNT: \$200,128.00	
DATE OF COMPLAINT: NA	POST INSP. CONTACTS: None	JOINT INSP. AGENCY: None	
INSPECTOR(S): Brock Bowles	INSPECTOR'S SIGNATURE:

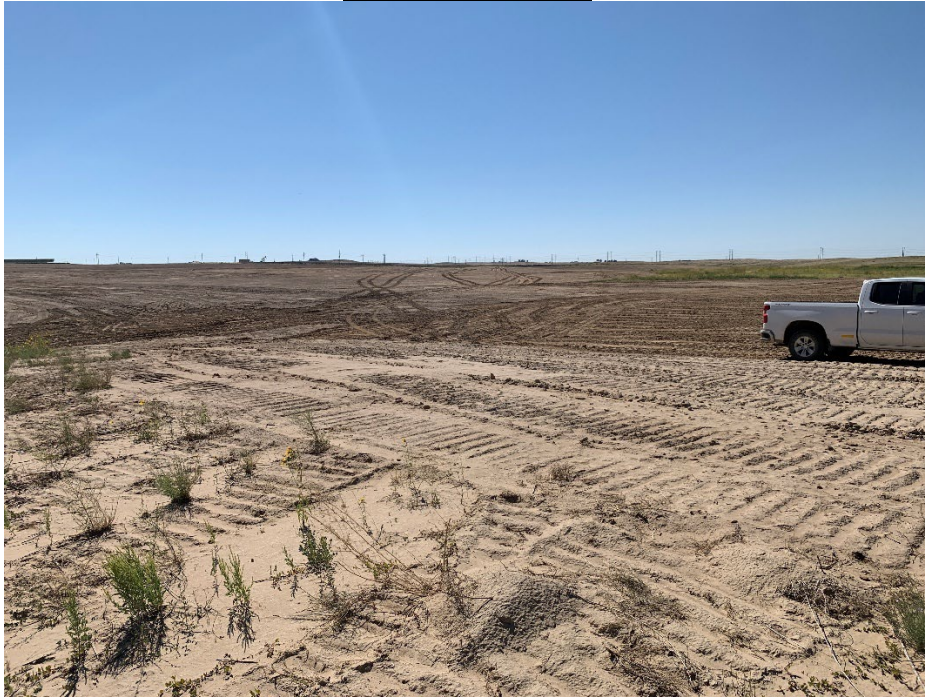
All product stockpiles have been cleared. The pit area has been regraded to seamlessly integrate with the surrounding landscape (photo 1). The slopes of the regraded area match the angles of the adjacent farmland, allowing for the use of farming equipment in line with the post-mining land use as cropland. Topsoil was distributed to the required 6-inch depth across the entire pit area. No topsoil stockpiles remained on site.

Photo 1- Mining area regraded to blend in with surrounding landscape, facing south

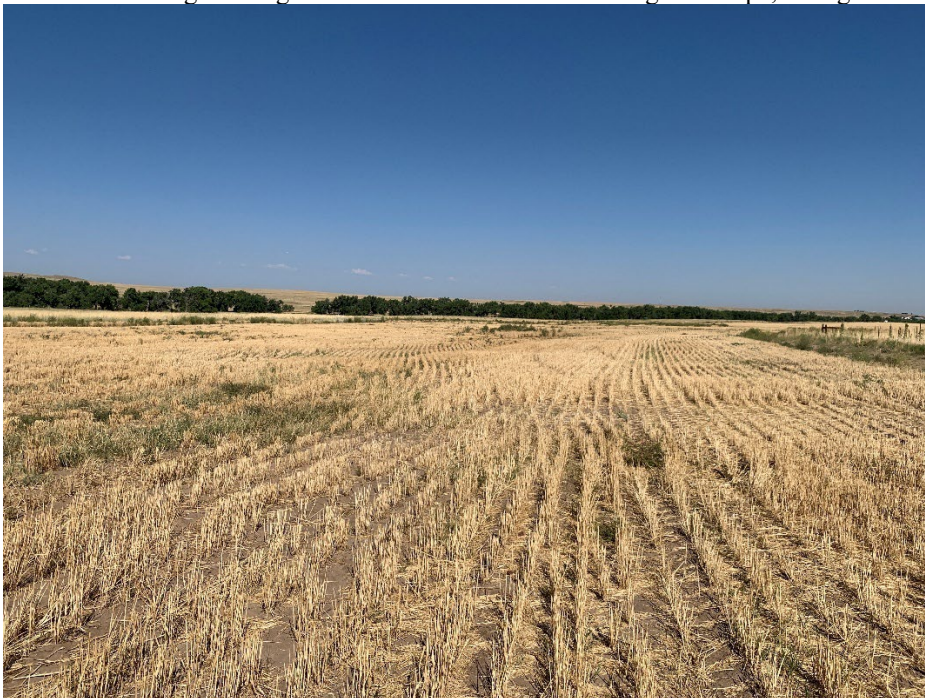
Winter wheat was planted and harvested in the western section of the permit area, which had been previously reclaimed (photo 2)

Photo 2- The reclaimed area west of the oil pad has been planted and harvested.

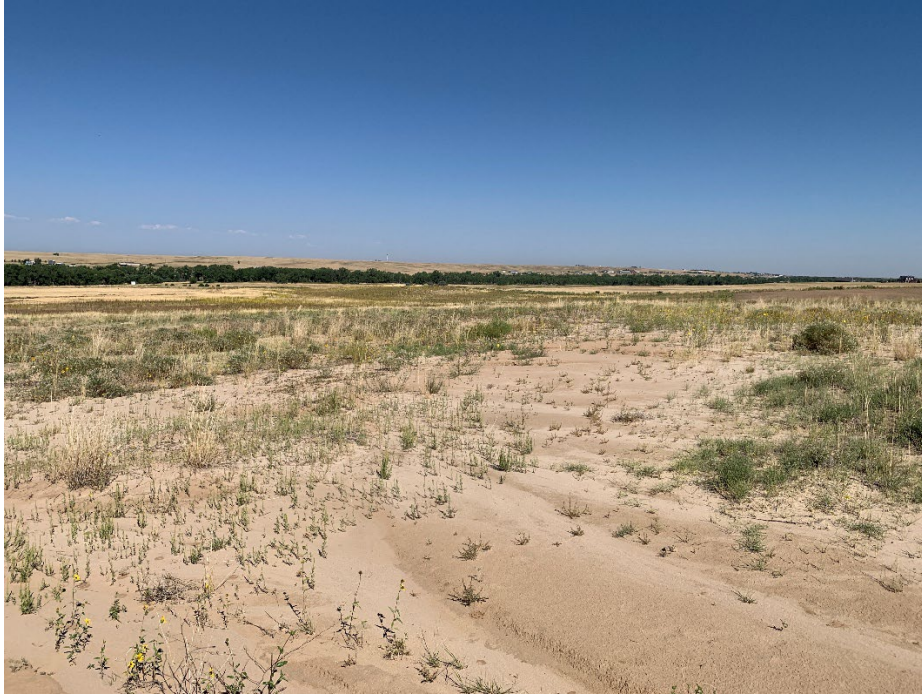
Photo 3- Former pit area regraded and ready for cultivation and seeding, facing northwest.

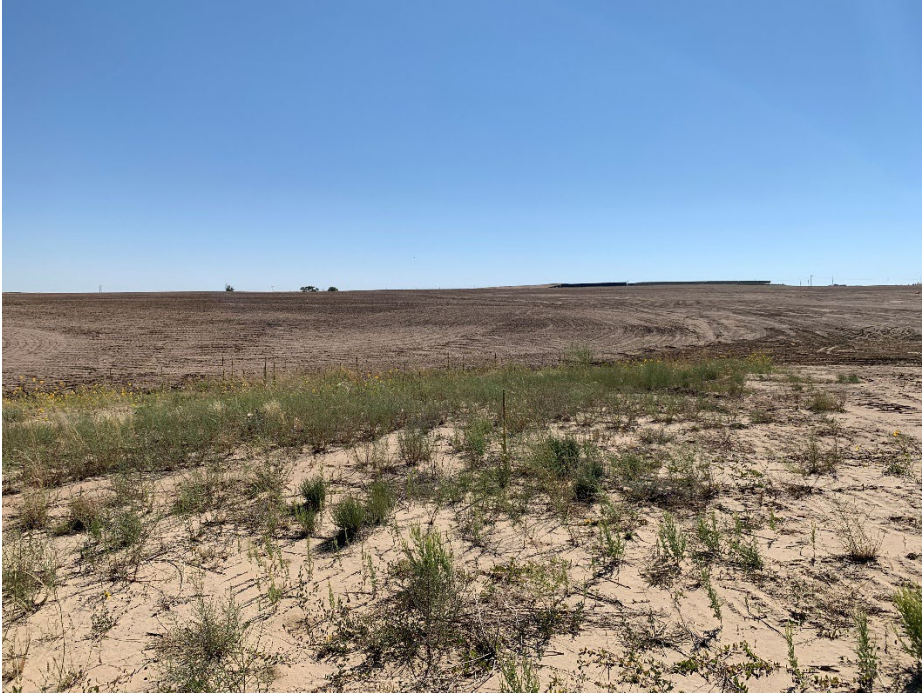
Photo 4- East sections of the permit area that were not disturbed by mining and are still farmed.
